## Appendix N Exceedance Report

**Incident Report on Action Level or Limit Level Non-compliance**

Project	Integrated Waste Management Facilities, Phase 1		
Date	04 Jul 2019 (Lab result received on 09 Jul 2019)		
Time	17:10 – 19:00 (Mid-Flood)		
Mid-Flood			
Monitoring Location	<p>S1</p>		
Parameter	Suspended Solid (SS)		
Action & Limit Levels	Action Level		Limit Level
	≥ 12.0 mg/L		≥ 14.0 mg/L
Measurement Level	Impact Station(s) of Exceedance	Control Stations	Impact Station(s) without Exceedance

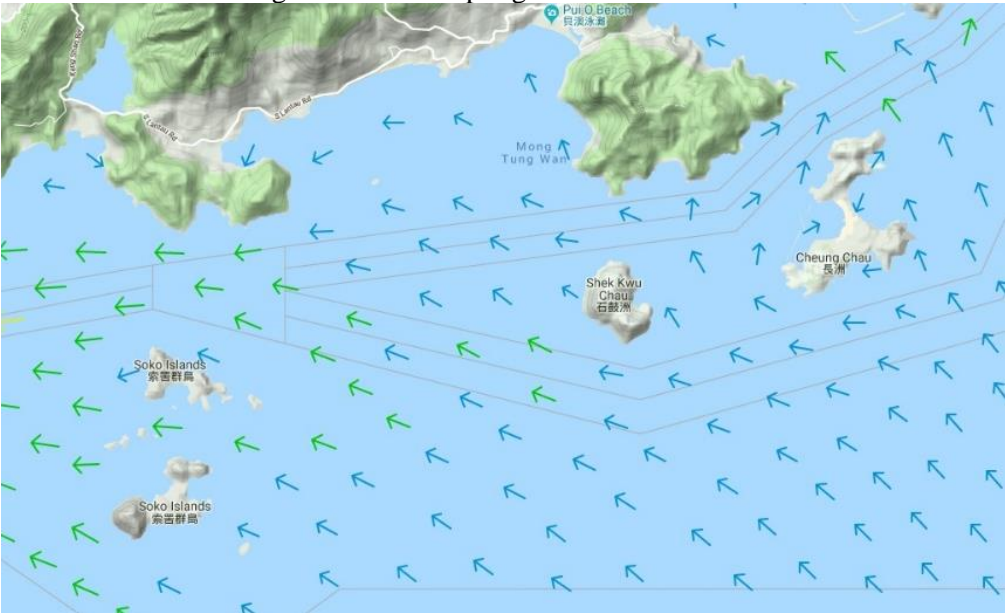
<p>barge (GD-851) on that day while no construction activities were conducted on that day.</p> <p>No silt curtain checking before the commencement of construction activities was implemented by the Contractor since there was no construction activities to be carried out on 04/07/2019.</p> <p>Site tidiness on the barges was checked during the weekly site inspection on 8 Jul 2019. No major observation of improper site practices that could contribute to the increase of the suspended solids was recorded.</p>								
<p>Actions taken / to be taken</p>	<p>Examination of environmental performance of the Project will be continued during the weekly inspection, and the Contractor is reminded to implement all applicable mitigation measures as per the Updated EM&amp;A Manual.</p>								
<p>Remarks</p>	<p>Current direction during mid-flood sampling on 04/07:</p>
