Appendix N Exceedance Report

Incident Report on Action Level or Limit Level Non-compliance

Project	Integrated Waste Management Facilities, Phase 1		
Date	06 Sep 2019 (Lab result received on 11 Sep 2019)		
Time	10:53 – 14:23 (Mid-Flood)		
Mid-Flood			
Monitoring Location	B3 & CR2

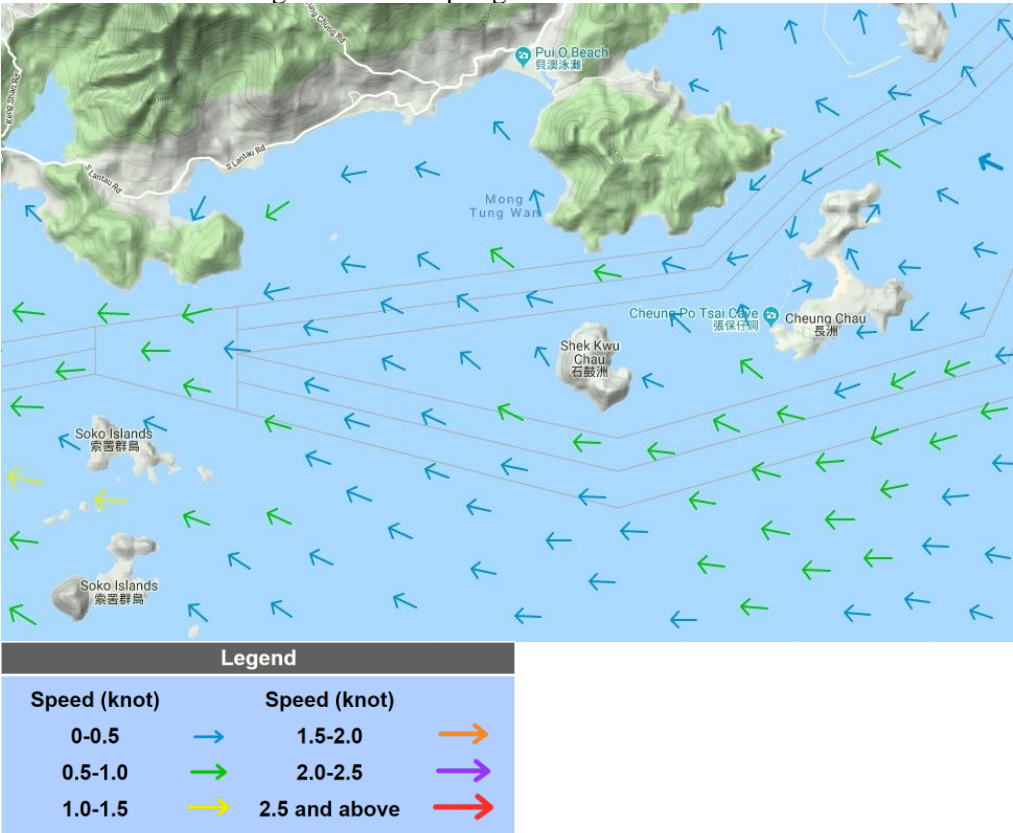
<p>Actions taken / to be taken</p>	<p>Two parts of secondary silt curtain of ESC-62 has been maintained in good condition on 11/09. The Contractor was reminded to keep tracking on the status of the deployed silt curtain during construction works.</p> <p>Examination of environmental performance of the Project will be continued during the weekly inspection, and the Contractor is remained to implement all applicable mitigation measures as per the Updated EM&A Manual.</p>
<p>Remarks</p>	<p>Current direction during mid-ebb sampling on 06/09:</p>

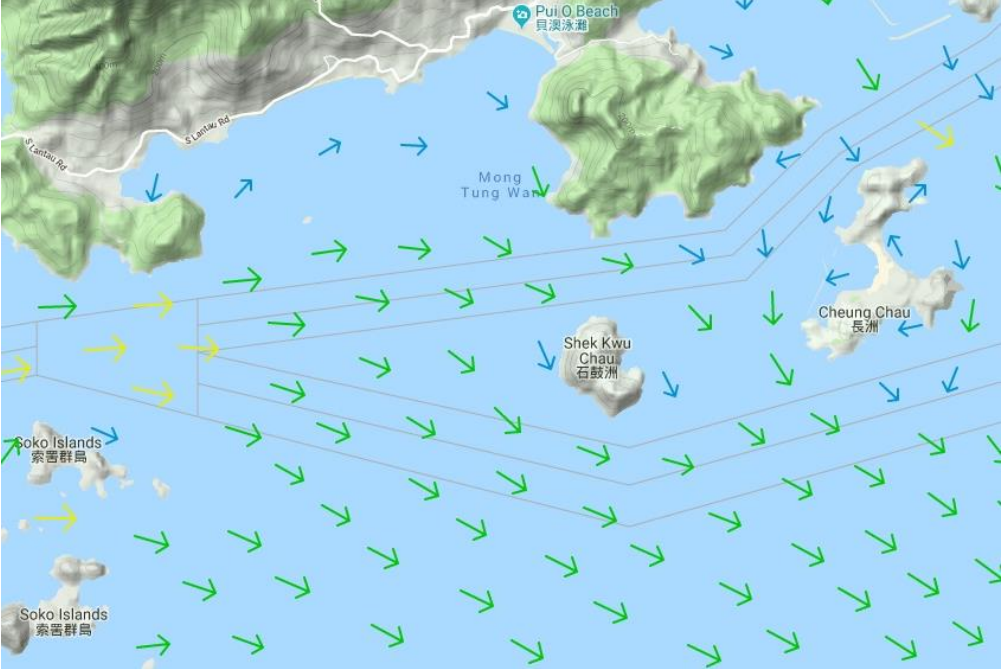
<p>Actions taken / to be taken</p>	<p>Two parts of secondary silt curtain of ESC-62 has been maintained in good condition on 11/09. The Contractor was reminded to keep tracking on the status of the deployed silt curtain during construction works.</p> <p>Examination of environmental performance of the Project will be continued during the weekly inspection, and the Contractor is remained to implement all applicable mitigation measures as per the Updated EM&A Manual.</p>
<p>Remarks</p>	<p>Current direction during mid-ebb sampling on 11/09:</p>

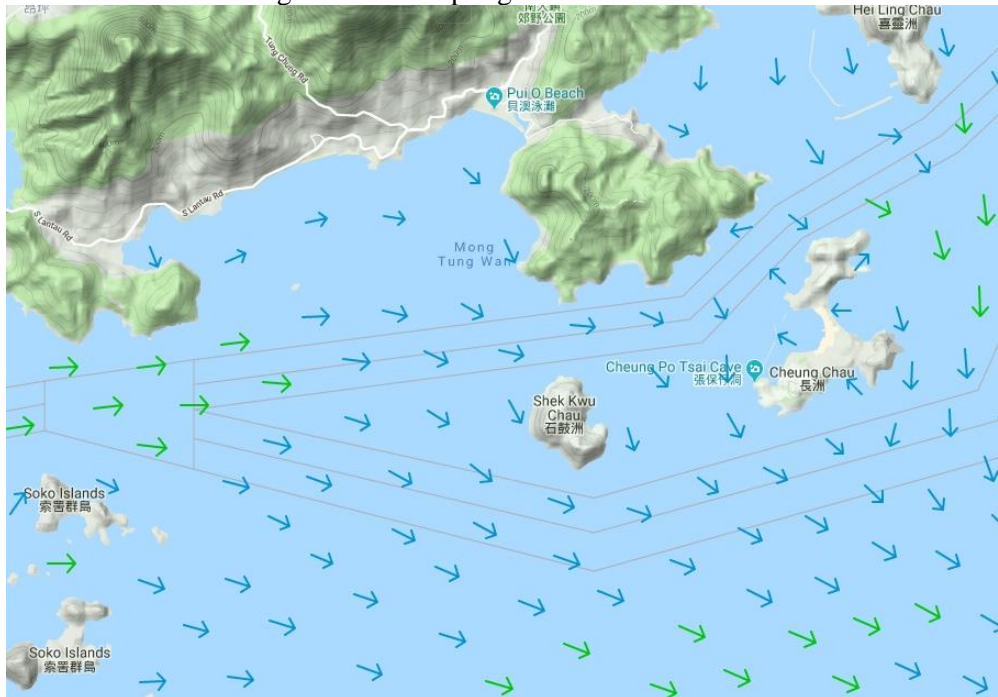
<p>Actions taken / to be taken</p>	<p>The two-double layers silt curtain for coral protection keep repairing. The Contractor was reminded to keep tracking on the status of the deployed silt curtain during construction works.</p> <p>Examination of environmental performance of the Project will be continued during the weekly inspection, and the Contractor is remained to implement all applicable mitigation measures as per the Updated EM&A Manual.</p>
<p>Remarks</p>	<p>Current direction during mid-ebb sampling on 18/09:</p>

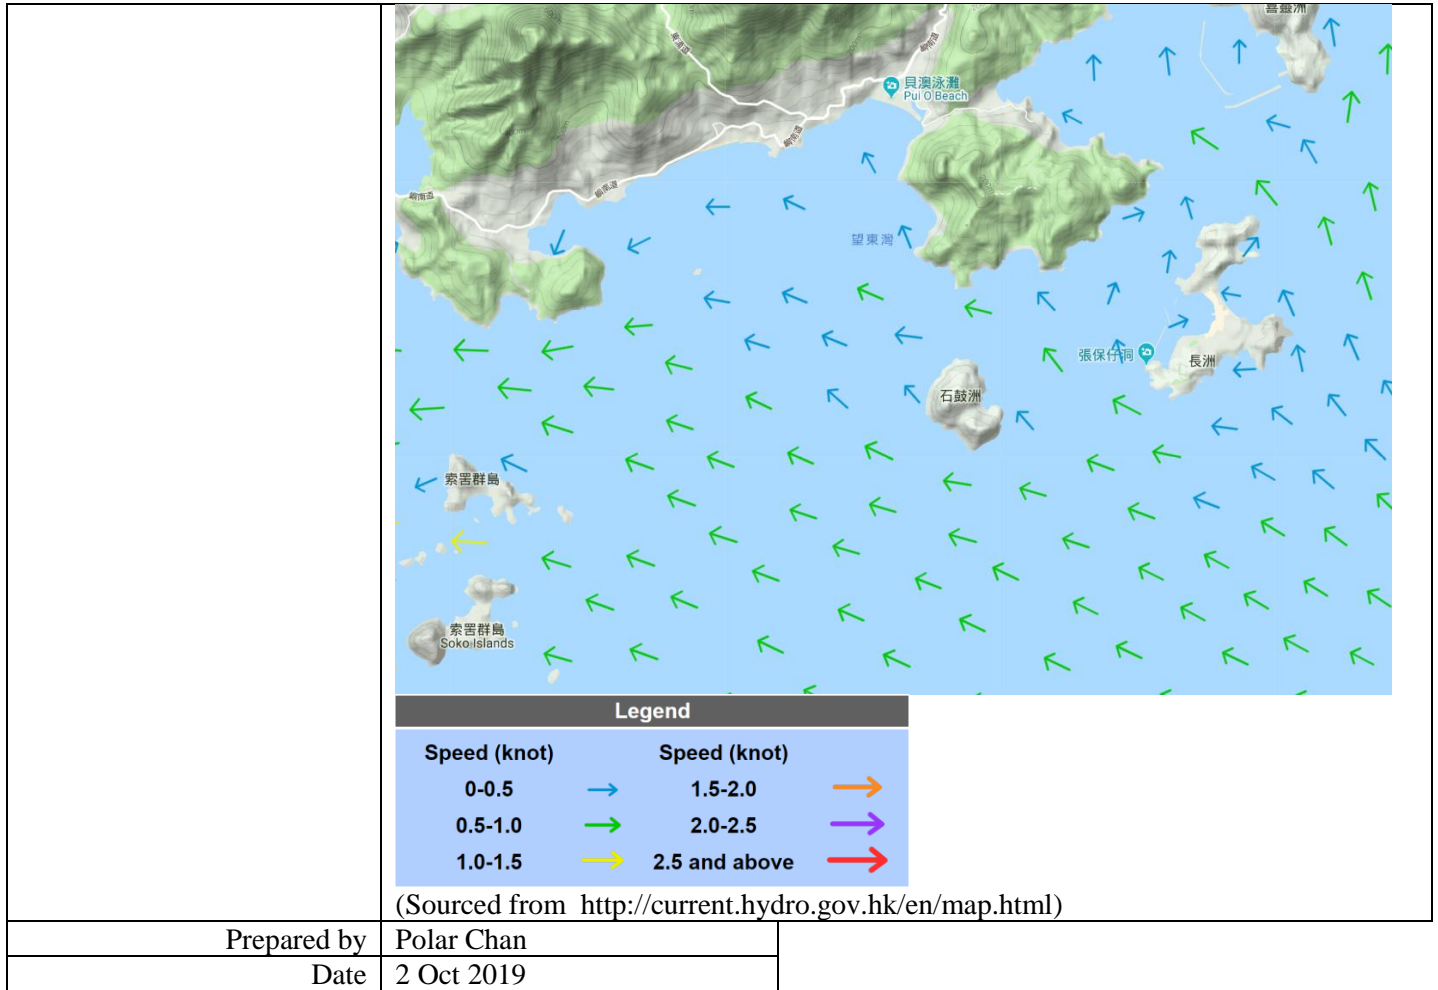
17.2 mg/L (F1A)	6.7 mg/L (C1A) 5.7 mg/L (C2A)	2.8 mg/L (B1) 4.0 mg/L (B2) 3.3 mg/L (B3) 4.3 mg/L (B4) 4.0 mg/L (H1) 3.8 mg/L (M1) 4.0 mg/L (S1) 3.3 mg/L (S2A) 4.3 mg/L (S3) 3.3 mg/L (CR1) 2.7 mg/L (CR2)
Possible reason for Action or Limit Level Non-compliance	Dominating sea current direction was found to be from Southeast to Northwest at waters around Shek Kwu Chau. F1A is located at unrelated stream direction (neither upstream nor downstream, far away) to the works location, exceedance of this monitoring station is deemed to be unrelated to the Project.		
Actions taken / to be taken	Notified the Contractor to collect more information.		
Remarks	Current direction during mid-flood sampling on 25/09:

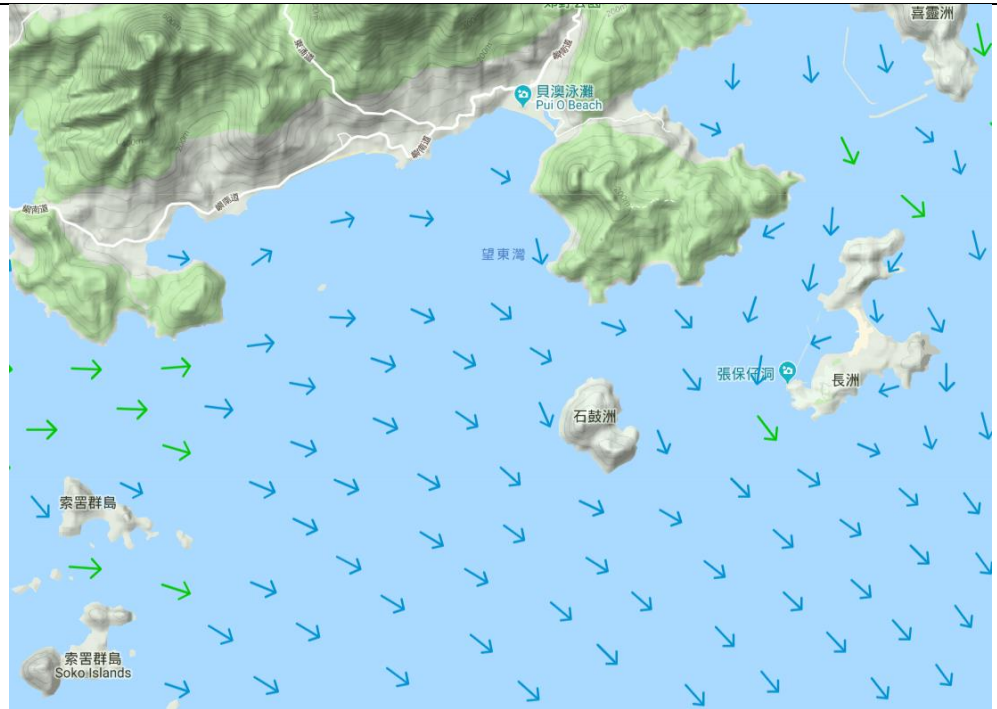
14.0 mg/L (B2) 15.5 mg/L (B3) 17.8 mg/L (B4)	10.7 mg/L (C1A) 11.3 mg/L (C2A)	10.0 mg/L (B1) 10.5 mg/L (F1A) 13.2 mg/L (H1) 11.0 mg/L (M1) 10.0 mg/L (S1) 9.8 mg/L (S2A) 10.8 mg/L (S3) 12.2 mg/L (CR1) 11.3 mg/L (CR2)
Possible reason for Action or Limit Level Non-compliance	Dominating sea current direction was found to be from Southeast to Northwest at waters around Shek Kwu Chau.		
	B2, B3 & B4 are located at unrelated stream direction (neither upstream nor downstream, far away) to the works location, exceedances of these monitoring stations are deemed to be unrelated to the Project.		
Actions taken / to be taken	Notified the Contractor to collect more information.		
Remarks	Current direction during mid-ebb sampling on 27/09:

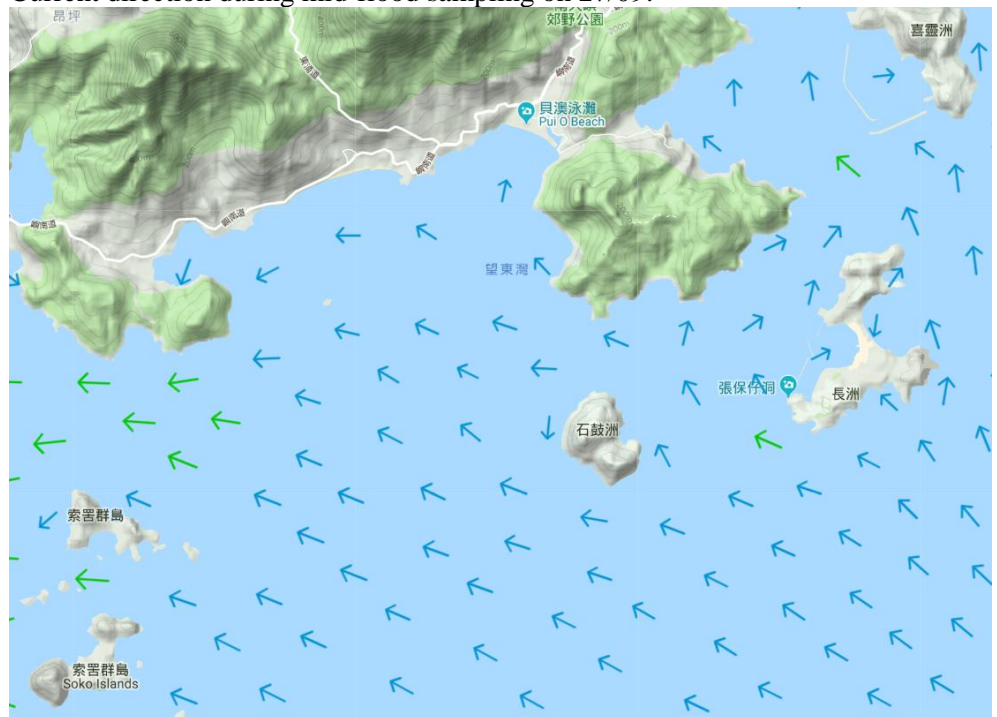
Current direction during mid-flood sampling on 27/09:
