Contract No. EP/SP/66/12 Integrated Waste Management Facilities, Phase 1 Monthly EM&A Report No.17

Monthly EM&A Report No.17 (Period from 1 November to 30 November 2019)

(Clause 3.3, Further Environmental Permit FEP-01/429/2012/A)

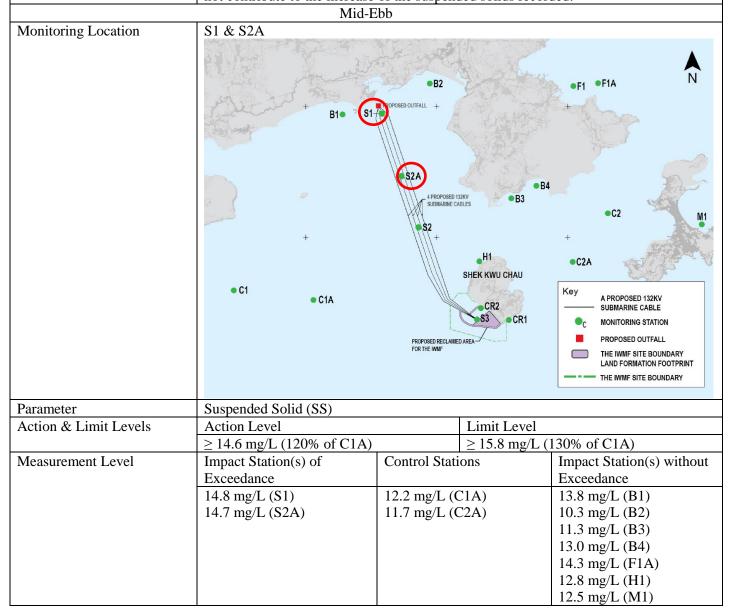
Site tidiness in the present barges in the Project site were checked during weekly site inspection on 29/10, where some sediment was observed on the edge of 港龍 108 and a small part of silt curtain near the boarding area was observed floating up on ESC-62. However, according to the rationale in previous paragraphs, these observations might not contribute to the increase of the suspended solids recorded.

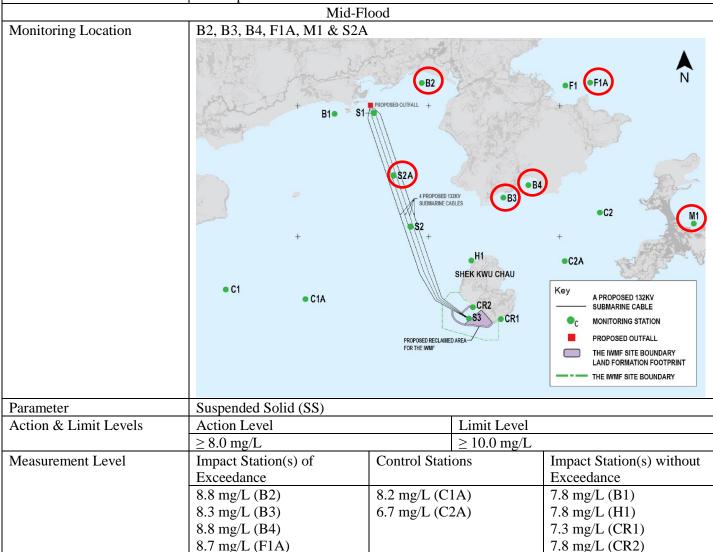
Weekly site inspection for Portion 1 (Shek Kwu Chau) was conducted on 04/11 but no boarding of barges within the Project site was made. For reference, site tidiness in the present barges in the Project site were checked during weekly site inspection on 12/11. No major observation of improper site practices that could contribute to the increase of the suspended solids recorded.

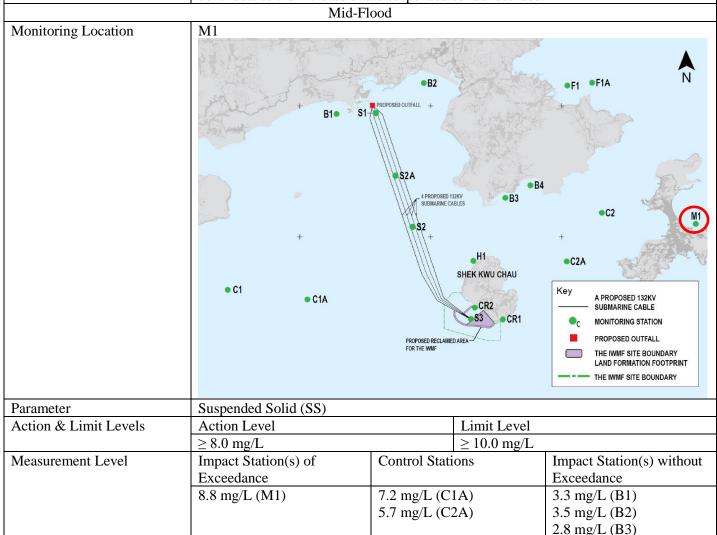
Site tidiness in the present barges in the Project site were checked during weekly site inspection on 15/11 where small amount of sediment was found at the edge of UDL-2. However, according to the rationale in previous paragraphs, this observation might not contribute to the increase of the suspended solids recorded.
