Appendix N Exceedance Report

Incident Report on Action Level or Limit Level Non-compliance

Project	Integrated Waste Management Facilities, Phase 1		
Date	04 Jan 2020 (Lab result received on 08 Jan 2020)		
Time	12:15 – 15:45 (Mid-Flood)		
Mid-Flood			
Monitoring Location	B1 & B2

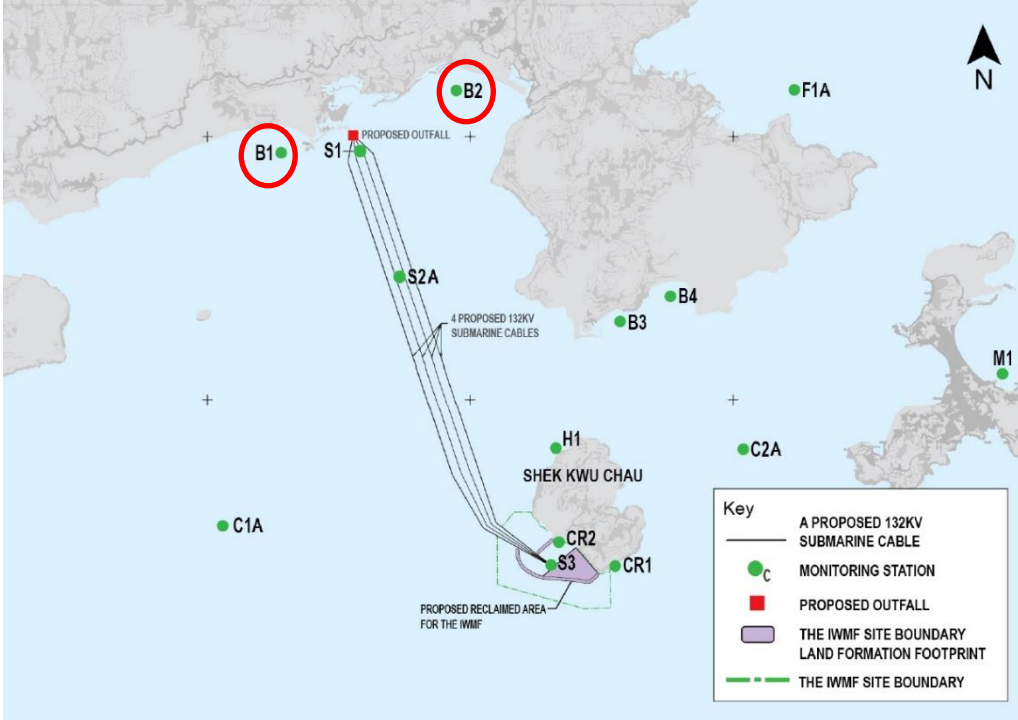
Parameter	Suspended Solid (SS)		
Action & Limit Levels	Action Level		Limit Level
	≥ 8.0 mg/L		≥ 10.0 mg/L
Measurement Level	Impact Station(s) of Exceedance	Control Stations	Impact Station(s) without Exceedance

8.5 mg/L (B1) 8.5 mg/L (B2)	7.2 mg/L (C1A) 5.8 mg/L (C2A)	7.3 mg/L (B3) 6.5 mg/L (B4) 7.8 mg/L (F1A) 6.0 mg/L (H1) 6.8 mg/L (M1) 6.8 mg/L (CR1) 6.2 mg/L (CR2) 7.0 mg/L (S1) 5.0 mg/L (S2A) 7.0 mg/L (S3)
Possible reason for Action or Limit Level Non-compliance	<p>Works scheduled on site on 04 Jan 2020 include DCM main works, infilling of caisson, DCM sample coring for DCM main works, cone penetration test levelling the slag materials, surveying works at vertical seawall, loading slag materials, removal of boulder, laying sand blanket, laying of rockfill, guide rail installation, flattening of rockfill and installation of caisson.</p> <p>Dominating sea current direction was found to be from Southeast to Northwest at waters around Shek Kwu Chau.</p> <p>B1 & B2 is located at unrelated stream direction (neither upstream nor downstream, far away) to the works location, exceedances of these monitoring stations are deemed to be unrelated to the Project.</p>

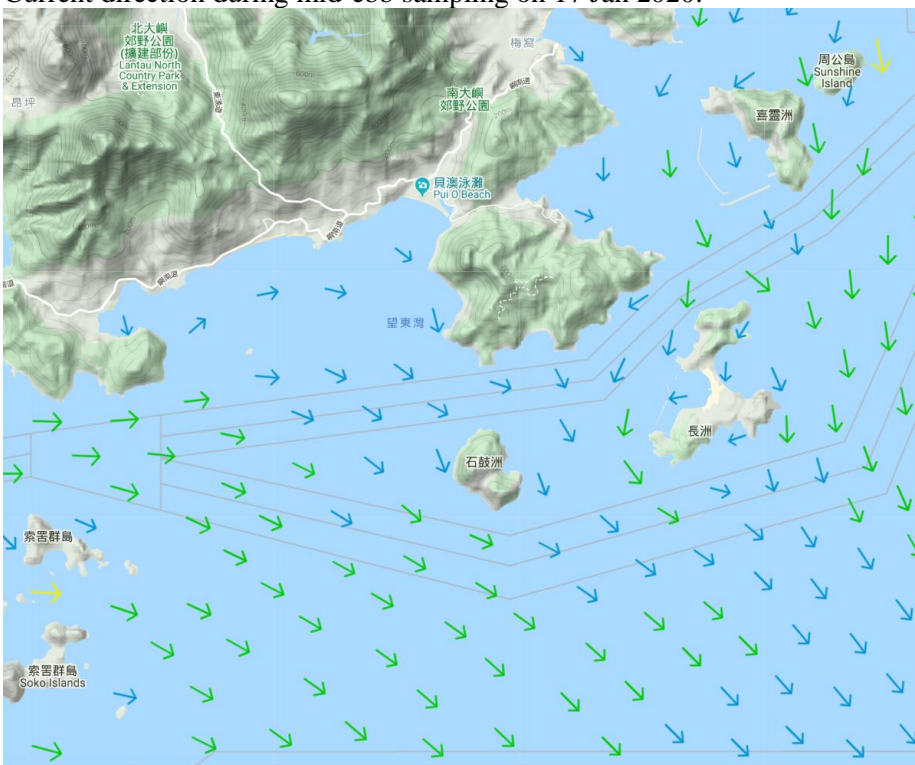
17.7 mg/L (M1)	13.5 mg/L (C1A) 12.5 mg/L (C2A)	14.0 mg/L (B1) 13.3 mg/L (B2) 11.8 mg/L (B3) 13.0 mg/L (B4) 13.7 mg/L (F1A) 12.3 mg/L (H1) 10.7 mg/L (CR1) 11.3 mg/L (CR2) 10.8 mg/L (S1) 10.0 mg/L (S2A) 12.2 mg/L (S3)
Possible reason for Action or Limit Level Non-compliance	<p>Works scheduled on site on 17 Jan 2020 include DCM main works, infilling of caisson, DCM sample coring for DCM main works, cone penetration test, levelling the slag materials, laying sand blanket, loading slag materials, survey work, installation of blockwork seawall, guide rail installation, flattening of rockfill and laying of rockfill.</p> <p>Dominating sea current direction was found to be from Northwest to Southeast at waters around Shek Kwu Chau.</p> <p>M1 is located at unrelated stream direction (neither upstream nor downstream, far away) to the works location, exceedance of this monitoring station is deemed to be unrelated to the Project.</p>

<p>Site curtain checking was implemented by the Contractor on DL4 (07:00 @ 16 Jan), ESC-61 (07:00), ESC-62 (07:00), GD-853 (07:00), 宏建 2 (07:00), 志富 (07:00), 港龍 108 (20:00), Cheung Kee No.10 (07:00) and checking results showed that no deficiency of silt curtain was found on that day. As confirmed by the Contractor, construction works at DL4 was conducted before 7:00 am on 17 Jan 2020, the silt curtain of DL4 was checked on 16 Jan 2020 instead. As per the site information provided from the Contractor, no works related to 宏建 5 was stated.</p> <p>From MMO monitoring records on 17 Jan 2020, MMO teams were arranged for derrick barges (GD-853, 宏建 5, 港龍 108, Cheung Kee No.10, 宏建 2, DL4 & 志富) and two DCM barges (ESC-61 & ESC-62) on that day while no deficiency of silt curtain was found before the commencement of and during construction activity.</p> <p>According to the field observation by Marine Mammal Observer team & sampling team during sampling event, no silt plume was observed in the Project site.</p> <p>Site tidiness in the present barges in the Project site were checked during weekly site inspection on 14 Jan 2020. No major observation of improper site practices that could contribute to the increase of the suspended solids recorded.</p>

<p>Actions taken / to be taken</p>	<p>Examination of environmental performance of the Project will be continued during the weekly inspection, and the Contractor is reminded to implement all applicable mitigation measures as per the Updated EM&A Manual.</p>
<p>Remarks</p>	<p>Current direction during mid-ebb sampling on 17 Jan 2020:</p>

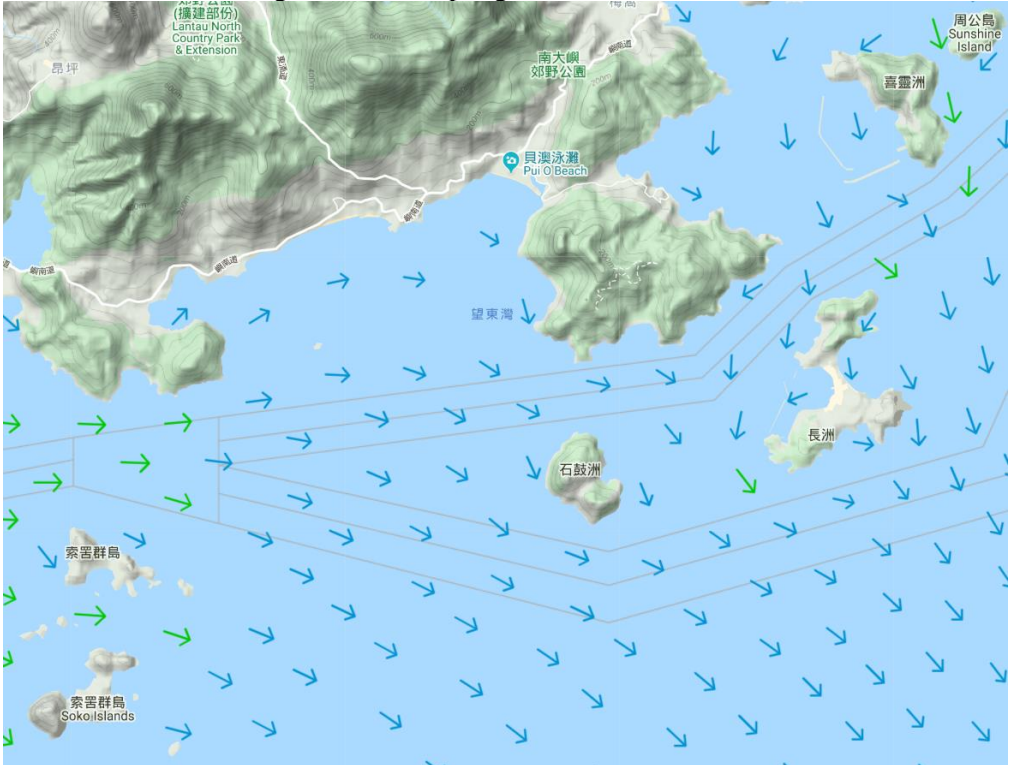
14.0 mg/L (S1) 11.3 mg/L (S2A)	9.0 mg/L (C1A) 9.8 mg/L (C2A)	7.5 mg/L (B1) 8.0 mg/L (B2) 9.8 mg/L (B3) 7.8 mg/L (B4) 9.8 mg/L (F1A) 10.0 mg/L (H1) 10.0 mg/L (M1) 9.0 mg/L (CR1) 8.7 mg/L (CR2) 10.0 mg/L (S3)
Possible reason for Action or Limit Level Non-compliance	<p>Works scheduled on site on 29 Jan 2020 include DCM main works, infilling of caisson, DCM sample coring for DCM main works, cone penetration test, levelling the slag materials, laying sand blanket, loading slag materials, survey work, installation of blockwork seawall, guide rail installation, flattening of rockfill, installation of caisson and laying of rockfill.</p> <p>Dominating sea current direction was found to be from Northwest to Southeast at waters around Shek Kwu Chau.</p> <p>S1 & S2A are located at unrelated stream direction (neither upstream nor downstream, far away) to the works location, exceedances of these monitoring station are deemed to be unrelated to the Project.</p>

<p>Silt curtain checking was implemented by the Contractor on ESC-61 (09:00) & ESC-62 (07:00) and checking results showed no deficiency of silt curtain was found on that day. No slag materials levelling works scheduled in GD-853 was carried out with refer to the site diary on that day.</p> <p>From MMO monitoring records on 29 Jan 2020, MMO teams were arranged for one derrick barge (GD-853) and two DCM barges (ESC-61 & ESC-62) on that day while no deficiency of silt curtain was found before commencement of and during construction activity.</p> <p>According to the field observation by Marine Mammal Observer team & sampling team during sampling event, no silt plume was observed in the Project site.</p> <p>Site tidiness in the present barges in the Project site were checked during weekly site inspection on 21 Jan 2020. No major observation of improper site practices that could contribute to the increase of the suspended solids recorded.</p>																				
<p>Actions taken / to be taken</p>	<p>Examination of environmental performance of the Project will be continued during the weekly inspection, and the Contractor is reminded to implement all applicable mitigation measures as per the Updated EM&A Manual.</p>																				
<p>Remarks</p>	<p>Current direction during mid-ebb sampling on 29 Jan 2020:</p>
