Appendix N Exceedance Report

Incident Report on Action Level or Limit Level Non-compliance

| Project | Integrated Waste Management Facilities, Phase 1 | | |

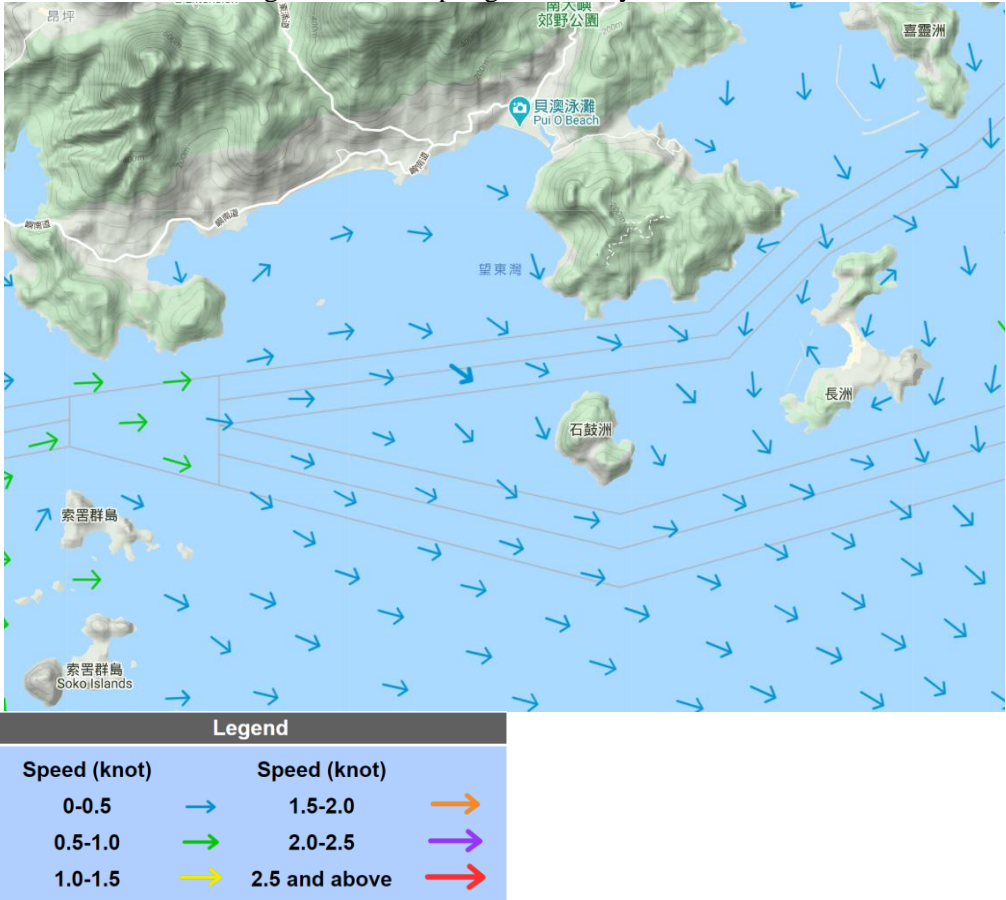
| Possible reason for Action or Limit Level Non-compliance | <p>Works scheduled on site on 13 May 2020 include DCM main works, PVD installation, DCM sample coring for DCM main works, laying of geotextile, cone penetration test, levelling the slag materials, loading slag materials, dredging work, G200 drop test, installation of blockwork seawall, laying of rockfill, installation of metal plates and laying sand blanket.</p> <p>Dominating sea current direction was found to be from Northwest to Southeast at waters around Shek Kwu Chau.</p> <p>S1 is located at unrelated stream direction (neither upstream nor downstream, far away) to the works location, exceedance of this monitoring station is deemed to be</p> | | |

| | <p>unrelated to the Project.</p> <p>Silt curtain checking by the Contractor was implemented on ESC-61 (07:00), GD-851 (07:00) & 宏建 1 (07:00) and checking results showed that no deficiency of silt curtain was found on that day.</p> <p>From MMO monitoring records on 13 May 2020, MMO team were arranged for two derrick barges (GD-851 & 宏建 1) and one DCM barge (ESC-61) on that day while no deficiency of silt curtain was found before the commencement of and during construction activity.</p> <p>According to the field observation by Marine Mammal Observer team & sampling team during sampling event, no silt plume was observed in the Project site.</p> <p>Site tidiness in the present barges in the Project site were checked during weekly site inspection on 5 May 2020. No major observation of improper site practices that could contribute to the increase of the suspended solids recorded.</p> |
| <p>Remarks</p> | <p>Current direction during mid-ebb sampling on 13 May 2020:</p> <p>(Sourced from http://current.hydro.gov.hk/en/map.html)</p> |

| <p>Actions taken / to be taken</p> | <p>Examination of environmental performance of the Project will be continued during the weekly inspection, and the Contractor is remained to implement all applicable mitigation measures as per the Updated EM&A Manual.</p> |

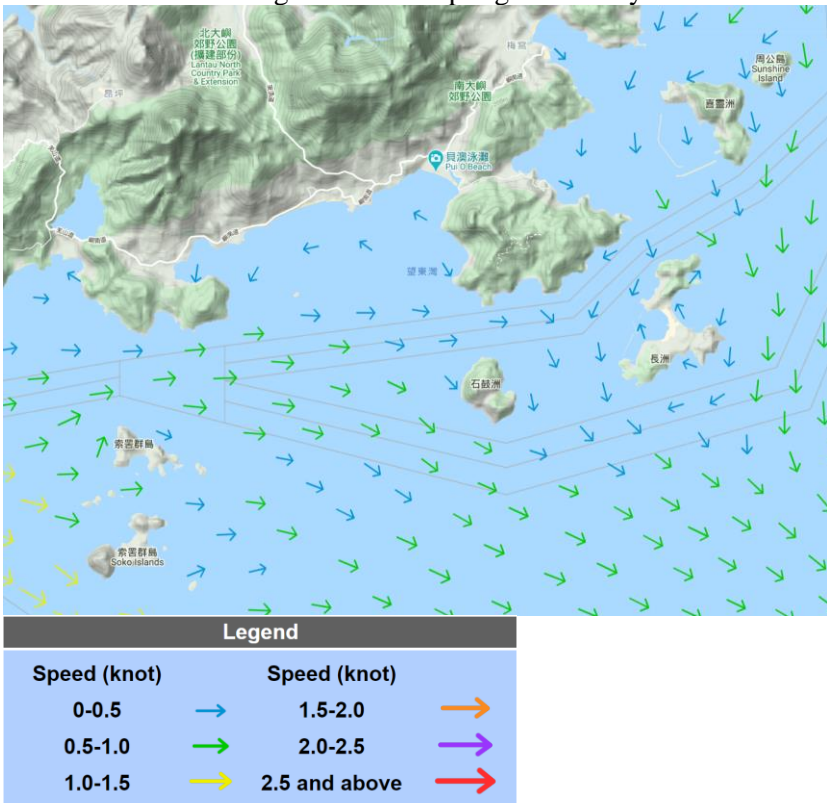
| Possible reason for Action or Limit Level Non-compliance | <p>Works scheduled on site on 22 May 2020 include DCM main works, PVD installation, DCM sample coring for DCM main works, laying of geotextile, cone penetration test, levelling the slag materials, loading slag materials, dredging work, storage sand, installation of blockwork seawall, laying of rockfill, caisson installation and laying of sand blanket.</p> <p>Dominating sea current direction was found to be from Northwest to Southeast at waters around Shek Kwu Chau.</p> <p>S2A is located at unrelated stream direction (neither upstream nor downstream, far away) to the works location, exceedance of this monitoring station is deemed to be unrelated to the Project.</p> | | |

| | <p>S3 is located close to works location within the Project site while silt curtain checking by the Contractor was implemented on GD-851 (07:00) and checking results showed that no deficiency of silt curtain was found on that day. No DCM works scheduled in ESC-61 was carried out with refer to the site diary on that day. No loading works of slag materials scheduled in DL-5 was carried out with refer to the site diary on that day. As confirmed by the Contractor, no slag materials levelling was conducted by 永照 18 on that day.</p> <p>From MMO monitoring records on 22 May 2020, MMO team were arranged for three derrick barges (DL-5, GD-851 & 永照 18) and one DCM barge (ESC-61) on that day while no deficiency of silt curtain was found before the commencement of and during construction activity. As confirmed by on duty MMO, GD-851 & 永照 18 were working in pair and using the same silt curtain, therefore, the silt curtain of GD-851 & 永照 18 was checked by MMO at the same time.</p> <p>According to the field observation by Marine Mammal Observer team & sampling team during sampling event, no silt plume was observed in the Project site. It might suggest that exceedances at S3 is deemed to be unrelated to the Project.</p> <p>Site tidiness in the present barges in the Project site were checked during weekly site inspection on 19 May 2020. No major observation of improper site practices that could contribute to the increase of the suspended solids recorded.</p> |
| <p>Remarks</p> | <p>Current direction during mid-ebb sampling on 22 May 2020:</p> <p>(Sourced from http://current.hydro.gov.hk/en/map.html)</p> |

| <p>Actions taken / to be taken</p> | <p>Examination of environmental performance of the Project will be continued during the weekly inspection, and the Contractor is reminded to implement all applicable mitigation measures as per the Updated EM&A Manual.</p> |
