Appendix N Exceedance Report

Incident Report on Action Level or Limit Level Non-compliance

Project	Integrated Waste Management Facilities, Phase 1		
Date	10 Nov 2020 (Lab result received on 13 Nov 2020)		
Time	08:00 – 11:30 (Mid-Ebb) 12:59 – 16:29 (Mid Flood)		
Mid-Ebb			
Monitoring Location	<div>M1</div> <div>

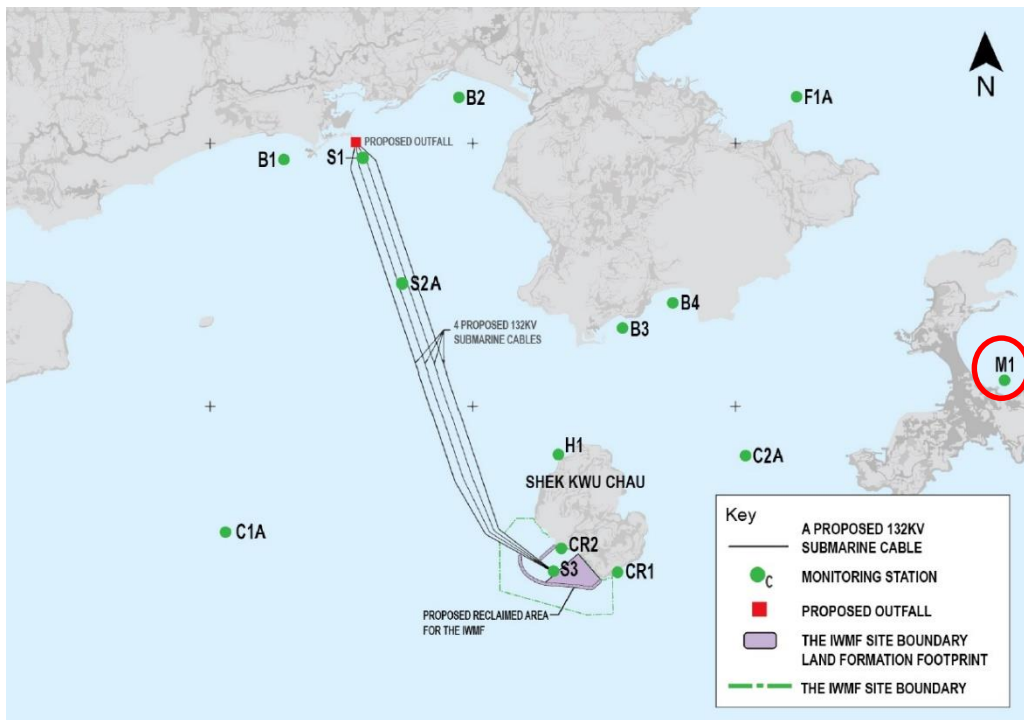
</div>		
Parameter	Suspended Solid (SS)		
Action & Limit Levels	Action Level		Limit Level
	≥ 14.8 mg/L (120% of C1A)		≥ 16.0 mg/L (130% of C1A)
Measurement Level	Impact Station(s) of Exceedance	Control Stations	Impact Station(s) without Exceedance

16.8 mg/L (M1)	12.3 mg/L (C1A) 9.3 mg/L (C2A)	9.0 mg/L (B1) 9.0 mg/L (B2) 8.3 mg/L (B3) 9.5 mg/L (B4) 11.0 mg/L (F1A) 9.2 mg/L (H1) 9.0 mg/L (CR1) 14.0 mg/L (CR2) 10.5 mg/L (S1) 11.2 mg/L (S2A) 9.3 mg/L (S3)
Possible reason for Action or Limit Level Non-compliance	<p>Works scheduled on site on 10 Nov 2020 include reclamation works, levelling the slag materials, loading slag materials, laying geotextile, laying of rockfill and caisson installation.</p> <p>Dominating sea current direction was found to be from Northwest to Southeast at waters around Shek Kwu Chau.</p> <p>M1 is located at unrelated stream direction neither upstream nor downstream, far away) to the works location, exceedance of this monitoring station is deemed to be unrelated to the Project.</p>

<p>Silt curtain checking by the Contractor was implemented on Marine Access (10 Nov 2020, 09:30am), Eastern Silt Curtain (10 Nov 2020, 09:30am), GD851 (10 Nov 2020, 07:00am) and checking results showed that no deficiency of silt curtain was found on that day.</p> <p>From MMO monitoring records on 10 Nov 2020, MMO team was arranged for one crane barge (GD-851), silt curtain at western marine access area and the eastern silt curtain on that day while no deficiency of silt curtain was found before the commencement of and during construction activity.</p> <p>According to the field observation by Marine Mammal Observer team & sampling team during sampling event, no silt plume was observed in the Project site.</p> <p>Site tidiness in the present barges in the Project site were checked during weekly site inspection on 10 Nov 2020. No major observation of improper site practices that could contribute to the increase of the suspended solids recorded.</p>

<p>Actions taken / to be taken</p>	<p>Examination of environmental performance of the Project will be continued during the weekly inspection, and the Contractor is reminded to implement all applicable mitigation measures as per the Updated EM&A Manual.</p>
<p>Remarks</p>	<p>Current direction during mid-ebb sampling on 10 Nov 2020:</p>

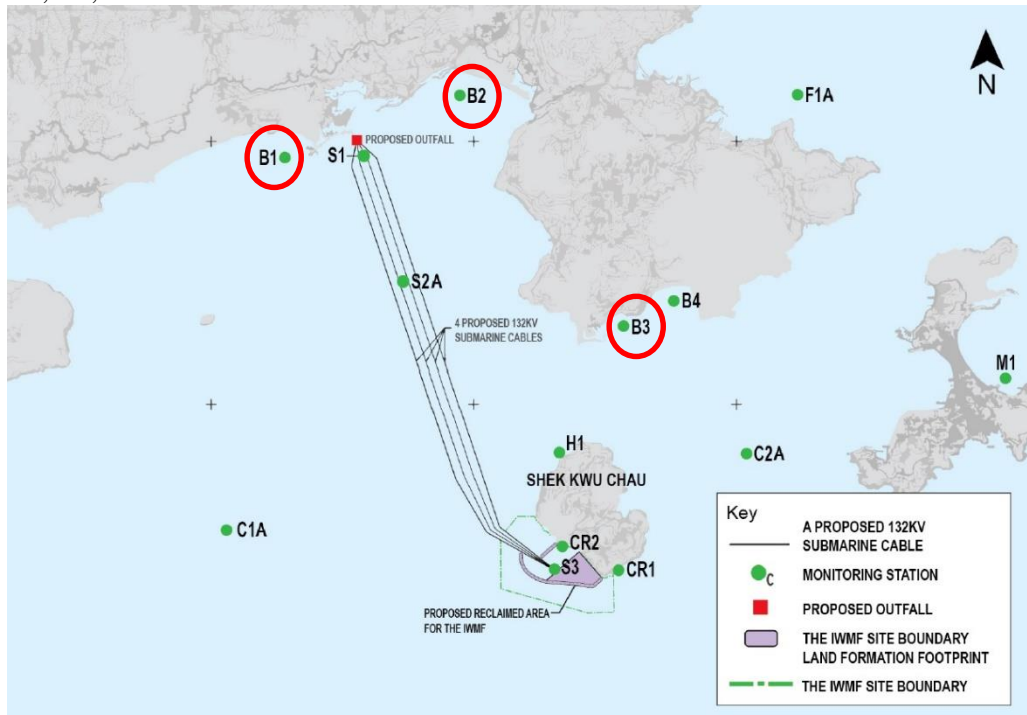
Mid-Flood			
Monitoring Location	<p>B1, B2, B3</p>

Parameter	Suspended Solid (SS)		
Action & Limit Levels	Action Level		Limit Level
	≥ 11.2 mg/L (120% of C2A)		≥ 12.1 mg/L (130% of C2A)
Measurement Level	Impact Station(s) of Exceedance	Control Stations	Impact Station(s) without Exceedance

16.0 mg/L (B1) 15.5 mg/L (B2) 12.8 mg/L (B3)	7.5 mg/L (C1A) 9.3 mg/L (C2A)	7.8 mg/L (B4) 7.8 mg/L (F1A) 8.3 mg/L (H1) 10.0 mg/L (M1) 8.2 mg/L (CR1) 8.7 mg/L (CR2) 8.3 mg/L (S1) 8.8 mg/L (S2A) 8.2 mg/L (S3)
Possible reason for Action or Limit Level Non-compliance	Works scheduled on site on 10 Nov 2020 include reclamation works, levelling the slag materials, loading slag materials, laying geotextile, laying of rockfill and caisson

<p>installation.</p> <p>Dominating sea current direction was found to be from Southeast to Northwest at waters around Shek Kwu Chau.</p> <p>B1, B2 and B3 are located at unrelated stream direction (neither upstream nor downstream, far away) to the works location, exceedance of this monitoring station is deemed to be unrelated to the Project.</p> <p>Silt curtain checking by the Contractor was implemented on Marine Access (10 Nov 2020, 09:30am), Eastern Silt Curtain (10 Nov 2020, 09:30am), GD851 (10 Nov 2020, 07:00am) and checking results showed that no deficiency of silt curtain was found on that day.</p> <p>From MMO monitoring records on 10 Nov 2020, MMO team was arranged for one crane barge (GD-851), silt curtain at western marine access area and the eastern silt curtain on that day while no deficiency of silt curtain was found before the commencement of and during construction activity.</p> <p>According to the field observation by Marine Mammal Observer team & sampling team during sampling event, no silt plume was observed in the Project site.</p> <p>Site tidiness in the present barges in the Project site were checked during weekly site inspection on 10 Nov 2020. No major observation of improper site practices that could contribute to the increase of the suspended solids recorded.</p>

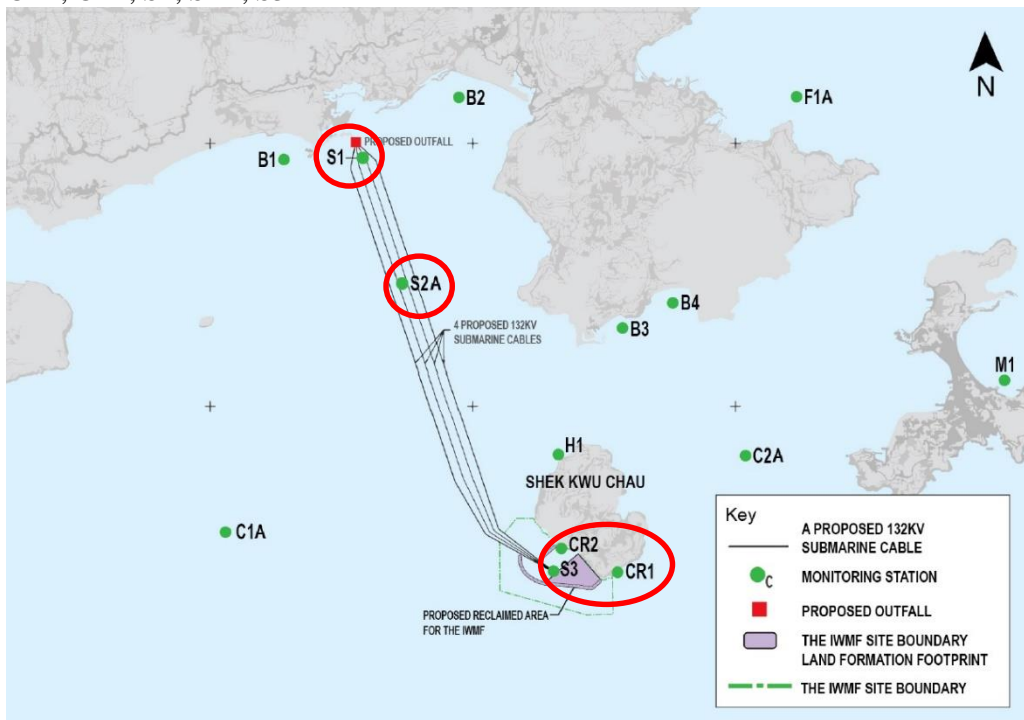
</div>		
Parameter	Suspended Solid (SS)		
Action & Limit Levels	Action Level		Limit Level
	≥ 8.0 mg/L		≥ 10.0 mg/L
Measurement Level	Impact Station(s) of Exceedance	Control Stations	Impact Station(s) without Exceedance

10.0 mg/L (CR1) 9.2 mg/L (CR2) 10.3 mg/L (S1) 10.2 mg/L (S2A) 9.8 mg/L (S3)	6.0 mg/L (C1A) 5.7 mg/L (C2A)	6.3 mg/L (B1) 7.0 mg/L (B2) 8.0 mg/L (B3) 7.3 mg/L (B4) 6.8 mg/L (F1A) 7.3 mg/L (H1) 7.0 mg/L (M1)
Possible reason for Action or Limit Level Non-compliance	<p>Works scheduled on site on 14 Nov 2020 include reclamation works, levelling the slag materials, loading slag materials, laying rock filter, laying of rockfill and caisson installation.</p> <p>Dominating sea current direction was found to be from Northwest to Southeast at waters around Shek Kwu Chau.</p> <p>S1 and S2A are located at unrelated stream direction neither upstream nor downstream, far away) to the works location, exceedance of this monitoring station is deemed to be unrelated to the Project.</p> <p>CR1, CR2 and S3 are located close to the works location within the Project site while silt curtain checking by the Contractor Silt curtain checking by the Contractor was implemented on Marine Access (14 Nov 2020, 06:00am), Eastern Silt Curtain (14 Nov</p>

<p>2020, 06:00am), GD851 (14 Nov 2020, 07:00am) and checking results showed that no deficiency of silt curtain was found on that day.</p> <p>From MMO monitoring records on 14 Nov 2020, MMO team was arranged for one crane barge (GD-851), silt curtain at western marine access area and the eastern silt curtain on that day while no deficiency of silt curtain was found before the commencement of and during construction activity.</p> <p>According to the field observation by Marine Mammal Observer team & sampling team during sampling event, no silt plume was observed in the Project site.</p> <p>Site tidiness in the present barges in the Project site were checked during weekly site inspection on 10 Nov 2020. No major observation of improper site practices that could contribute to the increase of the suspended solids recorded.</p>		
Mid-Flood			
Monitoring Location	<p>S1, S3</p>

Actions taken / to be taken	Examination of environmental performance of the Project will be continued during the weekly inspection, and the Contractor is reminded to implement all applicable mitigation measures as per the Updated EM&A Manual.
Remarks	<p>Current direction during mid-ebb sampling on 14 Nov 2020:</p>

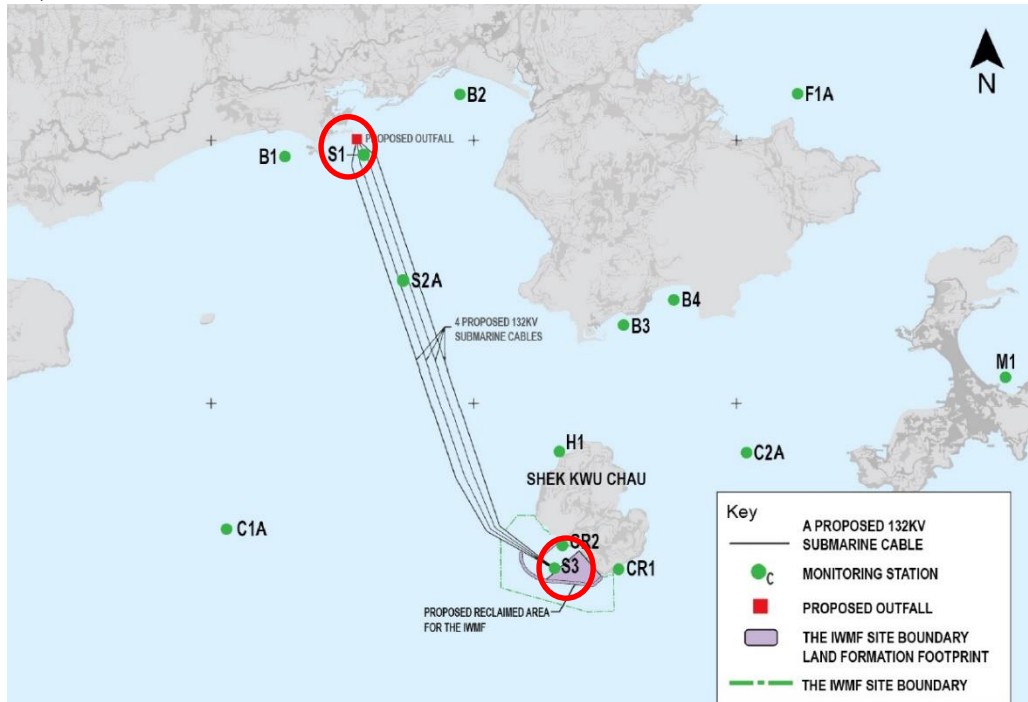
Action & Limit Levels	Action Level		Limit Level
	≥ 8.0 mg/L		≥ 10.0 mg/L
Measurement Level	Impact Station(s) of Exceedance	Control Stations	Impact Station(s) without Exceedance

8.3 mg/L (S1) 8.8 mg/L (S3)	4.8 mg/L (C1A) 6.0 mg/L (C2A)	7.8 mg/L (B1) 8.0 mg/L (B2) 6.8 mg/L (B3) 5.8 mg/L (B4) 7.7 mg/L (F1A) 5.8 mg/L (H1) 6.0 mg/L (M1) 7.2 mg/L (CR1) 5.8 mg/L (CR2) 7.5 mg/L (S2A)
Possible reason for Action or Limit Level Non-compliance	Works scheduled on site on 14 Nov 2020 include reclamation works, levelling the slag materials, loading slag materials, laying rock filter, laying of rockfill and caisson installation.

<p>Dominating sea current direction was found to be from Southeast to Northwest at waters around Shek Kwu Chau.</p> <p>S1 is located at unrelated stream direction (neither upstream nor downstream, far away) to the works location, exceedance of this monitoring station is deemed to be unrelated to the Project.</p> <p>S3 is located close to the works location within the Project site while silt curtain checking by the Contractor Silt curtain checking by the Contractor was implemented on Marine Access (14 Nov 2020, 06:00am), Eastern Silt Curtain (14 Nov 2020, 06:00am), GD851 (14 Nov 2020, 07:00am) and checking results showed that no deficiency of silt curtain was found on that day.</p> <p>From MMO monitoring records on 14 Nov 2020, MMO team was arranged for one crane barge (GD-851), silt curtain at western marine access area and the eastern silt curtain on that day while no deficiency of silt curtain was found before the commencement of and during construction activity.</p> <p>According to the field observation by Marine Mammal Observer team & sampling team during sampling event, no silt plume was observed in the Project site.</p> <p>Site tidiness in the present barges in the Project site were checked during weekly site inspection on 10 Nov 2020. No major observation of improper site practices that could contribute to the increase of the suspended solids recorded.</p>

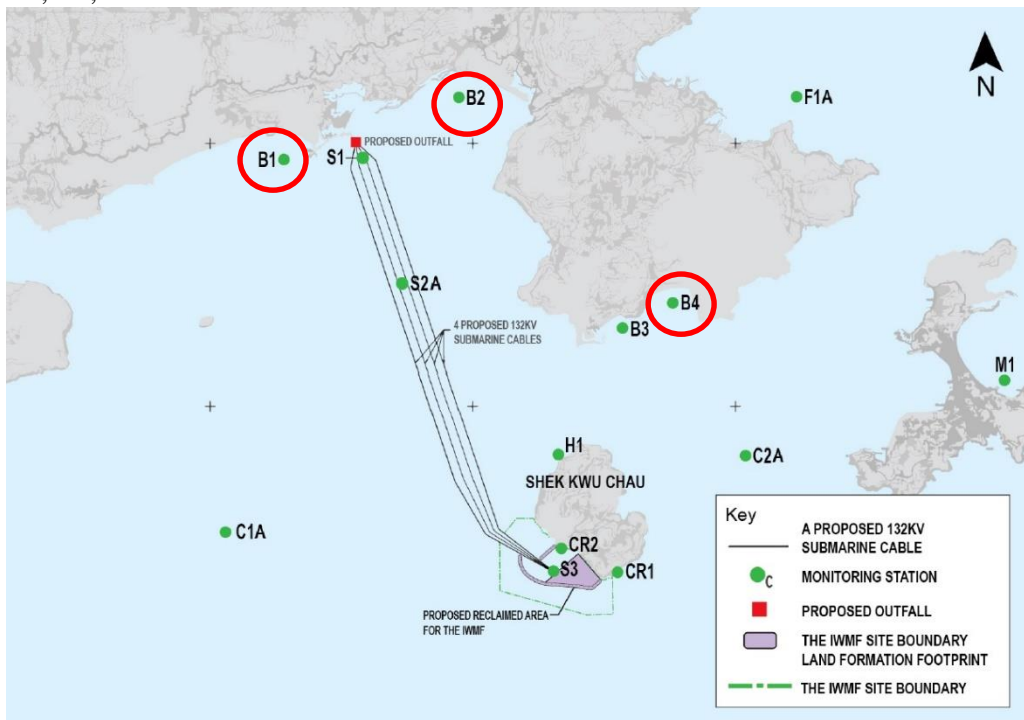
</div>		
Parameter	Suspended Solid (SS)		
Action & Limit Levels	Action Level		Limit Level
	≥ 13.8 mg/L (120% of C1A)		≥ 15.0 mg/L (130% of C1A)
Measurement Level	Impact Station(s) of Exceedance	Control Stations	Impact Station(s) without Exceedance

14.5 mg/L (B1) 14.0 mg/L (B2) 14.3 mg/L (B4)	11.5 mg/L (C1A) 14.3 mg/L (C2A)	13.3 mg/L (B3) 12.5 mg/L (F1A) 12.7 mg/L (H1) 13.7 mg/L (M1) 13.2 mg/L (CR1) 11.8 mg/L (CR2)
Possible reason for Action or Limit Level Non-compliance	Works scheduled on site on 16 Nov 2020 include reclamation works, levelling the slag materials, loading slag materials, formation of B9 loading platform, laying of rockfill and caisson installation.		
	Dominating sea current direction was found to be from East to Northwest at waters around Shek Kwu Chau.		
	B1, B2 and B4 are located at unrelated stream direction neither upstream nor downstream, far away) to the works location, exceedance of this monitoring station is deemed to be unrelated to the Project.		
	Silt curtain checking by the Contractor was implemented on Marine Access (16 Nov 2020, 01:00pm), Eastern Silt Curtain (16 Nov 2020, 01:00pm), GD851 (16 Nov 2020, 07:00am) and checking results showed that no deficiency of silt curtain was found on that day.

From MMO monitoring records on 16 Nov 2020, MMO team was arranged for one crane barge (GD-851), silt curtain at western marine access area and the eastern silt curtain on that day while no deficiency of silt curtain was found before the commencement of and during construction activity.		
	According to the field observation by Marine Mammal Observer team & sampling team during sampling event, no silt plume was observed in the Project site.		
	Site tidiness in the present barges in the Project site were checked during weekly site inspection on 10 Nov 2020. No major observation of improper site practices that could contribute to the increase of the suspended solids recorded.		
Mid-Flood			
Monitoring Location	F1A, CR2

Actions taken / to be taken	<p>Examination of environmental performance of the Project will be continued during the weekly inspection, and the Contractor is reminded to implement all applicable mitigation measures as per the Updated EM&A Manual.</p>
Remarks	<p>Current direction during mid-ebb sampling on 16 Nov 2020:</p>

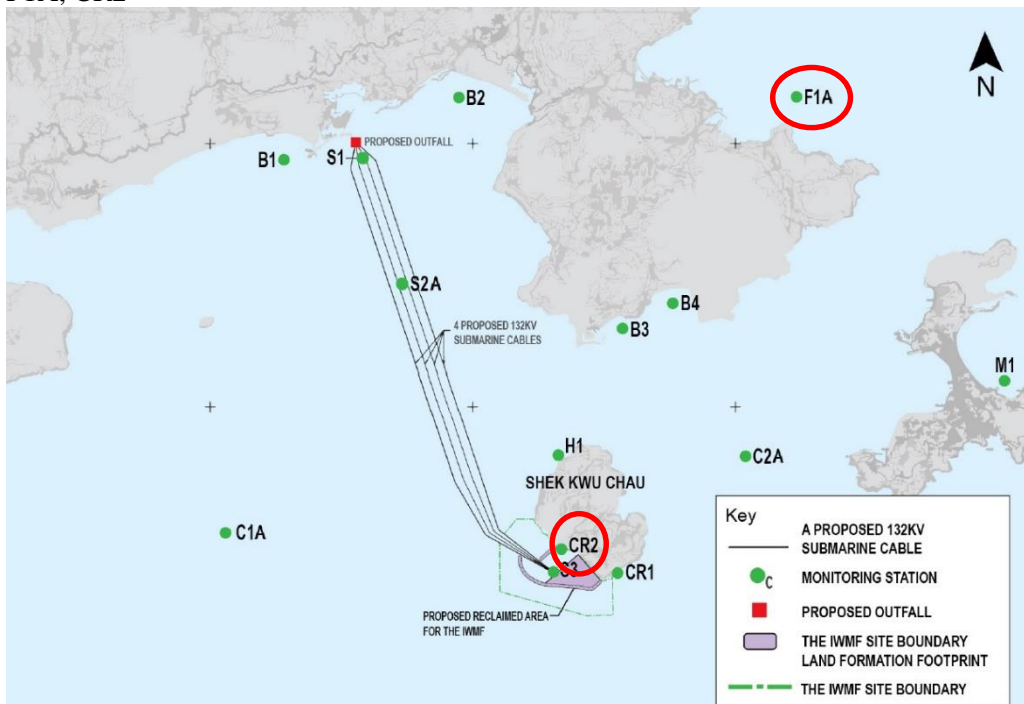
Parameter	Suspended Solid (SS)		
Action & Limit Levels	Action Level		Limit Level
	≥ 13.6 mg/L (120% of C2A)		≥ 14.7 mg/L (130% of C2A)
Measurement Level	Impact Station(s) of Exceedance	Control Stations	Impact Station(s) without Exceedance

15.5 mg/L (F1A) 14.2 mg/L (CR2)	14.3 mg/L (C1A) 11.3 mg/L (C2A)	12.8 mg/L (B1) 12.8 mg/L (B2) 12.5 mg/L (B3) 12.5 mg/L (B4) 12.8 mg/L (H1) 13.0 mg/L (M1) 12.2 mg/L (CR1)
Possible reason for Action or Limit Level Non-compliance	Works scheduled on site on 16 Nov 2020 include reclamation works, levelling the slag materials, loading slag materials, formation of B9 loading platform, laying of rockfill and caisson installation.		
	Dominating sea current direction was found to be from Southeast to Northwest at waters around Shek Kwu Chau.		
	F1A is located at unrelated stream direction (neither upstream nor downstream, far away) to the works location, exceedance of this monitoring station is deemed to be

<p>unrelated to the Project.</p> <p>CR2 is located close to the works location within the Project site while silt curtain checking by the Contractor was implemented on Marine Access (16 Nov 2020, 01:00pm), Eastern Silt Curtain (16 Nov 2020, 01:00pm), GD851 (16 Nov 2020, 07:00am) and checking results showed that no deficiency of silt curtain was found on that day.</p> <p>From MMO monitoring records on 16 Nov 2020, MMO team was arranged for one crane barge (GD-851), silt curtain at western marine access area and the eastern silt curtain on that day while no deficiency of silt curtain was found before the commencement of and during construction activity.</p> <p>According to the field observation by Marine Mammal Observer team & sampling team during sampling event, no silt plume was observed in the Project site.</p> <p>Site tidiness in the present barges in the Project site were checked during weekly site inspection on 10 Nov 2020. No major observation of improper site practices that could contribute to the increase of the suspended solids recorded.</p>

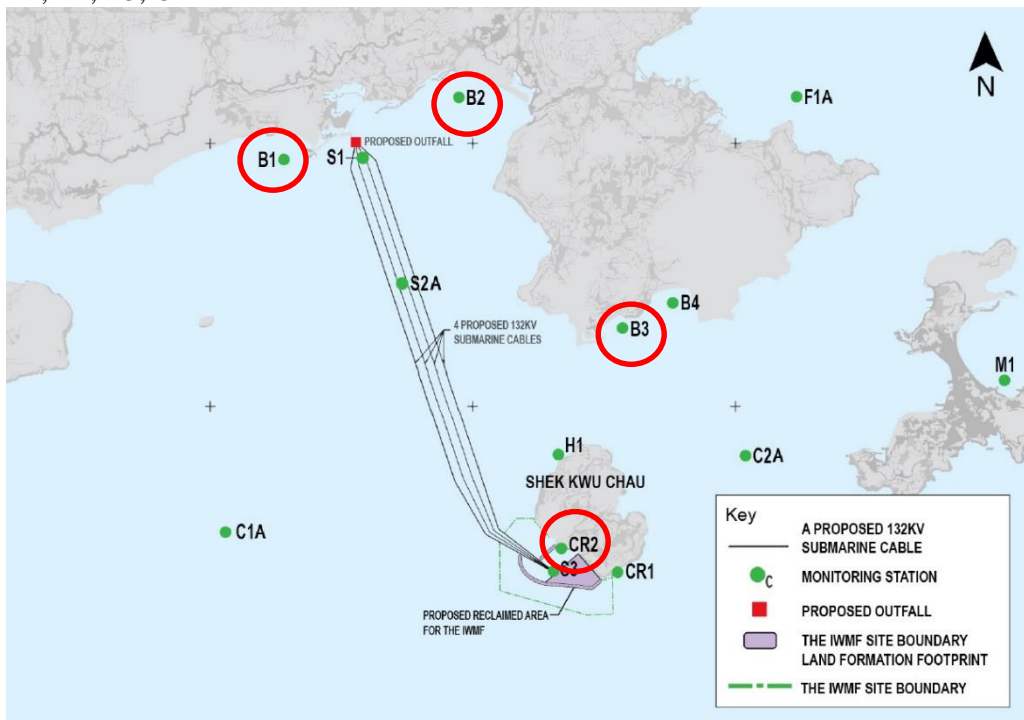
</div>		
Parameter	Suspended Solid (SS)		
Action & Limit Levels	Action Level		Limit Level
	≥ 19.8 mg/L (120% of C1A)		≥ 21.5 mg/L (130% of C1A)
Measurement Level	Impact Station(s) of Exceedance	Control Stations	Impact Station(s) without Exceedance

22.8 mg/L (B1) 22.8 mg/L (B2) 22.3 mg/L (B3) 20.8 mg/L (CR2)	16.5 mg/L (C1A) 18.7 mg/L (C2A)	18.3 mg/L (B4) 19.3 mg/L (F1A) 16.0 mg/L (H1) 16.8 mg/L (M1) 18.7 mg/L (CR1)
Possible reason for Action or Limit Level Non-compliance	<p>Works scheduled on site on 18 Nov 2020 include reclamation works, levelling the slag materials, loading slag materials, laying of rockfill and Chinese pod installation.</p> <p>Dominating sea current direction was found to be from Northwest to Southeast at waters around Shek Kwu Chau.</p> <p>B1, B2 and B3 are located at unrelated stream direction neither upstream nor downstream, far away) to the works location, exceedance of this monitoring station is deemed to be unrelated to the Project.</p> <p>CR2 is located close to the works location within the Project site while silt curtain checking by the Contractor was implemented on Marine Access (18 Nov 2020, 01:00pm), Eastern Silt Curtain (18 Nov 2020, 01:00pm), GD851 (18 Nov 2020, 07:00am) and checking results showed that no deficiency of silt curtain was found on that day.</p> <p>From MMO monitoring records on 18 Nov 2020, MMO team was arranged for one</p>

<p>crane barge (GD-851), silt curtain at western marine access area and the eastern silt curtain on that day while no deficiency of silt curtain was found before the commencement of and during construction activity.</p> <p>According to the field observation by Marine Mammal Observer team & sampling team during sampling event, no silt plume was observed in the Project site.</p> <p>Site tidiness in the present barges in the Project site were checked during weekly site inspection on 17 Nov 2020 while some soil was observed on the edge of vertical seawall and this observation had been rectified immediately by Contractor. However, according to the rationale in previous paragraphs, this observation might not contribute to the increase of the suspended solids recorded.</p>		
Mid-Flood			
Monitoring Location	<p>CR2</p>

Actions taken / to be taken	Examination of environmental performance of the Project will be continued during the weekly inspection, and the Contractor is reminded to implement all applicable mitigation measures as per the Updated EM&A Manual.
Remarks	<p>Current direction during mid-ebb sampling on 18 Nov 2020:</p>

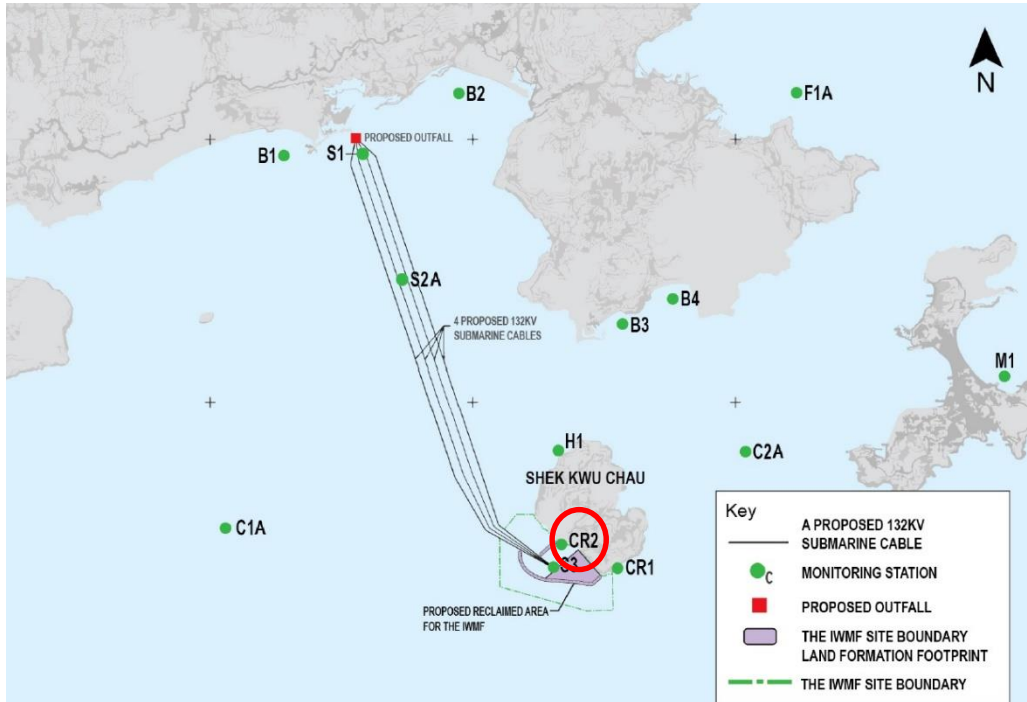
≥ 23.8 mg/L (120% of C2A)		≥ 25.8 mg/L (130% of C2A)
Measurement Level	Impact Station(s) of Exceedance	Control Stations	Impact Station(s) without Exceedance

24.3 mg/L (CR2)	21.2 mg/L (C1A) 19.8 mg/L (C2A)	13.3 mg/L (B1) 23.8 mg/L (B2) 22.3 mg/L (B3) 21.0 mg/L (B4) 23.7 mg/L (F1A) 17.5 mg/L (H1) 23.2 mg/L (M1) 22.8 mg/L (CR1)
Possible reason for Action or Limit Level Non-compliance	<p>Works scheduled on site on 18 Nov 2020 include reclamation works, levelling the slag materials, loading slag materials, laying of rockfill and Chinese pod installation.</p> <p>Dominating sea current direction was found to be from Southeast to Northwest at waters around Shek Kwu Chau.</p> <p>CR2 is located close to the works location within the Project site while silt curtain checking by the Contractor was implemented on Marine Access (18 Nov 2020,</p>

<p>01:00pm), Eastern Silt Curtain (18 Nov 2020, 01:00pm), GD851 (18 Nov 2020, 07:00am) and checking results showed that no deficiency of silt curtain was found on that day.</p> <p>From MMO monitoring records on 18 Nov 2020, MMO team was arranged for one crane barge (GD-851), silt curtain at western marine access area and the eastern silt curtain on that day while no deficiency of silt curtain was found before the commencement of and during construction activity.</p> <p>According to the field observation by Marine Mammal Observer team & sampling team during sampling event, no silt plume was observed in the Project site.</p> <p>Site tidiness in the present barges in the Project site were checked during weekly site inspection on 17 Nov 2020 while some soil was observed on the edge of vertical seawall and this observation had been rectified immediately by Contractor. However, according to the rationale in previous paragraphs, this observation might not contribute to the increase of the suspended solids recorded.</p>
