## Appendix N Exceedance Report

**Incident Report on Action Level or Limit Level Non-compliance**

Project	Integrated Waste Management Facilities, Phase 1		
Date	1 August 2018 (Lab result received on 7 August 2018)		
Time	13:09 – 16:39 (Mid-Ebb)		
Monitoring Location	B4 and H1

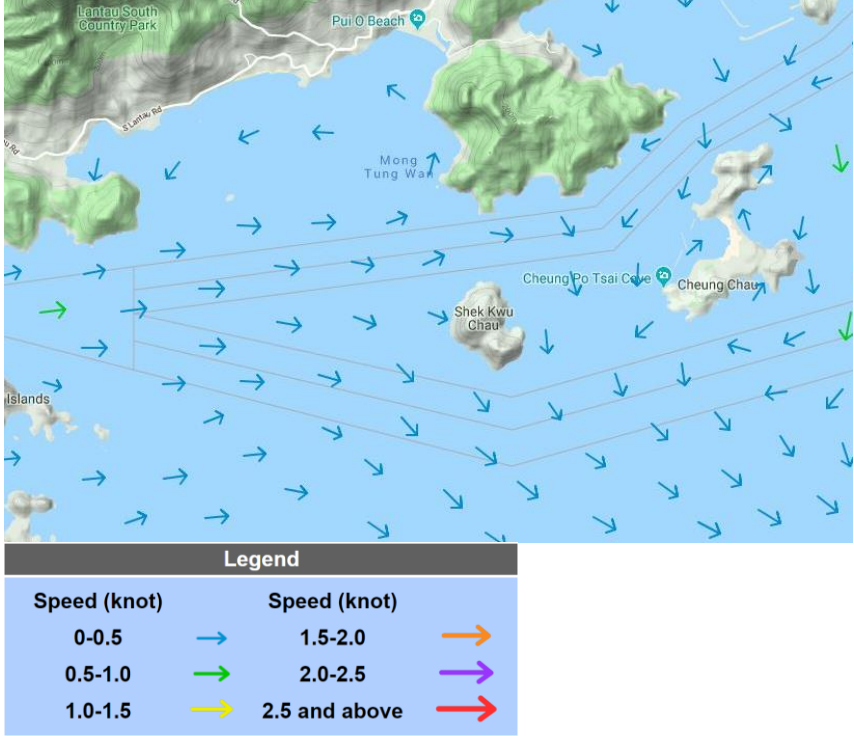
<p>Actions taken / to be taken</p>	<p>Examination of environmental performance of the Project will be continued during the weekly inspection, and the Contractor is reminded to implement all applicable mitigation measures as per the Updated EM&amp;A Manual.</p>	
<p>Remarks</p>	<p>Current direction during mid-ebb sampling on 1/8:</p>

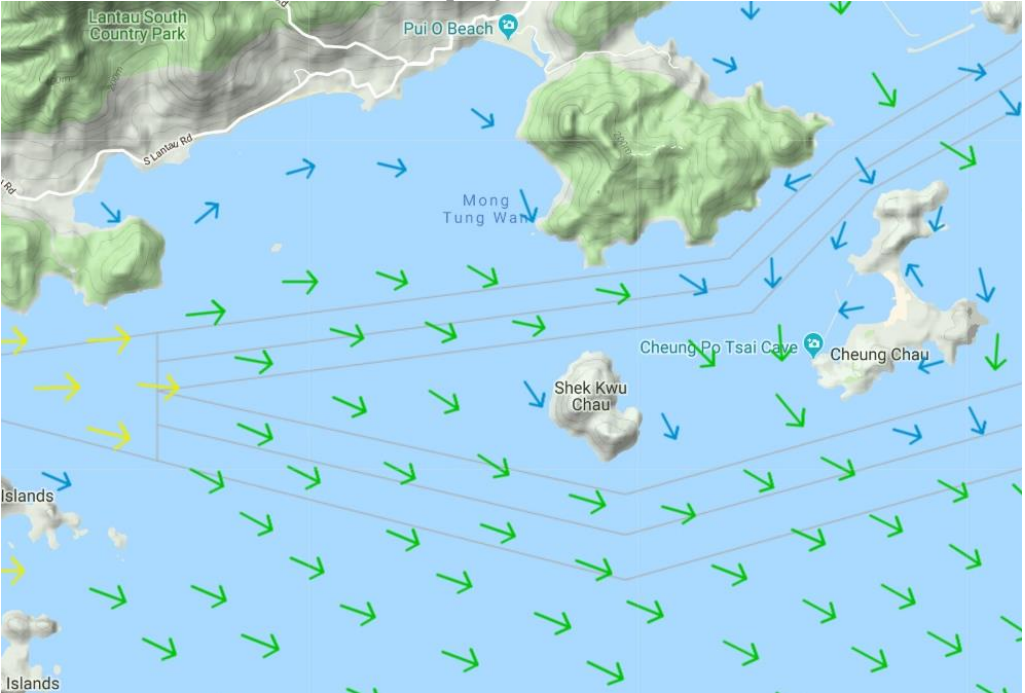
<p>monitoring stations in between B3 and the Project site, exceedance of this monitoring location is deemed to be unrelated to the Project and a localized event.</p> <p>Site tidiness in the present barges in the Project site were checked during weekly site inspection on 9/8, where applicable mitigation measures on water quality were found implemented and no improper site practice that might contribute to the increase in SS level was observed during the inspection.</p>																				
<p>Actions taken / to be taken</p>	<p>Examination of environmental performance of the Project will be continued during the weekly inspection, and the Contractor is reminded to implement all applicable mitigation measures as per the Updated EM&amp;A Manual.</p>																				
<p>Remarks</p>	<p>Current direction during mid-ebb sampling on 8/8:</p>

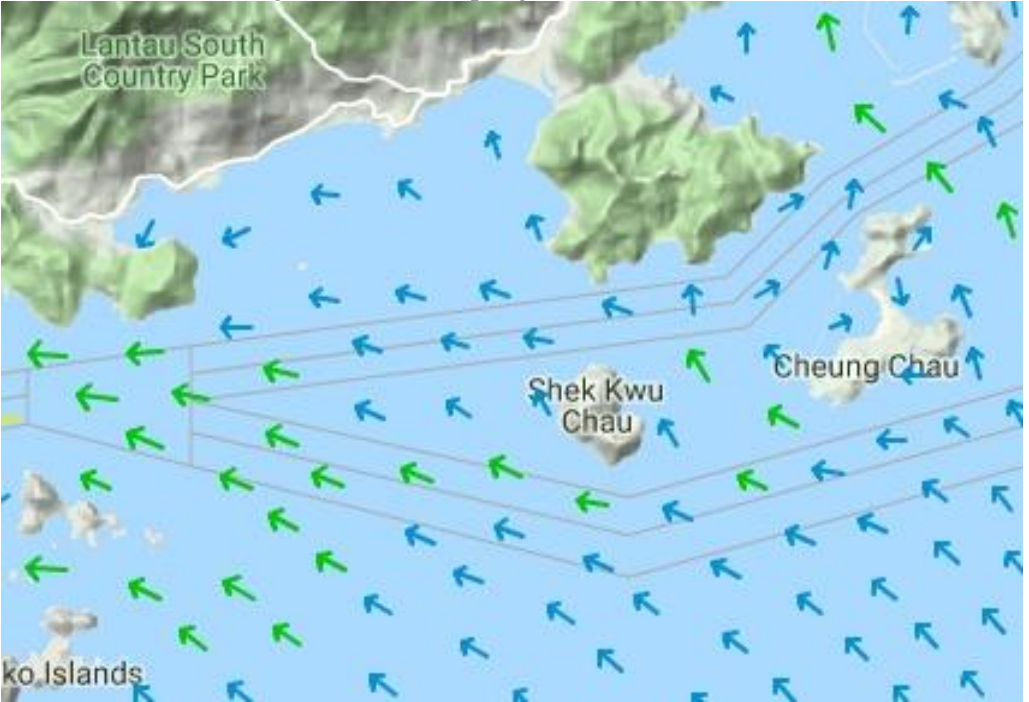
<p>Remarks</p>	<p>Current direction during <b>mid-flood</b> sampling on 15/8:</p>

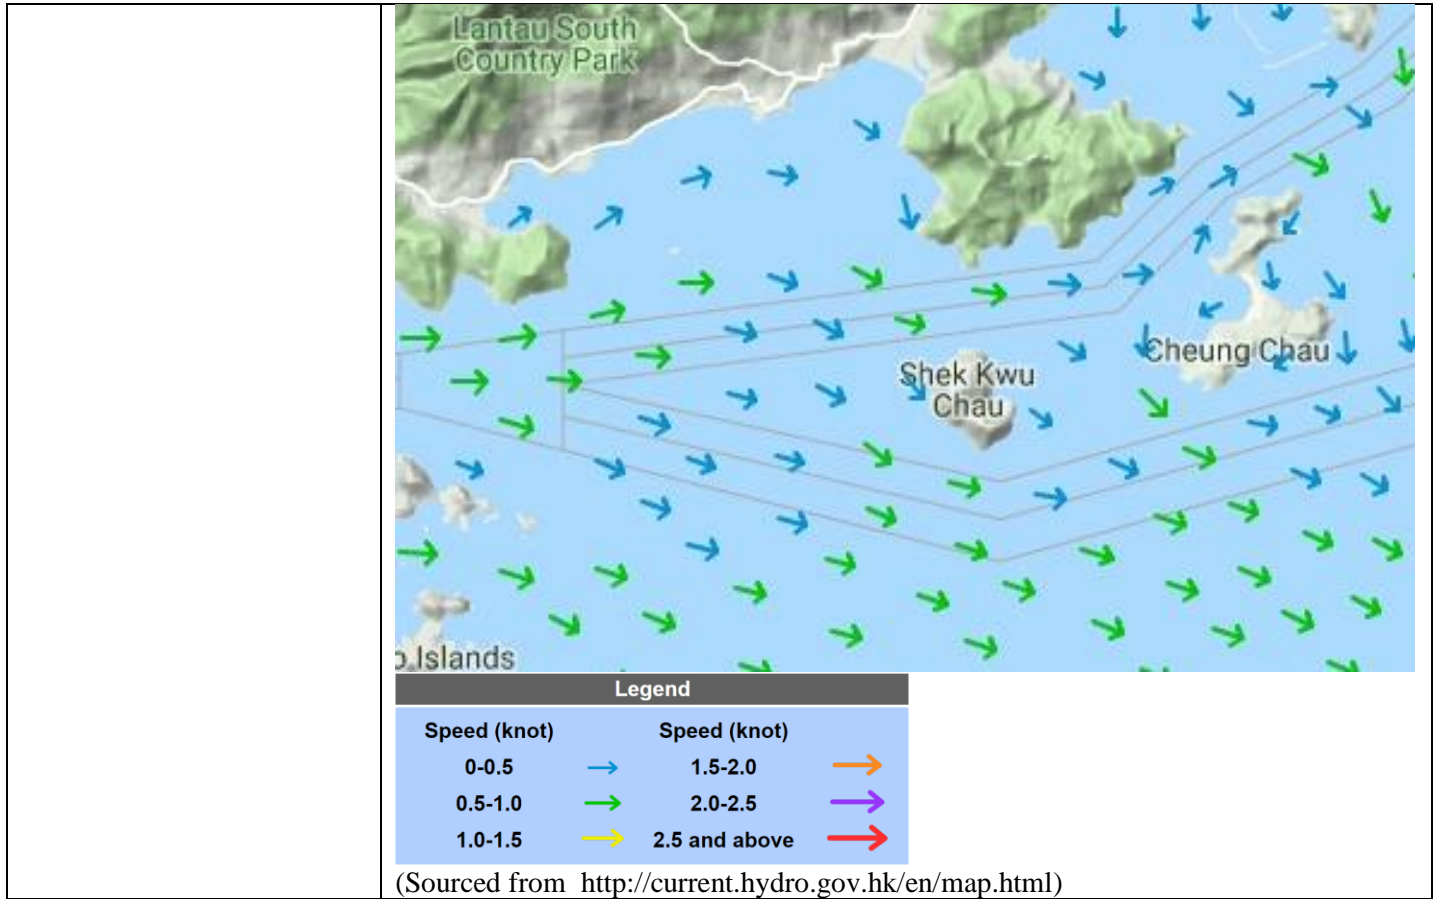
<p>Current direction during <b>mid-ebb</b> sampling on 15/8:</p>

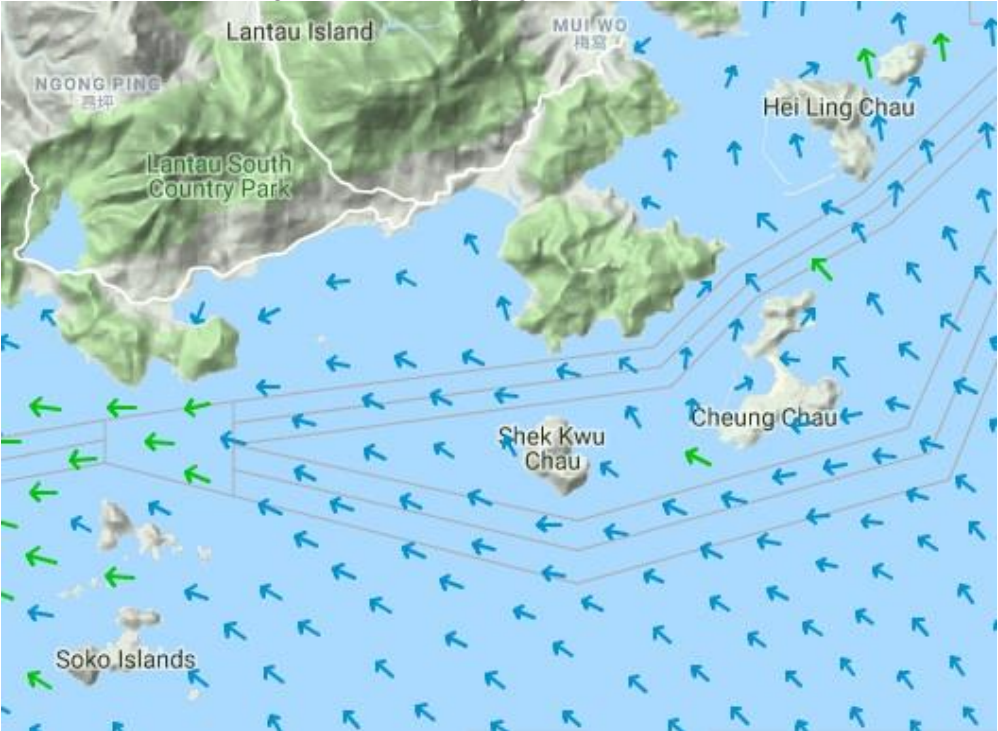
<p>Remarks</p>	<p>Current direction during <b>mid-flood</b> sampling on 17/8:</p>

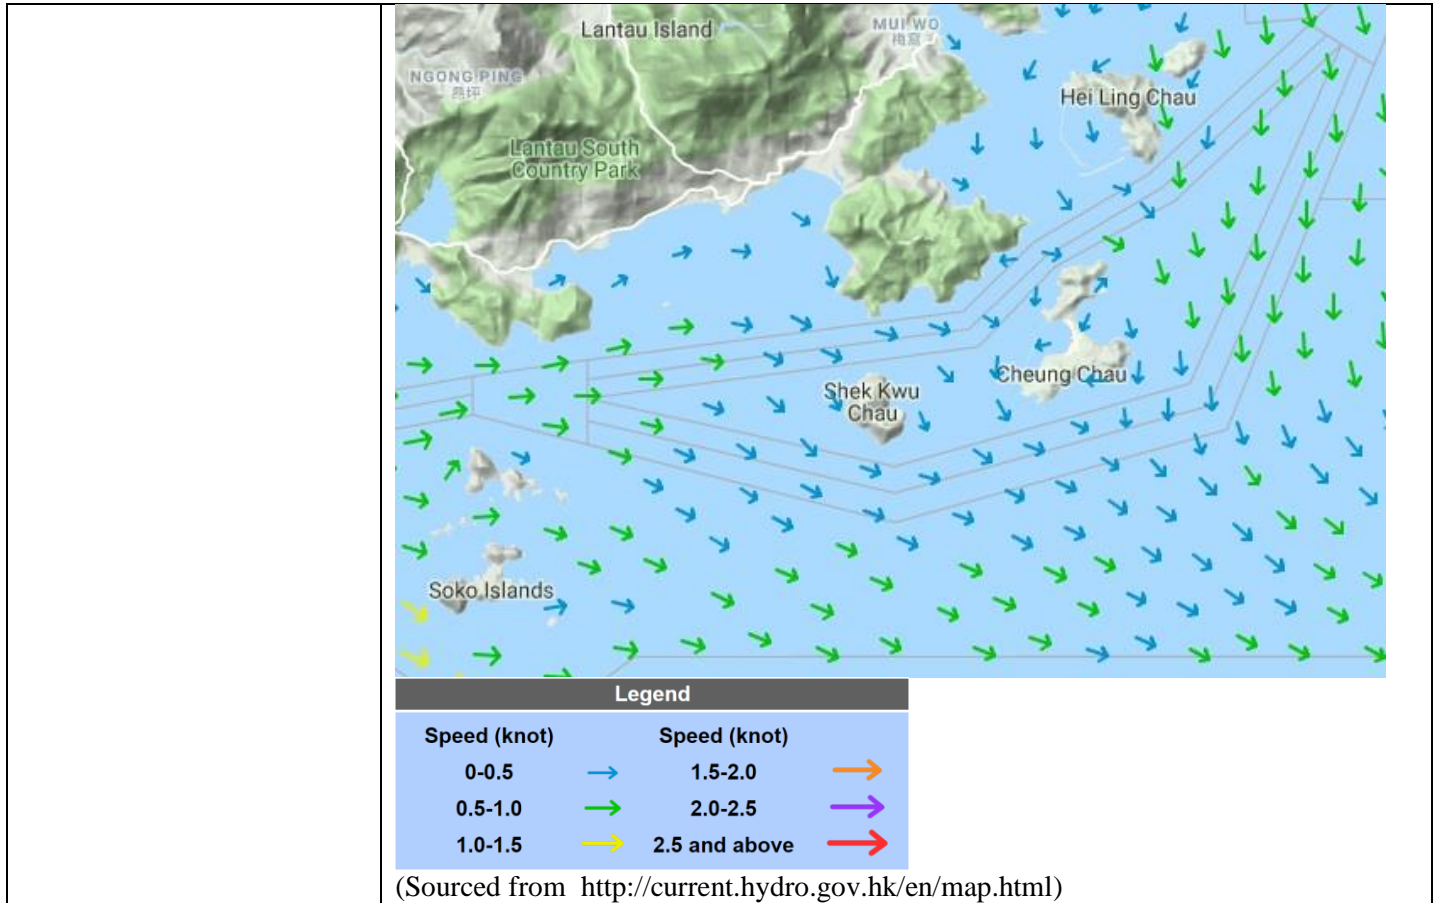
<p>Current direction during <b>mid-ebb</b> sampling on 17/8:</p>

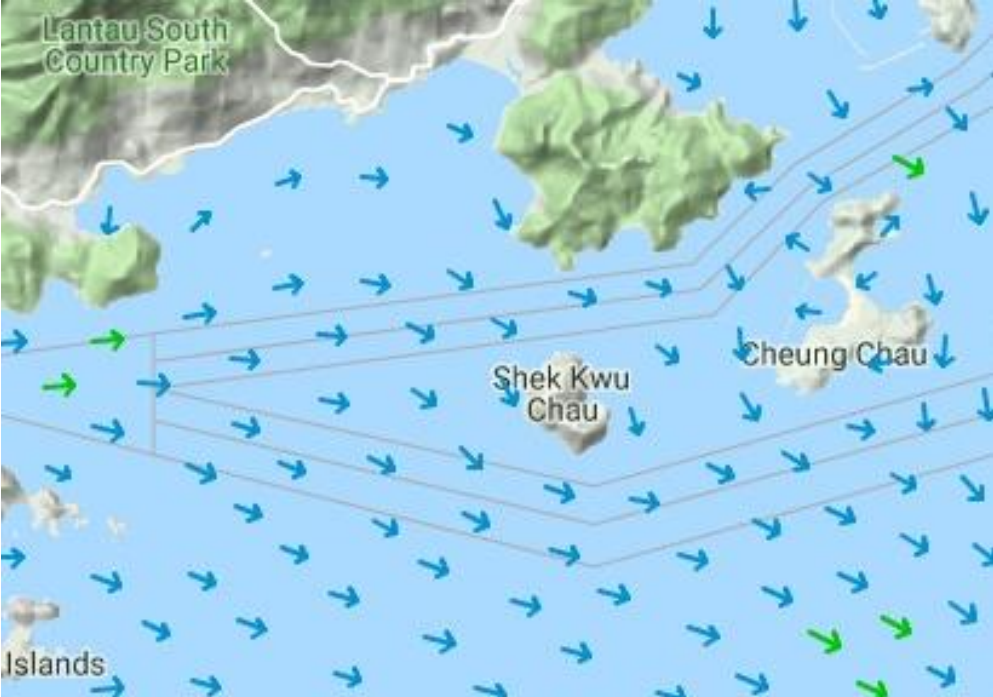
<p>S3 were not due to the Project.</p> <p>Site tidiness in the present barges in the Project site were checked during weekly site inspection on 21/8, where applicable mitigation measures on water quality were found implemented and no improper site practice that might contribute to the increase in SS level was observed during the inspection.</p>
<p>Actions taken / to be taken</p>	<p>Examination of environmental performance of the Project will be continued during the weekly inspection, and the Contractor is reminded to implement all applicable mitigation measures as per the Updated EM&amp;A Manual.</p>
<p>Remarks</p>	<p>Current direction during mid-ebb sampling on 22/8:</p>

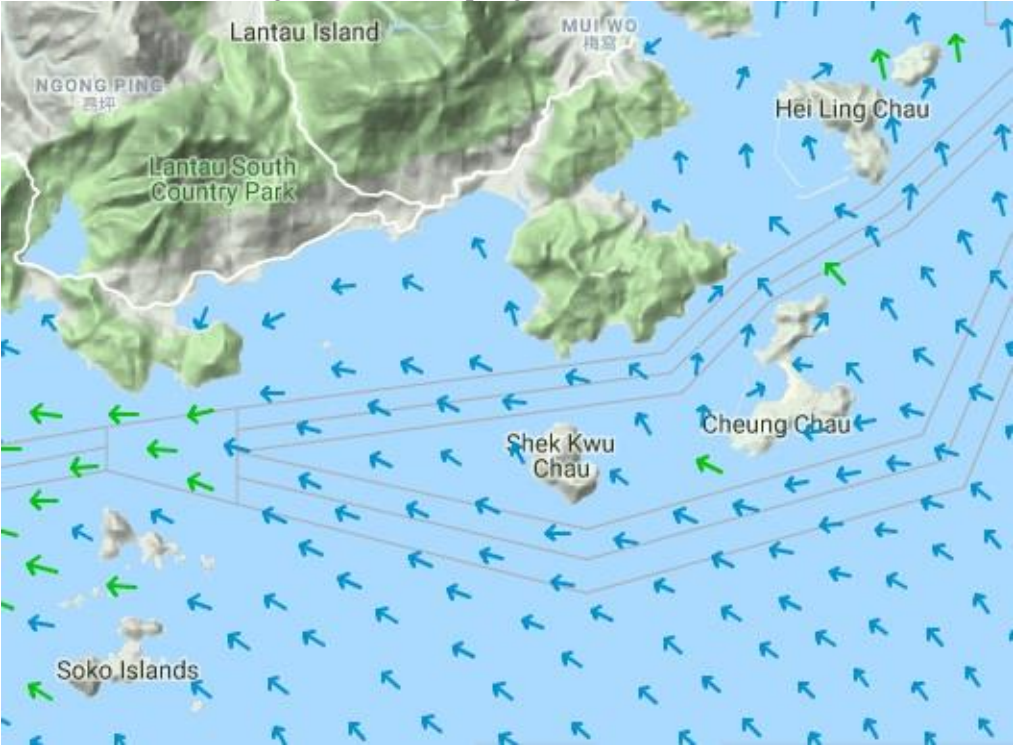
<p>monitoring stations in between B2, B3 and the Project site, exceedance of this monitoring location is deemed to be unrelated to the Project.</p> <p>Site tidiness in the present barges in the Project site were checked during weekly site inspection on 21/8, where applicable mitigation measures on water quality were found implemented and no improper site practice that might contribute to the increase in SS level was observed during the inspection.</p>
<p>Actions taken / to be taken</p>	<p>Examination of environmental performance of the Project will be continued during the weekly inspection, and the Contractor is reminded to implement all applicable mitigation measures as per the Updated EM&amp;A Manual.</p>
<p>Remarks</p>	<p>Current direction during mid-flood sampling on 24/8:</p>

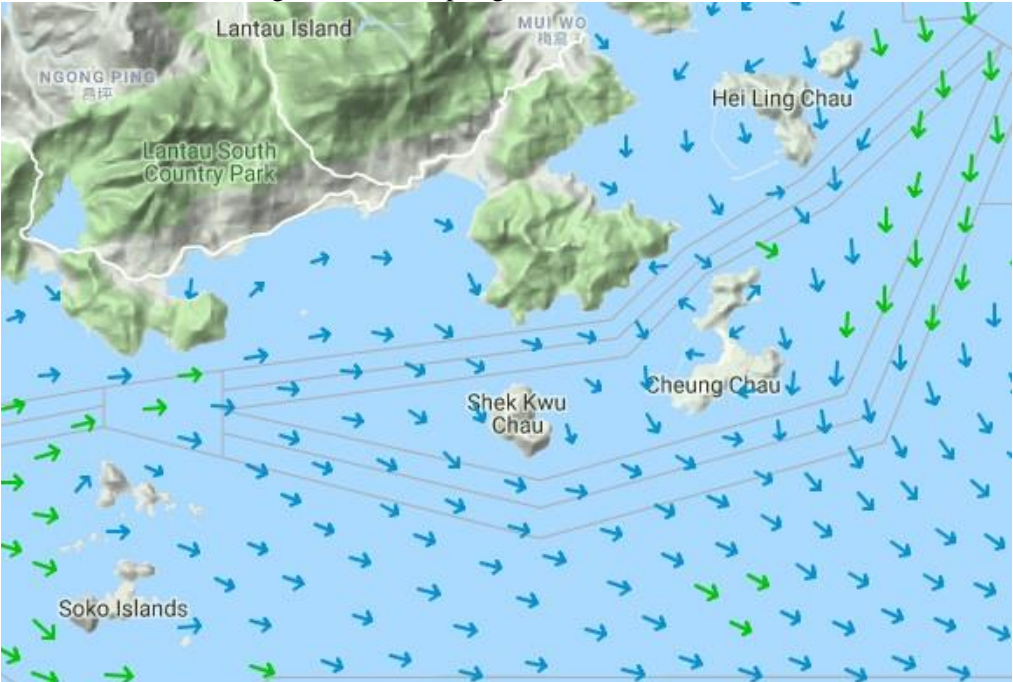
<p>Current direction during mid-ebb sampling on 24/8:</p>

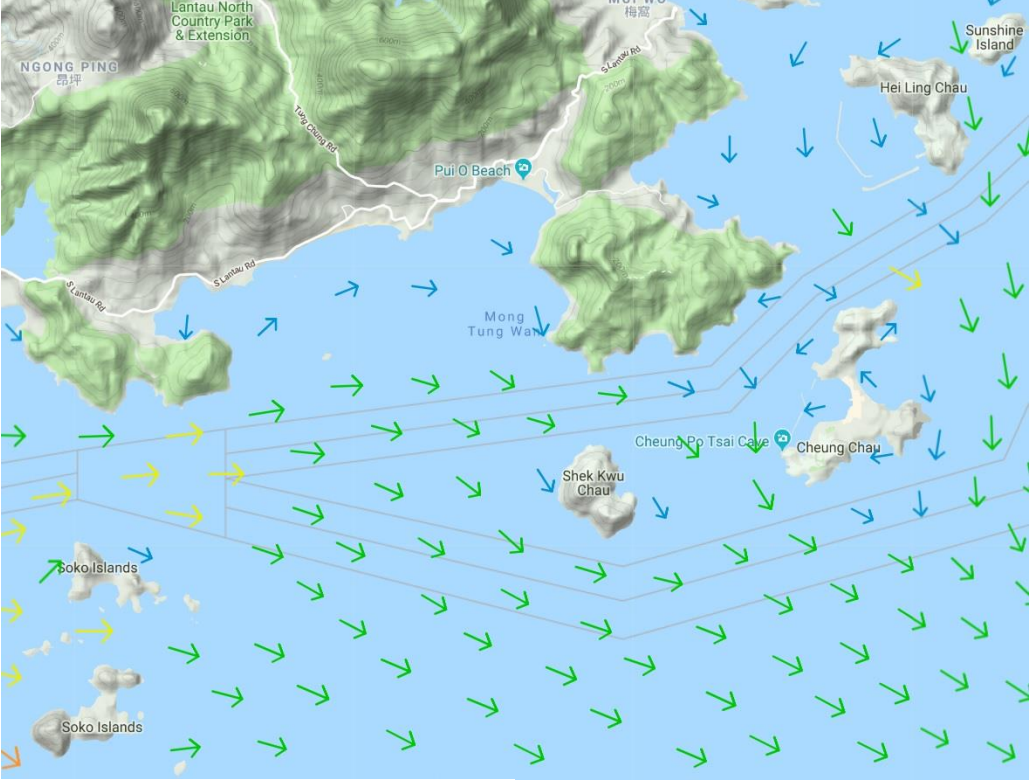
inspection on 28/8, where applicable mitigation measures on water quality were found implemented and no improper site practice that might contribute to the increase in SS level was observed during the inspection.
Actions taken / to be taken	Examination of environmental performance of the Project will be continued during the weekly inspection, and the Contractor is reminded to implement all applicable mitigation measures as per the Updated EM&A Manual.
Remarks	<p>Current direction during mid-ebb sampling on 27/8:</p>

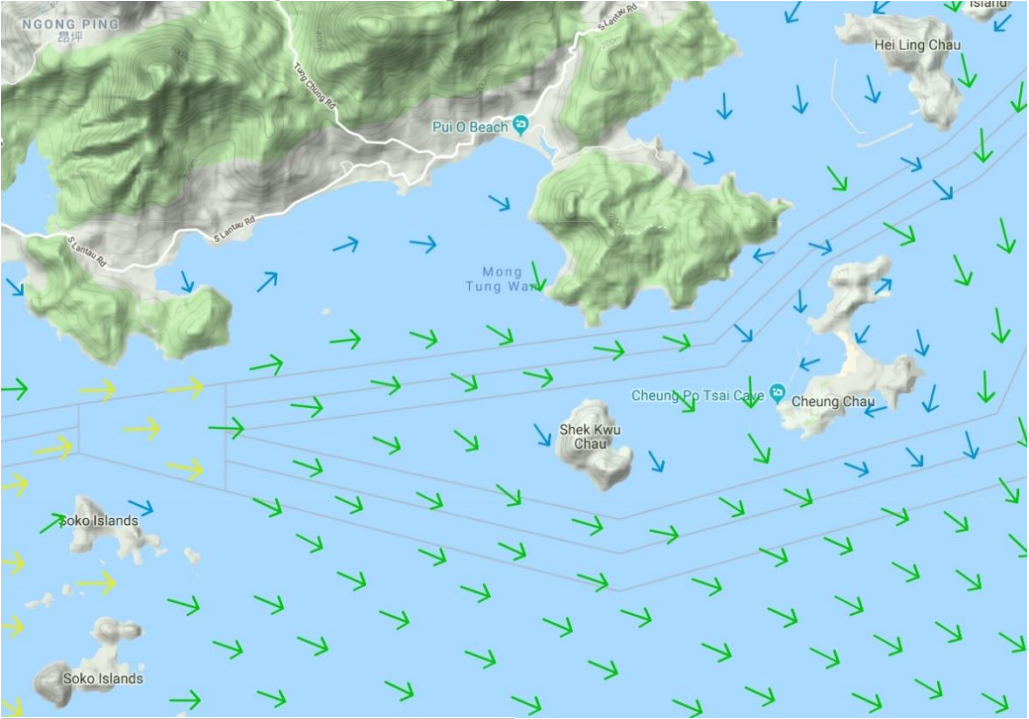
<p>Site tidiness in the present barges in the Project site were checked during weekly site inspection on 28/8, where applicable mitigation measures on water quality were found implemented and no improper site practice that might contribute to the increase in SS level was observed during the inspection.</p>								
<p>Actions taken / to be taken</p>	<p>Examination of environmental performance of the Project will be continued during the weekly inspection, and the Contractor is reminded to implement all applicable mitigation measures as per the Updated EM&amp;A Manual.</p>								
<p>Remarks</p>	<p>Current direction during mid-ebb sampling on 29/8:</p>
