Appendix N Exceedance Report

Incident Report on Action Level or Limit Level Non-compliance

| Project | Integrated Waste Management Facilities, Phase 1 | | |

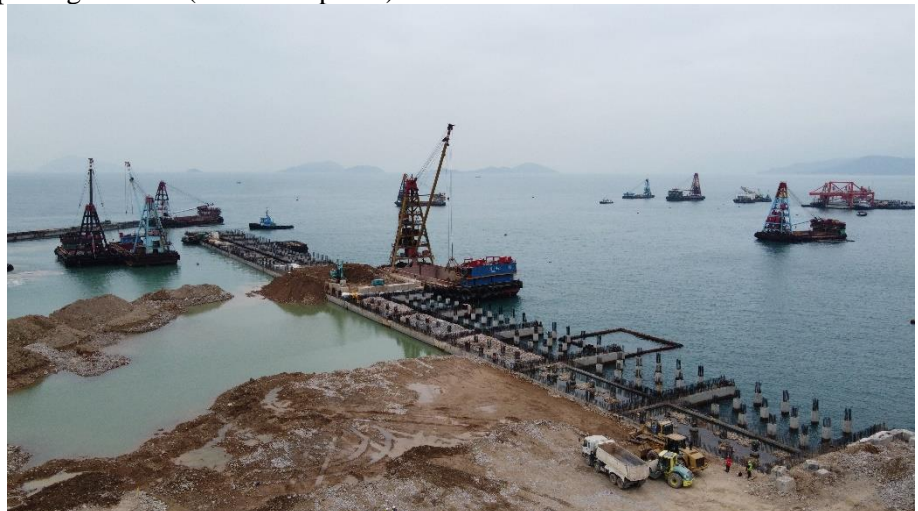
Supporting Photo 1 (Overview photo):

On 16 Dec 2020, Marine Mammal Observer (MMO) team stood by on one derrick barge (金盈 8). According to the field observation by MMO team & sampling team during sampling event, no silt plume was observed outside the seawall and marine access opening, no silt plume was observed during the water sampling at CR2, which is the closest sampling point near the marine access. (Supporting photos 1,2&3).
