Appendix N Exceedance Report

Incident Report on Action Level or Limit Level Non-compliance

Project	Integrated Waste Management Facilities, Phase 1		
Date	13 Jan 2021 (Lab result received on 18 Jan 2021)		
Time	11:02 – 14:32 (Mid-Ebb)		
Monitoring Location	Mid-Ebb		
Monitoring Location	B2 		
Parameter	Suspended Solid (SS)		
Action & Limit Levels	Action Level		Limit Level
	≥ 8.0 mg/L		≥ 10.0 mg/L
Measurement Level	Impact Station(s) of Exceedance	Control Stations	Impact Station(s) without Exceedance

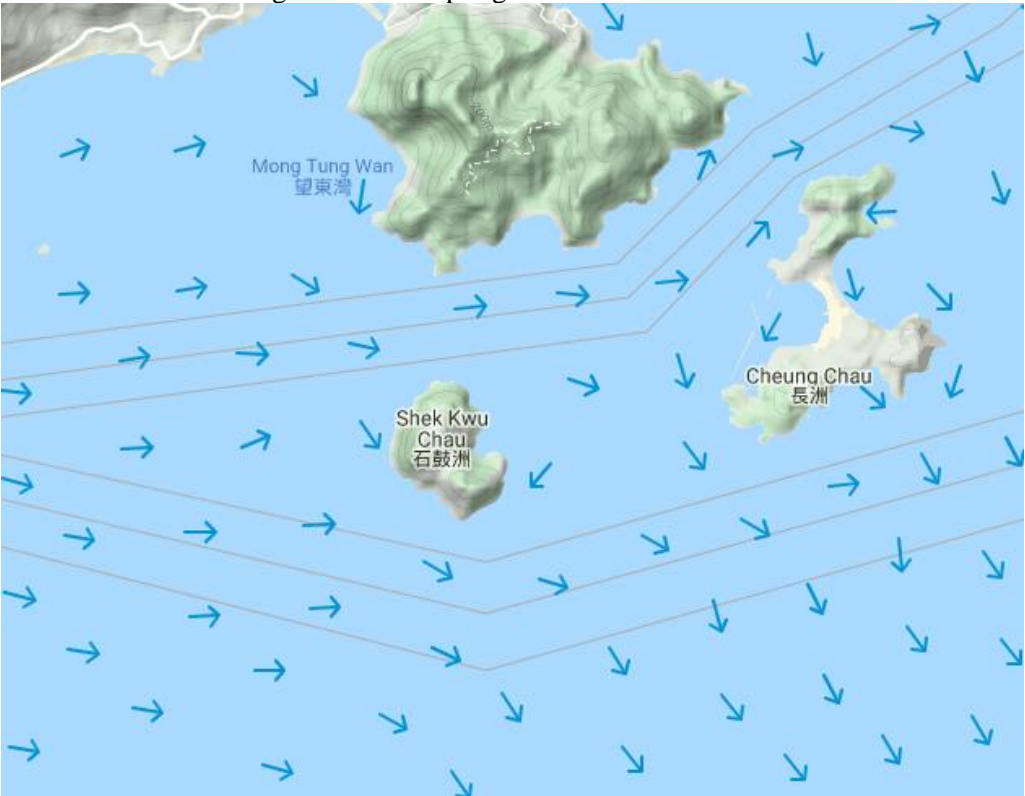
<p>From MMO monitoring records on 13 Jan 2021, MMO team was arranged for one derrick barge (金盈 8)) and silt curtain at western marine access area on that day while no deficiency of silt curtain was found before the commencement of and during construction activity.</p> <p>According to the field observation by Marine Mammal Observer team & sampling team during sampling event, no silt plume was observed in the Project site.</p> <p>Site tidiness in the present barges in the Project site were checked during weekly site inspection on 12 Jan 2021. No major observation of improper site practices that could contribute to the increase of the suspended solids recorded.</p>										
<p>Remarks</p>	<p>Current direction during mid-ebb sampling on 13 Jan 2021:</p>

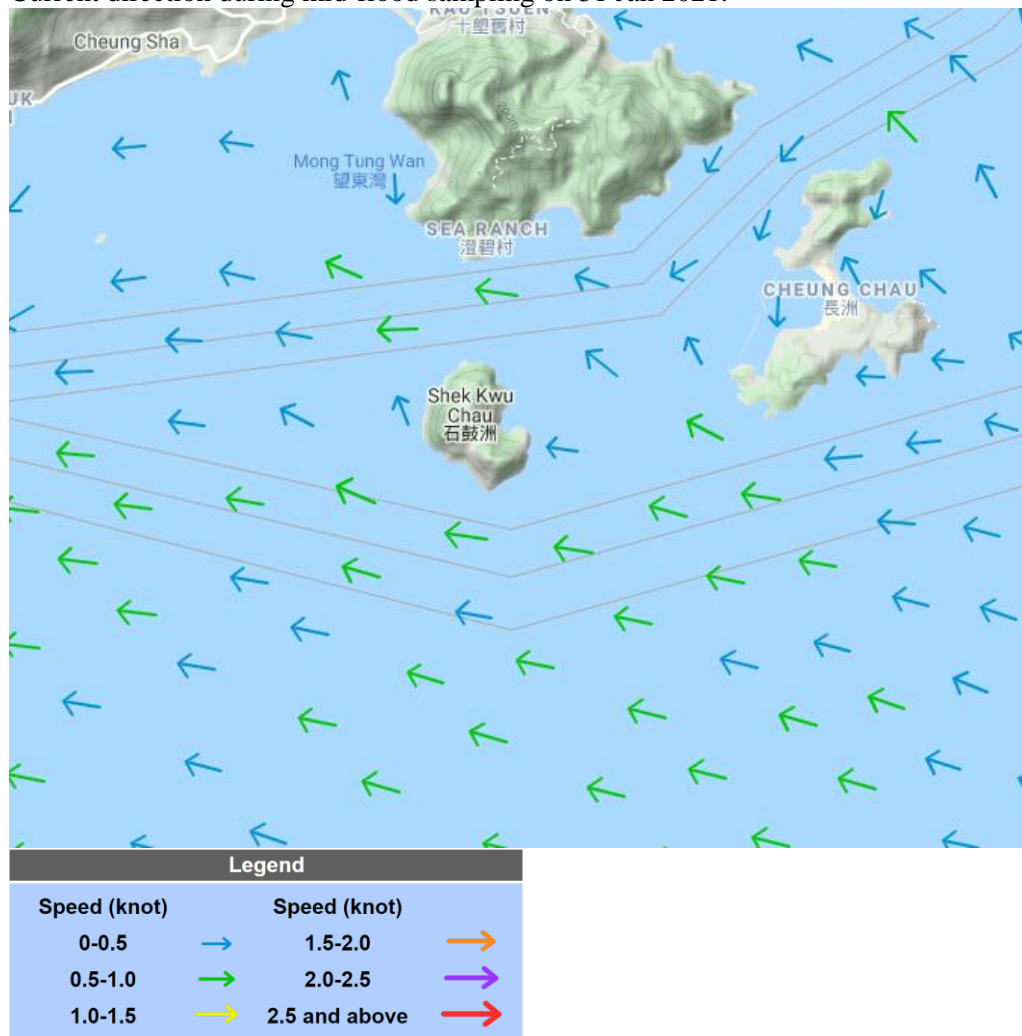
Current direction during mid-flood sampling on 31 Jan 2021:
