Appendix N Exceedance Report

Incident Report on Action Level or Limit Level Non-compliance

Project	Integrated Waste Management Facilities, Phase 1		
Date	3 September 2018 (Lab result received on 7 September 2018)		
Time	03:25 - 07:55 (Mid-Ebb)		
Monitoring Location	B2 & H1

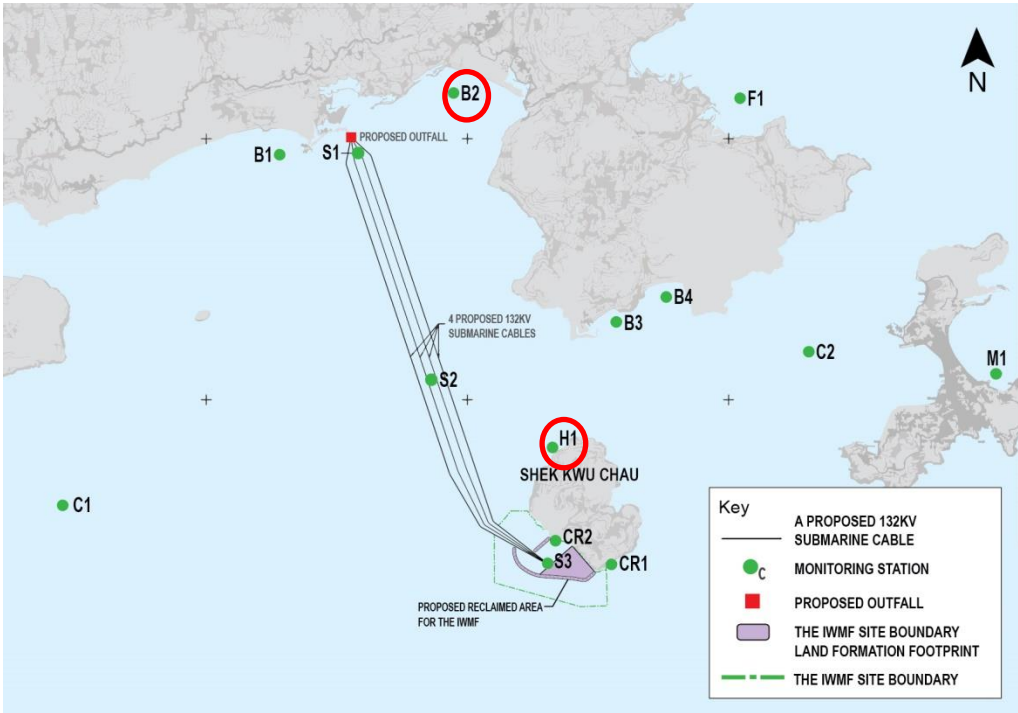
Parameter	Suspended Solid (SS)		
Action & Limit Levels	Action Level	Limit Level	
	≥ 8.0 mg/L	≥ 10.0 mg/L	
Measurement Level	Impact Station(s) with Exceedance	Control Stations	Impact Station(s) without Exceedance

8.5 mg/L (B2) 9.0 mg/L (H1)	6.1 mg/L (C1) 7.3 mg/L (C2)	3.5 mg/L (B1) 4.8 mg/L (B3) 5.0 mg/L (B4) 6.3 mg/L (F1) 4.7 mg/L (M1) 5.7 mg/L (CR1) 7.3 mg/L (CR2) 5.3 mg/L (S1) 5.2 mg/L (S2) 4.3 mg/L (S3)
Possible reason for Action or Limit Level Non-compliance	<p>Works scheduled on site on 3/9 include ground investigation (GI) works of 3 small borehole drilling and 2 sample coring, which shall not be a major source of SS concentration increase considering the limited scale and nature of works.</p> <p>Dominating sea current direction was found to be from Northwest to Southeast at waters around Shek Kwu Chau.</p> <p>B2 is located at unrelated stream direction (neither upstream nor downstream, far away) and H1 is located at upstream direction to the works location, exceedance of this monitoring location is deemed to be unrelated to the Project at the sampling period.</p> <p>Site tidiness in the present barges in the Project site were checked during weekly site</p>

inspection on 4/9, where applicable mitigation measures on water quality were found implemented and no improper site practice that might contribute to the increase in SS level was observed during the inspection.								
Actions taken / to be taken	Examination of environmental performance of the Project will be continued during the weekly inspection, and the Contractor is reminded to implement all applicable mitigation measures as per the Updated EM&A Manual.								
Remarks	<p>Current direction during mid-ebb sampling on 3/9:</p>

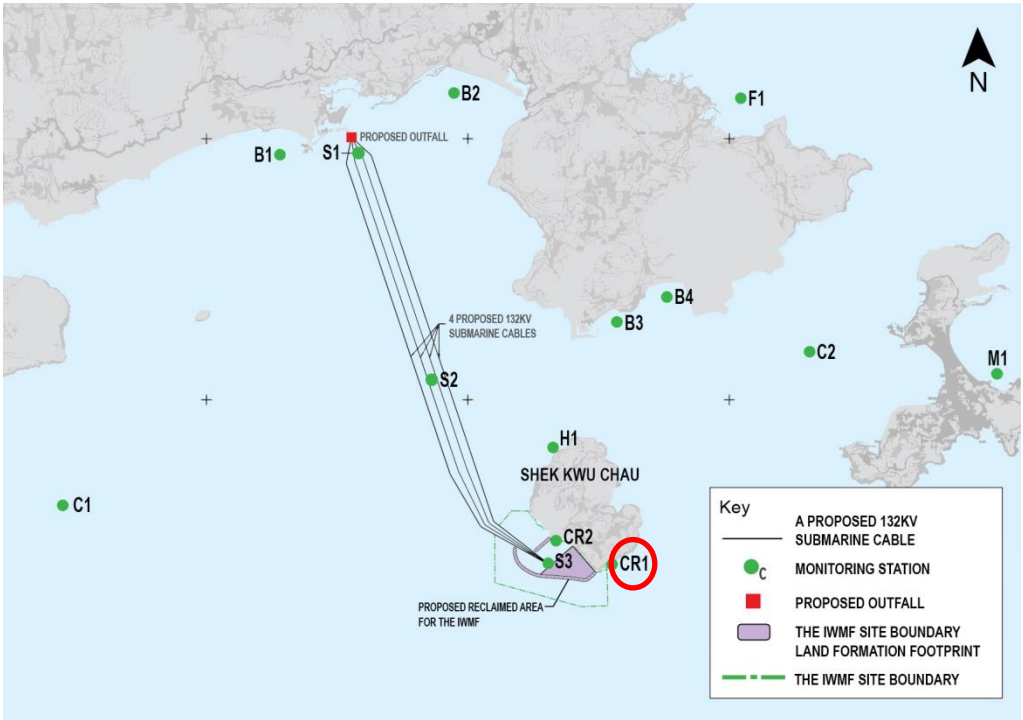
Parameter	Suspended Solid (SS)		
Action & Limit Levels	Action Level	Limit Level	
	≥ 13.8 mg/L (120% of C2)	≥ 15.0 mg/L (130% of C2)	
Measurement Level	Impact Station(s) with Exceedance	Control Stations	Impact Station(s) without Exceedance

14.0 mg/L (CR1)	10.5 mg/L (C1) 11.5 mg/L (C2)	11.0 mg/L (B1) 9.8 mg/L (B2) 8.0 mg/L (B3) 12.0 mg/L (B4) 9.7 mg/L (F1) 10.8 mg/L (H1) 9.7 mg/L (M1) 7.5 mg/L (CR2)
Possible reason for Action or Limit Level Non-compliance	<p>All works scheduled on site on 18/9 were suspended due to the yet to recover progress from typhoon MANGKHUT.</p> <p>Dominating sea current direction was found to be from Southeast to Northwest at waters around Shek Kwu Chau.</p> <p>CR2 and S3, the closer downstream monitoring stations to CR1 (upstream monitoring station), exhibited a much lower SS level. The above and absent of works suggest that the exceedance at CR1 should be unrelated to the Project.</p> <p>Site tidiness in the present barges in the Project site were checked during weekly site inspection on 11/9, where applicable mitigation measures on water quality were found implemented and no improper site practice that might contribute to the increase in SS level was observed during the inspection.</p>

Actions taken / to be taken	Examination of environmental performance of the Project will be continued during the

weekly inspection, and the Contractor is reminded to implement all applicable mitigation measures as per the Updated EM&A Manual.

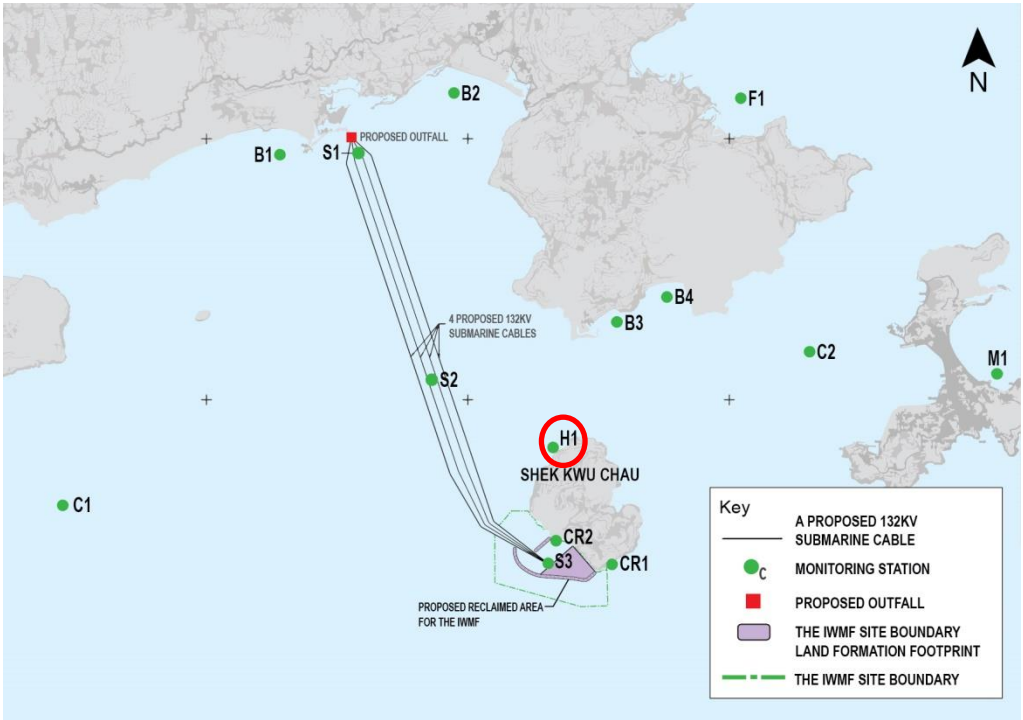
Parameter	Suspended Solid (SS)		
Action & Limit Levels	Action Level		Limit Level
	≥ 11.2 mg/L (120% of C2)		≥ 12.1 mg/L (130% of C2)
Measurement Level	Impact Station(s) with Exceedance	Control Stations	Impact Station(s) without Exceedance

11.5 mg/L (H1)	8.8 mg/L (C1) 9.3 mg/L (C2)	8.8 mg/L (B1) 8.8 mg/L (B2) 9.0 mg/L (B3) 8.8 mg/L (B4) 8.8 mg/L (F1) 8.3 mg/L (M1) 7.8 mg/L (CR1) 10.2 mg/L (CR2)
Possible reason for Action or Limit Level Non-compliance	<p>Works scheduled on site on 24/9 include ground investigation (GI) works of 3 small borehole drilling, which shall not be a major source of SS concentration increase considering the limited scale and nature of works.</p> <p>Dominating sea current direction was found to be from Southeast to Northwest at waters around Shek Kwu Chau.</p> <p>CR2, the closest downstream monitoring stations to H1, exhibited a lower SS level. It may suggest that the exceedance at H1 should be unrelated to the Project.</p> <p>Site tidiness in the present barges in the Project site were checked during weekly site inspection on 26/9, where applicable mitigation measures on water quality were found implemented and no improper site practice that might contribute to the increase in SS level was observed during the inspection.</p>

Actions taken / to be taken	Examination of environmental performance of the Project will be continued during the

weekly inspection, and the Contractor is reminded to implement all applicable mitigation measures as per the Updated EM&A Manual.	
Remarks	Current direction during mid-flood sampling on 24/9:
