## Appendix N Exceedance Report

**Incident Report on Action Level or Limit Level Non-compliance**

Project	Integrated Waste Management Facilities, Phase 1		
Date	01 Oct 2021 (Lab result received on 8 Oct 2021)		
Time	14:40-18:10 (Mid Flood)		
Mid-Flood			
Monitoring Location	<p>B3</p>		
Parameter	Suspended Solid (SS)		
Action & Limit Levels	Action Level		Limit Level
	≥ 14.0 mg/L (120% of C2A)		≥ 15.2 mg/L (130% of C2A)
Measurement Level	Impact Station(s) of Exceedance	Control Stations	Impact Station(s) without Exceedance

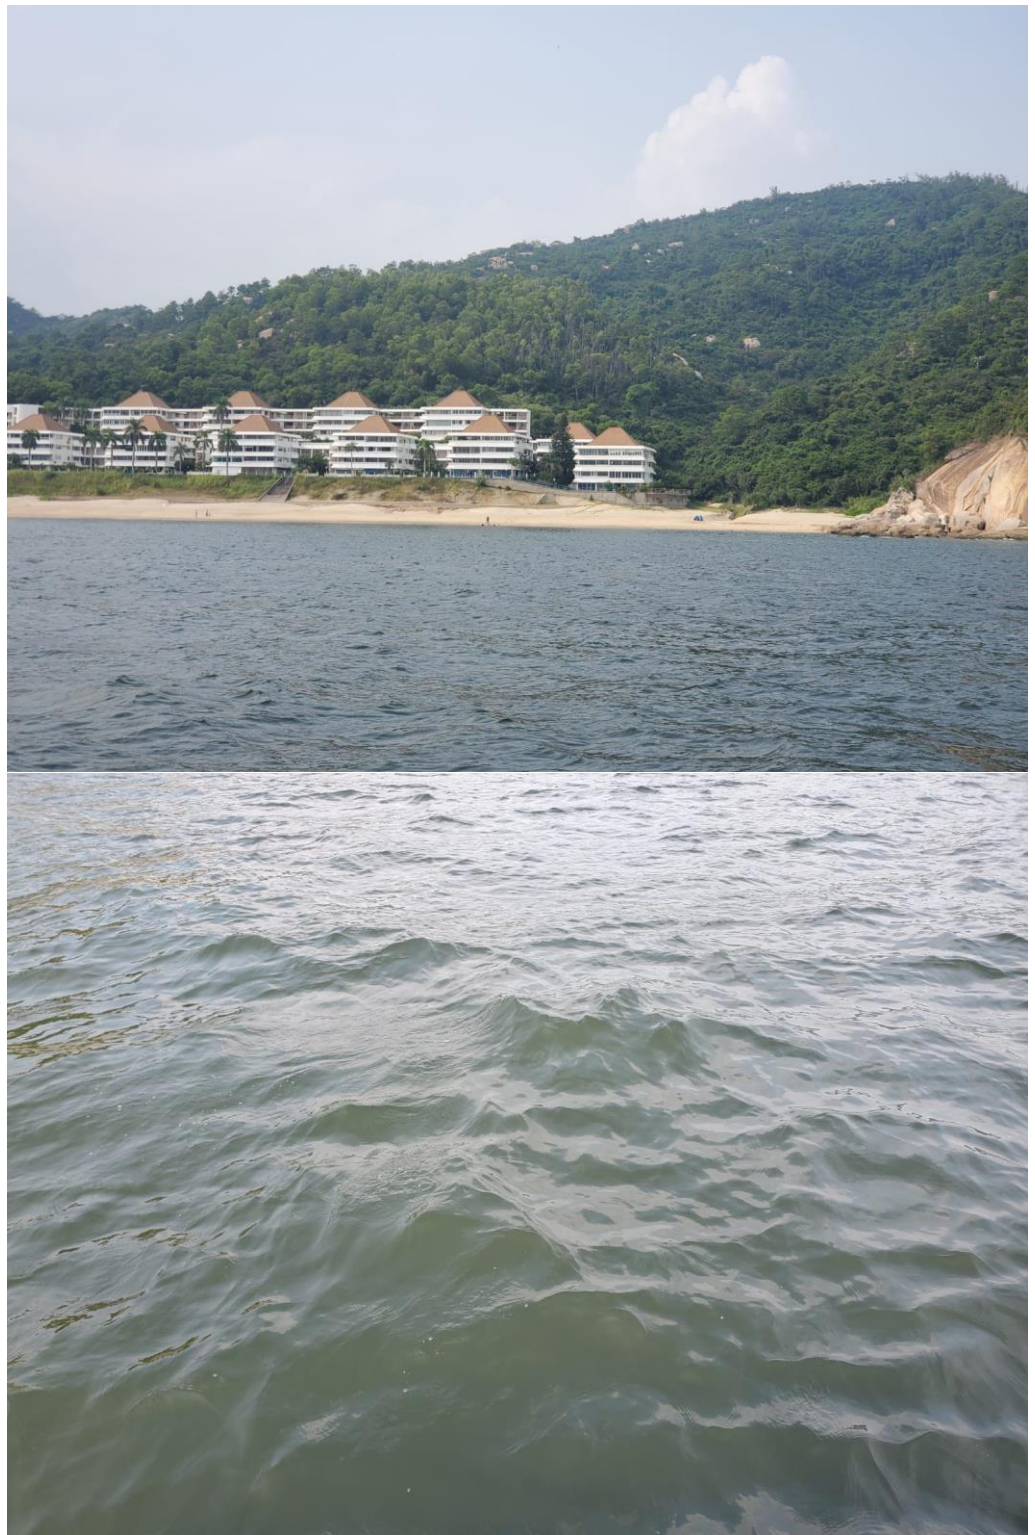
According to the field observation by sampling team during sampling event, no silt plume was observed in the Project site and the weather was fine during the sampling event taken at B3 as shown at the site photo below:

No major observation of improper site practices that could contribute to the increase of the suspended solids was recorded during the weekly inspection on 28 September 2021.

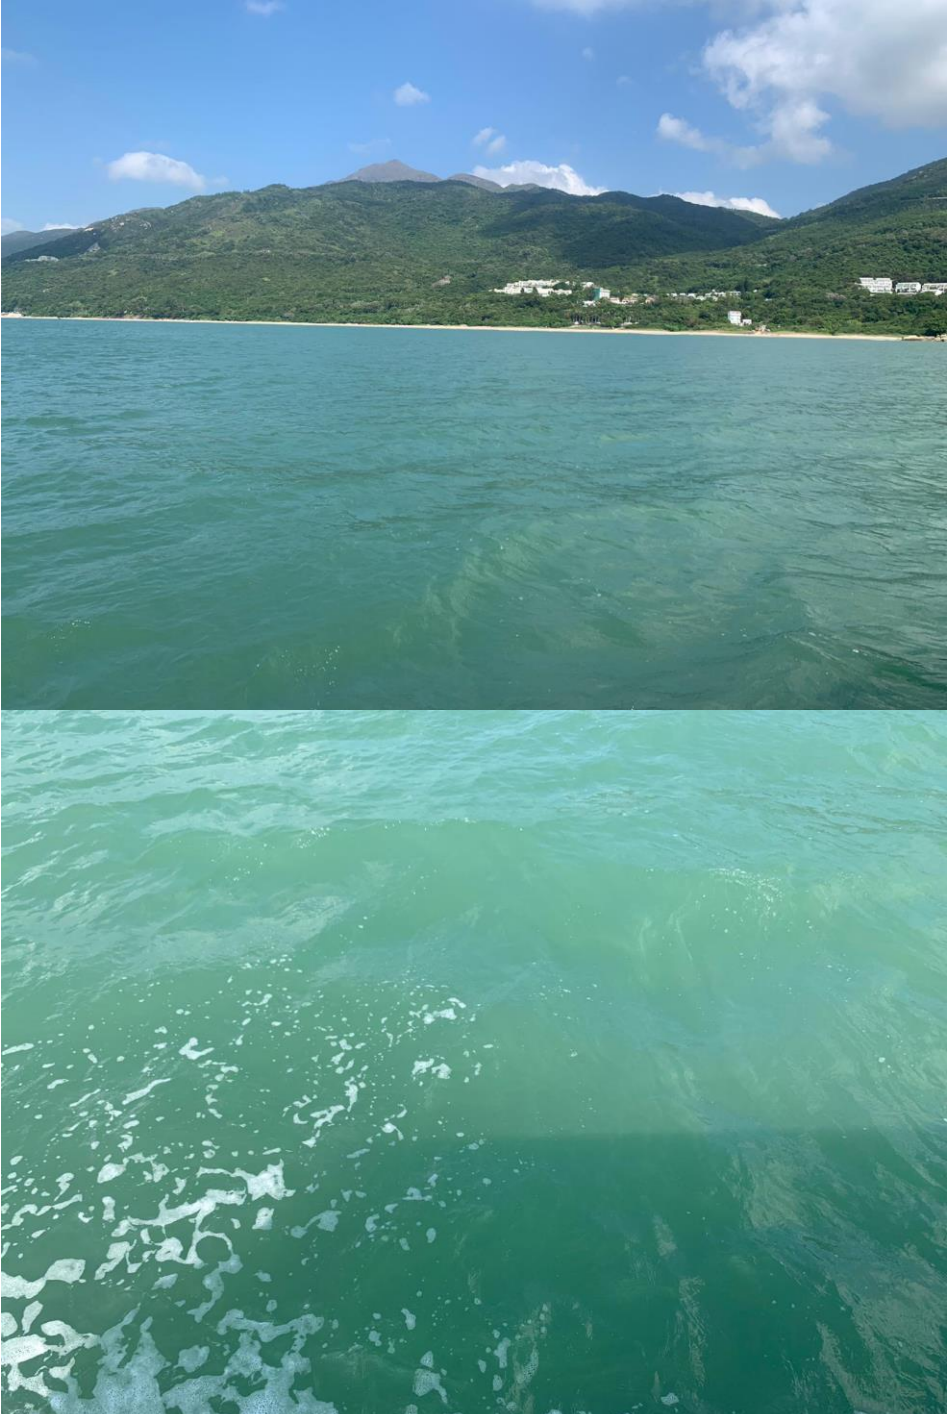
10.5 mg/L (B1) 8.2 mg/L (H1) 11.2 mg/L (M1) 9.7 mg/L (CR1) 11.7 mg/L (CR2)	6.0 mg/L (C1A) 7.8 mg/L (C2A)	5.5 mg/L (B2) 6.0 mg/L (B3) 5.0 mg/L (B4) 7.8 mg/L (F1A)
Possible reason for Action or Limit Level Non-compliance	<p>Works scheduled on site on 04 Oct 2021 include installation of caisson stoppers, landfilling works, installation of instrumentation, piling pre-drilling works, piling works and existing caisson extension.</p> <p>Dominating sea current direction was found to be from Northwest to Southeast at waters around Shek Kwu Chau.</p> <p>Exceedances of SS action level were found at H1 and CR1 on 04 Oct 2021 and exceedances of SS limit level were found at B1, M1 and CR2 on 04 Oct 2021.</p> <p>B1, H1 and M1 are located at unrelated stream direction (neither upstream nor downstream, far away) to the works location, exceedance of these monitoring stations are deemed to be unrelated to the Project.</p> <p>CR1 and CR2 are located close to the works location within the Project site while no marine work was conducted on 04 Oct 2021.</p>

<p>The installation of caisson No.19 was completed on 18 Mar 2021, the reclamation area was enclosed.</p> <p>According to the field observation by sampling team during sampling event, no silt plume was observed in the Project site and the weather was fine during the sampling event.</p> <p>No major observation of improper site practices that could contribute to the increase of the suspended solids was recorded during the weekly inspection on 28 September 2021.</p> <p>After the investigation, the exceedances on 04 Oct 2021 at B1, H1, M1, CR1 and CR2 are deemed to be unrelated to the Project.</p>
<p>Monitoring photos of stations with exceedance</p>	<p>B1:</p>

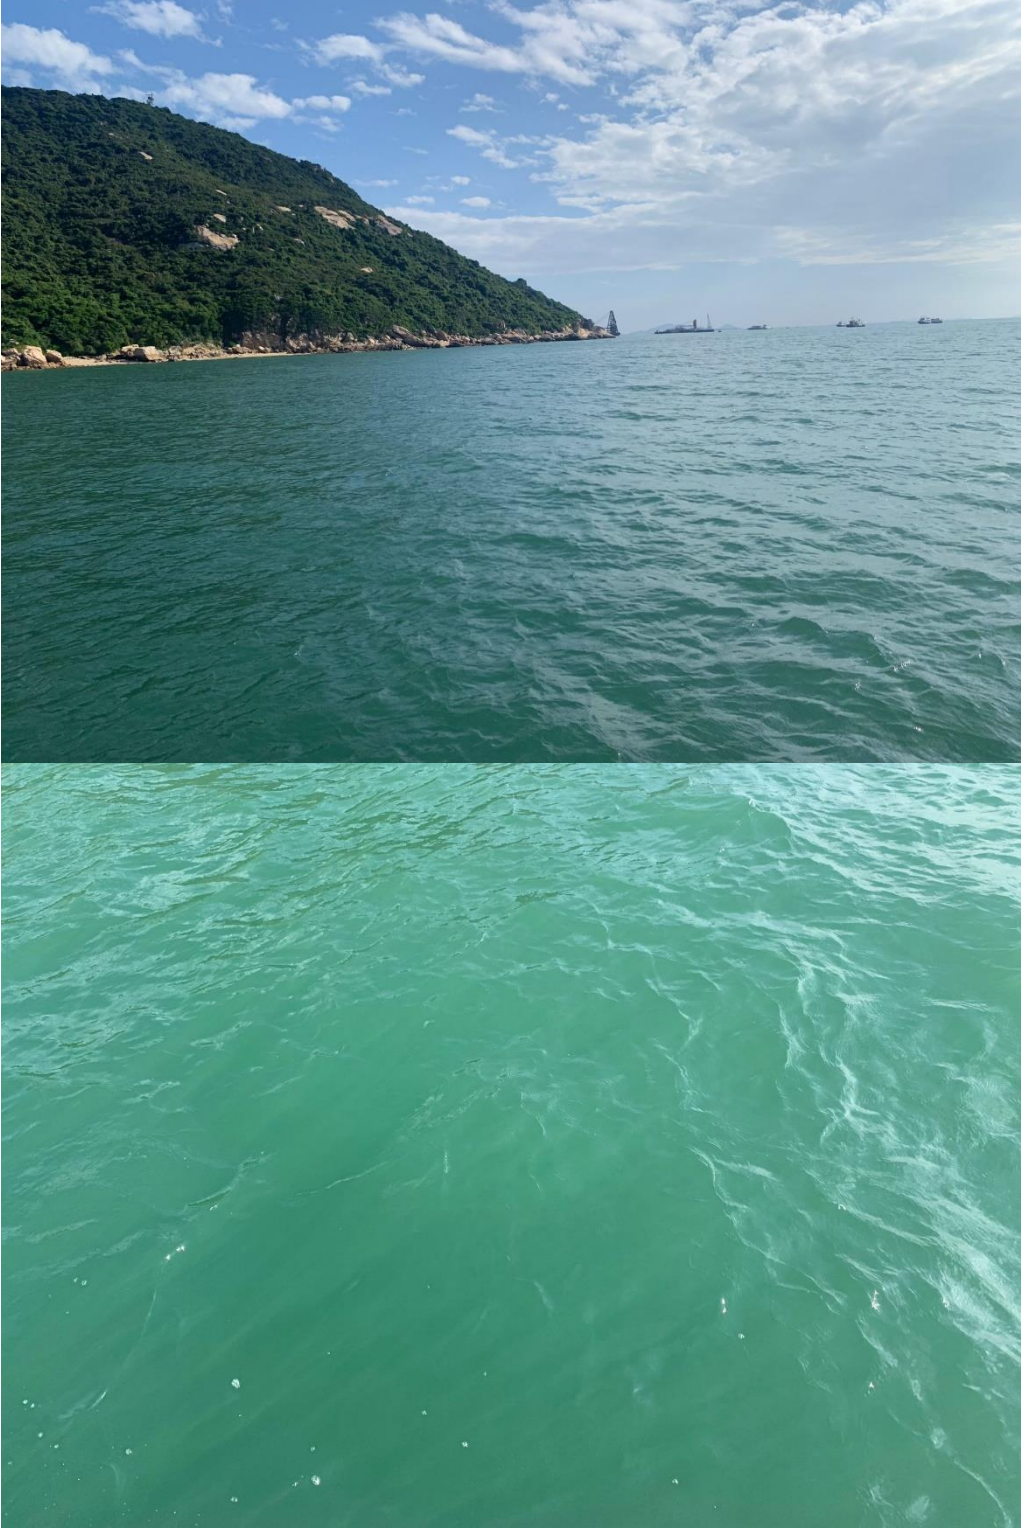
Impact Station(s) of Exceedance	Control Stations	Impact Station(s) without Exceedance					
8.0 mg/L (H1) 10.5 mg/L (M1) 12.2 mg/L (CR1) 8.8 mg/L (CR2)	5.5 mg/L (C1A) 4.2 mg/L (C2A)	6.3 mg/L (B1) 5.1 mg/L (B2) 7.5 mg/L (B3) 5.3 mg/L (B4) 7.8 mg/L (F1A)					
Possible reason for Action or Limit Level Non-compliance	<p>Works scheduled on site on 04 Oct 2021 include installation of caisson stoppers, landfilling works, installation of instrumentation, piling pre-drilling works, piling works and existing caisson extension.</p> <p>Dominating sea current direction was found to be from Southeast to Northwest at waters around Shek Kwu Chau.</p> <p>Exceedances of SS action level were found at H1 and CR2 on 04 Oct 2021 and exceedances of SS limit level were found at M1 and CR1 on 04 Oct 2021.</p> <p>H1 and M1 are located at unrelated stream direction (neither upstream nor downstream, far away) to the works location, exceedances of these monitoring stations are deemed to be unrelated to the Project.</p> <p>CR1 and CR2 are located close to the works location within the Project site while no marine work was conducted on 04 Oct 2021.</p> <p>The installation of caisson No.19 was completed on 18 Mar 2021, the reclamation area was enclosed.</p> <p>According to the field observation by sampling team during sampling event, no silt</p>

<p>plume was observed in the Project site and the weather was fine during the sampling event.</p> <p>No major observation of improper site practices that could contribute to the increase of the suspended solids was recorded during the weekly inspection on 28 September 2021.</p> <p>After the investigation, the exceedances on 04 Oct 2021 at H1, M1, CR1 and CR2 are deemed to be unrelated to the Project.</p>
Monitoring photos of stations with exceedance	<p>H1:</p>

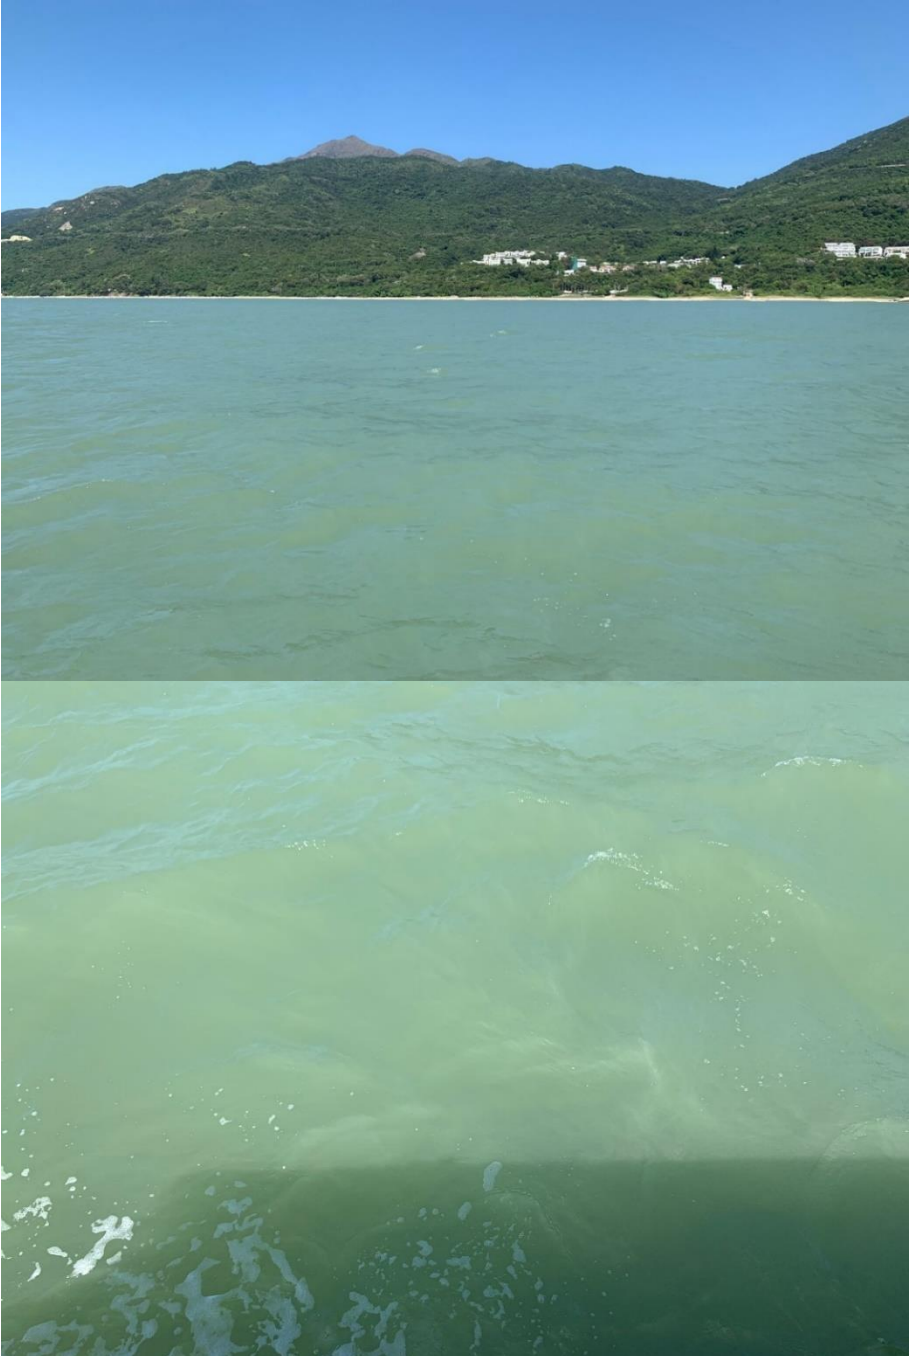
10.0 mg/L (B1) 12.2 mg/L (CR2)	8.0 mg/L (C1A) 9.3 mg/L (C2A)	5.0 mg/L (B2) 5.3 mg/L (B3) 4.5 mg/L (B4) 8.3 mg/L (F1A) 4.3 mg/L (H1) 7.8 mg/L (M1) 4.0 mg/L (CR1)
Possible reason for Action or Limit Level Non-compliance	<p>Works scheduled on site on 06 Oct 2021 include laying of underlayer, landfilling works, installation of instrumentation, piling pre-drilling works, piling works, piling works for pre-bored socketed H-pile and existing caisson extension.</p> <p>Dominating sea current direction was found to be from Northwest to Southeast at waters around Shek Kwu Chau.</p> <p>Exceedance of SS action level was found at B1 on 06 Oct 2021 and exceedance of SS limit level was found at CR2 on 06 Oct 2021.</p> <p>B1 is located at unrelated stream direction (neither upstream nor downstream, far away) to the works location, exceedance of this monitoring station is deemed to be unrelated to the Project.</p>

<p>CR2 is located close to the works location within the Project site while no marine work was conducted on 06 Oct 2021.</p> <p>The installation of caisson No.19 was completed on 18 Mar 2021, the reclamation area was enclosed.</p> <p>According to the field observation by sampling team during sampling event, no silt plume was observed in the Project site and the weather was fine during the sampling event.</p> <p>No major observation of improper site practices that could contribute to the increase of the suspended solids was recorded during the weekly inspection on 05 Oct 2021.</p> <p>After the investigation, the exceedances on 06 Oct 2021 at B1 and CR2 are deemed to be unrelated to the Project.</p>
<p>Monitoring photos of stations with exceedance</p>	<p>B1:</p>

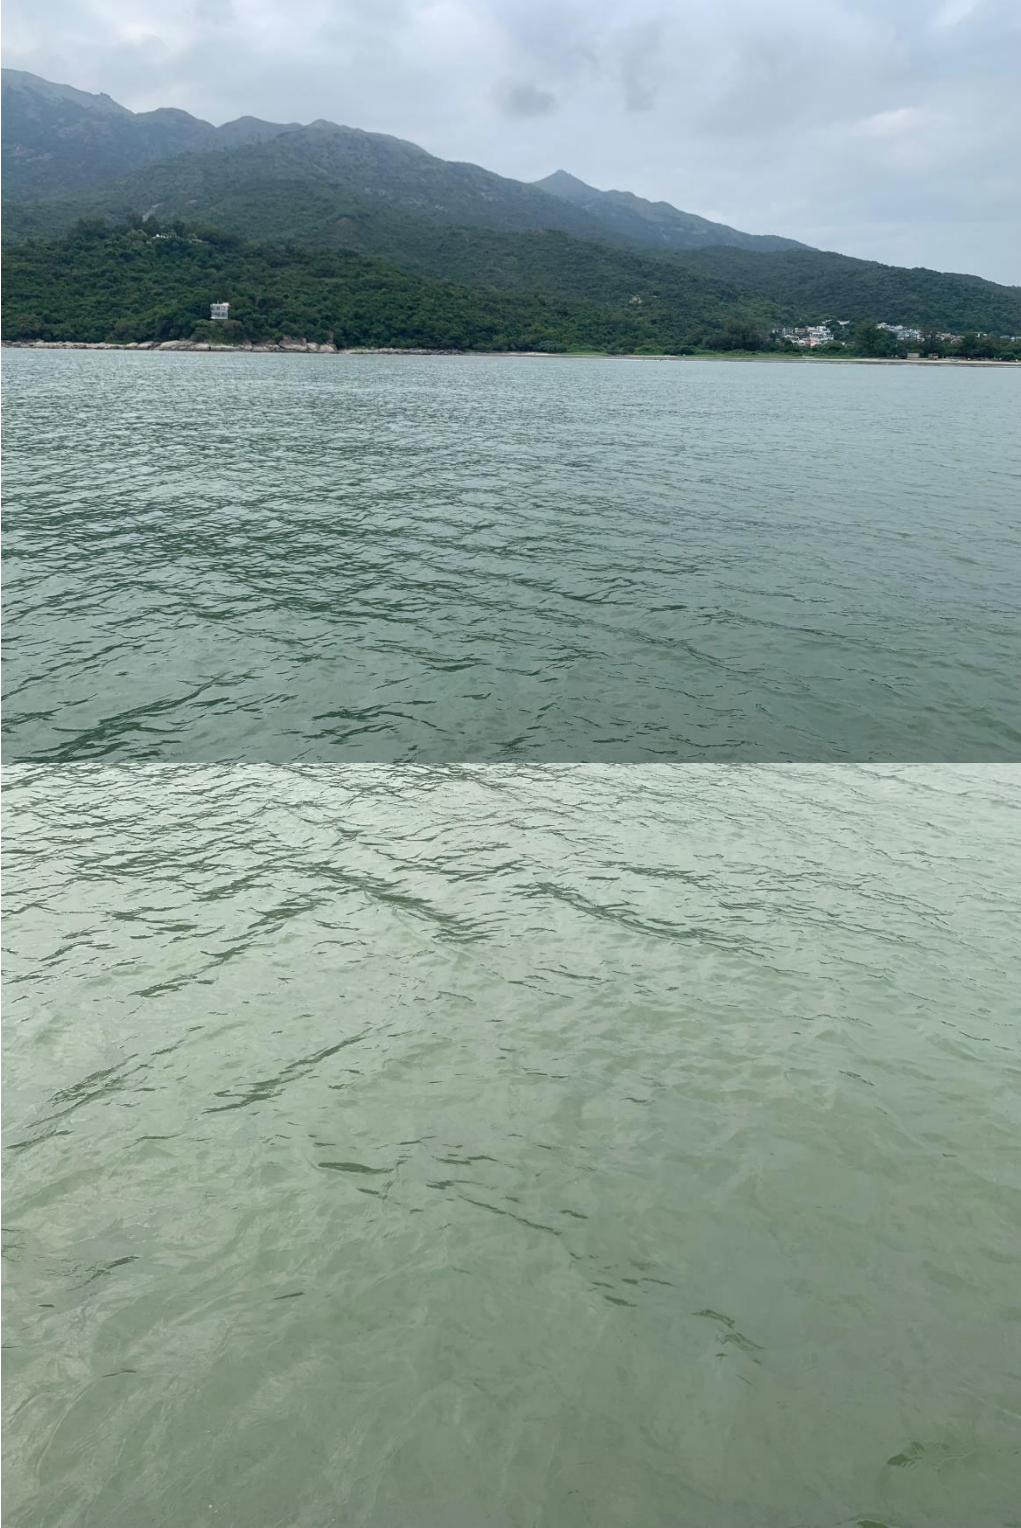
<p>Parameter</p>	<p>Suspended Solid (SS)</p>		
<p>Action &amp; Limit Levels</p>	<p>Action Level  <math>\geq 9.2</math> mg/L (120% of C2A)</p>		<p>Limit Level  <math>\geq 10.0</math> mg/L (130% of C2A)</p>
<p>Measurement Level</p>	<p>Impact Station(s) of Exceedance                  12.0 mg/L (B2)                  10.0 mg/L (F1A)</p>	<p>Control Stations                  11.5 mg/L (C1A)                  7.7 mg/L (C2A)</p>	<p>Impact Station(s) without Exceedance                  6.6 mg/L (B1)                  8.8 mg/L (B3)                  8.3 mg/L (B4)                  9.2 mg/L (H1)                  8.2 mg/L (M1)                  6.7 mg/L (CR1)                  7.3 mg/L (CR2)</p>
<p>Possible reason for Action or Limit Level Non-compliance</p>	<p>Works scheduled on site on 06 Oct 2021 include laying of underlayer, landfilling works, installation of instrumentation, piling pre-drilling works, piling works, piling works for pre-bored socketed H-pile and existing caisson extension.</p> <p>Dominating sea current direction was found to be from Southeast to Northwest at waters around Shek Kwu Chau.</p> <p>Exceedances of SS limit level were found at B2 and F1A on 06 Oct 2021.</p> <p>B2 and F1A are located at unrelated stream direction (neither upstream nor downstream, far away) to the works location, exceedances of this monitoring stations are deemed to be unrelated to the Project.</p> <p>The installation of caisson No.19 was completed on 18 Mar 2021, the reclamation area was enclosed.</p> <p>According to the field observation by sampling team during sampling event, no silt plume was observed in the Project site and the weather was fine during the sampling event.</p>

<p>No major observation of improper site practices that could contribute to the increase of the suspended solids was recorded during the weekly inspection on 5 Oct 2021.</p> <p>After the investigation, the exceedances on 06 Oct 2021 at B2 and F1A are deemed to be unrelated to the Project.</p>
<p>Monitoring photos of stations with exceedance</p>	<p>B2:</p>

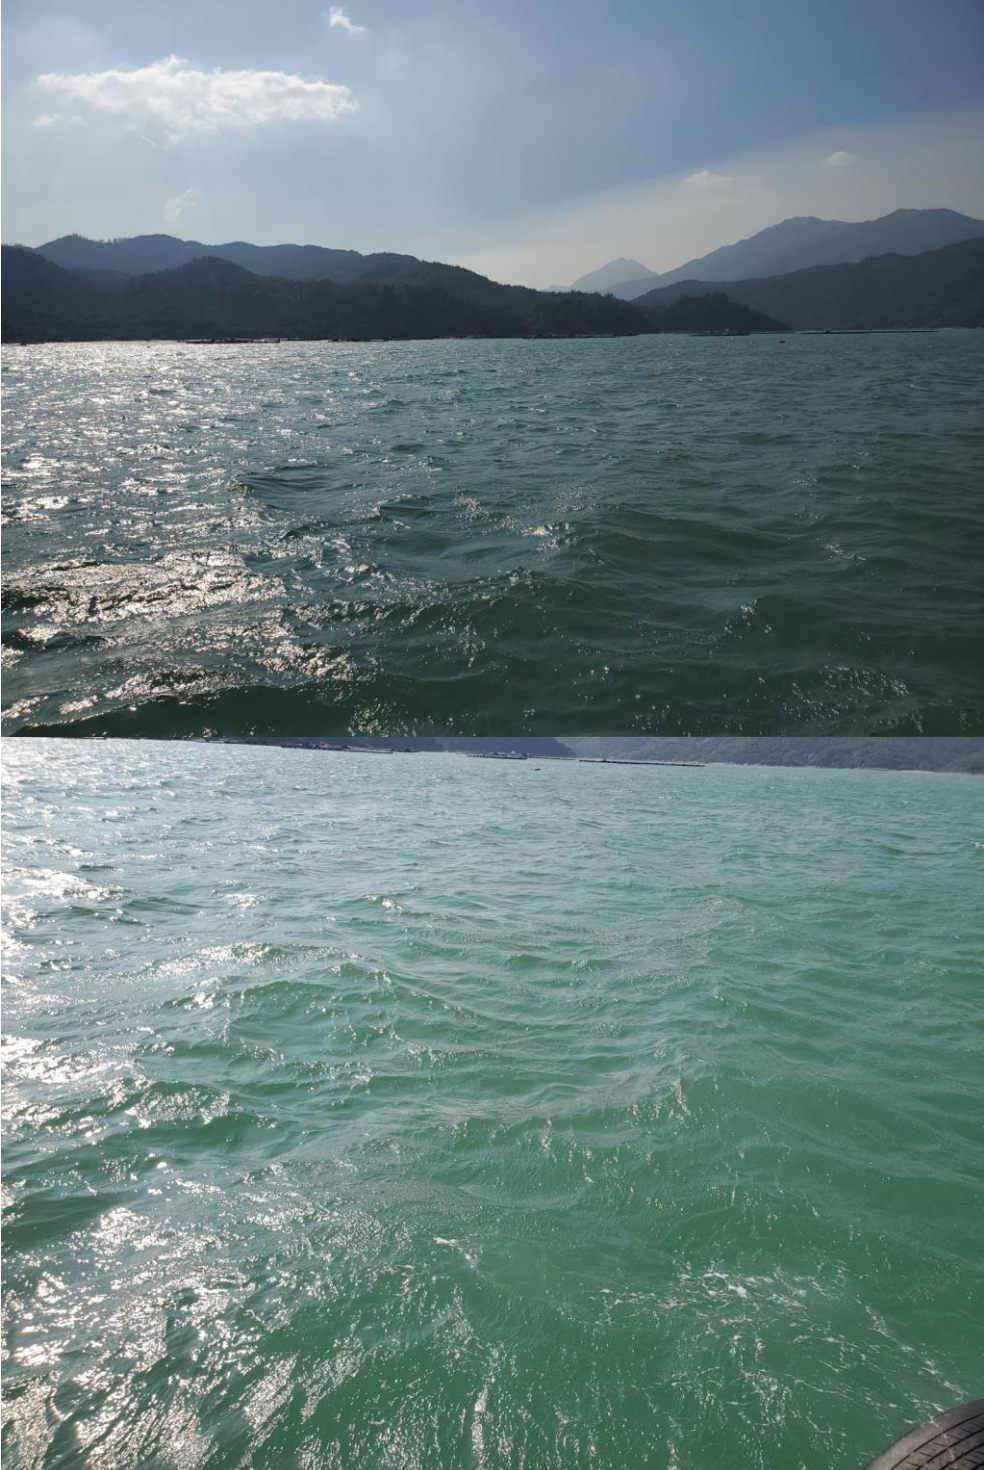
15.7 mg/L (F1A)	10.7 mg/L (C1A) 10.5 mg/L (C2A)	8.0 mg/L (B1) 6.3 mg/L (B2) 9.0 mg/L (B3) 8.5 mg/L (B4) 8.7 mg/L (H1) 5.0 mg/L (M1) 8.5 mg/L (CR1) 5.5 mg/L (CR2)
Possible reason for Action or Limit Level Non-compliance	<p>Works scheduled on site on 11 Oct 2021 include installation of instrumentation, piling pre-drilling works, piling works, piling works for driven pile, piling works for pre-bored socketed H-pile and existing caisson extension.</p> <p>Dominating sea current direction was found to be from Northwest to Southeast at waters around Shek Kwu Chau.</p> <p>Exceedance of SS limit level was found at F1A on 11 Oct 2021.</p> <p>F1A is located at unrelated stream direction (neither upstream nor downstream, far away) to the works location, exceedance of this monitoring station is deemed to be unrelated to the Project.</p> <p>The installation of caisson No.19 was completed on 18 Mar 2021, the reclamation area</p>

<p>was enclosed.</p> <p>According to the field observation by sampling team during sampling event, no silt plume was observed in the Project site and the weather was fine during the sampling event.</p> <p>No major observation of improper site practices that could contribute to the increase of the suspended solids was recorded during the weekly inspection on 5 Oct 2021.</p> <p>After the investigation, the exceedance on 11 Oct 2021 at F1A is deemed to be unrelated to the Project.</p>
<p>Monitoring photos of stations with exceedance</p>	<p>F1A:</p>

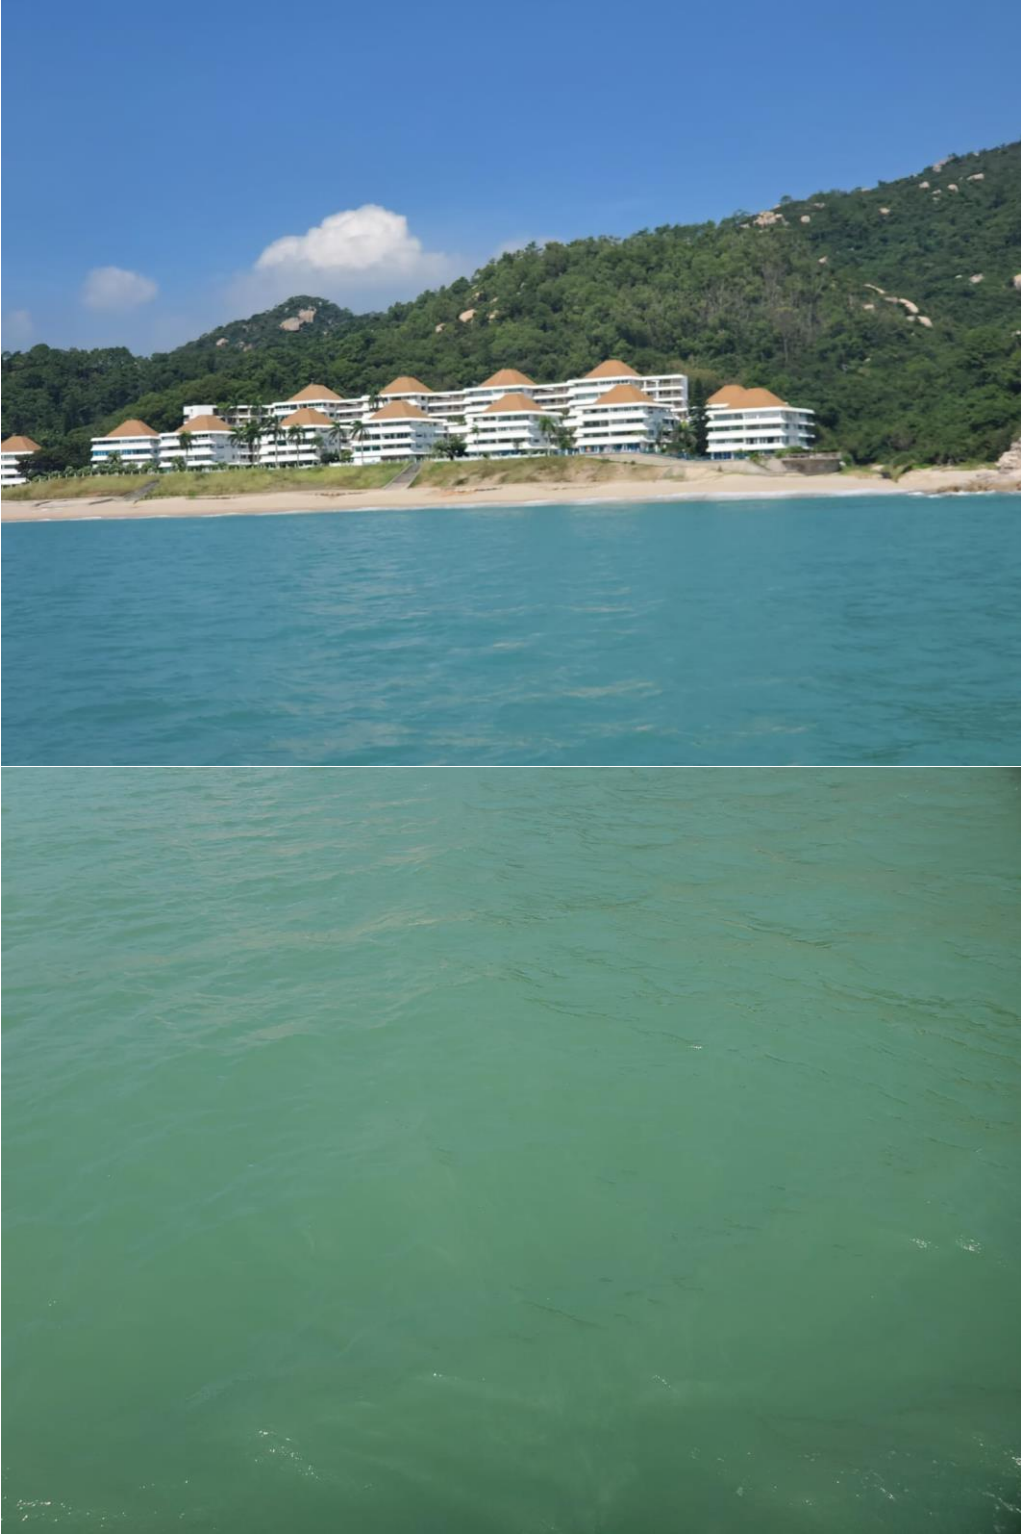
<p>Key</p> <ul style="list-style-type: none"> <li>A PROPOSED 132KV SUBMARINE CABLE</li> <li>MONITORING STATION</li> <li>PROPOSED OUTFALL</li> <li>THE IWMF SITE BOUNDARY</li> <li>LAND FORMATION FOOTPRINT</li> <li>THE IWMF SITE BOUNDARY</li> </ul>		
<p>Parameter</p>	<p>Suspended Solid (SS)</p>		
<p>Action &amp; Limit Levels</p>	<p>Action Level  <math>\geq 8.0</math> mg/L</p>	<p>Limit Level  <math>\geq 10.0</math> mg/L</p>	
<p>Measurement Level</p>	<p>Impact Station(s) of Exceedance              8.5 mg/L (B3)</p>	<p>Control Stations              7.8 mg/L (C1A)              6.2 mg/L (C2A)</p>	<p>Impact Station(s) without Exceedance              6.8 mg/L (B1)              5.8 mg/L (B2)              7.8 mg/L (B4)              6.0 mg/L (F1A)              5.7 mg/L (H1)              6.8 mg/L (M1)              6.5 mg/L (CR1)              6.5 mg/L (CR2)</p>
<p>Possible reason for Action or Limit Level Non-compliance</p>	<p>Works scheduled on site on 11 Oct 2021 include installation of instrumentation, piling pre-drilling works, piling works, piling works for driven pile, piling works for pre-bored socketed H-pile and existing caisson extension.</p> <p>Dominating sea current direction was found to be from Southeast to Northwest at waters around Shek Kwu Chau.</p> <p>Exceedance of SS action level was found at B3 on 11 Oct 2021.</p> <p>B3 is located at unrelated stream direction (neither upstream nor downstream, far away) to the works location, exceedance of this monitoring station is deemed to be unrelated to the Project.</p> <p>The installation of caisson No.19 was completed on 18 Mar 2021, the reclamation area was enclosed.</p> <p>According to the field observation by sampling team during sampling event, no silt plume was observed in the Project site and the weather was fine during the sampling event.</p>

<p>No major observation of improper site practices that could contribute to the increase of the suspended solids was recorded during the weekly inspection on 5 Oct 2021.</p> <p>After the investigation, the exceedance on 11 Oct 2021 at B3 is deemed to be unrelated to the Project.</p>
<p>Monitoring photos of stations with exceedance</p>	<p>B3:</p>

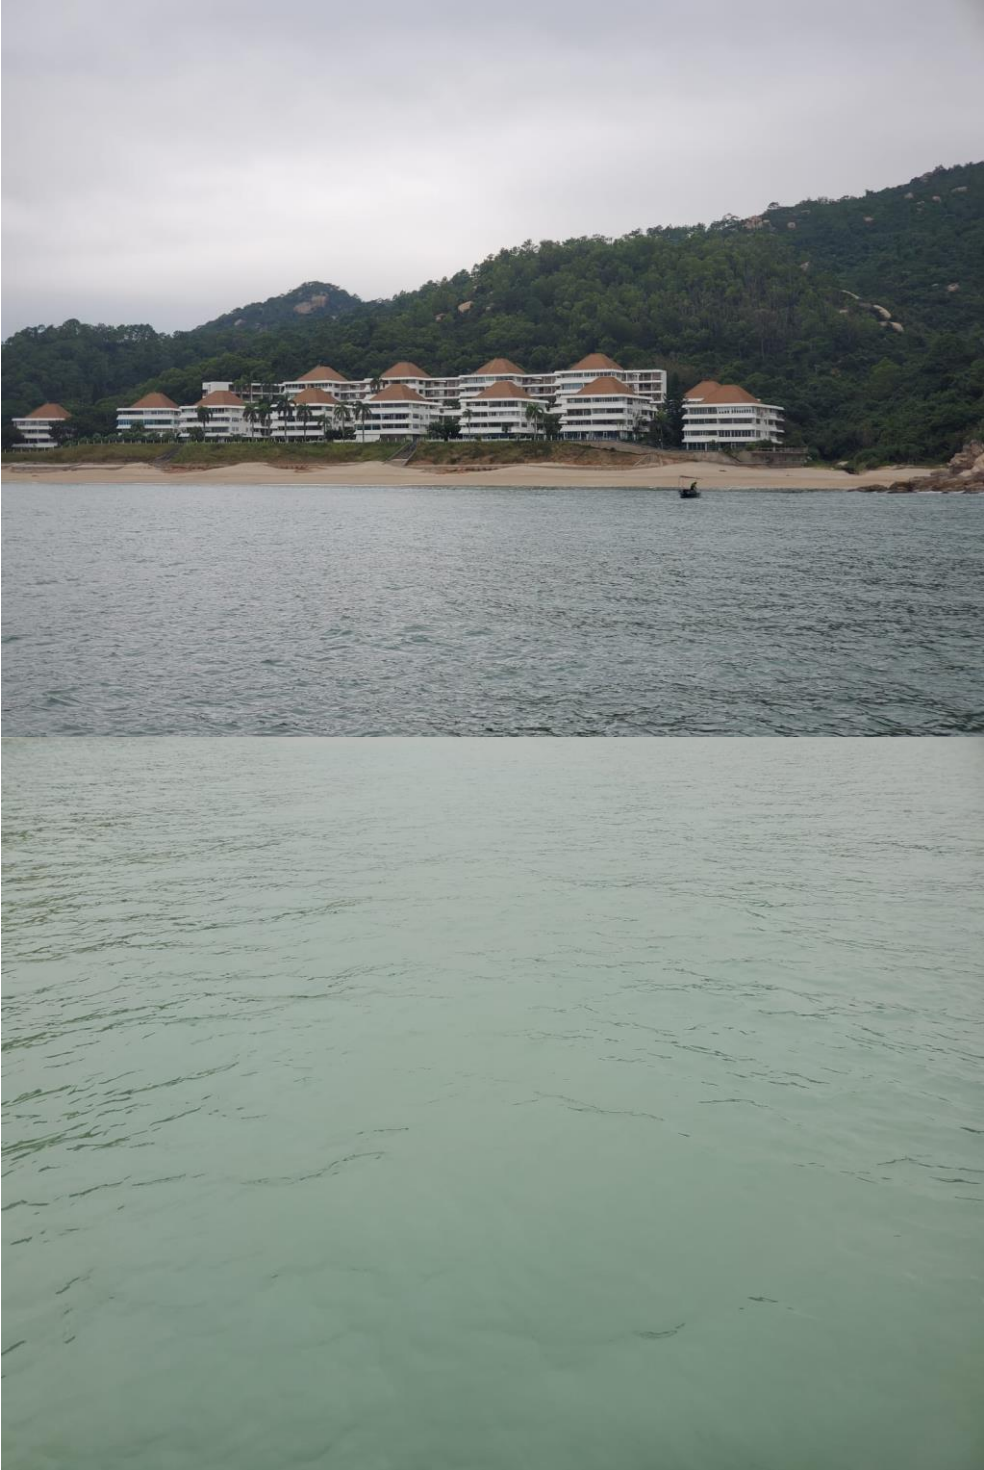
16.5 mg/L (B3) 15.5 mg/L (B4) 17.8 mg/L (H1) 14.7 mg/L (CR1) 16.7 mg/L (CR2)	11.3 mg/L (C1A) 8.5 mg/L (C2A)	12.5 mg/L (B1) 13.3 mg/L (B2) 9.7 mg/L (F1A) 7.8 mg/L (M1)
Possible reason for Action or Limit Level Non-compliance	<p>Works scheduled on site on 15 Oct 2021 include installation of blockwork marine access facility, landfilling works, installation of instrumentation, piling pre-drilling works, pilling works, piling works for driven pile, piling works for pre-bored socketed H-pile and existing caisson extension.</p> <p>Dominating sea current direction was found to be from Northwest to Southeast at waters around Shek Kwu Chau.</p> <p>Exceedances of SS limit level were found at B3, B4, H1, CR1 and CR2 on 15 Oct 2021</p> <p>B3, B4, H1 are located at unrelated stream direction (neither upstream nor downstream, far away) to the works location, exceedances of these monitoring stations are deemed to be unrelated to the Project.</p> <p>CR1 and CR2 are located close to the works location within the Project site while no</p>

<p>marine work was conducted on 15 Oct 2021.</p> <p>The installation of caisson No.19 was completed on 18 Mar 2021, the reclamation area was enclosed.</p> <p>According to the field observation by sampling team during sampling event, no silt plume was observed in the Project site and the weather was cloudy and rainy during the sampling event.</p> <p>After the investigation, the exceedances on 15 Oct 2021 at B3, B4, H1, CR1 and CR2 are deemed to be unrelated to the Project.</p>
Monitoring photos of stations with exceedance	<p>B3:</p>

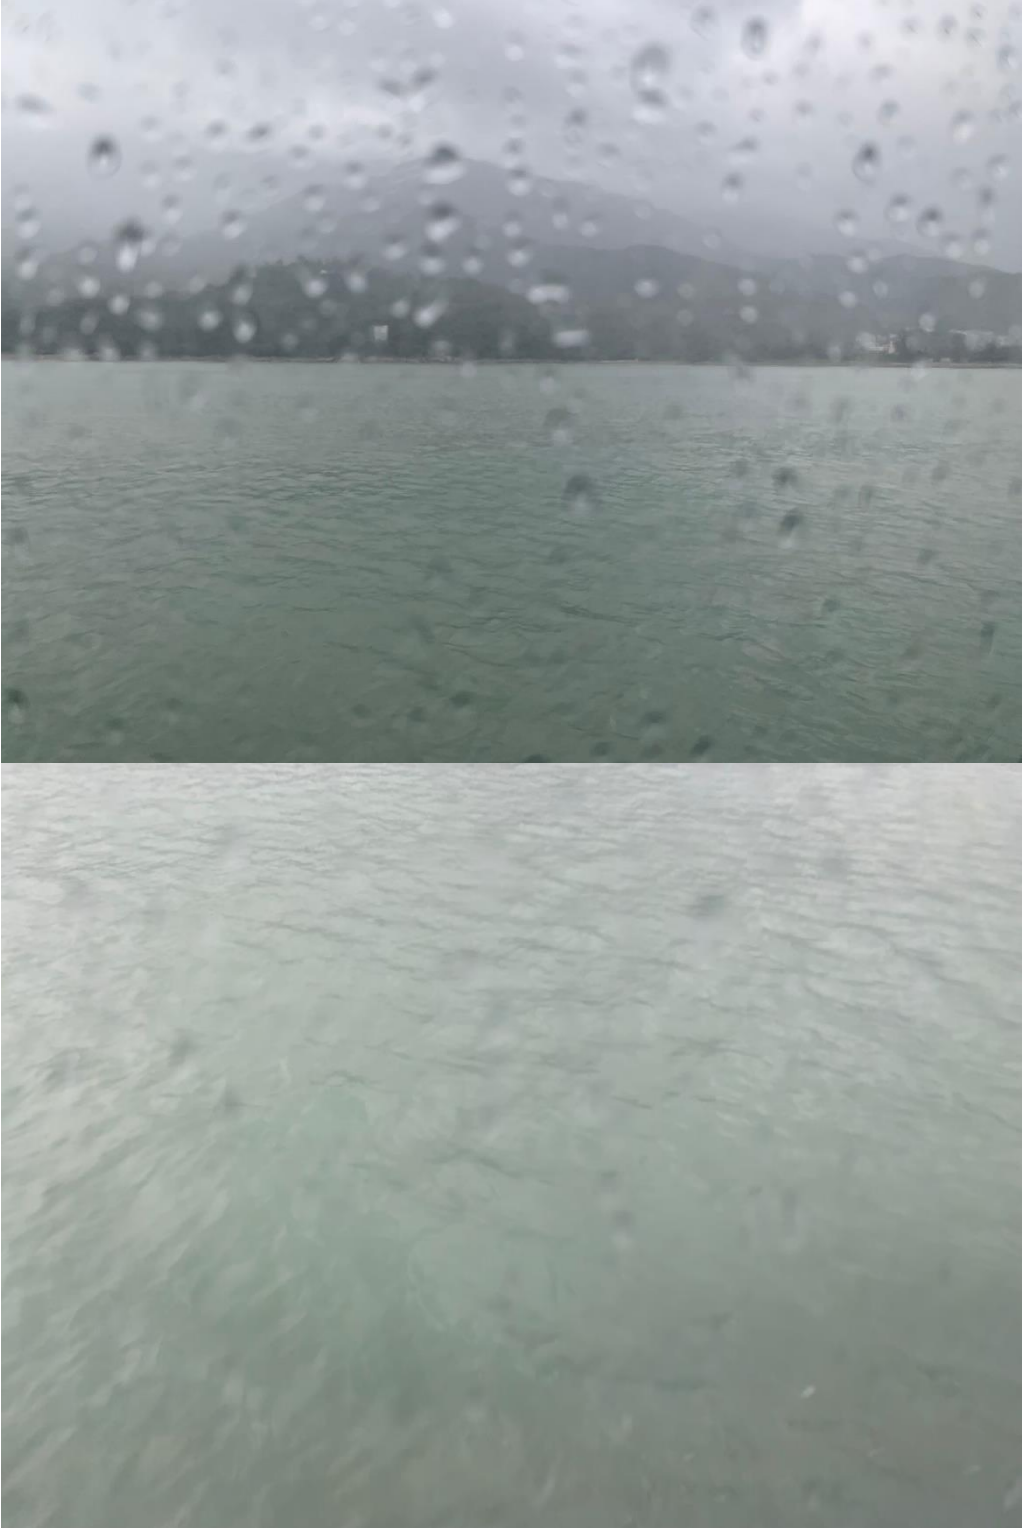
<p>Parameter</p>	<p>Suspended Solid (SS)</p>		
<p>Action &amp; Limit Levels</p>	<p>Action Level  <math>\geq 8.0</math> mg/L</p>		<p>Limit Level  <math>\geq 10.0</math> mg/L</p>
<p>Measurement Level</p>	<p>Impact Station(s) of Exceedance</p> <p>11.0 mg/L (B1)              13.5 mg/L (B2)              10.5 mg/L (B3)              15.3 mg/L (B4)              9.8 mg/L (F1A)              12.8 mg/L (H1)</p>	<p>Control Stations</p> <p>7.3 mg/L (C1A)              6.5 mg/L (C2A)</p>	<p>Impact Station(s) without Exceedance</p> <p>7.0 mg/L (M1)              6.2 mg/L (CR1)              7.5 mg/L (CR2)</p>
<p>Possible reason for Action or Limit Level Non-compliance</p>	<p>Works scheduled on site on 15 Oct 2021 include installation of blockwork marine access facility, landfilling works, installation of instrumentation, piling pre-drilling works, pilling works, piling works for driven pile, piling works for pre-bored socketed H-pile and existing caisson extension.</p> <p>Dominating sea current direction was found to be from Southeast to Northwest at waters around Shek Kwu Chau.</p> <p>Exceedance of SS action level was found at F1A on 15 Oct 2021 and exceedances of SS limit level were found at B1, B2, B3, B4 and H1 on 15 Oct 2021</p> <p>B1, B2, B3, B4, F1A and H1 are located at unrelated stream direction (neither upstream nor downstream, far away) to the works location, exceedances of these monitoring stations are deemed to be unrelated to the Project.</p> <p>The installation of caisson No.19 was completed on 18 Mar 2021, the reclamation area was enclosed.</p> <p>According to the field observation by sampling team during sampling event, no silt plume was observed in the Project site and the weather was cloudy and rainy during</p>

<p>the sampling event.</p> <p>After the investigation, the exceedances on 15 Oct 2021 at B1, B2, B3, B4, F1A and H1 are deemed to be unrelated to the Project.</p>
<p>Monitoring photos of stations with exceedance</p>	<p>B1:</p>

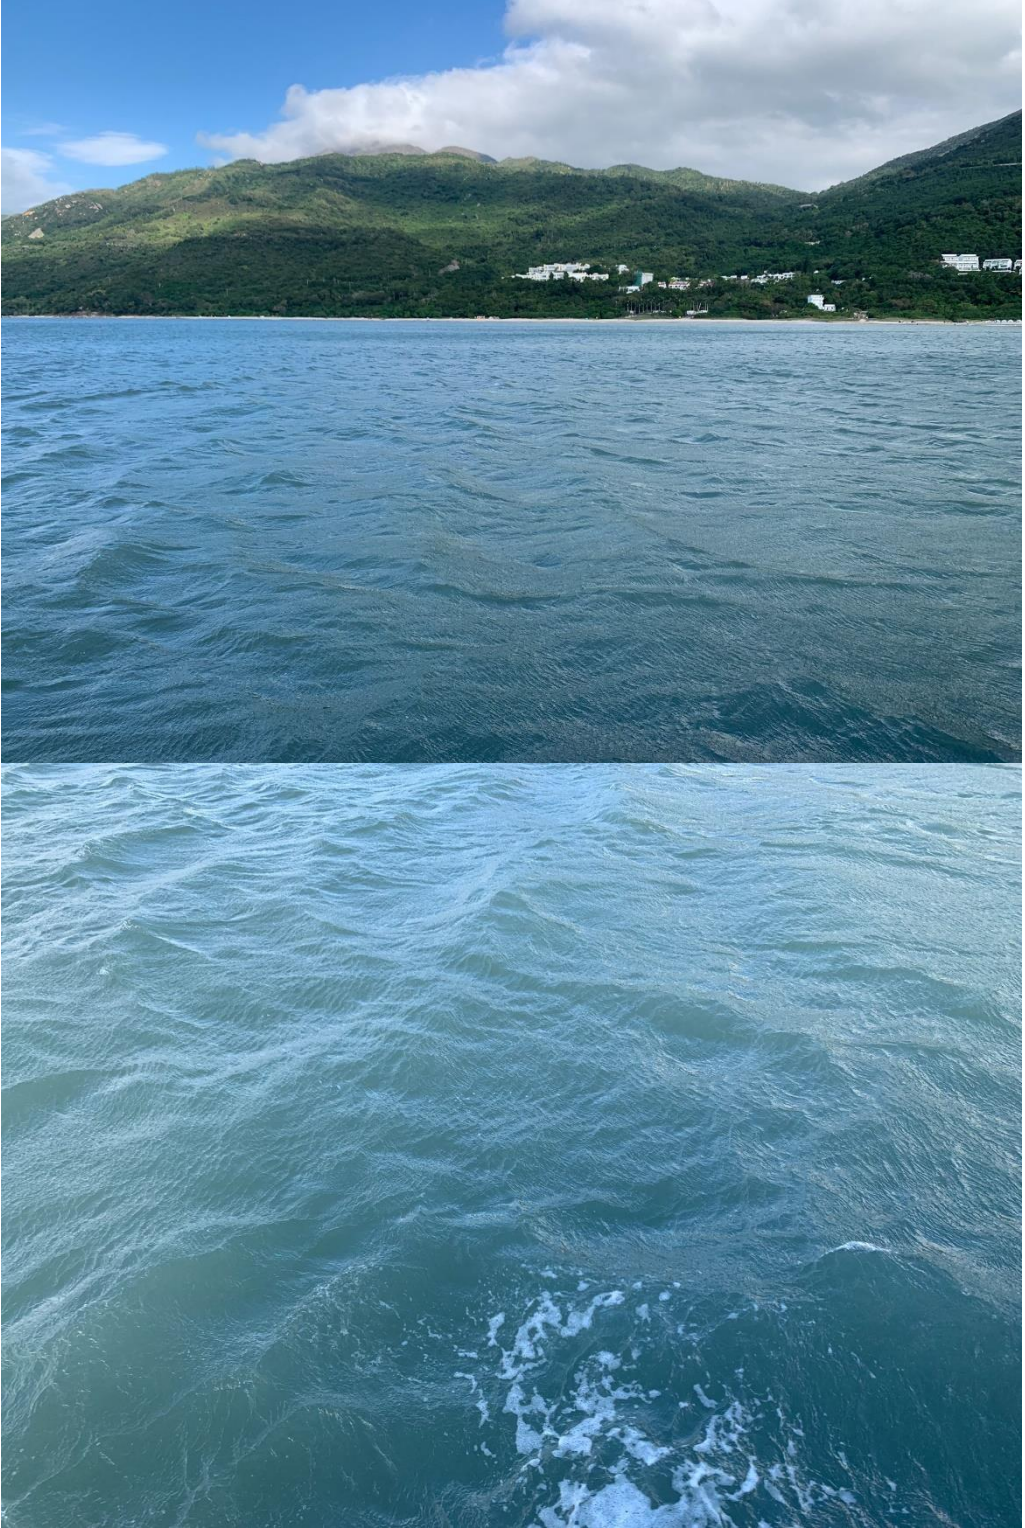
16.8 mg/L (B1) 11.0 mg/L (F1A)	8.2 mg/L (C1A) 10.3 mg/L (C2A)	5.0 mg/L (B2) 7.5 mg/L (B3) 8.0 mg/L (B4) 7.5 mg/L (H1) 4.3 mg/L (M1) 6.3 mg/L (CR1) 4.7 mg/L (CR2)
Possible reason for Action or Limit Level Non-compliance	<p>Works scheduled on site on 17 Oct 2021 include installation of blockwork marine access facility, installation of concrete mattress, landfilling works, pilling works and existing caisson extension.</p> <p>Dominating sea current direction was found to be from Northwest to Southeast at waters around Shek Kwu Chau.</p> <p>Exceedances of SS limit level were found at B1 and F1A on 17 Oct 2021</p> <p>B1 and F1A are located at unrelated stream direction (neither upstream nor downstream, far away) to the works location, exceedances of these monitoring stations are deemed to be unrelated to the Project.</p> <p>The installation of caisson No.19 was completed on 18 Mar 2021, the reclamation area was enclosed.</p>

<p>According to the field observation by sampling team during sampling event, no silt plume was observed in the Project site and the weather was fine during the sampling event.</p> <p>No major observation of improper site practices that could contribute to the increase of the suspended solids was recorded during the weekly inspection on 05 Oct 2021.</p> <p>After the investigation, the exceedances on 17 Oct 2021 at B1 and F1A are deemed to be unrelated to the Project.</p>
<p>Monitoring photos of stations with exceedance</p>	<p>B1:</p>

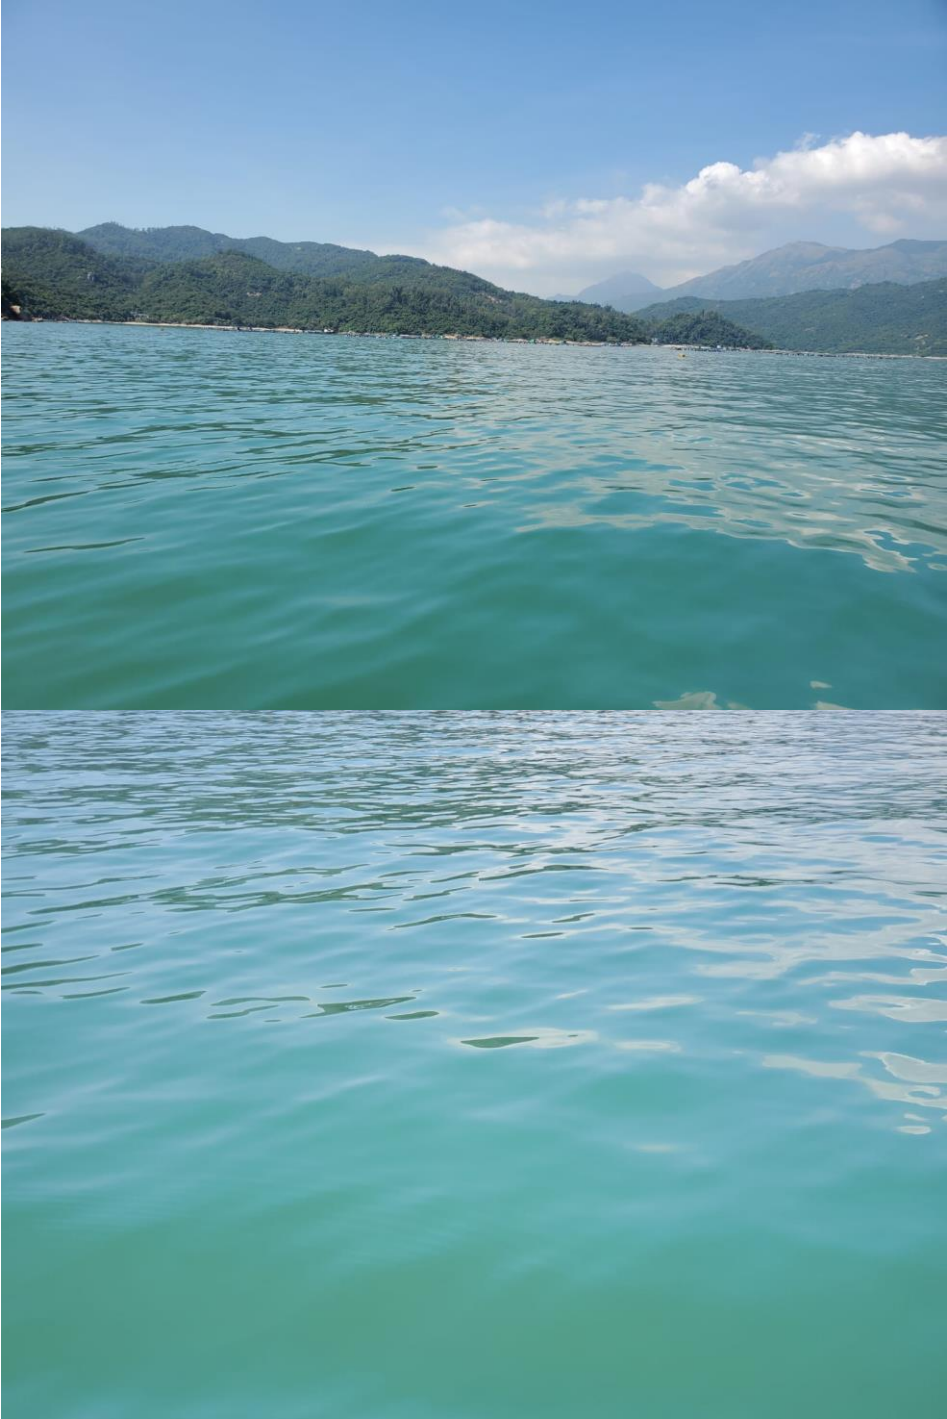
11.8 mg/L (F1A)	7.7 mg/L (C1A) 11.7 mg/L (C2A)	7.3 mg/L (B1) 5.5 mg/L (B2) 7.3 mg/L (B3) 5.3 mg/L (B4) 6.2 mg/L (H1) 7.7 mg/L (M1) 8.3 mg/L (CR1) 6.8 mg/L (CR2)
Possible reason for Action or Limit Level Non-compliance	<p>Works scheduled on site on 19 Oct 2021 include installation of caisson, laying of rock armour, landfilling works, installation of instrumentation, piling pre-drilling works, piling works and existing caisson extension.</p> <p>Dominating sea current direction was found to be from Northwest to Southeast at waters around Shek Kwu Chau.</p> <p>Exceedance of SS limit level was found at F1A on 19 Oct 2021</p> <p>F1A is located at unrelated stream direction (neither upstream nor downstream, far away) to the works location, exceedance of this monitoring station is deemed to be unrelated to the Project.</p>

<p>The installation of caisson No.19 was completed on 18 Mar 2021, the reclamation area was enclosed.</p> <p>According to the field observation by sampling team during sampling event, no silt plume was observed in the Project site and the weather was fine during the sampling event.</p> <p>No major observation of improper site practices that could contribute to the increase of the suspended solids was recorded during the weekly inspection on 19 Oct 2021.</p> <p>After the investigation, the exceedance on 19 Oct 2021 at F1A is deemed to be unrelated to the Project.</p>
<p>Monitoring photos of stations with exceedance</p>	<p>F1A:</p>
