## Appendix N Exceedance Report

**Incident Report on Action Level or Limit Level Non-compliance**

Project	Integrated Waste Management Facilities, Phase 1		
Date	01 Oct 2021 (Lab result received on 8 Oct 2021)		
Time	14:40-18:10 (Mid Flood)		
Mid-Flood			
Monitoring Location	<p>B3</p>		
Parameter	Suspended Solid (SS)		
Action & Limit Levels	Action Level		Limit Level
	≥ 14.0 mg/L (120% of C2A)		≥ 15.2 mg/L (130% of C2A)
Measurement Level	Impact Station(s) of Exceedance	Control Stations	Impact Station(s) without Exceedance

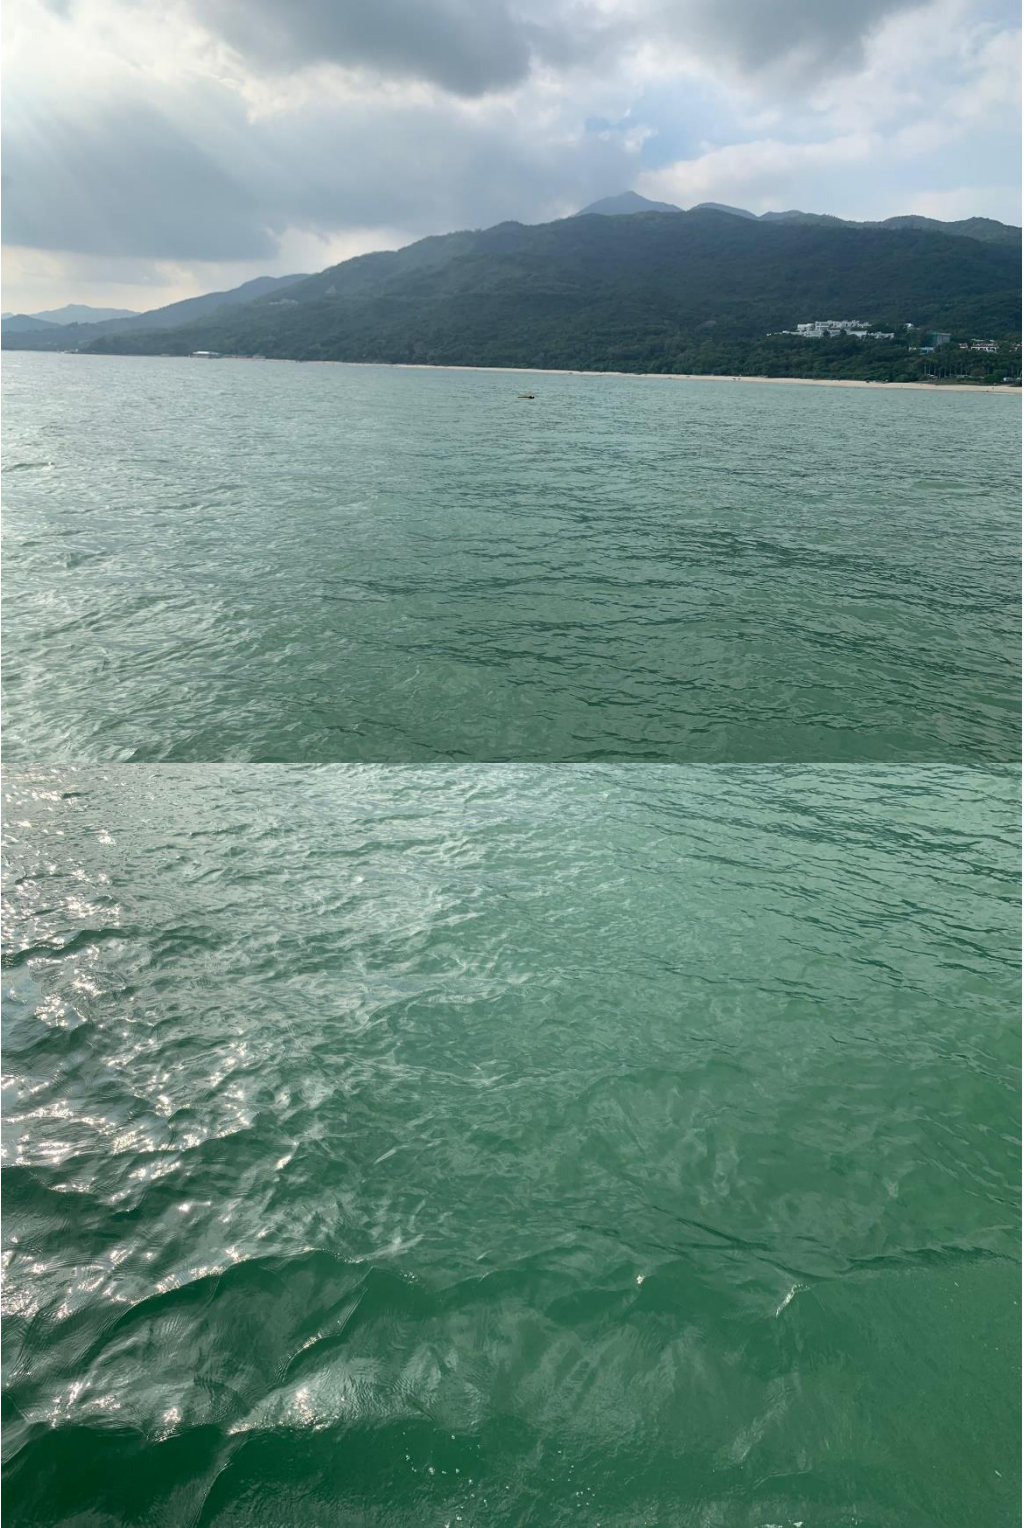
<p>Parameter</p>	<p>Suspended Solid (SS)</p>		
<p>Action &amp; Limit Levels</p>	<p>Action Level  <math>\geq 8.0</math> mg/L</p>		<p>Limit Level  <math>\geq 10.0</math> mg/L</p>
<p>Measurement Level</p>	<p>Impact Station(s) of Exceedance</p> <p>8.5 mg/L (B1)              12.3 mg/L (B2)              13.3 mg/L (B3)              13.5 mg/L (B4)              9.5 mg/L (H1)              10.8 mg/L (M1)              10.0 mg/L (CR2)</p>	<p>Control Stations</p> <p>5.0 mg/L (C1A)              4.5 mg/L (C2A)</p>	<p>Impact Station(s) without Exceedance</p> <p>4.8 mg/L (F1A)              7.7 mg/L (CR1)</p>
<p>Possible reason for Action or Limit Level Non-compliance</p>	<p>Works scheduled on site on 19 Oct 2021 include installation of caisson, laying of rock armour, landfilling works, installation of instrumentation, piling pre-drilling works, piling works and existing caisson extension.</p> <p>Dominating sea current direction was found to be from Southeast to Northwest at waters around Shek Kwu Chau.</p> <p>Exceedances of SS action level were found at B1 and H1 on 19 Oct 2021 and exceedances of SS limit level were found at B2, B3, B4, M1 and CR2 on 19 Oct 2021</p> <p>B1, B2, B3, B4, H1 and M1 are located at unrelated stream direction (neither upstream nor downstream, far away) to the works location, exceedances of these monitoring stations are deemed to be unrelated to the Project.</p> <p>CR2 is located close to the works location within the Project site while no marine work was conducted on 19 Oct 2021.</p> <p>The installation of caisson No.19 was completed on 18 Mar 2021, the reclamation area was enclosed.</p>

<p>According to the field observation by sampling team during sampling event, no silt plume was observed in the Project site and the weather was fine during the sampling event.</p> <p>No major observation of improper site practices that could contribute to the increase of the suspended solids was recorded during the weekly inspection on 05 Oct 2021.</p> <p>After the investigation, the exceedances on 19 Oct 2021 at B1, B2, B3, B4, H1, M1 and CR2 are deemed to be unrelated to the Project.</p>
<p>Monitoring photos of stations with exceedance</p>	<p>B1:</p>

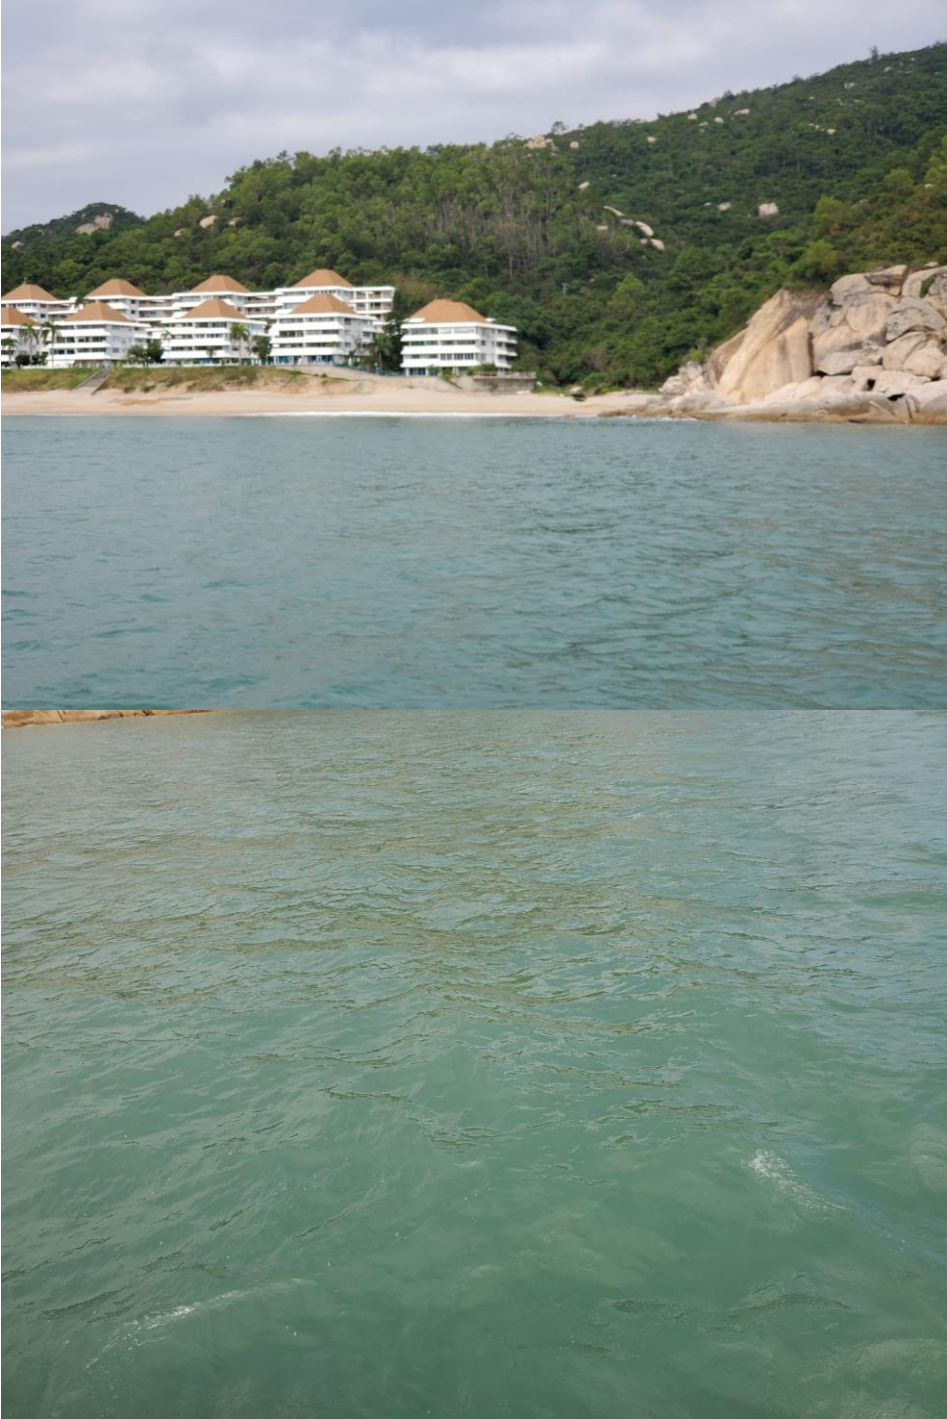
12.8 mg/L (B3) 9.2 mg/L (M1) 9.8 mg/L (CR2)	4.6 mg/L (C1A) 6.2 mg/L (C2A)	2.9 mg/L (B1) 4.3 mg/L (B2) 6.5 mg/L (B4) 4.3 mg/L (H1) 5.8 mg/L (F1A) 7.2 mg/L (CR1)
Possible reason for Action or Limit Level Non-compliance	<p>Works scheduled on site on 24 Oct 2021 include installation of caisson stoppers and construction of blockwork marine access facility</p> <p>Dominating sea current direction was found to be from Southeast to Northwest at waters around Shek Kwu Chau.</p> <p>Exceedances of SS action level were found at M1 and CR2 on 24 Oct 2021 and exceedance of SS limit level was found at B3 on 24 Oct 2021</p> <p>B3 and M1 are located at unrelated stream direction (neither upstream nor downstream, far away) to the works location, exceedances of these monitoring stations are deemed to be unrelated to the Project.</p> <p>CR2 is located close to the works location within the Project site while no marine work was conducted on 24 Oct 2021.</p>

<p>The installation of caisson No.19 was completed on 18 Mar 2021, the reclamation area was enclosed.</p> <p>According to the field observation by sampling team during sampling event, no silt plume was observed in the Project site and the weather was fine during the sampling event.</p> <p>No major observation of improper site practices that could contribute to the increase of the suspended solids was recorded during the weekly inspection on 19 Oct 2021.</p> <p>After the investigation, the exceedances on 24 Oct 2021 at B3, M1 and CR2 are deemed to be unrelated to the Project.</p>
<p>Monitoring photos of stations with exceedance</p>	<p>B3:</p>

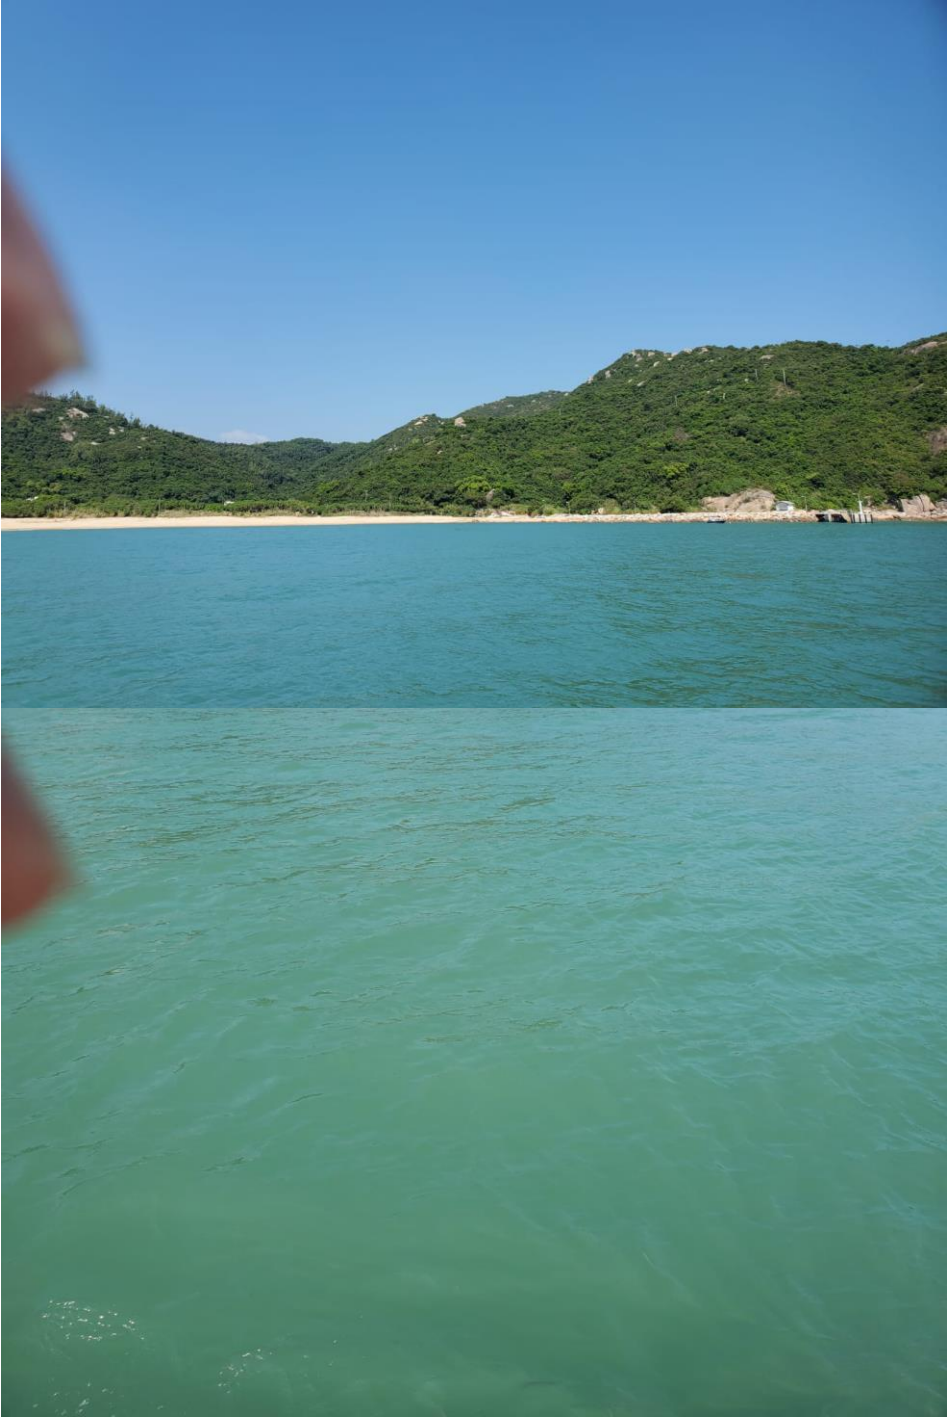
8.3 mg/L (B4)	6.3 mg/L (C1A) 7.0 mg/L (C2A)	4.3 mg/L (B1) 3.4 mg/L (B2) 4.3 mg/L (B3) 7.8 mg/L (F1A) 5.2 mg/L (H1) 6.5 mg/L (M1) 7.5 mg/L (CR1) 7.7 mg/L (CR2)
Possible reason for Action or Limit Level Non-compliance	<p>Works scheduled on site on 26 Oct 2021 include levelling of rock armour, landfilling works, installation of instrumentation, piling pre-drilling works, pilling works and existing caisson extension.</p> <p>Dominating sea current direction was found to be from Northwest to Southeast at waters around Shek Kwu Chau.</p> <p>Exceedance of SS action level was found at B4 on 26 Oct 2021.</p> <p>B4 is located at unrelated stream direction (neither upstream nor downstream, far away) to the works location, exceedance of this monitoring station is deemed to be unrelated to the Project.</p>

<p>The installation of caisson No.19 was completed on 18 Mar 2021, the reclamation area was enclosed.</p> <p>According to the field observation by sampling team during sampling event, no silt plume was observed in the Project site and the weather was fine during the sampling event.</p> <p>No major observation of improper site practices that could contribute to the increase of the suspended solids was recorded during the weekly inspection on 26 Oct 2021.</p> <p>After the investigation, the exceedance on 26 Oct 2021 at B4 is deemed to be unrelated to the Project.</p>
<p>Monitoring photos of stations with exceedance</p>	<p>B4:</p>

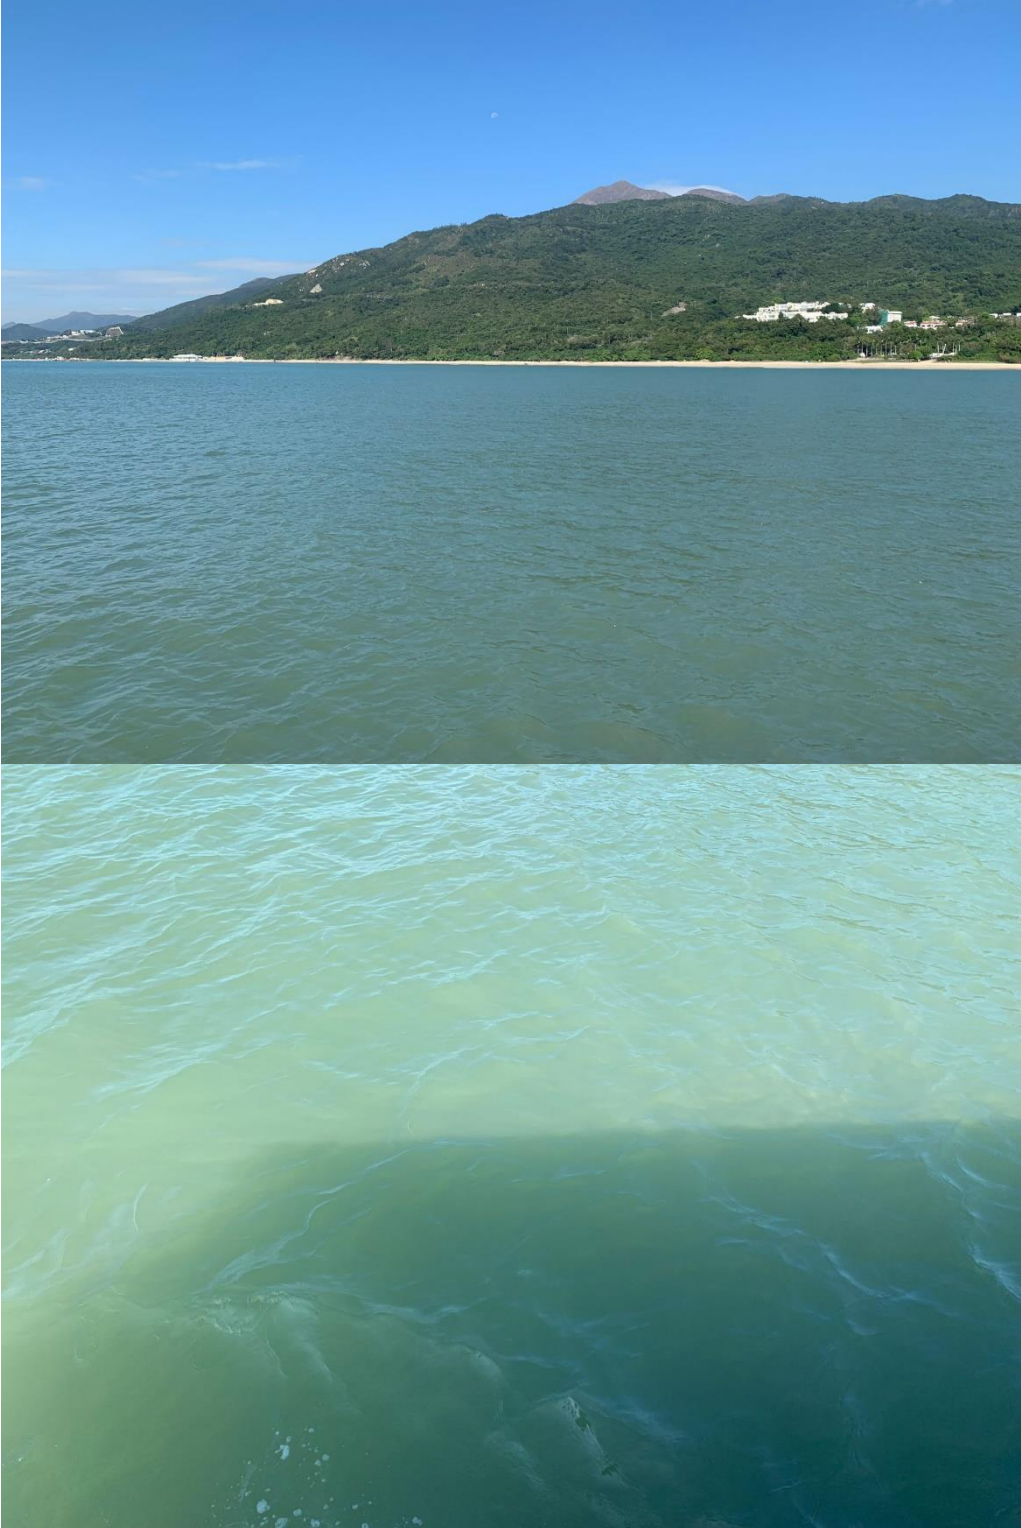
<p>Parameter</p>	<p>Suspended Solid (SS)</p>		
<p>Action &amp; Limit Levels</p>	<p>Action Level  <math>\geq 8.4</math> mg/L (120% of C2A)</p>		<p>Limit Level  <math>\geq 10.0</math> mg/L</p>
<p>Measurement Level</p>	<p>Impact Station(s) of Exceedance              8.5 mg/L (B1)              11.0 mg/L (B3)              8.7 mg/L (CR2)</p>	<p>Control Stations              5.8 mg/L (C1A)              7.0 mg/L (C2A)</p>	<p>Impact Station(s) without Exceedance              7.3 mg/L (B2)              5.8 mg/L (B4)              8.0 mg/L (F1A)              5.7 mg/L (H1)              6.3 mg/L (M1)              5.7 mg/L (CR1)</p>
<p>Possible reason for Action or Limit Level Non-compliance</p>	<p>Works scheduled on site on 26 Oct 2021 include levelling of rock armour, landfilling works, installation of instrumentation, piling pre-drilling works, pilling works and existing caisson extension.</p> <p>Dominating sea current direction was found to be from Southeast to Northwest at waters around Shek Kwu Chau.</p> <p>Exceedances of SS action level were found at B1 and CR2 on 26 Oct 2021 and exceedance of SS limit level was found at B3 on 26 Oct 2021</p> <p>B1 and B3 are located at unrelated stream direction (neither upstream nor downstream, far away) to the works location, exceedances of these monitoring stations are deemed to be unrelated to the Project.</p> <p>CR2 is located close to the works location within the Project site while no marine work was conducted on 26 Oct 2021.</p> <p>The installation of caisson No.19 was completed on 18 Mar 2021, the reclamation area was enclosed.</p>

<p>According to the field observation by sampling team during sampling event, no silt plume was observed in the Project site and the weather was fine during the sampling event.</p> <p>No major observation of improper site practices that could contribute to the increase of the suspended solids was recorded during the weekly inspection on 05 Oct 2021.</p> <p>After the investigation, the exceedances on 26 Oct 2021 at B1, B3 and CR2 are deemed to be unrelated to the Project.</p>
Monitoring photos of stations with exceedance	<p>B1:</p>

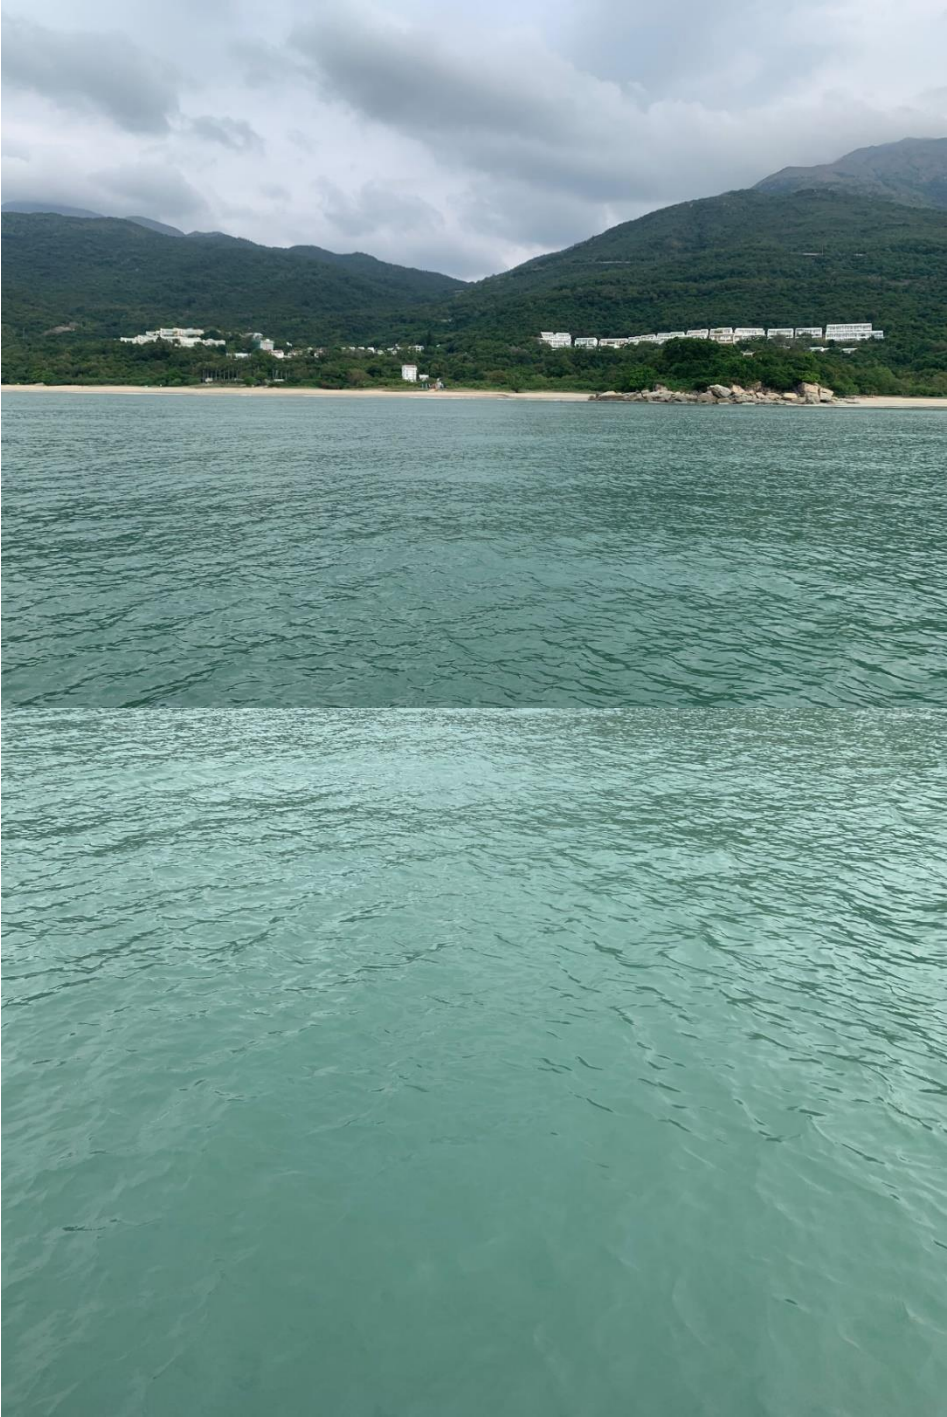
9.5 mg/L (B1) 8.0 mg/L (B2) 11.3 mg/L (B3) 10.8 mg/L (B4)	6.5 mg/L (C1A) 6.0 mg/L (C2A)	5.3 mg/L (F1A) 7.2 mg/L (H1) 5.5 mg/L (M1) 5.5 mg/L (CR1) 7.0 mg/L (CR2)
Possible reason for Action or Limit Level Non-compliance	<p>Works scheduled on site on 28 Oct 2021 include laying of geotextile, landfilling works, installation of instrumentation, piling pre-drilling works, piling works, piling works for driven pile, piling works for pre-bored socketed H-pile and existing caisson extension.</p> <p>Dominating sea current direction was found to be from Northwest to Southeast at waters around Shek Kwu Chau.</p> <p>Exceedances of action level were found at B1 and B2 and exceedances of limit level were found at B3 and B4.</p> <p>B1, B2, B3 and B4 are located at unrelated stream direction (neither upstream nor downstream, far away) to the works location, exceedances of these monitoring stations are deemed to be unrelated to the Project.</p>

<p>The installation of caisson No.19 was completed on 18 Mar 2021, the reclamation area was enclosed.</p> <p>According to the field observation by sampling team during sampling event, no silt plume was observed in the Project site and the weather was fine during the sampling event.</p> <p>No major observation of improper site practices that could contribute to the increase of the suspended solids was recorded during the weekly inspection on 26 Oct 2021.</p> <p>After the investigation, the exceedances on 28 Oct 2021 at B1, B2, B3 and B4 are deemed to be unrelated to the Project.</p>
<p>Monitoring photos of stations with exceedance</p>	<p>B1:</p>

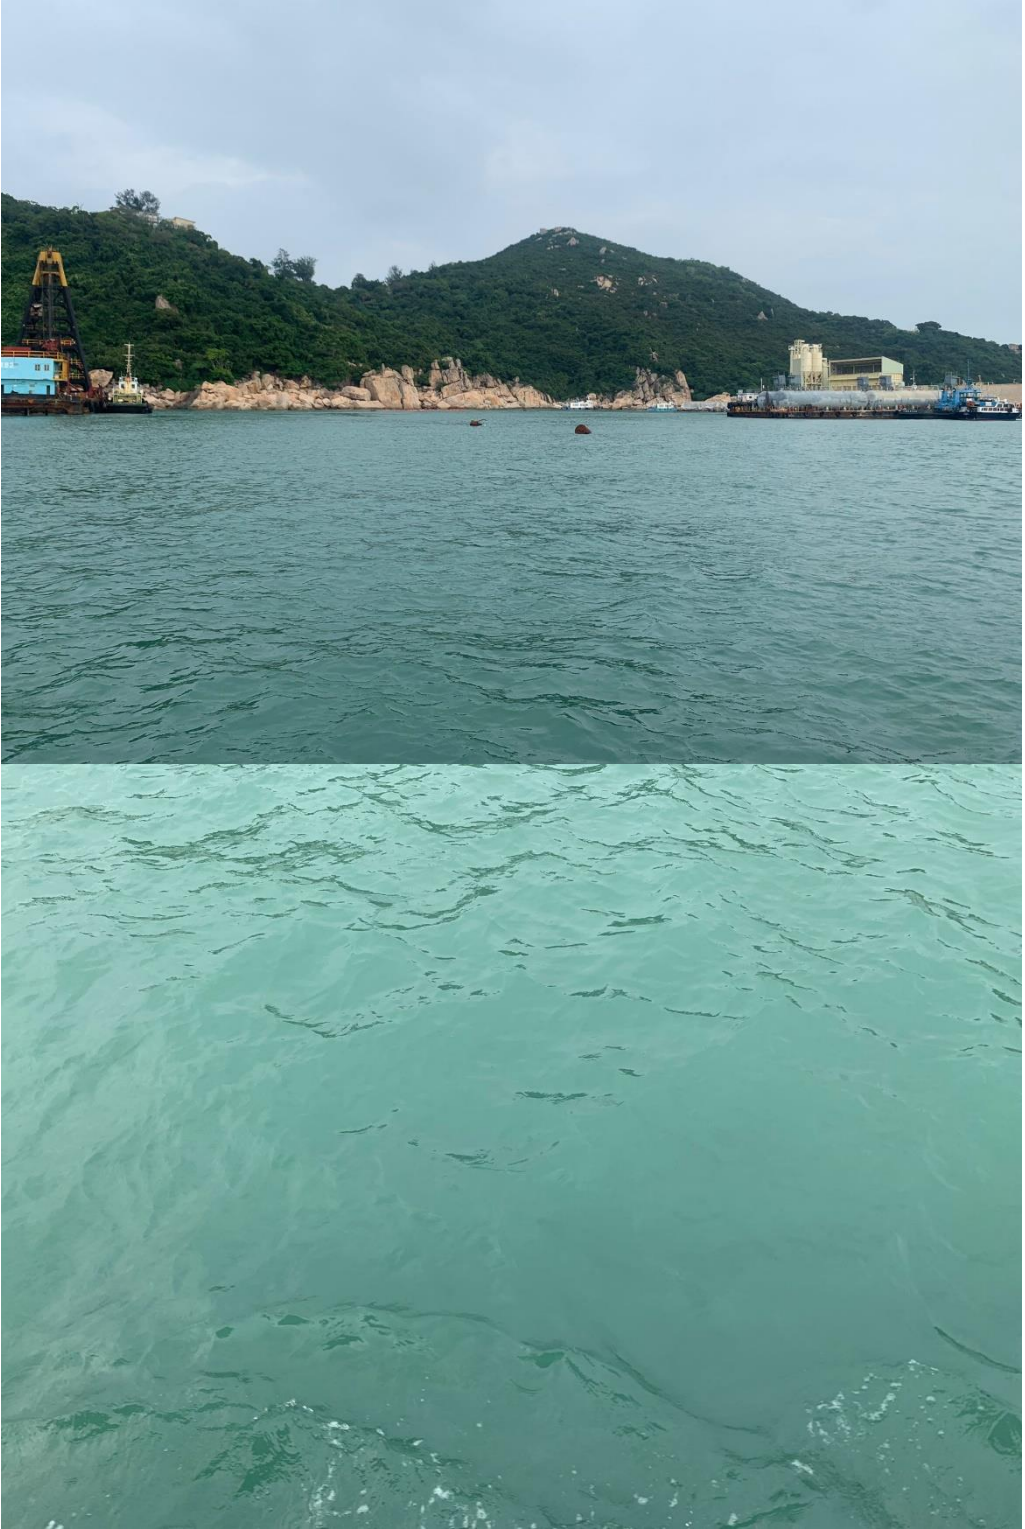
<p>Parameter</p>	<p>Suspended Solid (SS)</p>		
<p>Action &amp; Limit Levels</p>	<p>Action Level  <math>\geq 8.0</math> mg/L</p>		<p>Limit Level  <math>\geq 10.0</math> mg/L</p>
<p>Measurement Level</p>	<p>Impact Station(s) of Exceedance                  9.3 mg/L (CR2)</p>	<p>Control Stations                  7.2 mg/L (C1A)                  6.0 mg/L (C2A)</p>	<p>Impact Station(s) without Exceedance                  5.3 mg/L (B1)                  7.0 mg/L (B2)                  6.0 mg/L (B3)                  5.3 mg/L (B4)                  4.0 mg/L (F1A)                  5.7 mg/L (H1)                  7.2 mg/L (M1)                  7.8 mg/L (CR1)</p>
<p>Possible reason for Action or Limit Level Non-compliance</p>	<p>Works scheduled on site on 28 Oct 2021 include laying of geotextile, landfilling works, installation of instrumentation, pilling pre-drilling works, pilling works, pilling works for driven pile, piling works for pre-bored socketed H-pile and existing caisson extension.</p> <p>Dominating sea current direction was found to be from Southeast to Northwest at waters around Shek Kwu Chau.</p> <p>Exceedance of action level was found at CR2 on 28 Oct 2021.</p> <p>CR2 is located close to the works location within the Project site while no marine work was conducted on 28 Oct 2021.</p> <p>The installation of caisson No.19 was completed on 18 Mar 2021, the reclamation area was enclosed.</p> <p>According to the field observation by sampling team during sampling event, no silt plume was observed in the Project site and the weather was fine during the sampling</p>

<p>event.</p> <p>No major observation of improper site practices that could contribute to the increase of the suspended solids was recorded during the weekly inspection on 05 Oct 2021.</p> <p>After the investigation, the exceedances on 28 Oct 2021 at CR2 is deemed to be unrelated to the Project.</p>
<p>Monitoring photos of stations with exceedance</p>	<p>CR2:</p>

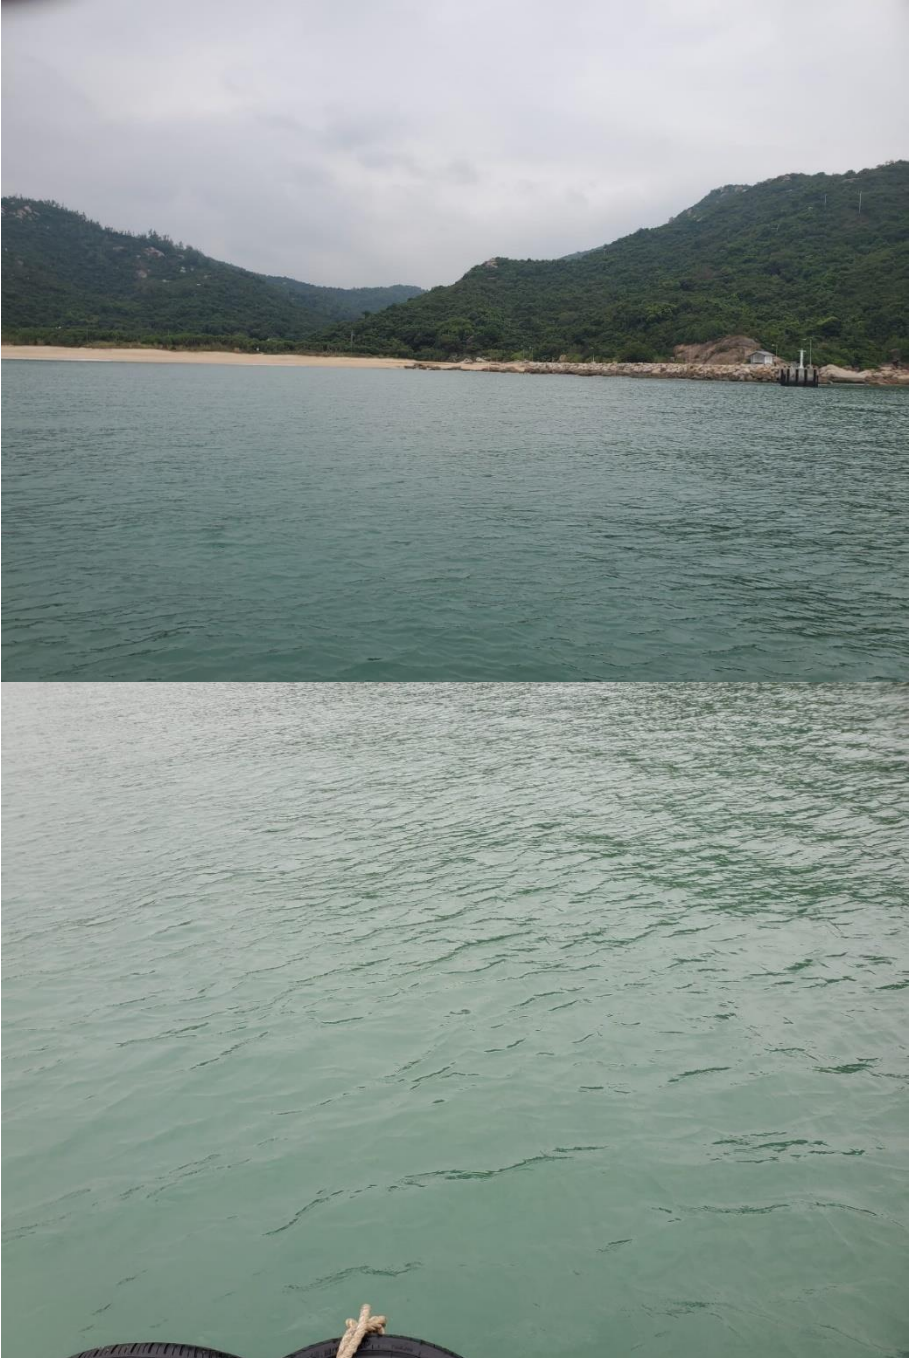
10.0 mg/L (B4) 10.7 mg/L (F1A) 10.3 mg/L (CR1)	7.7 mg/L (C1A) 10.0 mg/L (C2A)	6.3 mg/L (B1) 5.5 mg/L (B2) 4.8 mg/L (B3) 6.2 mg/L (H1) 8.7 mg/L (M1) 5.7 mg/L (CR2)
Possible reason for Action or Limit Level Non-compliance	<p>Works scheduled on site on 30 Oct 2021 include laying of geotextile, landfilling works, installation of instrumentation, piling pre-drilling works, piling works, piling works for driven pile, piling works for pre-bored socketed H-pile, existing caisson extension and armour scour protection.</p> <p>Dominating sea current direction was found to be from Northwest to Southeast at waters around Shek Kwu Chau.</p> <p>Exceedances of limit level were found at B4, F1A and CR1.</p> <p>B4 and F1A are located at unrelated stream direction (neither upstream nor downstream, far away) to the works location, exceedances of these monitoring stations are deemed to be unrelated to the Project.</p>

<p>CR1 is located close to the works location within the Project site while no marine work was conducted on 30 Oct 2021.</p> <p>The installation of caisson No.19 was completed on 18 Mar 2021, the reclamation area was enclosed.</p> <p>According to the field observation by sampling team during sampling event, no silt plume was observed in the Project site and the weather was fine during the sampling event.</p> <p>No major observation of improper site practices that could contribute to the increase of the suspended solids was recorded during the weekly inspection on 26 Oct 2021.</p> <p>After the investigation, the exceedances on 30 Oct 2021 at B4, F1A and CR1 are deemed to be unrelated to the Project.</p>
<p>Monitoring photos of stations with exceedance</p>	<p>B4:</p>
