Appendix N Exceedance Report

Incident Report on Action Level or Limit Level Non-compliance

Project	Integrated Waste Management Facilities, Phase 1		
Date	1 Nov 2021 (Lab result received on 5 Nov 2021)		
Time	08:00 – 11:08 (Mid-Ebb)		
Monitoring Location	Mid-Ebb B1, B2, M1		
	<p>The map shows the Shek Kwu Chau area with various monitoring stations and proposed infrastructure. Stations B1, B2, and M1 are circled in red. A key identifies symbols for proposed 132KV submarine cables, monitoring stations (green circle with 'c'), proposed outfalls (red square), IWMF site boundary (purple outline), IWMF site boundary land formation footprint (dashed green line), and the IWMF site boundary (solid green line).</p>		
Parameter	Suspended Solid (SS)		
Action & Limit Levels	Action Level		Limit Level
	≥ 8.6 mg/L (120% of C1A)		≥ 10.0 mg/L
Measurement Level	Impact Station(s) of Exceedance	Control Stations	Impact Station(s) without Exceedance

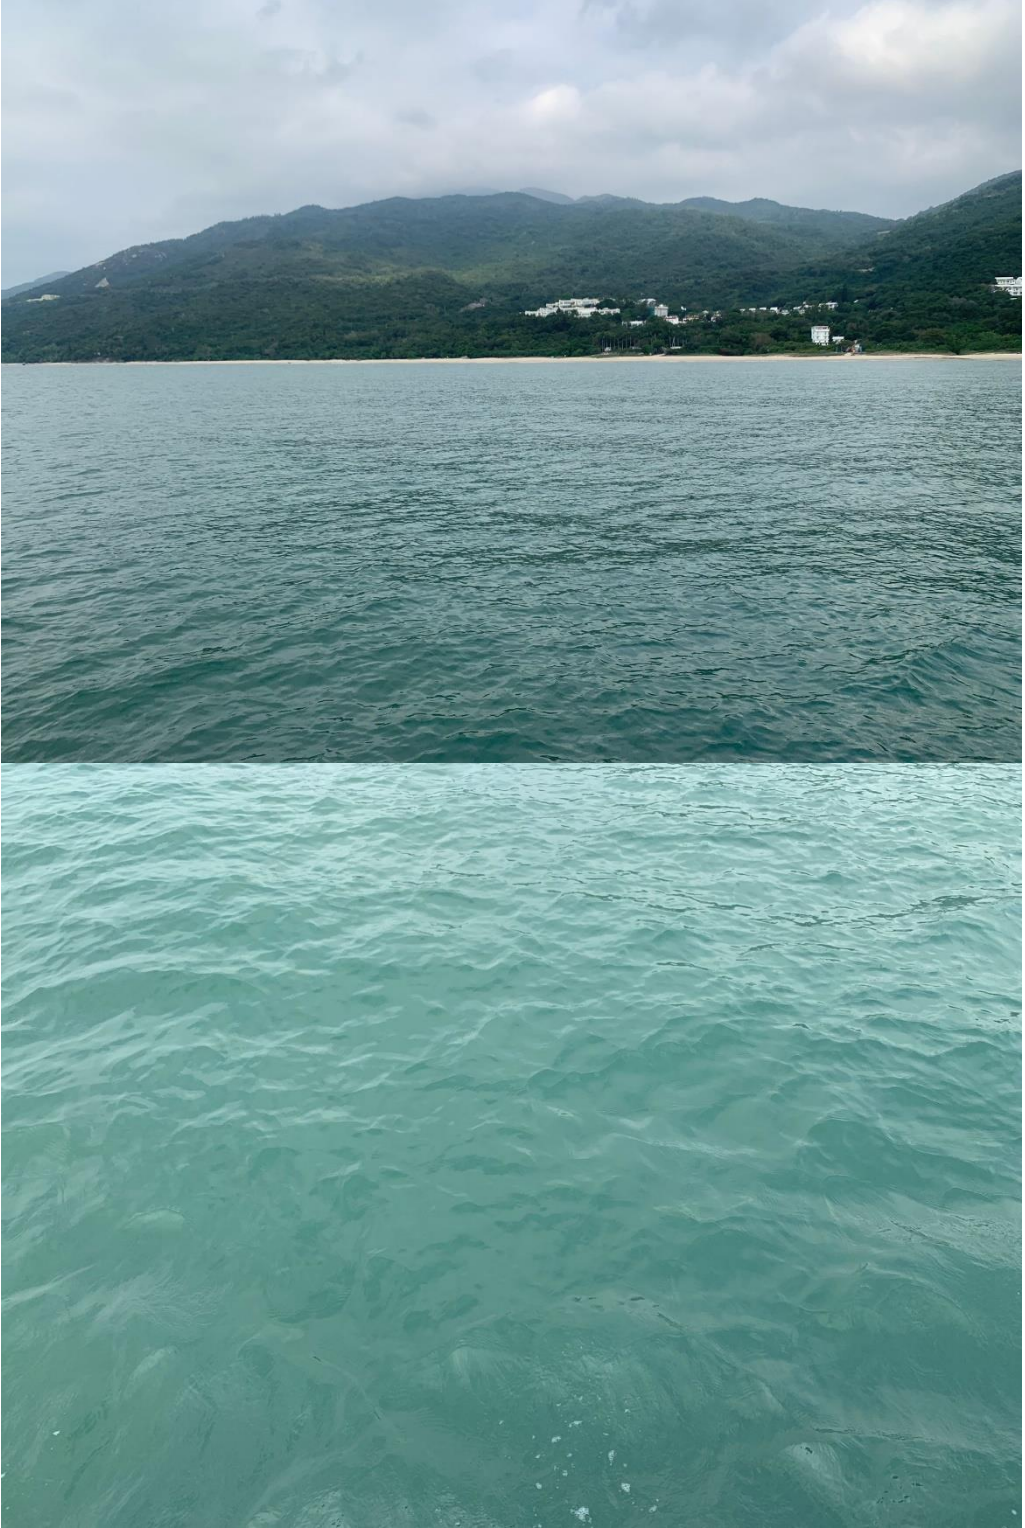
10.3 mg/L (B1) 10.0 mg/L (B2) 10.8 mg/L (M1)	7.2 mg/L (C1A) 6.7 mg/L (C2A)	10.3 mg/L (B1) 10.0 mg/L (B2) 10.8 mg/L (M1)
Possible reason for Action or Limit Level Non-compliance	<p>Works scheduled on site on 1 Nov 2021 include laying of scour apron, landfilling works for below +6.00mPD, landfilling works for above +6.00mPD, installation of instrumentation, piling pre-drilling works, piling works, piling works for driven pile, piling works for pre-bored socketed H-pile and existing caisson extension.</p> <p>Dominating sea current direction was found to be from Northwest to Southeast at waters around Shek Kwu Chau.</p> <p>Exceedances of limit level were found at B1, B2 and M1.</p> <p>B1, B2 and M1 are located at unrelated stream direction (neither upstream nor downstream, far away) to the works location, exceedances of these monitoring stations are deemed to be unrelated to the Project.</p> <p>The installation of caisson No.19 was completed on 18 Mar 2021, the reclamation area was enclosed.</p>

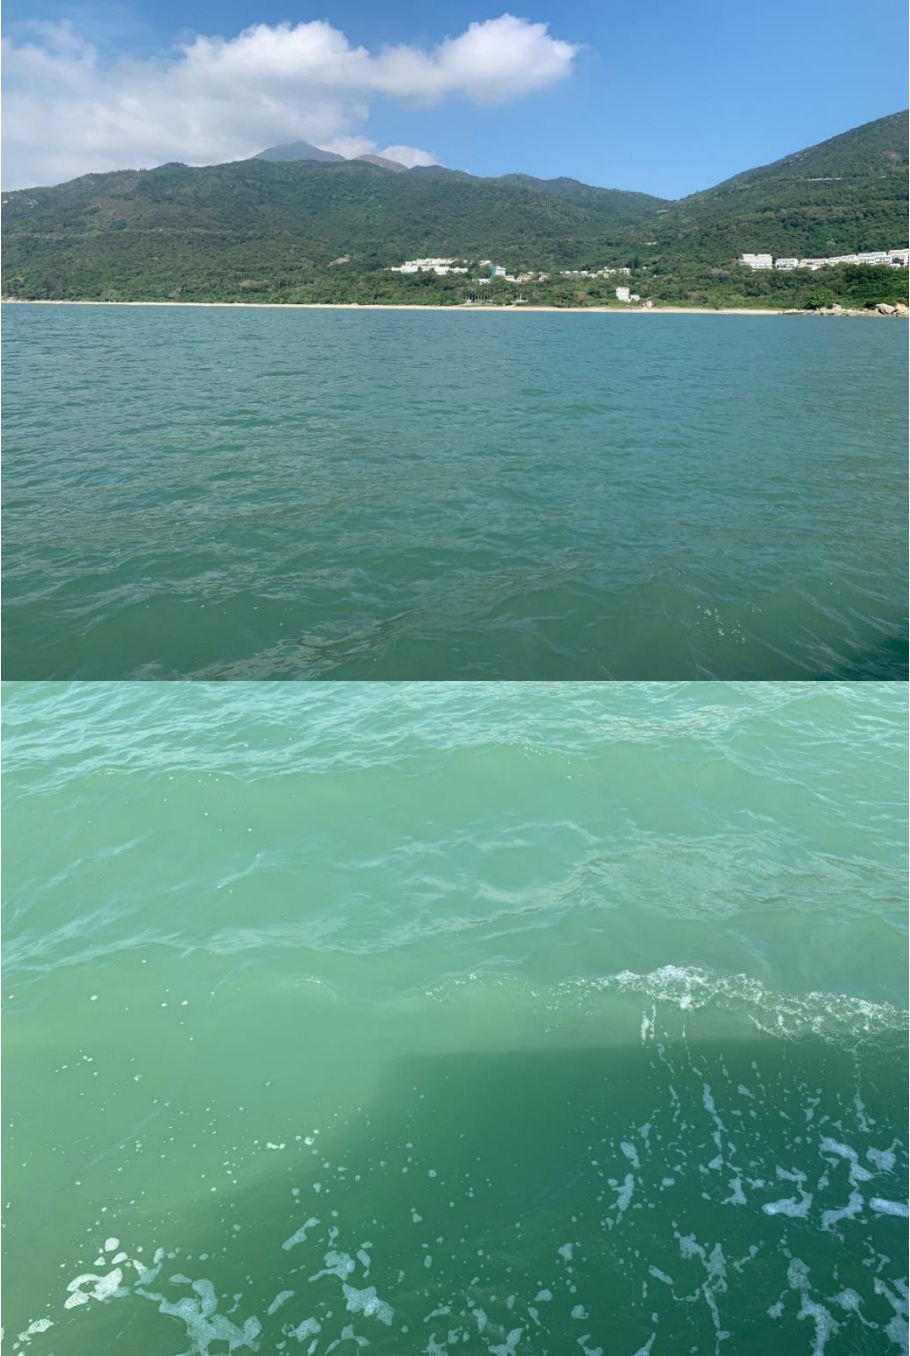
12.8 mg/L (B1) 13.2 mg/L (M1) 11.8 mg/L (CR1)	9.8 mg/L (C1A) 11.3 mg/L (C2A)	6.3 mg/L (B2) 5.3 mg/L (B3) 6.0 mg/L (B4) 9.0 mg/L (F1A) 9.3 mg/L (H1) 10.8 mg/L (CR2)
Possible reason for Action or Limit Level Non-compliance	<p>Works scheduled on site on 03 Nov 2021 include infilling of caisson, installation of blockwork for marine access facility, landfilling works for below +6.00mPD, landfilling works for above +6.00mPD, installation of instrumentation, piling pre-drilling works, piling works and existing caisson extension.</p> <p>Dominating sea current direction was found to be from Northwest to Southeast at waters around Shek Kwu Chau.</p> <p>Exceedance of action level was found at CR1 and exceedances of limit level were found at B1 and M1.</p> <p>B1 and M1 are located at unrelated stream direction (neither upstream nor downstream, far away) to the works location, exceedances of these monitoring stations are deemed to be unrelated to the Project.</p>

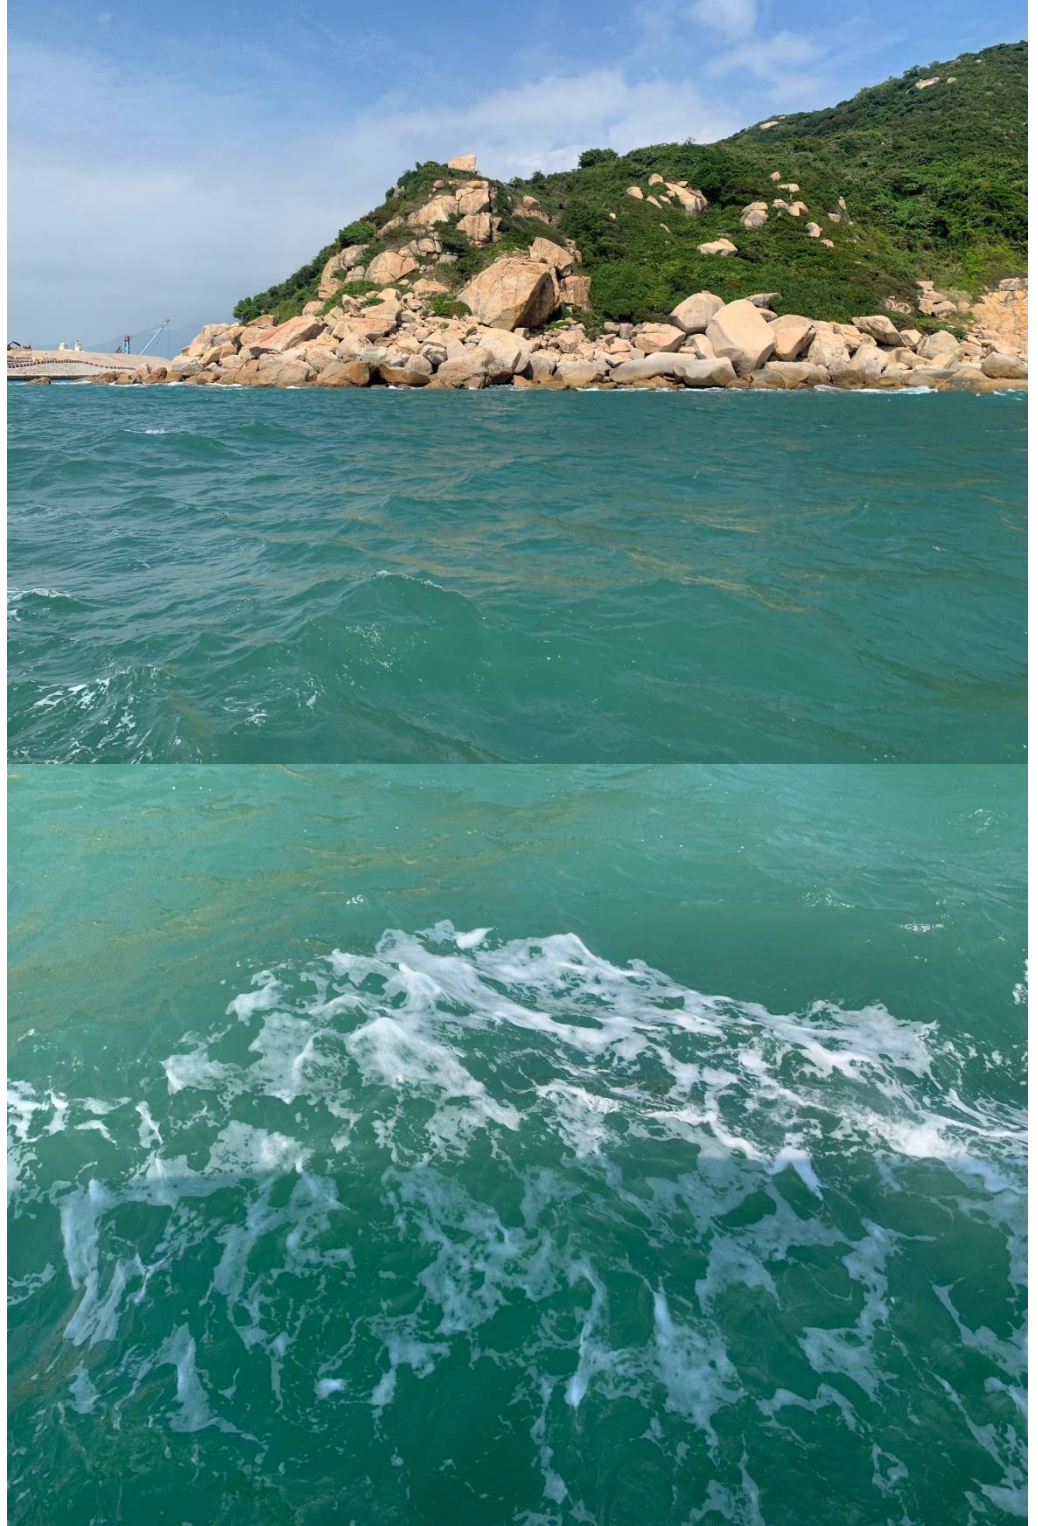
CR1:

<p>CR1 is located close to the works location within the Project site while no marine work was conducted on 03 Nov 2021.</p> <p>The installation of caisson No.19 was completed on 18 Mar 2021, the reclamation area was enclosed.</p> <p>According to the field observation by sampling team during sampling event, no silt plume was observed in the Project site and the weather was fine during the sampling event.</p> <p>No major observation of improper site practices that could contribute to the increase of the suspended solids was recorded during the weekly inspection on 02 Nov 2021.</p> <p>After the investigation, the exceedances on 03 Nov 2021 at B1, M1 and CR1 are deemed to be unrelated to the Project.</p>
<p>Monitoring photos of stations with exceedance</p>	<p>B1:</p>

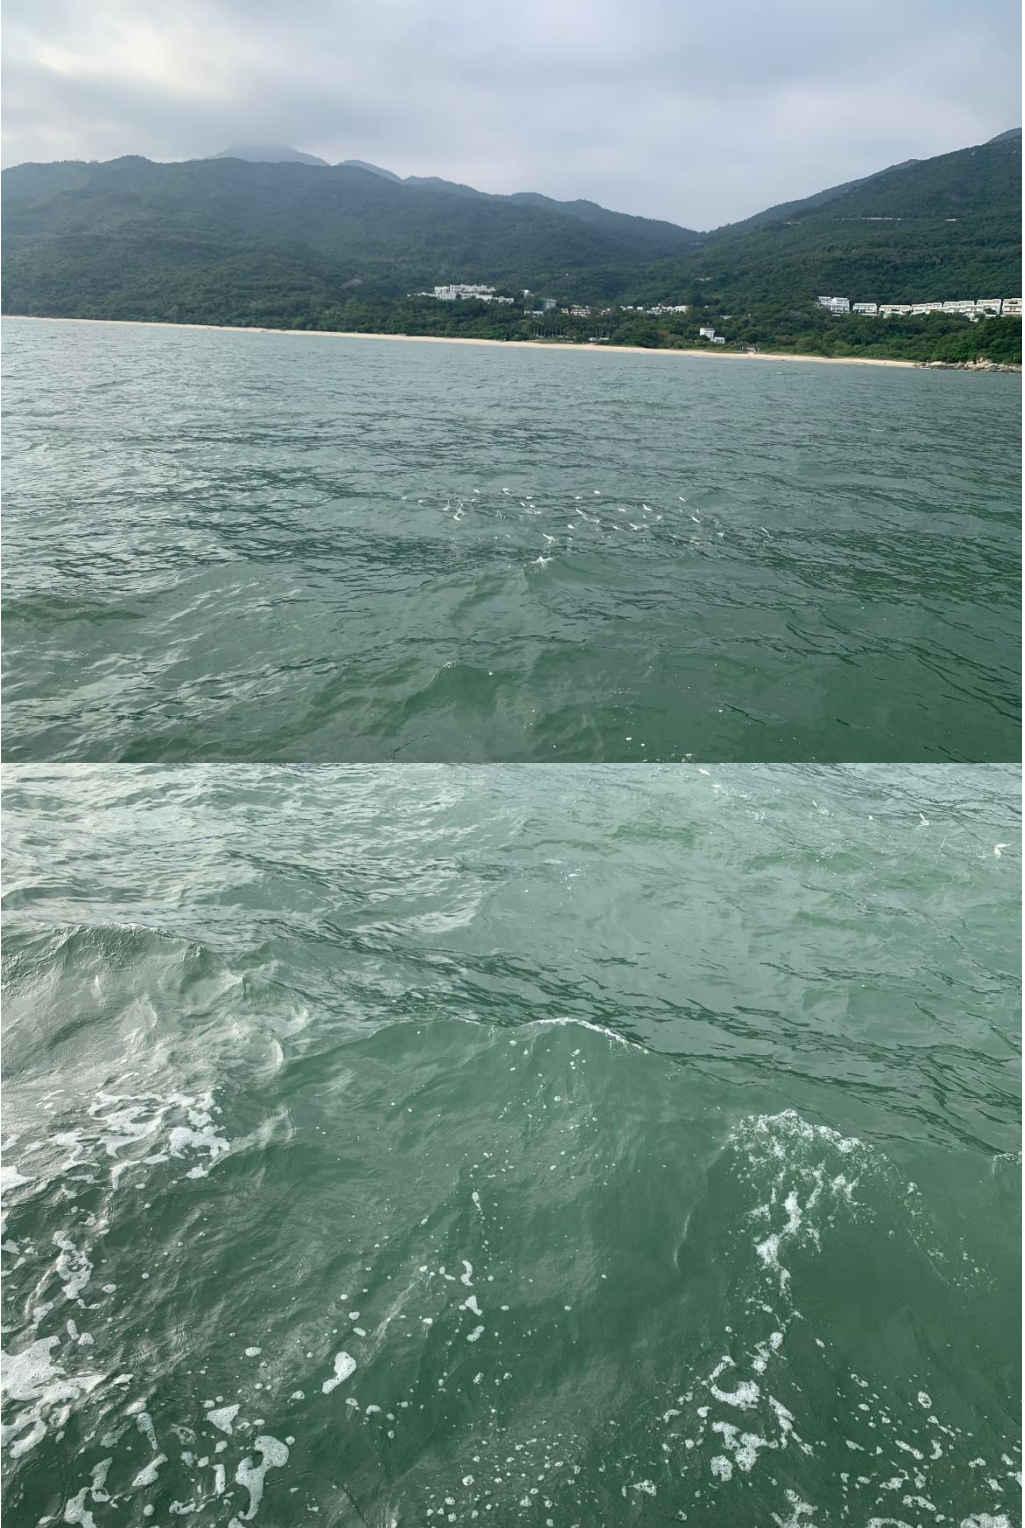
<p>Parameter</p>	<p>Suspended Solid (SS)</p>		
<p>Action & Limit Levels</p>	<p>Action Level $\geq 9.8 \text{ mg/L (120\% of C2A)}$</p>		<p>Limit Level $\geq 10.6 \text{ mg/L (130\% of C2A)}$</p>
<p>Measurement Level</p>	<p>Impact Station(s) of Exceedance</p> <p>10.5 mg/L (B1) 10.3 mg/L (B3) 10.0 mg/L (B4) 11.2 mg/L (M1) 14.2 mg/L (CR1) 12.2 mg/L (CR2)</p>	<p>Control Stations</p> <p>10.8 mg/L (C1A) 8.2 mg/L (C2A)</p>	<p>Impact Station(s) without Exceedance</p> <p>9.8 mg/L (B2) 9.0 mg/L (F1A) 8.8 mg/L (H1)</p>
<p>Possible reason for Action or Limit Level Non-compliance</p>	<p>Works scheduled on site on 03 Nov 2021 include infilling of caisson, installation of blockwork for marine access facility, landfilling works for below +6.00mPD, landfilling works for above +6.00mPD, installation of instrumentation, piling pre-drilling works, piling works and existing caisson extension.</p> <p>Dominating sea current direction was found to be from Southeast to Northwest at waters around Shek Kwu Chau.</p> <p>Exceedances of action level were found at B1, B3 and B4 and exceedances of limit level were found at M1, CR1 and CR2.</p> <p>B1, B3, B4 and M1 are located at unrelated stream direction (neither upstream nor downstream, far away) to the works location, exceedances of these monitoring stations are deemed to be unrelated to the Project.</p> <p>CR1 and CR2 are located close to the works location within the Project site while no marine work was conducted on 03 Nov 2021.</p> <p>The installation of caisson No.19 was completed on 18 Mar 2021, the reclamation area was enclosed.</p>

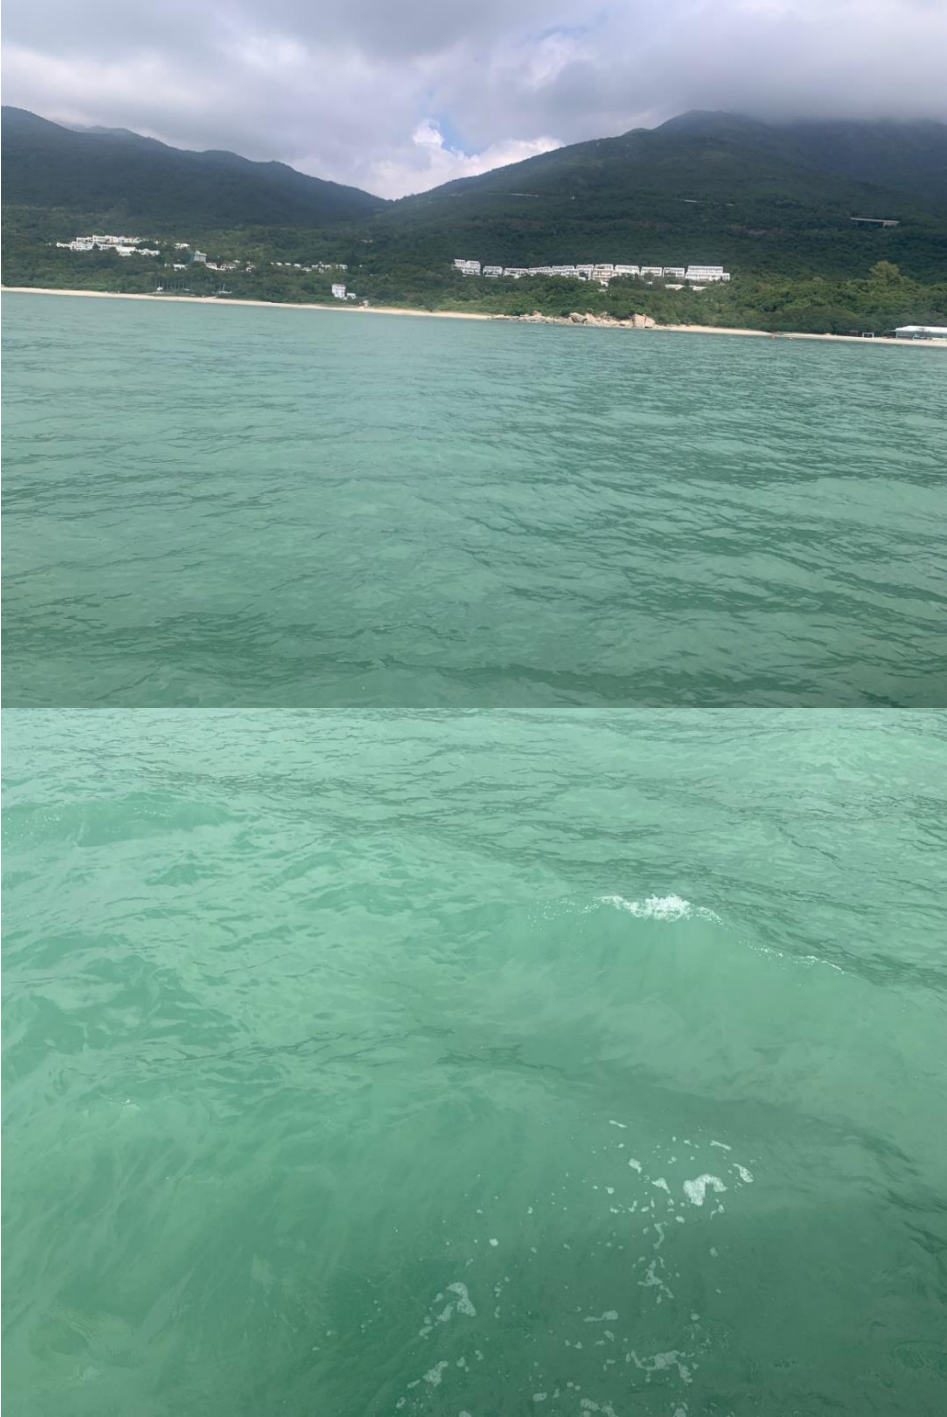
13.0 mg/L (B1) 12.0 mg/L (B2) 11.8 mg/L (M1)	9.0 mg/L (C1A) 8.2 mg/L (C2A)	8.0 mg/L (B3) 8.0 mg/L (B4) 7.3 mg/L (F1A) 8.2 mg/L (H1) 8.5 mg/L (CR1) 9.3 mg/L (CR2)
Possible reason for Action or Limit Level Non-compliance	<p>Works scheduled on site on 05 Nov 2021 include infilling of caisson, installation of blockwork for marine access facility, landfilling works for below +6.00mPD, landfilling works for above +6.00mPD, installation of instrumentation, piling pre-drilling works, piling works, piling works for pre-bored socketed H-pile and existing caisson extension.</p> <p>Dominating sea current direction was found to be from Northwest to Southeast at waters around Shek Kwu Chau.</p> <p>Exceedances of limit level were found at B1, B2 and M1.</p> <p>B1, B2 and M1 are located at unrelated stream direction (neither upstream nor downstream, far away) to the works location, exceedances of these monitoring stations are deemed to be unrelated to the Project.</p>

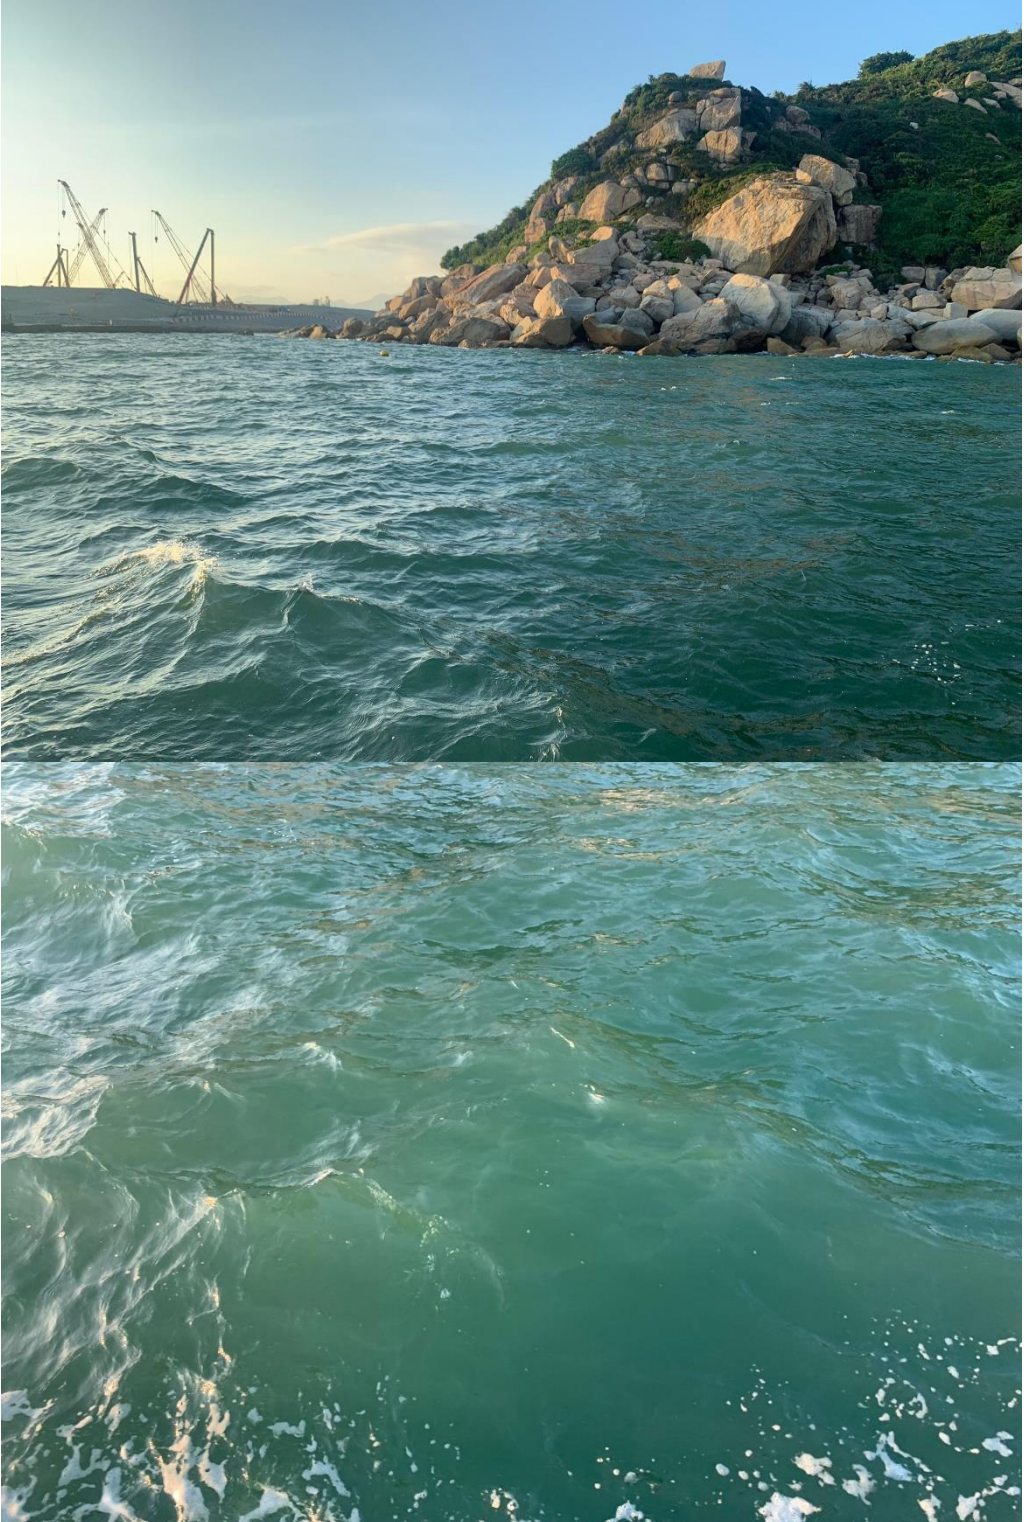
<p>Parameter</p>	<p>Suspended Solid (SS)</p>		
<p>Action & Limit Levels</p>	<p>Action Level ≥ 12.0 mg/L (120% of C2A)</p>		<p>Limit Level ≥ 13.0 mg/L (130% of C2A)</p>
<p>Measurement Level</p>	<p>Impact Station(s) of Exceedance 13.0 mg/L (CR1)</p>	<p>Control Stations 10.7 mg/L (C1A) 10.0 mg/L (C2A)</p>	<p>Impact Station(s) without Exceedance 10.3 mg/L (B1) 10.8 mg/L (B2) 10.8 mg/L (B3) 11.0 mg/L (B4) 10.8 mg/L (F1A) 11.0 mg/L (H1) 7.7 mg/L (M1) 6.3 mg/L (CR2)</p>
<p>Possible reason for Action or Limit Level Non-compliance</p>	<p>Works scheduled on site on 05 Nov 2021 include infilling of caisson, installation of blockwork marine access facility, landfilling works for below +6.00mPD, landfilling works for above +6.00mPD, installation of instrumentation, piling pre-drilling works, piling works, piling works for pre-bored socketed H-pile and existing caisson extension.</p> <p>Dominating sea current direction was found to be from Southeast to Northwest at waters around Shek Kwu Chau.</p> <p>Exceedance of limit level was found at CR1.</p> <p>CR1 is located close to the works location within the Project site while no marine work was conducted on 05 Nov 2021.</p> <p>The installation of caisson No.19 was completed on 18 Mar 2021, the reclamation area was enclosed.</p>

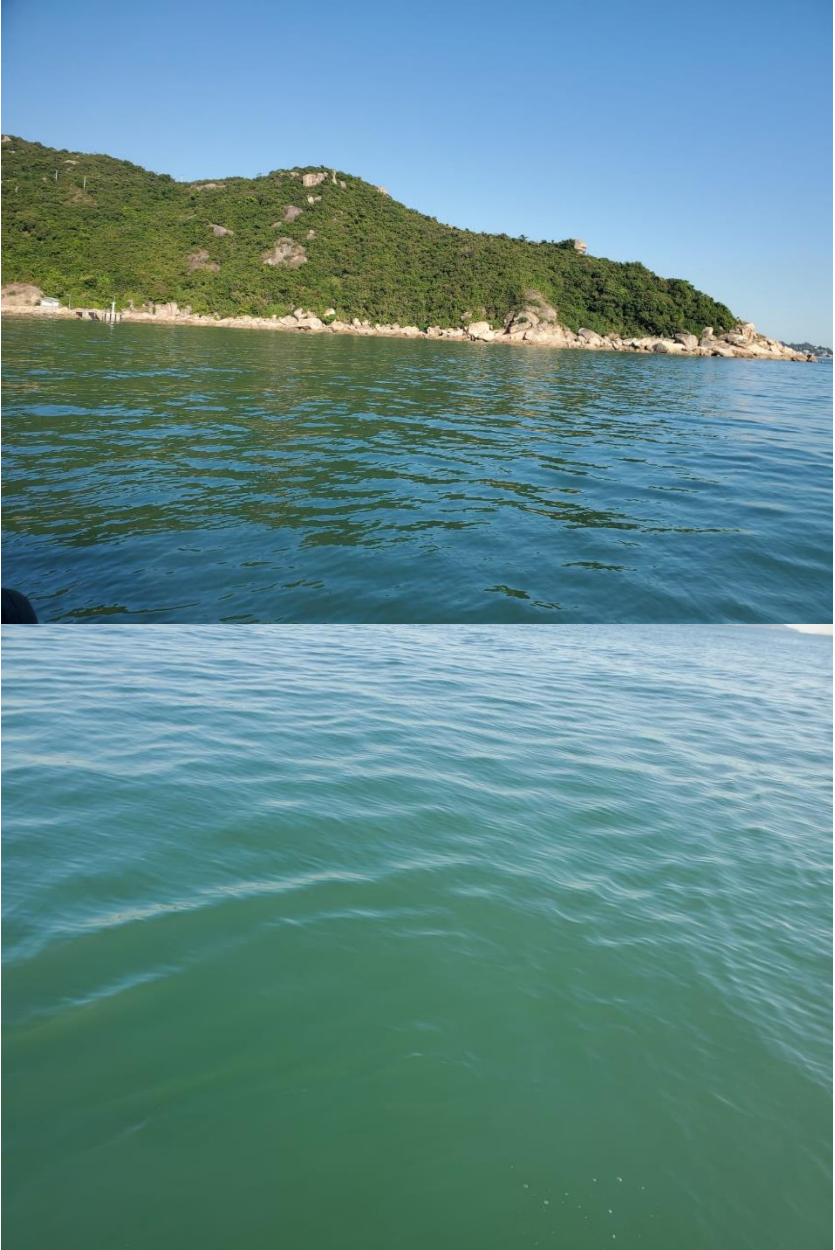
10.0 mg/L (B4) 8.8 mg/L (CR2)	6.8 mg/L (C1A) 4.2 mg/L (C2A)	6.5 mg/L (B1) 5.3 mg/L (B2) 5.5 mg/L (B3) 6.0 mg/L (F1A) 4.7 mg/L (H1) 6.5 mg/L (M1) 7.5 mg/L (CR1)
Possible reason for Action or Limit Level Non-compliance	<p>Works scheduled on site on 10 Nov 2021 include laying of armour, installation of blockwork for marine access facility, landfilling works for below +6.00mPD, landfilling works for above +6.00mPD, installation of instrumentation, piling pre-drilling works, piling works, piling works for driven pile, piling works for pre-bored socketed H-pile and existing caisson extension.</p> <p>Dominating sea current direction was found to be from Southeast to Northwest at waters around Shek Kwu Chau.</p> <p>Exceedance of action level was found at CR2 and exceedance of limit level was found at B4.</p> <p>B4 is located at unrelated stream direction (neither upstream nor downstream, far away) to the works location, exceedances of these monitoring stations are deemed to</p>

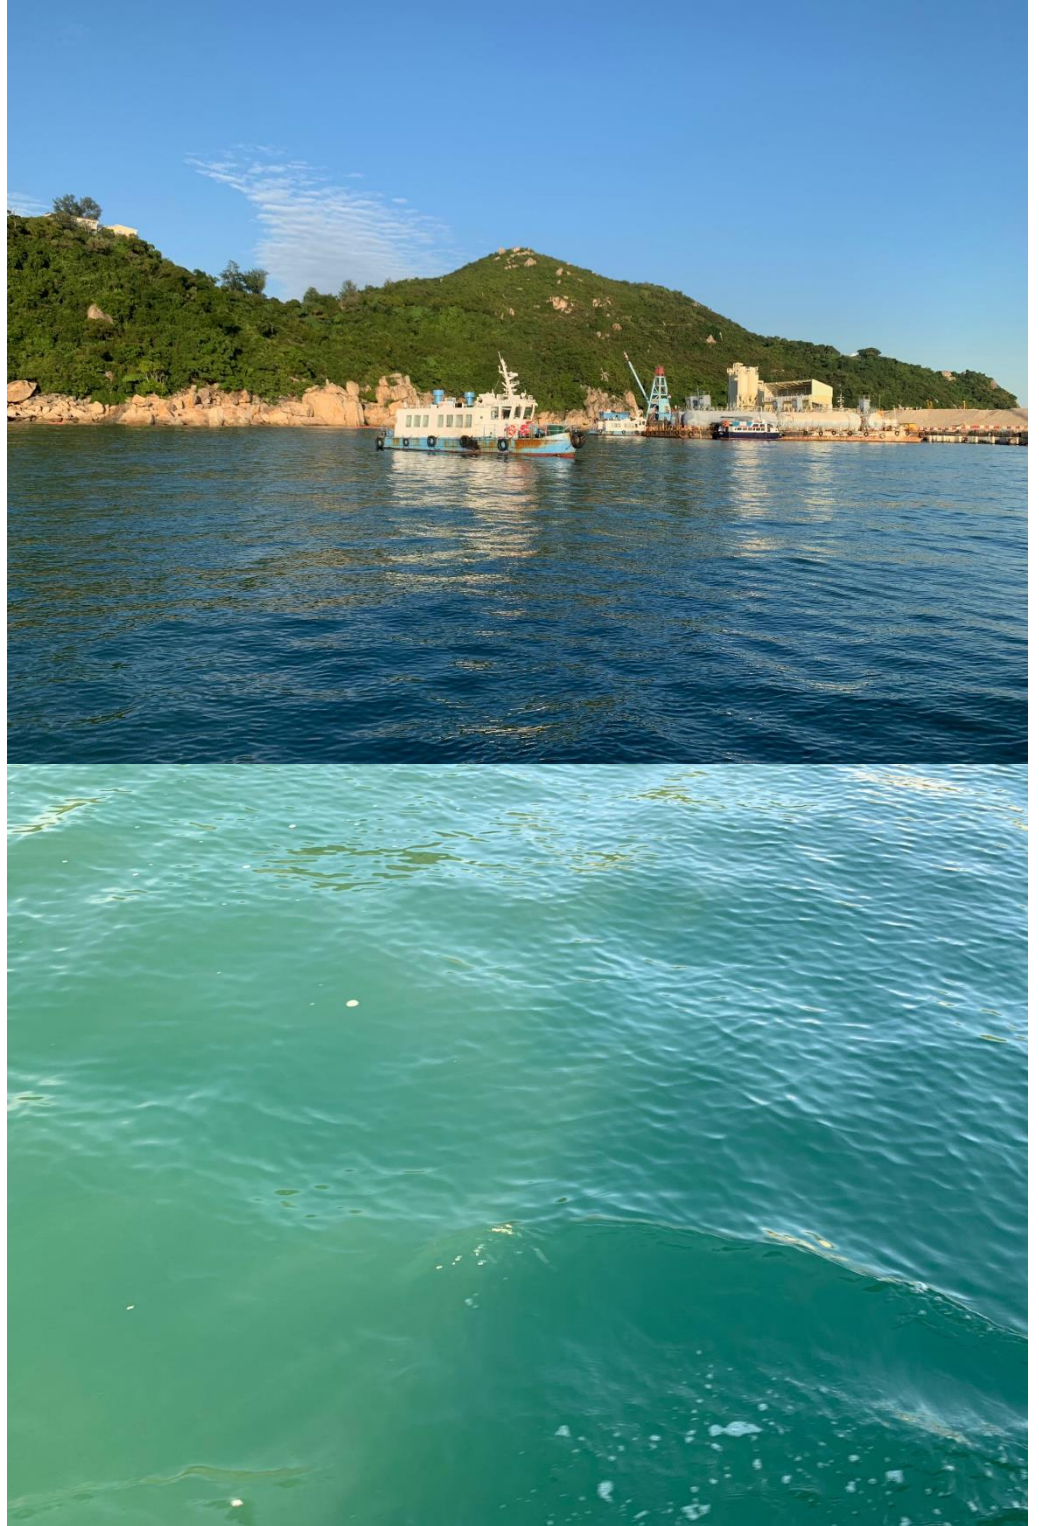
CR2:

<p>be unrelated to the Project.</p> <p>CR2 is located close to the works location within the Project site while no marine work was conducted on 10 Nov 2021.</p> <p>The installation of caisson No.19 was completed on 18 Mar 2021, the reclamation area was enclosed.</p> <p>According to the field observation by sampling team during sampling event, no silt plume was observed in the Project site and the weather was fine during the sampling event.</p> <p>No major observation of improper site practices that could contribute to the increase of the suspended solids was recorded during the weekly inspection on 09 Nov 2021.</p> <p>After the investigation, the exceedances on 10 Nov 2021 at B4 and CR2 are deemed to be unrelated to the Project.</p>
<p>Monitoring photos of stations with exceedance</p>	<p>B4:</p>

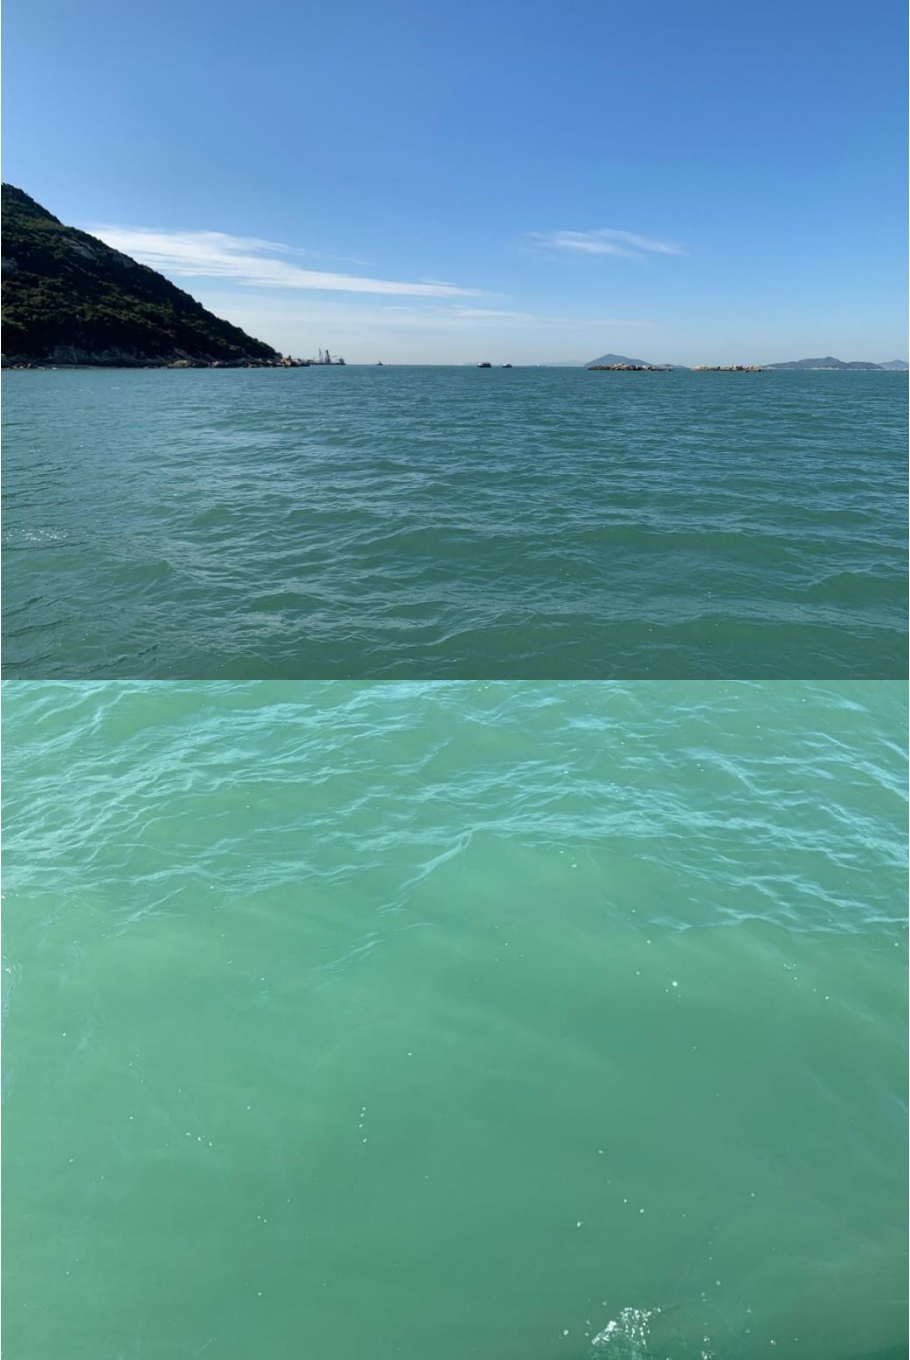
12.3 mg/L (H1)	9.5 mg/L (C1A) 10.5 mg/L (C2A)	10.0 mg/L (B1) 6.8 mg/L (B2) 9.0 mg/L (B3) 8.3 mg/L (B4) 7.2 mg/L (F1A) 10.3 mg/L (M1) 9.7 mg/L (CR1) 10.0 mg/L (CR2)
Possible reason for Action or Limit Level Non-compliance	<p>Works scheduled on site on 12 Nov 2021 include installation of blockwork marine for access facility, landfilling works for below +6.00mPD, landfilling works for above +6.00mPD, installation of instrumentation, piling pre-drilling works, piling works, piling works for pre-bored socketed H-pile, existing caisson extension and armour scour protection.</p> <p>Dominating sea current direction was found to be from Northwest to Southeast at waters around Shek Kwu Chau.</p> <p>Exceedance of action level was found at H1.</p> <p>H1 is located at unrelated stream direction (neither upstream nor downstream, far away) to the works location, exceedance of this monitoring stations is deemed to be</p>

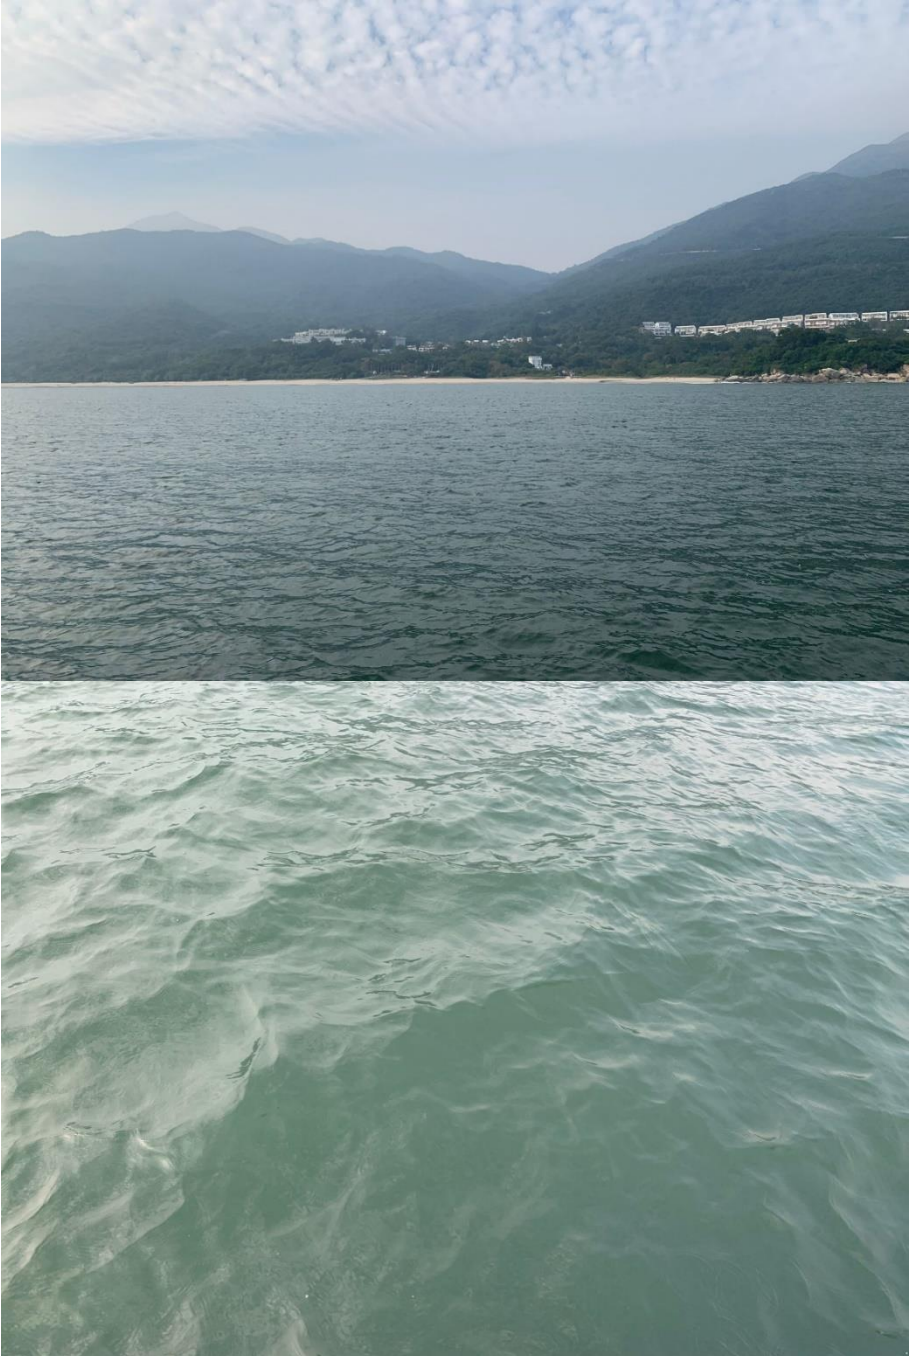
15.5 mg/L (B1)	5.0 mg/L (C1A) 7.0 mg/L (C2A)	2.5mg/L (B2) 2.9 mg/L (B3) 7.0 mg/L (B4) 4.3 mg/L (F1A) 4.9 mg/L (H1) 4.8 mg/L (M1) 4.2 mg/L (CR1) 5.0 mg/L (CR2)
Possible reason for Action or Limit Level Non-compliance	<p>Works scheduled on site on 17 Nov 2021 include installation of blockwork for marine access facility, landfilling works for below +6.00mPD, landfilling works for above +6.00mPD, installation of instrumentation, piling pre-drilling works, piling works, piling works for pre-bored socketed H-pile, existing caisson extension and armour scour protection.</p> <p>Dominating sea current direction was found to be from Southeast to Northwest at waters around Shek Kwu Chau.</p> <p>Exceedance of limit level was found at B1.</p> <p>B1 is located at unrelated stream direction (neither upstream nor downstream, far away) to the works location, exceedance of this monitoring station is deemed to be</p>

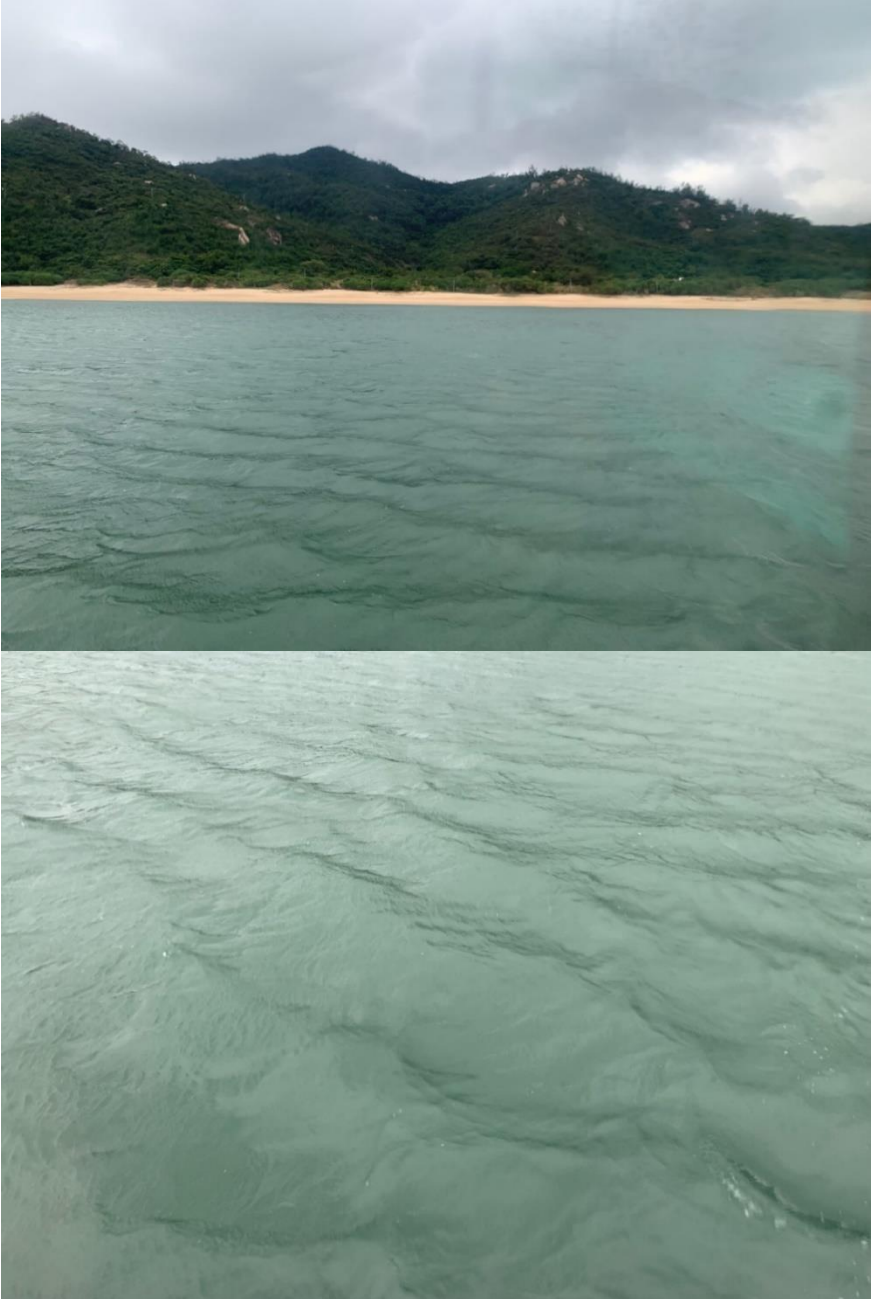
8.0 mg/L (B4) 8.0 mg/L (F1A) 8.5 mg/L (H1)	7.3 mg/L (C1A) 6.3 mg/L (C2A)	6.8 mg/L (B1) 6.8 mg/L (B2) 7.3 mg/L (B3) 7.0 mg/L (M1) 6.3 mg/L (CR1) 5.8 mg/L (CR2)
Possible reason for Action or Limit Level Non-compliance	<p>Works scheduled on site on 22 Nov 2021 include installation of blockwork marine for access facility, landfilling works for below +6.00mPD, landfilling works for above +6.00mPD, installation of instrumentation, piling pre-drilling works, piling works, piling works for pre-bored socketed H-pile, existing caisson extension and armour scour protection.</p> <p>Dominating sea current direction was found to be from Southeast to Northwest at waters around Shek Kwu Chau.</p> <p>Exceedances of action level were found at B4, F1A and H1.</p> <p>B4 and F1A are located at unrelated stream direction (neither upstream nor downstream, far away) to the works location, exceedances of these monitoring stations are deemed to be unrelated to the Project.</p>

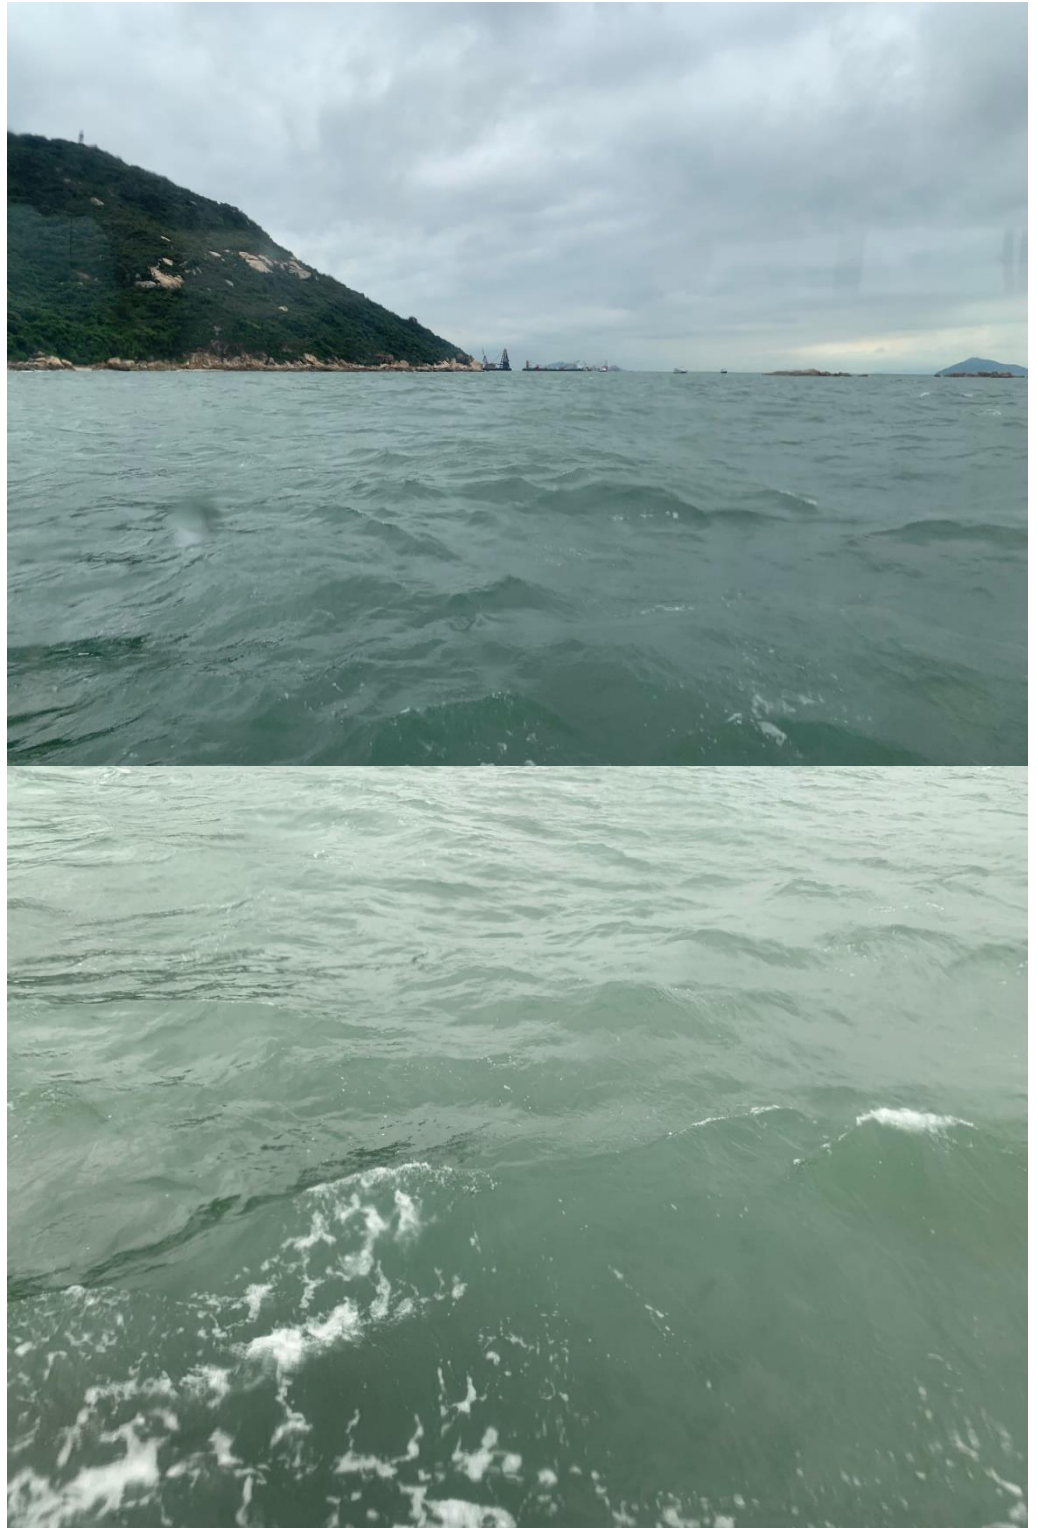
H1:

<p>H1 is the downstream of the Project site during Flood tide while no marine work was conducted on 22 Nov 2021.</p> <p>The installation of caisson No.19 was completed on 18 Mar 2021, the reclamation area was enclosed.</p> <p>According to the field observation by sampling team during sampling event, no silt plume was observed in the Project site and the weather was cloudy during the sampling event.</p> <p>No major observation of improper site practices that could contribute to the increase of the suspended solids was recorded during the weekly inspection on 16 Nov 2021 and 25 Nov 2021.</p> <p>After the investigation, the exceedances on 22 Nov 2021 at B4, F1A and H1 are deemed to be unrelated to the Project.</p>
<p>Monitoring photos of stations with exceedance</p>	<p>B4:</p>

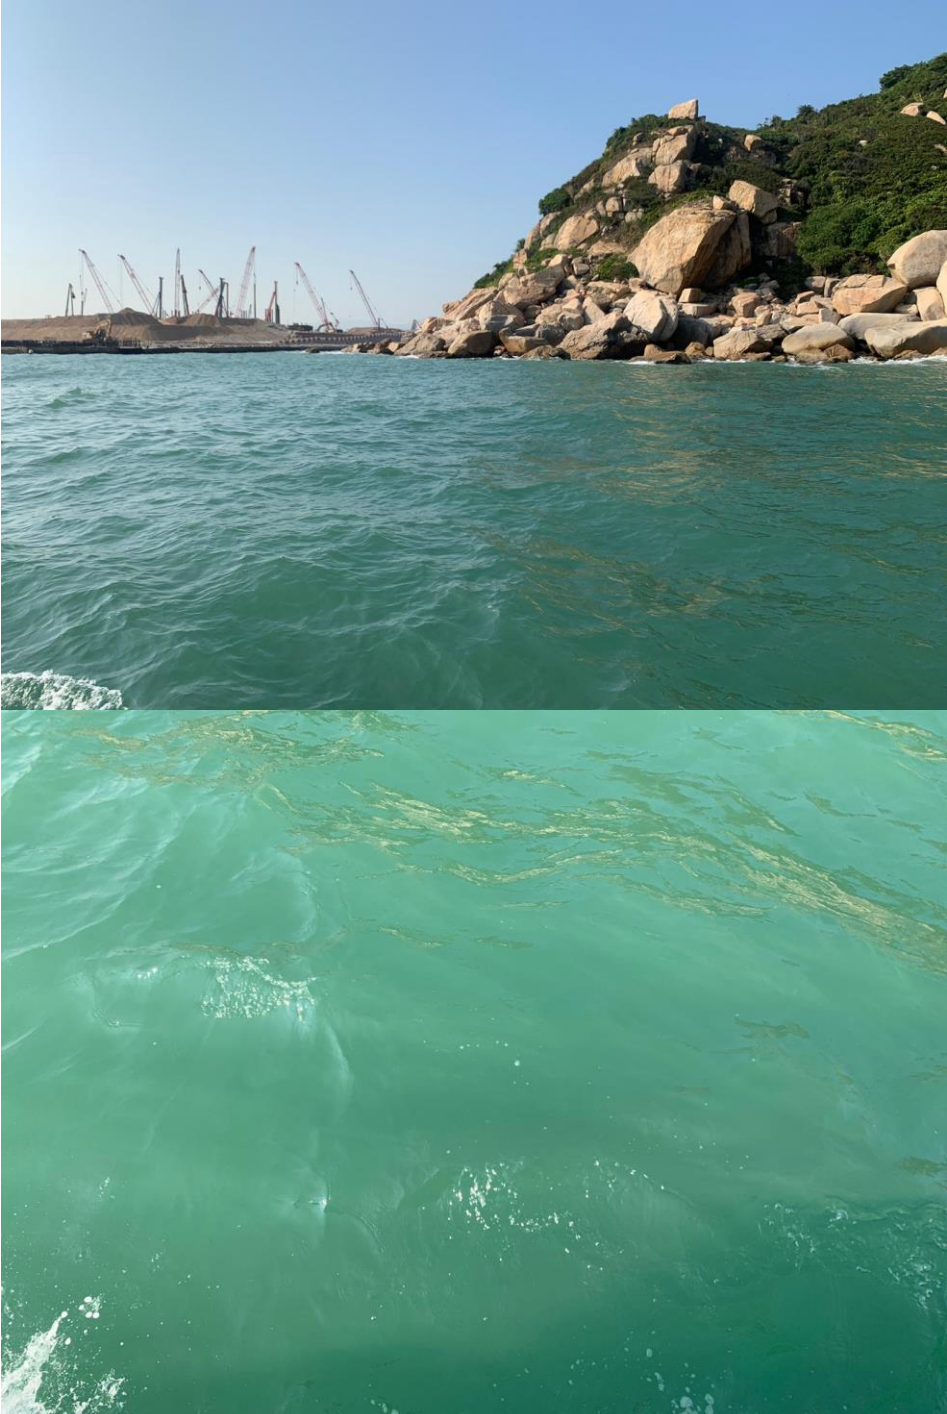
11.7 mg/L (CR1)	8.5 mg/L (C1A) 10.0 mg/L (C2A)	3.3 mg/L (B1) 6.0 mg/L (B2) 3.3 mg/L (B3) 3.1 mg/L (B4) 7.8 mg/L (F1A) 4.8 mg/L (H1) 8.3 mg/L (M1) 8.0 mg/L (CR2)
Possible reason for Action or Limit Level Non-compliance	<p>Works scheduled on site on 24 Nov 2021 include installation of blockwork marine for access facility, landfilling works for below +6.00mPD, landfilling works for above +6.00mPD, installation of instrumentation, piling pre-drilling works, piling works, piling works for driven pile, piling works for pre-bored socketed H-pile, existing caisson extension and armour scour protection.</p> <p>Dominating sea current direction was found to be from Southeast to Northwest at waters around Shek Kwu Chau.</p> <p>Exceedance of limit level was found at CR1.</p> <p>CR1 is located close to the works location within the Project site while no marine work was conducted on 24 Nov 2021.</p>
