Appendix N Exceedance Report

Incident Report on Action Level or Limit Level Non-compliance

Project	Integrated Waste Management Facilities, Phase 1		
Date	1 Nov 2021 (Lab result received on 5 Nov 2021)		
Time	08:00 – 11:08 (Mid-Ebb)		
Monitoring Location	Mid-Ebb B1, B2, M1		
	<p>The map shows the Shek Kwu Chau area with various monitoring stations and proposed infrastructure. Stations B1, B2, and M1 are circled in red. A key identifies symbols for proposed 132KV submarine cables, monitoring stations (green circle with 'c'), proposed outfalls (red square), IWMF site boundary (purple outline), IWMF site boundary land formation footprint (dashed green line), and the IWMF site boundary (solid green line).</p>		
Parameter	Suspended Solid (SS)		
Action & Limit Levels	Action Level		Limit Level
	≥ 8.6 mg/L (120% of C1A)		≥ 10.0 mg/L
Measurement Level	Impact Station(s) of Exceedance	Control Stations	Impact Station(s) without Exceedance

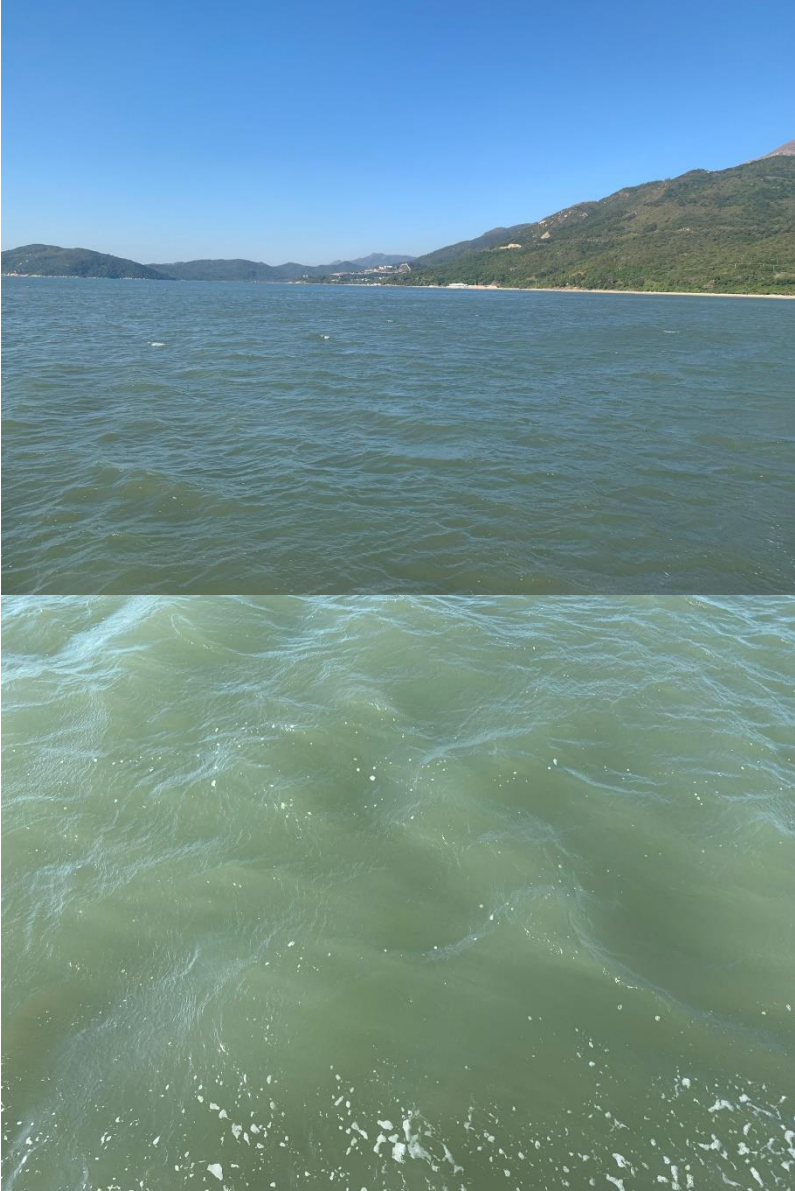
<p>Monitoring photos of stations with exceedance</p>	<p>B1:</p>

10.8 mg/L (B1) 12.0 mg/L (B3) 11.8 mg/L (B4) 13.5 mg/L (H1) 23.3 mg/L (M1) 11.8 mg/L (CR2)	9.0 mg/L (C1A) 8.5 mg/L (C2A)	9.8 mg/L (B2) 7.8 mg/L (F1) 10.5 mg/L (CR1)
Possible reason for Action or Limit Level Non-compliance	<p>Works scheduled on site on 29 Nov 2021 include installation of blockwork for marine access facility, landfilling works for below +6.00mPD, landfilling works for above +6.00mPD, installation of instrumentation, piling pre-drilling works, piling works, piling works for driven pile, piling works for pre-bored socketed H-pile and existing caisson extension and armour scour protection.</p> <p>Dominating sea current direction was found to be from Northwest to Southeast at waters around Shek Kwu Chau.</p> <p>Exceedance of action level was found at B1 and exceedances of limit level were found at B3, B4, H1, M1 and CR2.</p>

<p>B1, B3, B4, H1, M1 are located at unrelated stream direction (neither upstream nor downstream, far away) to the works location, exceedances of these monitoring stations are deemed to be unrelated to the Project.</p> <p>CR2 is located close to the works location within the Project site while no marine work was conducted on 29 Nov 2021.</p> <p>The installation of caisson No.19 was completed on 18 Mar 2021, the reclamation area was enclosed.</p> <p>According to the field observation by sampling team during sampling event, no silt plume was observed in the Project site and the weather was fine during the sampling event.</p> <p>No major observation of improper site practices that could contribute to the increase of the suspended solids was recorded during the weekly inspection on 02 Nov 2021.</p> <p>After the investigation, the exceedances on 29 Nov 2021 at B1, B3, B4, H1, M1 and CR2 are deemed to be unrelated to the Project.</p>

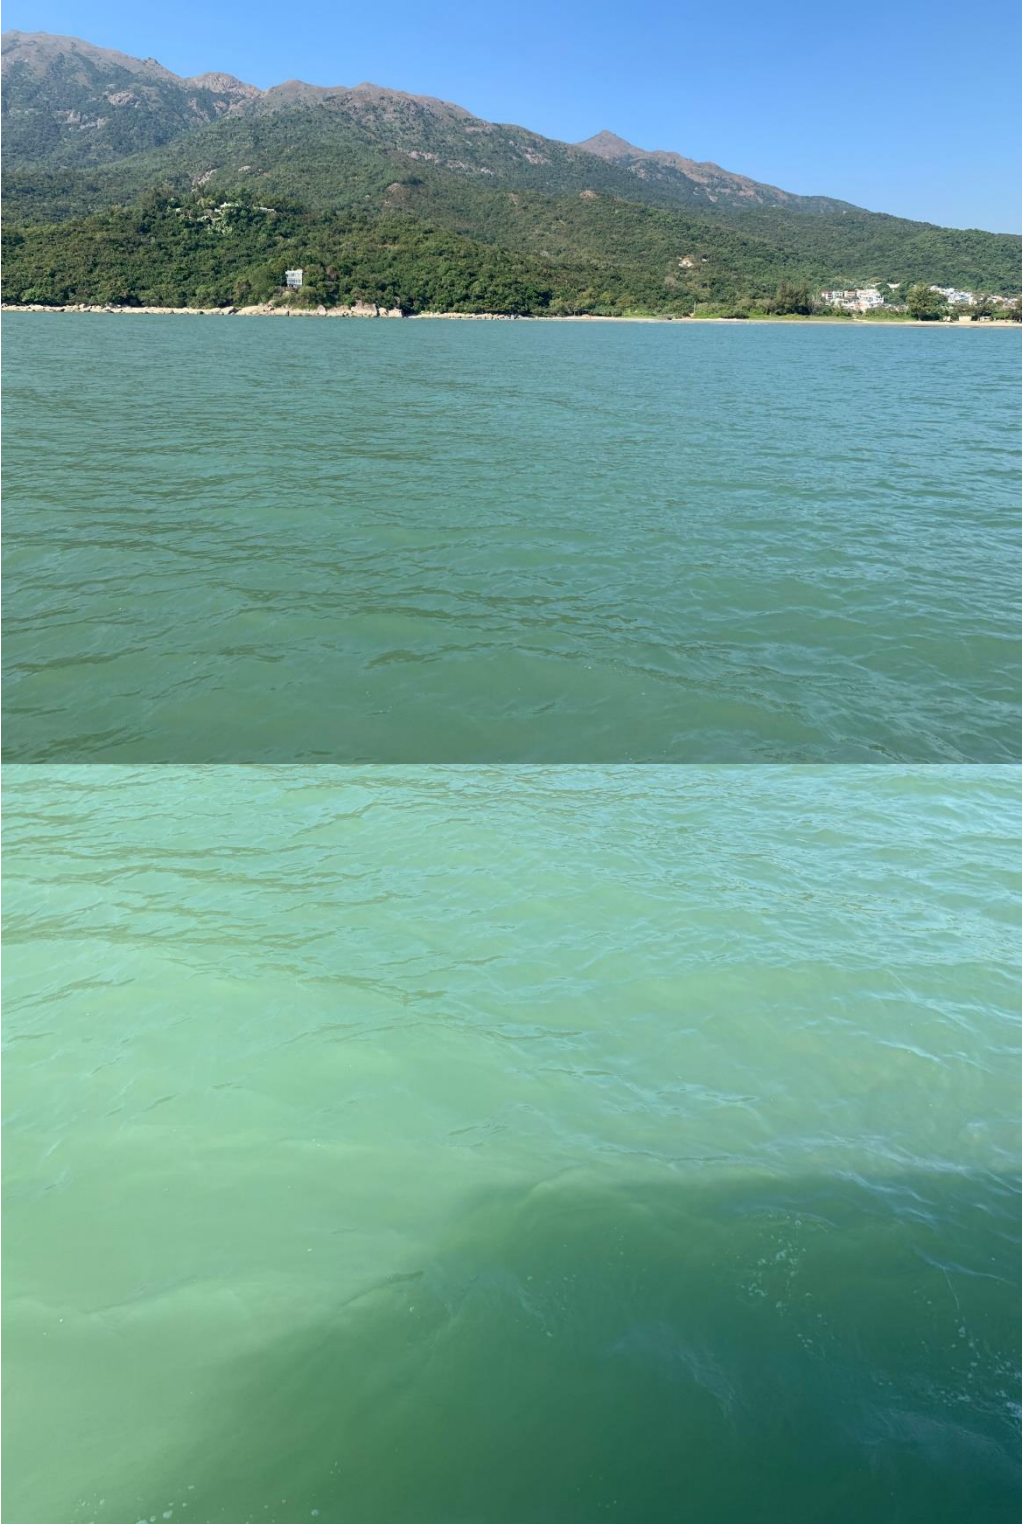
<p>Parameter</p>	<p>Suspended Solid (SS)</p>		
<p>Action & Limit Levels</p>	<p>Action Level $\geq 11.0 \text{ mg/L (120\% of C2A)}$</p>		<p>Limit Level $\geq 11.9 \text{ mg/L (130\% of C2A)}$</p>
<p>Measurement Level</p>	<p>Impact Station(s) of Exceedance</p> <p>16.5 mg/L (B2) 11.5 mg/L (B3) 12.5 mg/L (B4) 12.0 mg/L (H1)</p>	<p>Control Stations</p> <p>16.5 mg/L (C1A) 9.2 mg/L (C2A)</p>	<p>Impact Station(s) without Exceedance</p> <p>10.0 mg/L (B1) 8.3 mg/L (F1A) 9.5 mg/L (M1) 10.3 mg/L (CR1) 9.5 mg/L (CR2)</p>
<p>Possible reason for Action or Limit Level Non-compliance</p>	<p>Works scheduled on site on 29 Nov 2021 include installation of blockwork for marine access facility, landfilling works for below +6.00mPD, landfilling works for above +6.00mPD, installation of instrumentation, piling pre-drilling works, piling works, piling works for driven pile, piling works for pre-bored socketed H-pile and existing caisson extension and armour scour protection.</p> <p>Dominating sea current direction was found to be from Southeast to Northwest at waters around Shek Kwu Chau.</p> <p>Exceedance of action level was found at B3 and exceedances of limit level were found at B2, B4 and H1.</p> <p>B2, B3, B4, H1 are located at unrelated stream direction (neither upstream nor downstream, far away) to the works location, exceedances of these monitoring stations are deemed to be unrelated to the Project.</p> <p>The installation of caisson No.19 was completed on 18 Mar 2021, the reclamation area was enclosed.</p>
