Appendix N Exceedance Report

Incident Report on Action Level or Limit Level Non-compliance

Project	Integrated Waste Management Facilities, Phase 1		
Date	03 Feb 2022 (Lab result received on 10 Feb 2022)		
Time	12:25 – 15:55 (Mid-Ebb) 08:00 – 10:15 (Mid-Flood)		
Mid-Ebb			
Monitoring Location	<p>H1</p>		
Parameter	Suspended Solid (SS)		
Action & Limit Levels	Action Level		Limit Level
	≥ 17.8 mg/L (C1A of 120%)		≥ 19.3 mg/L (C1A of 130%)
Measurement Level	Impact Station(s) of Exceedance	Measurement Level	Impact Station(s) without Exceedance

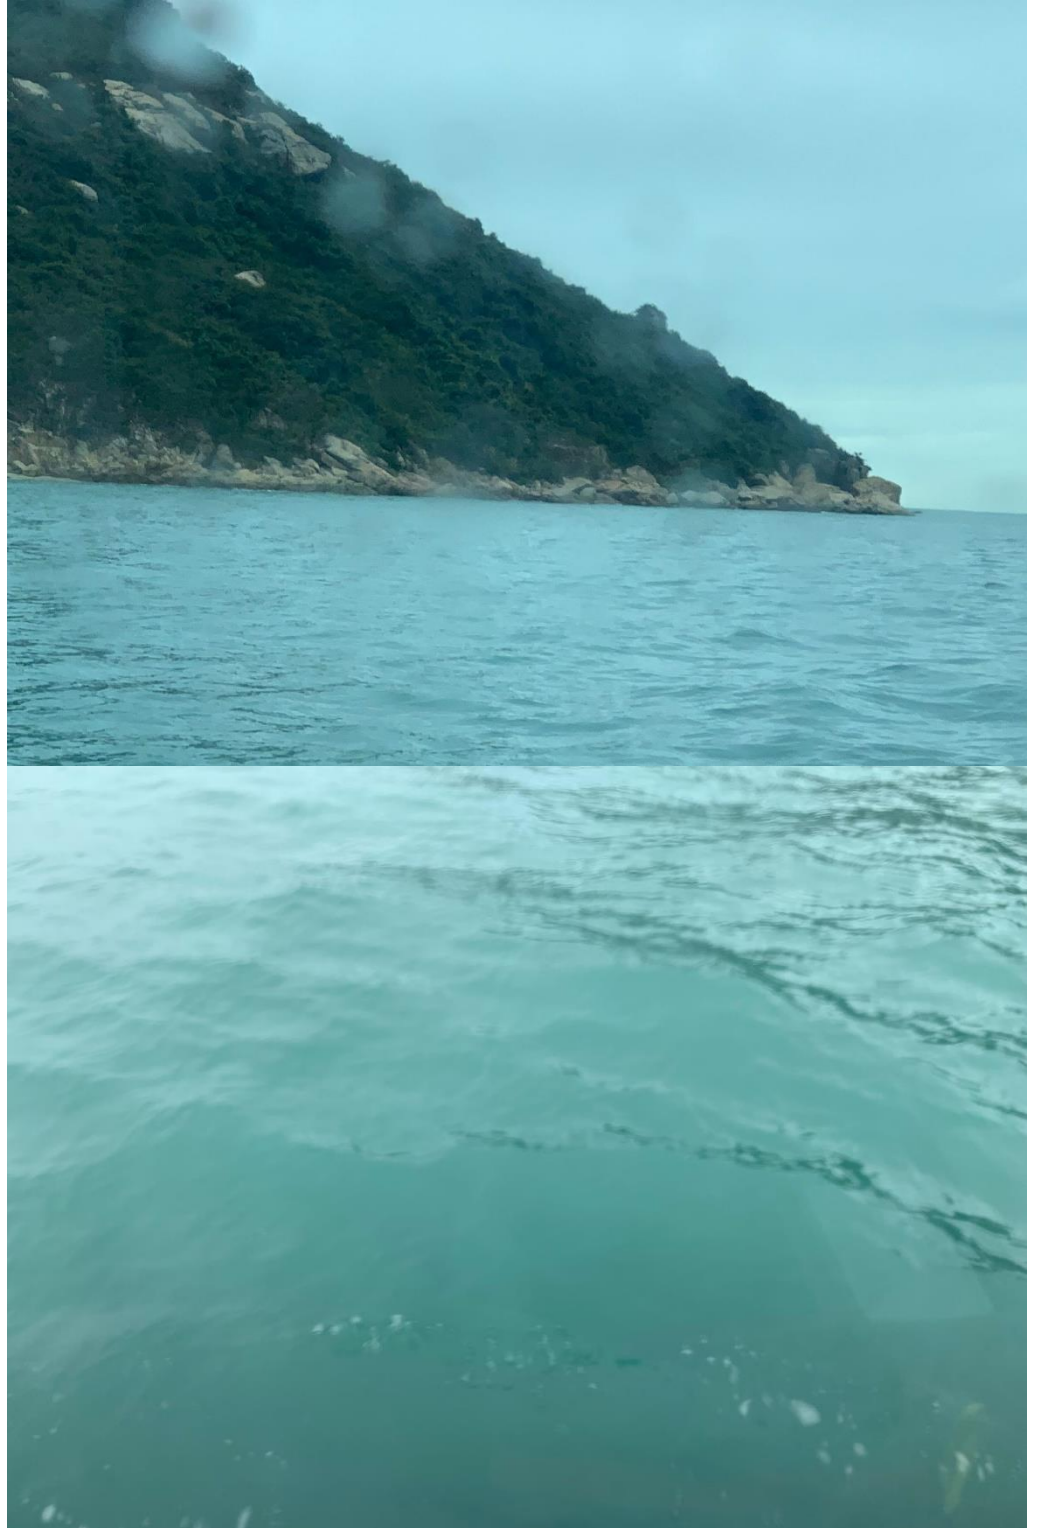
H1:

18.0 mg/L (H1)	14.8 mg/L (C1A) 16.0 mg/L (C2A)	14.5 mg/L (B1) 10.0 mg/L (B2) 13.3 mg/L (B3) 12.3 mg/L (B4) 12.3 mg/L (M1) 14.8 mg/L (F1A) 9.3 mg/L (CR1) 12.3 mg/L (CR2)
Possible reason for Action or Limit Level Non-compliance	<p>No site activity was recorded on 03 February 2022 due to public holiday (Chinese New Year Holiday).</p> <p>Dominant sea current direction was found to be from Northwest to Southeast at waters around Shek Kwu Chau.</p> <p>An exceedance of action level was found at H1.</p> <p>H1 is located at unrelated stream direction (neither upstream nor downstream) to the works location. The exceedance is deemed to be unrelated to the Project.</p>

<p>The installation of caisson No.19 was completed on 18 Mar 2021, the reclamation area was enclosed.</p> <p>According to the field observation by sampling team during sampling event, no silt plume was observed in the Project site and the weather was overcast during the sampling event.</p> <p>No major observation of improper site practices that contributed to the increase of the suspended solids was recorded during the weekly inspection on 31 Jan 2022.</p> <p>After the investigation, the exceedance on 03 Feb 2022 at H1 is deemed to be unrelated to the Project.</p>
--	--

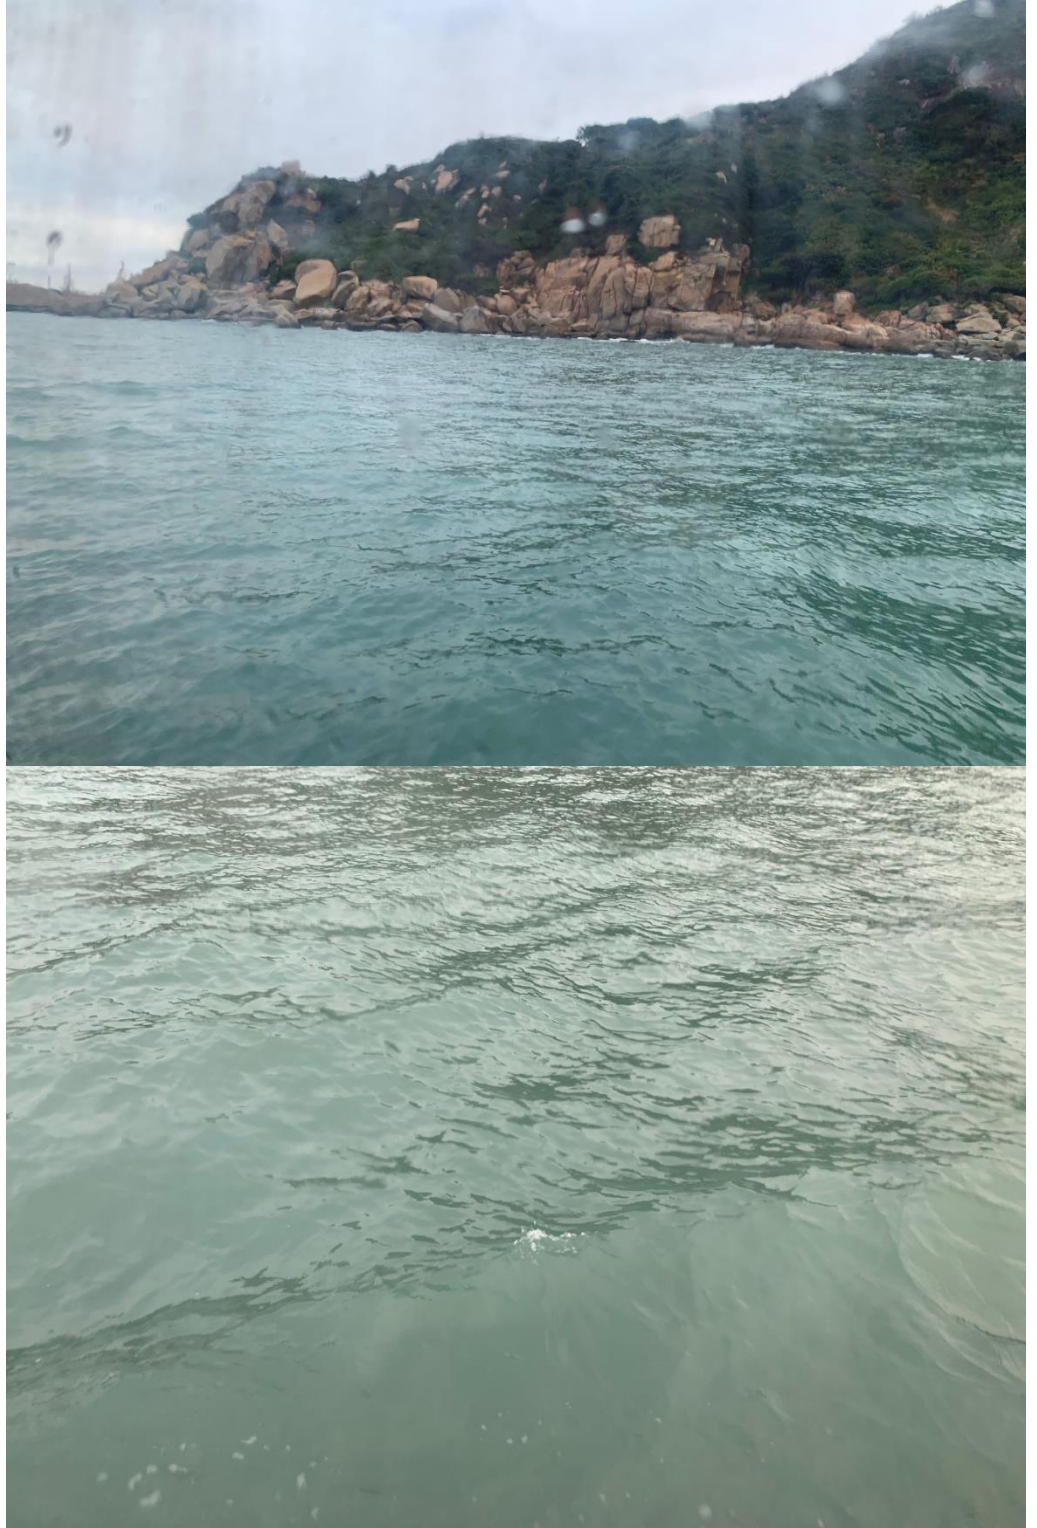
CR1:

<p>Possible reason for Action or Limit Level Non-compliance</p>	<p>No site activity was recorded 03 February 2022 due to public holiday (Chinese New Year Holiday).</p> <p>Dominant sea current direction was found to be from Southeast to Northwest at waters around Shek Kwu Chau.</p> <p>An exceedance of action level was found at CR1.</p> <p>CR1 is located close to the works location within the Project site while no marine work was conducted on 03 Feb 2022.</p> <p>The installation of caisson No.19 was completed on 18 Mar 2021, the reclamation area was enclosed.</p> <p>According to the field observation by sampling team during sampling event, no silt plume was observed in the Project site and the weather was overcast during the sampling event.</p>

<p>No major observation of improper site practices that contributed to the increase of the suspended solids was recorded during the weekly inspection on 31 Jan 2022.</p> <p>After the investigation, the exceedance on 03 Feb 2022 at CR1 is deemed to be unrelated to the Project.</p>
--	--

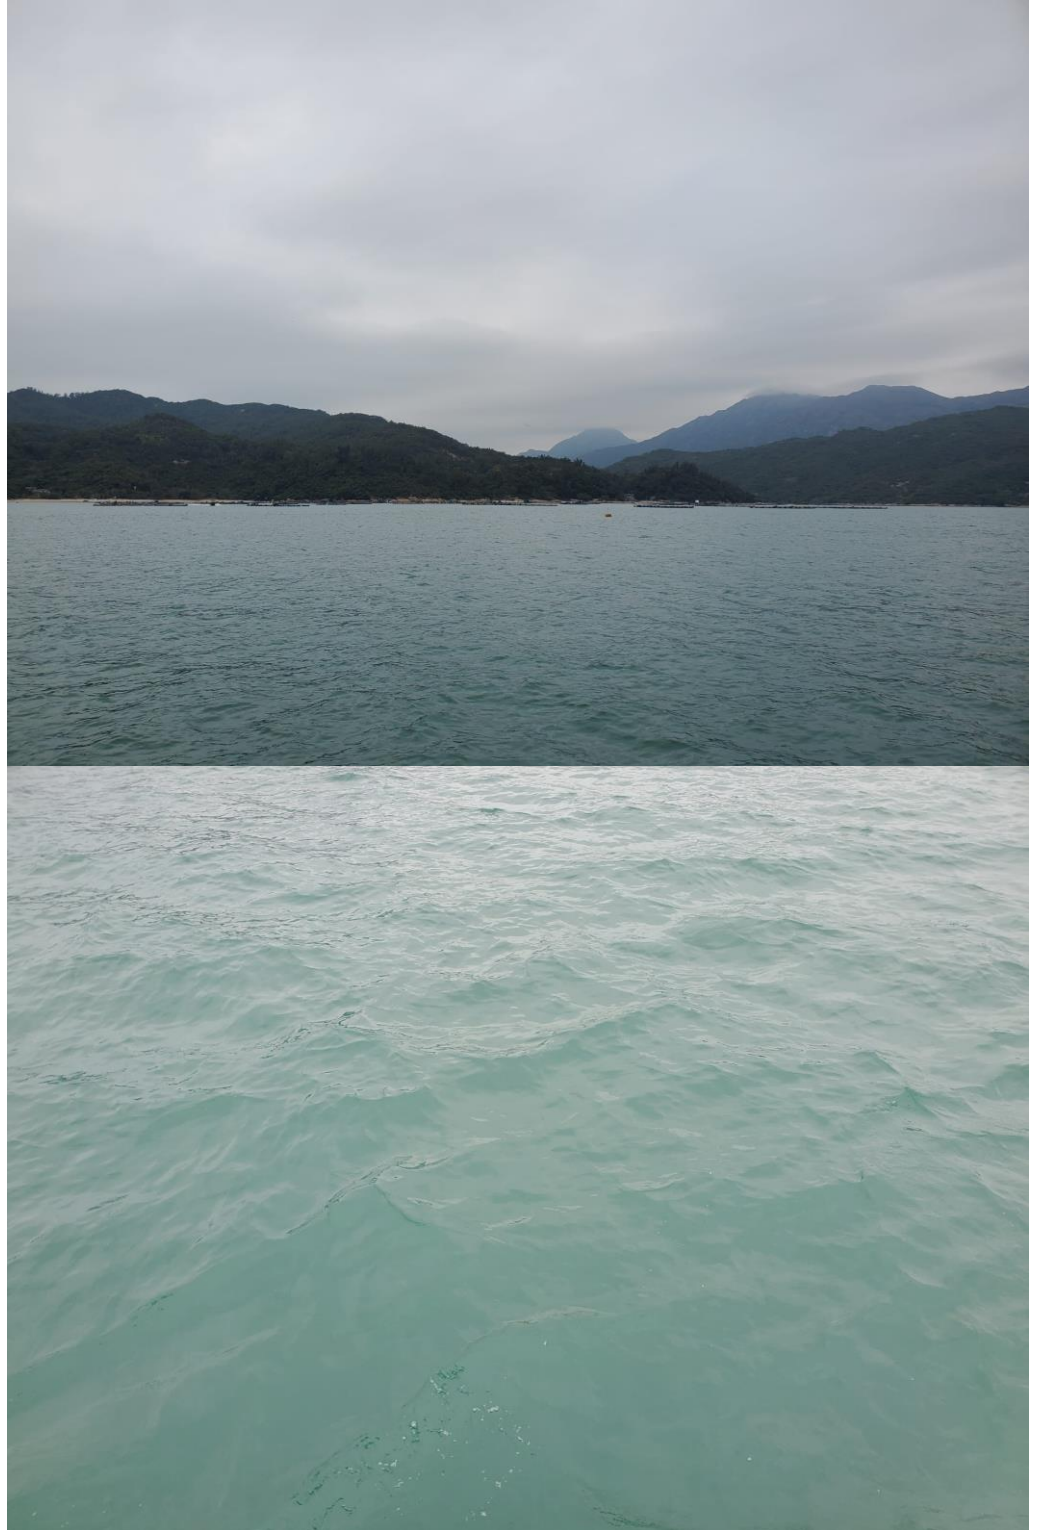
F1A:

10.2 mg/L (F1A)	9.2 mg/L (C1A) 8.3 mg/L (C2A)	8.3 mg/L (B1) 5.0 mg/L (B2) 4.3 mg/L (B3) 3.3 mg/L (B4) 6.8 mg/L (H1) 5.5 mg/L (M1) 6.0 mg/L (CR1) 4.5 mg/L (CR2)
Possible reason for Action or Limit Level Non-compliance	<p>Works scheduled on site on 05 Feb 2022 include infilling of caisson, laying armour rock at Breakwater B CH 220 – CH 230, leveling of underlayer rock at Caisson 52, installation of blockwork for marine access facility, landfilling works for below +6.00mPD, landfilling works for above +6.00mPD, piling pre-drilling works, piling works, piling works for pre-bored socketed H-pile, blockwork seawall and existing caisson extension.</p> <p>Dominant sea current direction was found to be from Southeast to Northwest at waters around Shek Kwu Chau.</p> <p>An exceedance of action level was found at F1A.</p>

<p>F1A is located at unrelated stream direction (neither upstream nor downstream, far away) to the works location. The exceedance at this monitoring station is deemed to be unrelated to the Project.</p> <p>The installation of caisson No.19 was completed on 18 Mar 2021, the reclamation area was enclosed.</p> <p>According to the field observation by sampling team during sampling event, no silt plume was observed in the Project site and the weather was overcast during the sampling event.</p> <p>No major observation of improper site practices that contributed to the increase of the suspended solids was recorded during the weekly inspection on 31 Jan and 08 Feb 2022.</p> <p>After the investigation, the exceedance on 05 Feb 2022 at F1A is deemed to be unrelated to the Project.</p>
--	---

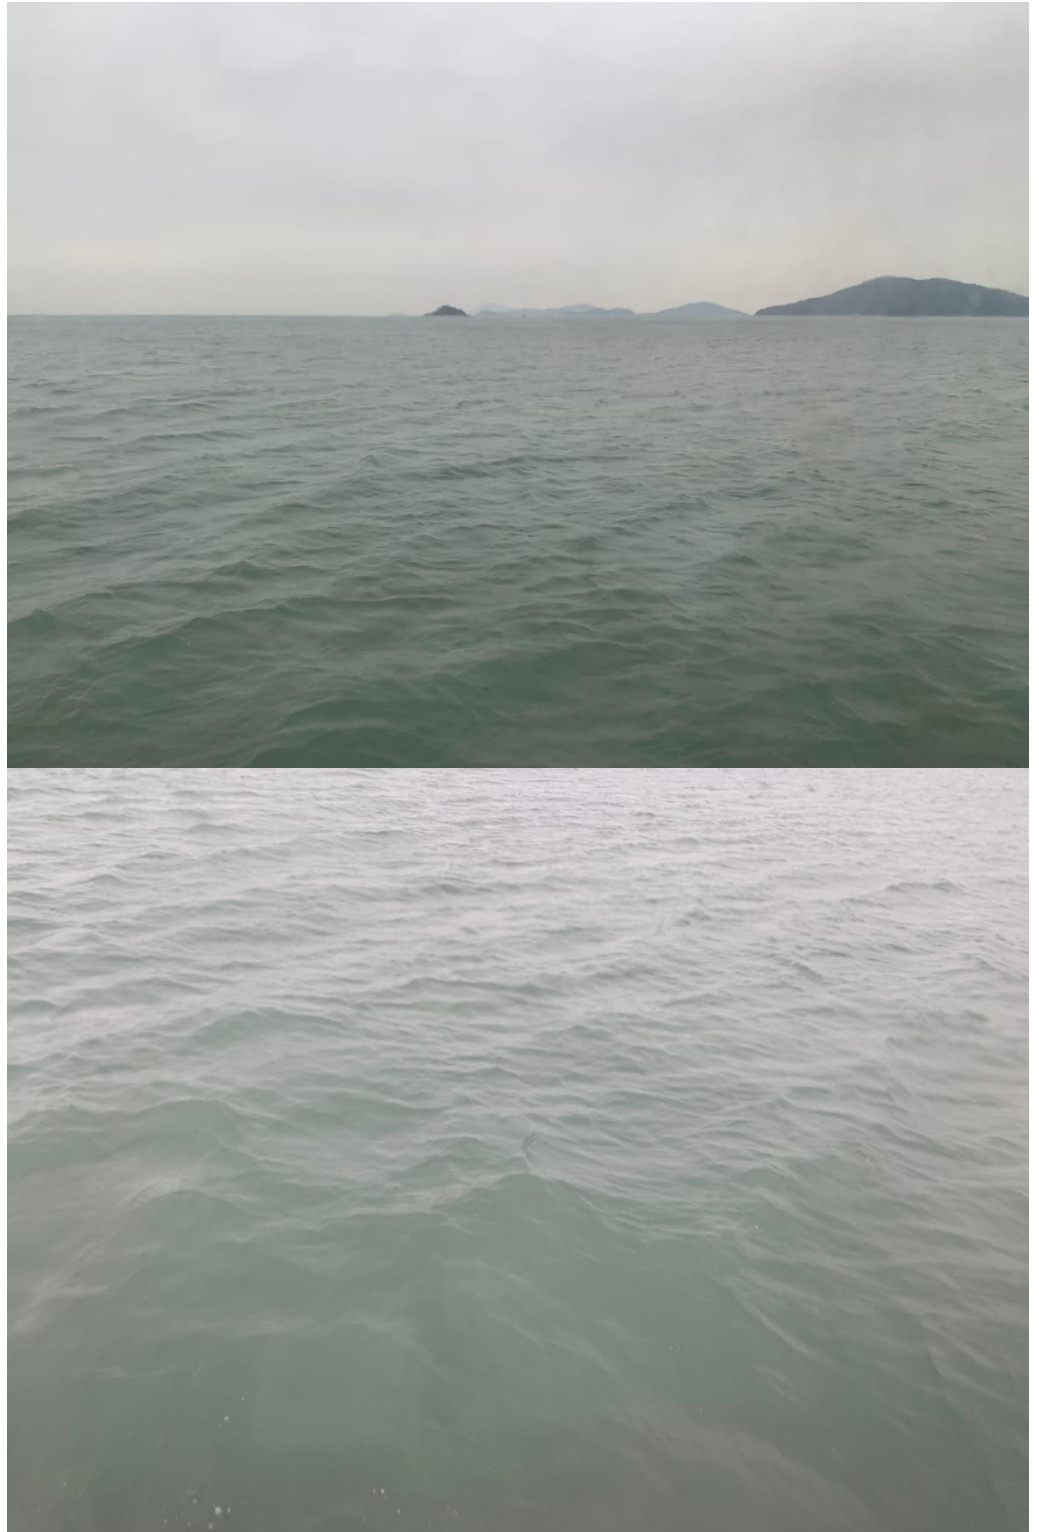
B1:

8.5 mg/L (B1)	5.3 mg/L (C1A) 6.5 mg/L (C2A)	5.0 mg/L (B2) 6.0 mg/L (B3) 5.3 mg/L (B4) 7.8 mg/L (M1) 6.2 mg/L (H1) 5.5 mg/L (F1A) 5.5 mg/L (CR1) 7.0 mg/L (CR2)
Possible reason for Action or Limit Level Non-compliance	<p>Works scheduled on site on 09 Feb 2022 include infilling of caisson, leveling of armour rock at Caisson A2 / A3, inspection works of underlayer rock at Caisson 52, installation of blockwork for marine access facility, landfilling works for below +6.00mPD, landfilling works for above +6.00mPD, piling pre-drilling works, piling works, piling works for driven pile, piling works for pre-bored socketed H-pile, blockwork seawall and existing caisson extension.</p> <p>Dominant sea current direction was found to be from Northwest to Southeast at waters around Shek Kwu Chau.</p> <p>An exceedance of action level was found at B1.</p>

<p>B1 is located at unrelated stream direction (neither upstream nor downstream, far away) to the works location. The exceedances are deemed to be unrelated to the Project.</p> <p>The installation of caisson No.19 was completed on 18 Mar 2021, the reclamation area was enclosed.</p> <p>According to the field observation by sampling team during sampling event, no silt plume was observed in the Project site and the weather was overcast during the sampling event.</p> <p>No major observation of improper site practices that contributed to the increase of the suspended solids was recorded during the weekly inspection on 08 Feb and 17 Feb 2022.</p> <p>After the investigation, the exceedance on 09 Feb 2022 at B1 is deemed to be unrelated to the Project.</p>
--	--

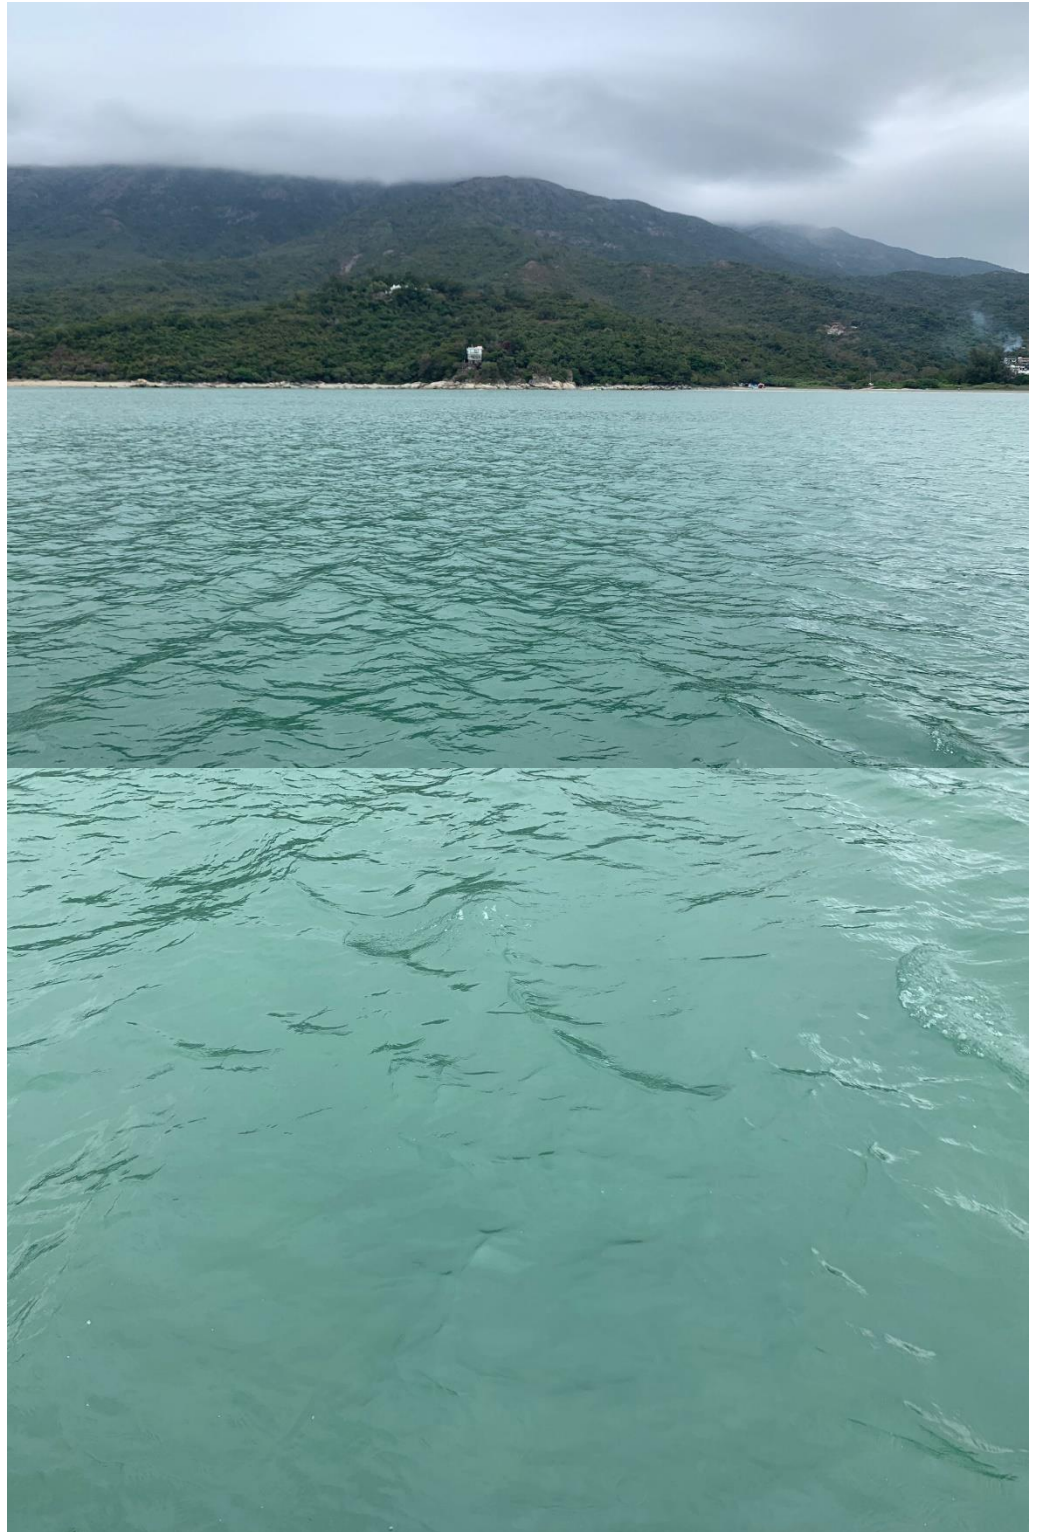
B2:

10.3 mg/L (B2) 9.0 mg/L (M1)	3.8 mg/L (C1A) 4.5 mg/L (C2A)	7.8 mg/L (B1) 6.3 mg/L (B3) 5.8 mg/L (B4) 4.3 mg/L (F1A) 5.0 mg/L (H1) 7.0 mg/L (CR1) 6.3 mg/L (CR2)
Possible reason for Action or Limit Level Non-compliance	<p>Works scheduled on site on 09 Feb 2022 include infilling of caisson, leveling of armour rock at Caisson A2 / A3, inspection works of underlayer rock at Caisson 52, installation of blockwork for marine access facility, landfilling works for below +6.00mPD, landfilling works for above +6.00mPD, piling pre-drilling works, piling works, piling works for driven pile, piling works for pre-bored socketed H-pile, blockwork seawall and existing caisson extension.</p> <p>Dominant sea current direction was found to be from Southeast to Northwest at waters around Shek Kwu Chau.</p> <p>An exceedance of action level was found at M1 and an exceedance of limit level was found at B2.</p> <p>B2 and M1 are located at unrelated stream direction (neither upstream nor downstream, far away) to the works location. The exceedances are deemed to be unrelated to the Project.</p> <p>The installation of caisson No.19 was completed on 18 Mar 2021, the reclamation area was enclosed.</p>

<p>According to the field observation by sampling team during sampling event, no silt plume was observed in the Project site and the weather was overcast during the sampling event.</p> <p>No major observation of improper site practices that contributed to the increase of the suspended solids was recorded during the weekly inspection on 08 Feb and 17 Feb 2022.</p> <p>After the investigation, the exceedances on 09 Feb 2022 at B2 and M1 are deemed to be unrelated to the Project.</p>
--	--

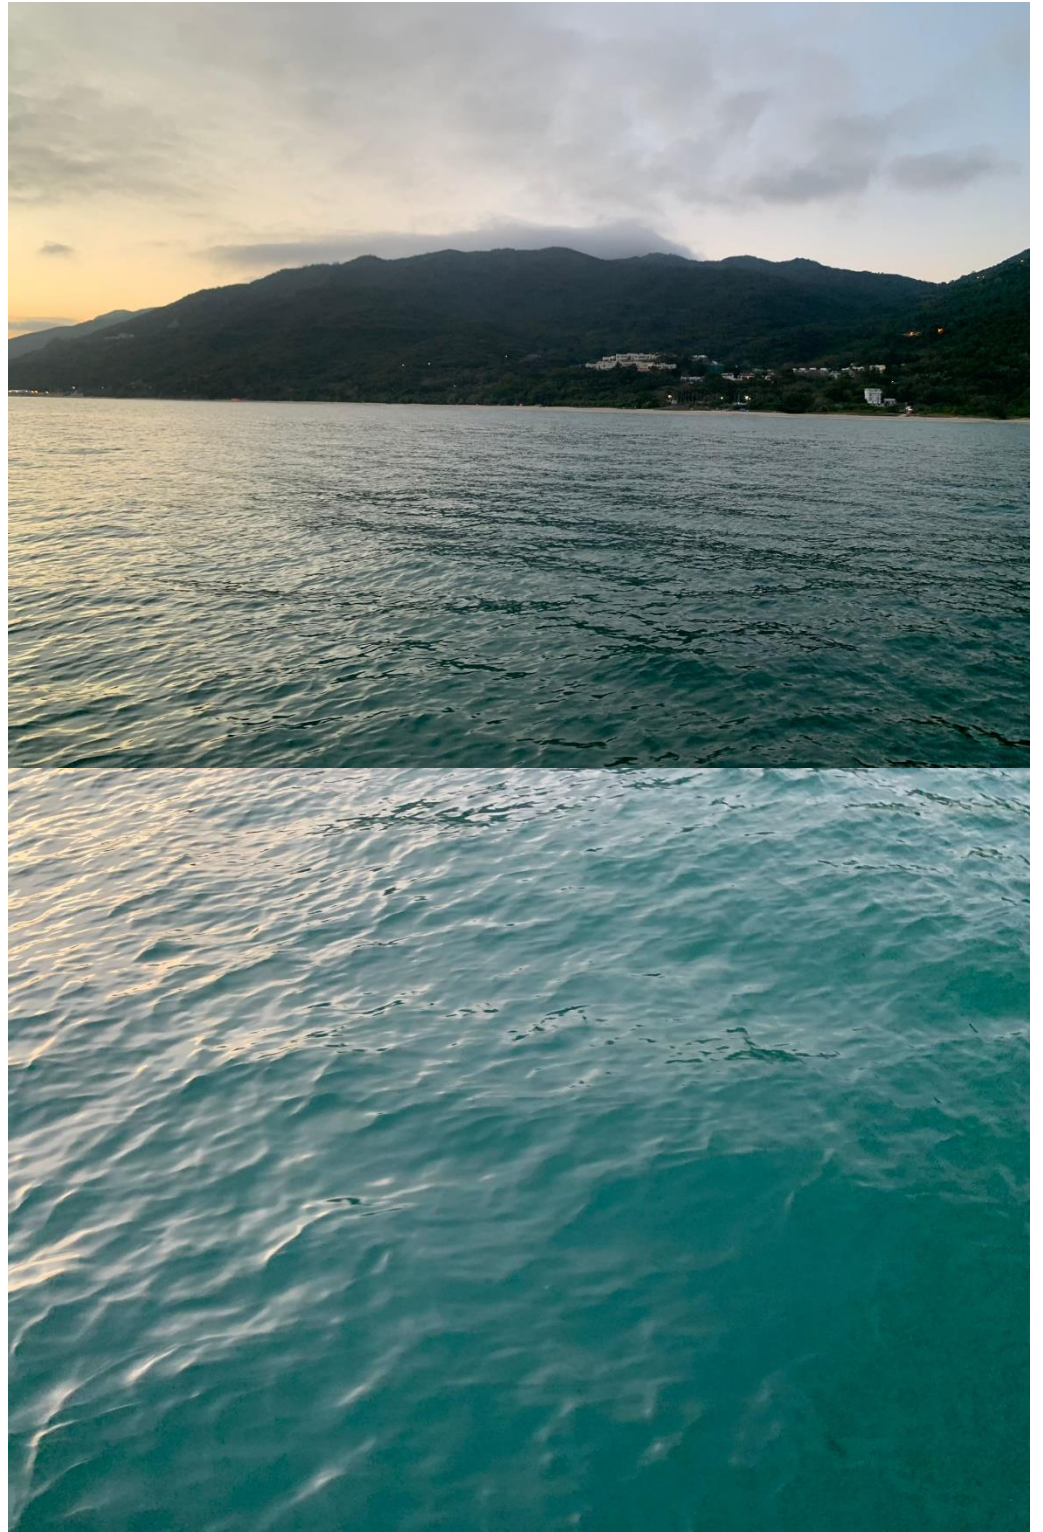
B1:

9.5 mg/L (B1) 8.5 mg/L (B4) 10.0 mg/L (M1) 8.2 mg/L (CR1) 10.7 mg/L (CR2)	5.7 mg/L (C1A) 5.2 mg/L (C2A)	5.8 mg/L (B2) 6.5 mg/L (B3) 6.0 mg/L (H1) 6.0 mg/L (F1A)
Possible reason for Action or Limit Level Non-compliance	<p>Works scheduled on site on 11 Feb 2022 include infilling of caisson, caisson installation, leveling of underlayer rock at Breakwater A CH1000 – CH1050, landfilling works for below +6.00mPD, landfilling works for above +6.00mPD, piling pre-drilling works, piling works, piling works for driven pile, piling works for pre-bored socketed H-pile, blockwork seawall and existing caisson extension.</p> <p>Dominant sea current direction was found to be from Northwest to Southeast at waters around Shek Kwu Chau.</p> <p>Exceedances of action level were found at B1, B4 and CR1; exceedances of limit level were found at M1 and CR2.</p> <p>B1, B4 and M1 are located at unrelated stream direction (neither upstream nor downstream, far away) to the works location. Exceedances are deemed to be unrelated to the Project.</p>

<p>CR1 and CR2 are located close to the works location within the Project site while no marine work was conducted on 11 Feb 2022.</p> <p>The installation of caisson No.19 was completed on 18 Mar 2021, the reclamation area was enclosed.</p> <p>According to the field observation by sampling team during sampling event, no silt plume was observed in the Project site and the weather was fine during the sampling event.</p> <p>No major observation of improper site practices that contributed to the increase of the suspended solids was recorded during the weekly inspection on 08 Feb and 17 Feb 2022.</p> <p>After the investigation, the exceedances on 11 Feb 2022 at B1, B4, M1, CR1 and CR2 are deemed to be unrelated to the Project.</p>
--	--

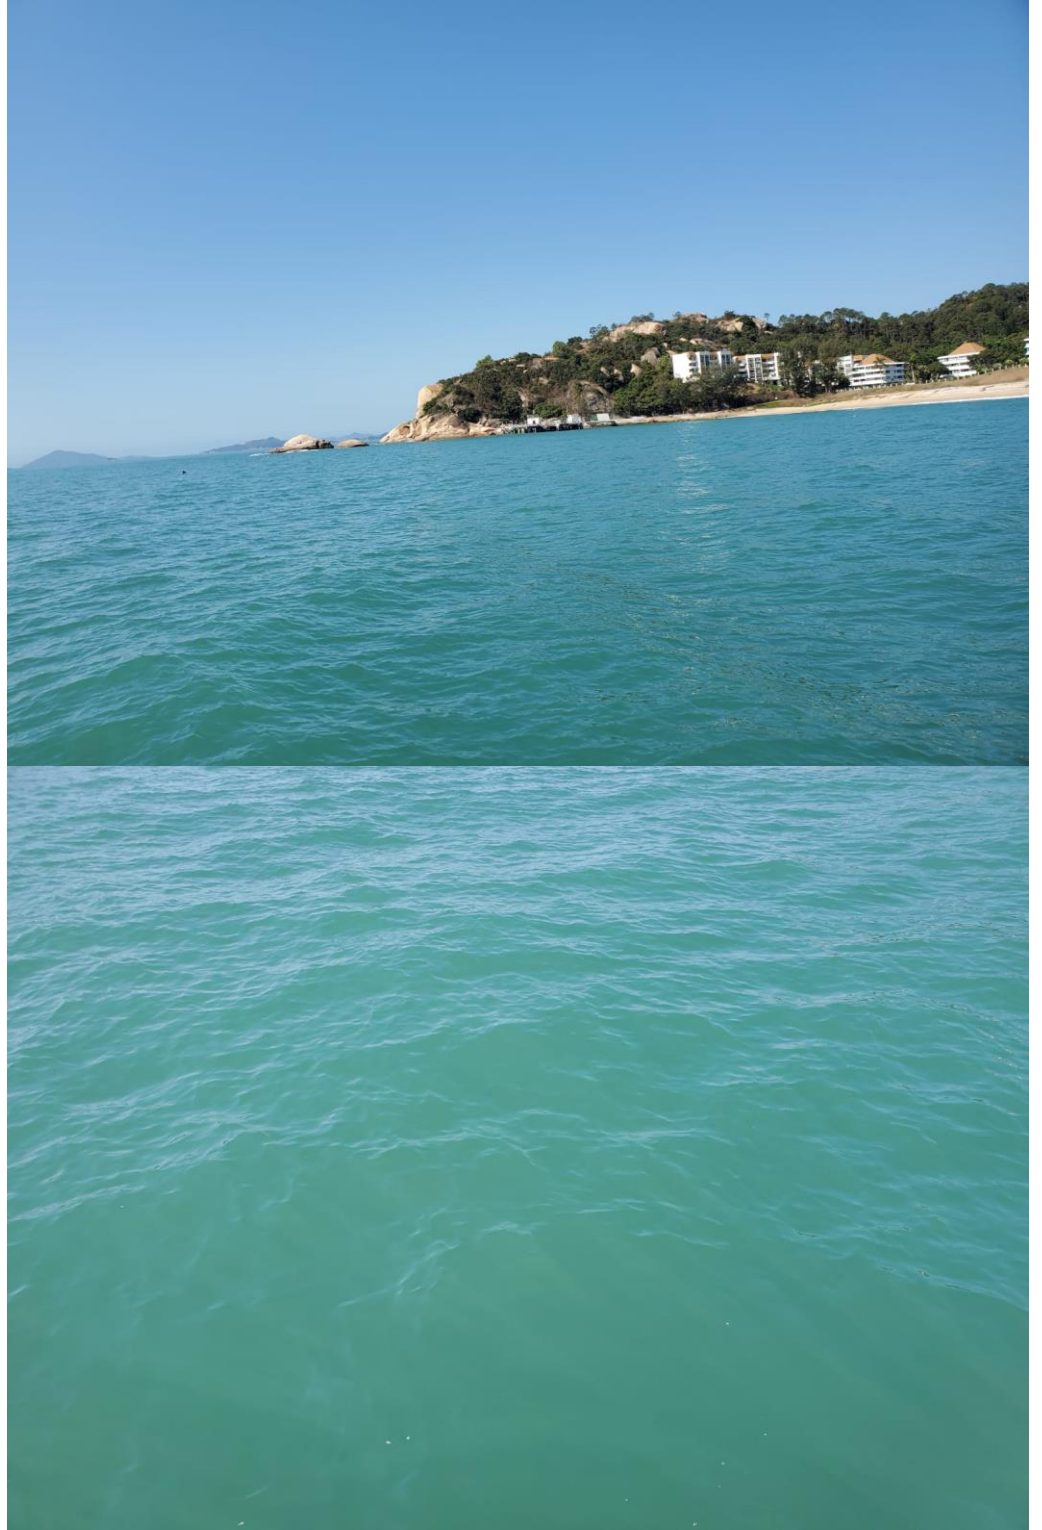
B3:

<p>An exceedance of action level was found at B3 and an exceedance of limit level was found at M1.</p> <p>B3 and M1 are located at unrelated stream direction (neither upstream nor downstream, far away) to the works location. The exceedances are deemed to be unrelated to the Project.</p> <p>The installation of caisson No.19 was completed on 18 Mar 2021, the reclamation area was enclosed.</p> <p>According to the field observation by sampling team during sampling event, no silt plume was observed in the Project site and the weather was fine during the sampling event.</p> <p>No major observation of improper site practices that contributed to the increase of the suspended solids was recorded during the weekly inspection on 08 Feb and 17 Feb 2022.</p> <p>After the investigation, the exceedances on 11 Feb 2022 at B3 and M1 are deemed to be unrelated to the Project.</p>
--	--

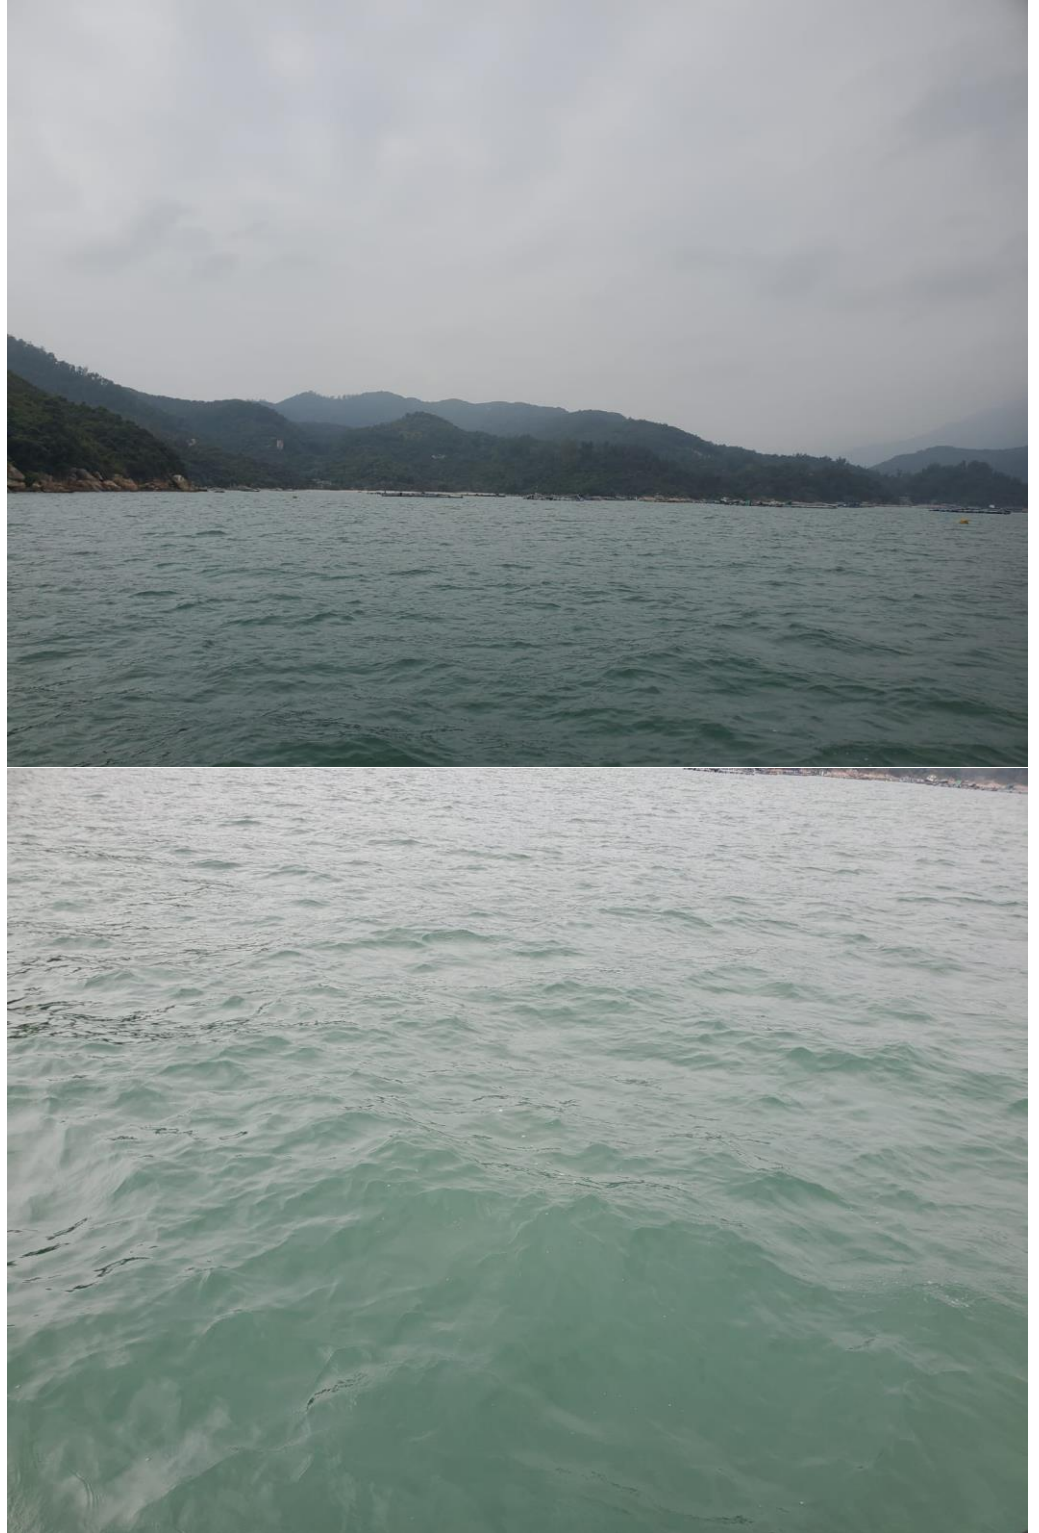
F1A:

26.0 mg/L (F1A) 18.2 mg/L (M1) 19.2 mg/L (CR1)	12.2 mg/L (C1A) 20.8 mg/L (C2A)	12.3 mg/L (B1) 13.5 mg/L (B2) 12.5 mg/L (B3) 11.3 mg/L (B4) 14.5 mg/L (H1) 13.8 mg/L (CR2)
Possible reason for Action or Limit Level Non-compliance	<p>Works scheduled on site on 16 Feb 2022 include infilling of caisson, installation of concrete blocks at Seawall B Caissons 8 and 9, leveling of scour apron at Breakwater A CH780 - CH 810, landfilling works for below +6.00mPD, landfilling works for above +6.00mPD, piling pre-drilling works, piling works, piling works for driven pile, piling works for pre-bored socketed H-pile, blockwork seawall and existing caisson extension.</p> <p>Dominant sea current direction was found to be from Northwest to Southeast at waters around Shek Kwu Chau.</p> <p>Exceedances of limit level were found at F1A, M1 and CR1.</p>

<p>F1A and M1 are located at unrelated stream direction (neither upstream nor downstream, far away) to the works location. Exceedances at these monitoring stations are deemed to be unrelated to the Project.</p> <p>CR1 is located close to the works location within the Project site while no marine work was conducted on 16 Feb 2022.</p> <p>The installation of caisson No.19 was completed on 18 Mar 2021, the reclamation area was enclosed.</p> <p>According to the field observation by sampling team during sampling event, no silt plume was observed in the Project site and the weather was fine during the sampling event.</p> <p>No major observation of improper site practices that contributed to the increase of the suspended solids was recorded during the weekly inspection on 17 Feb 2022.</p> <p>After the investigation, the exceedances on 16 Feb 2022 at F1A, M1 and CR1 are deemed to be unrelated to the Project.</p>

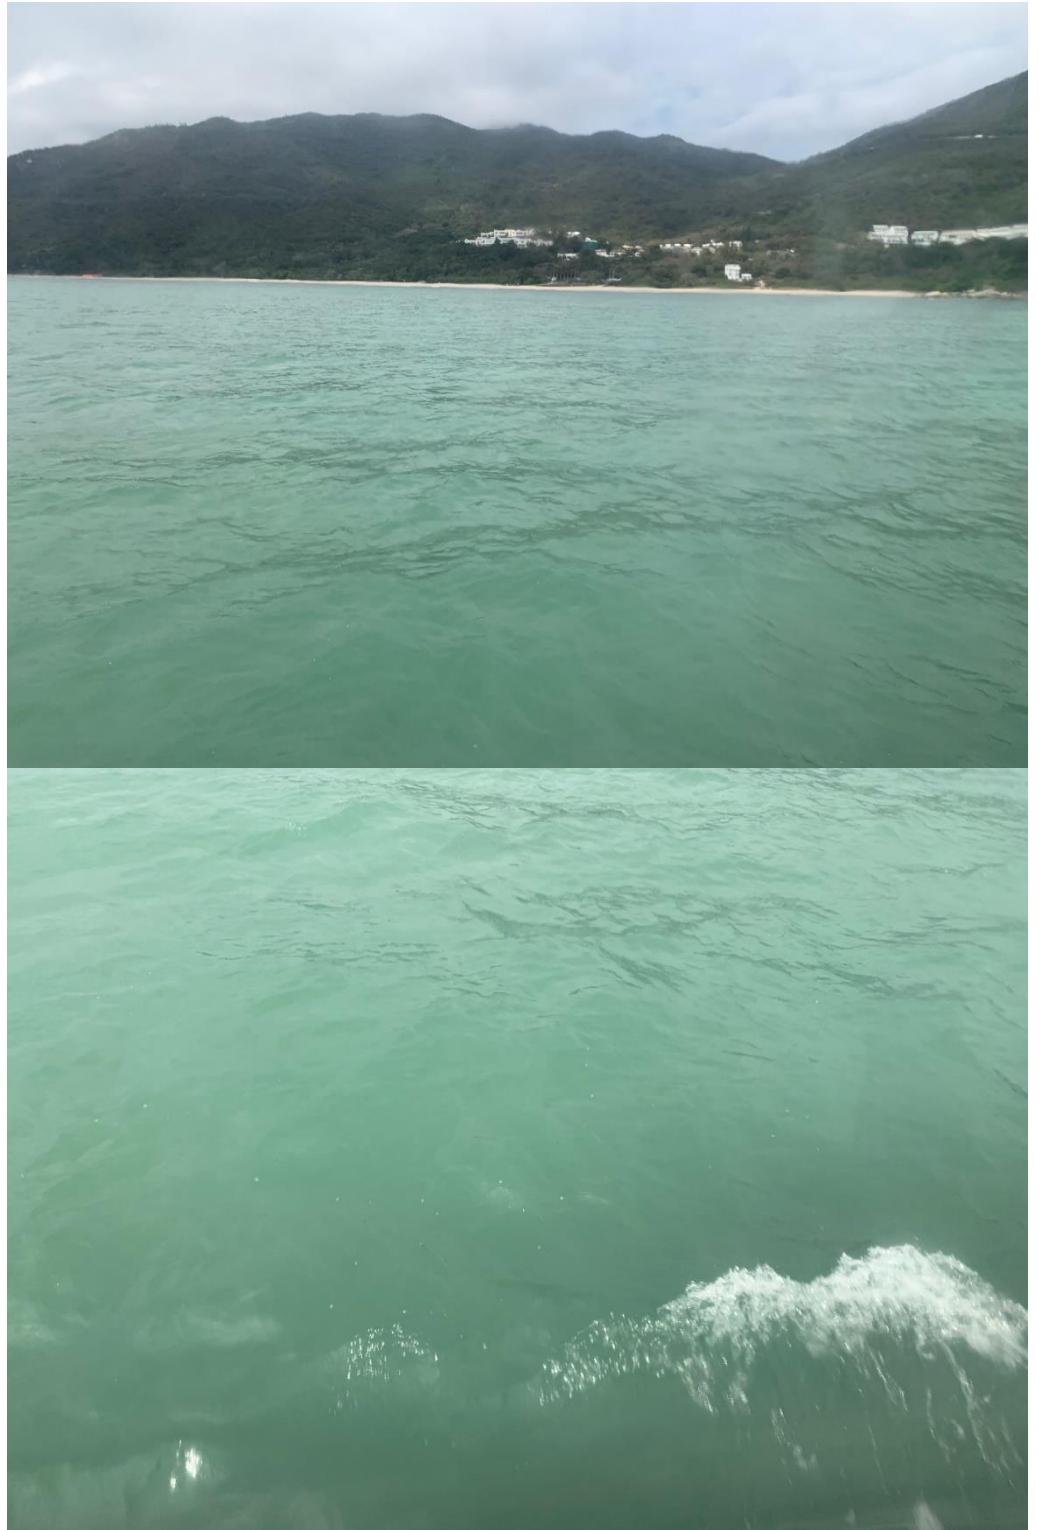
B1:

10.8 mg/L (B1) 15.0 mg/L (B4) 13.5 mg/L (H1)	6.5 mg/L (C1A) 6.7 mg/L (C2A)	6.5 mg/L (B2) 5.0 mg/L (B3) 5.3 mg/L (F1A) 6.2 mg/L (M1) 6.0 mg/L (CR1) 5.8 mg/L (CR2)
Possible reason for Action or Limit Level Non-compliance	Works scheduled on site on 18 Feb 2022 include installation of concrete blocks at Seawall B Caisson 9, inspection works for underlayer rock at Caisson 53K, landfilling works for below +6.00mPD, landfilling works for above +6.00mPD, piling pre-drilling works, piling works, piling works for driven pile, piling works for pre-bored socketed H-pile, blockwork seawall and existing caisson extension. Dominant sea current direction was found to be from Northwest to Southeast at waters around Shek Kwu Chau. Exceedances of Limit level were found at B1, B4 and H1.

<p>B1, B4 and H1 are located at unrelated stream direction (neither upstream nor downstream, far away) to the works location. Exceedances are deemed to be unrelated to the Project.</p> <p>The installation of caisson No.19 was completed on 18 Mar 2021, the reclamation area was enclosed.</p> <p>According to the field observation by sampling team during sampling event, no silt plume was observed in the Project site and the weather was cloudy during the sampling event.</p> <p>No major observation of improper site practices that contributed to the increase of the suspended solids was recorded during the weekly inspection on 17 Feb and 23 Feb 2022.</p> <p>After the investigation, the exceedances on 18 Feb 2022 at B1, B4 and H1 are deemed to be unrelated to the Project.</p>
--	---

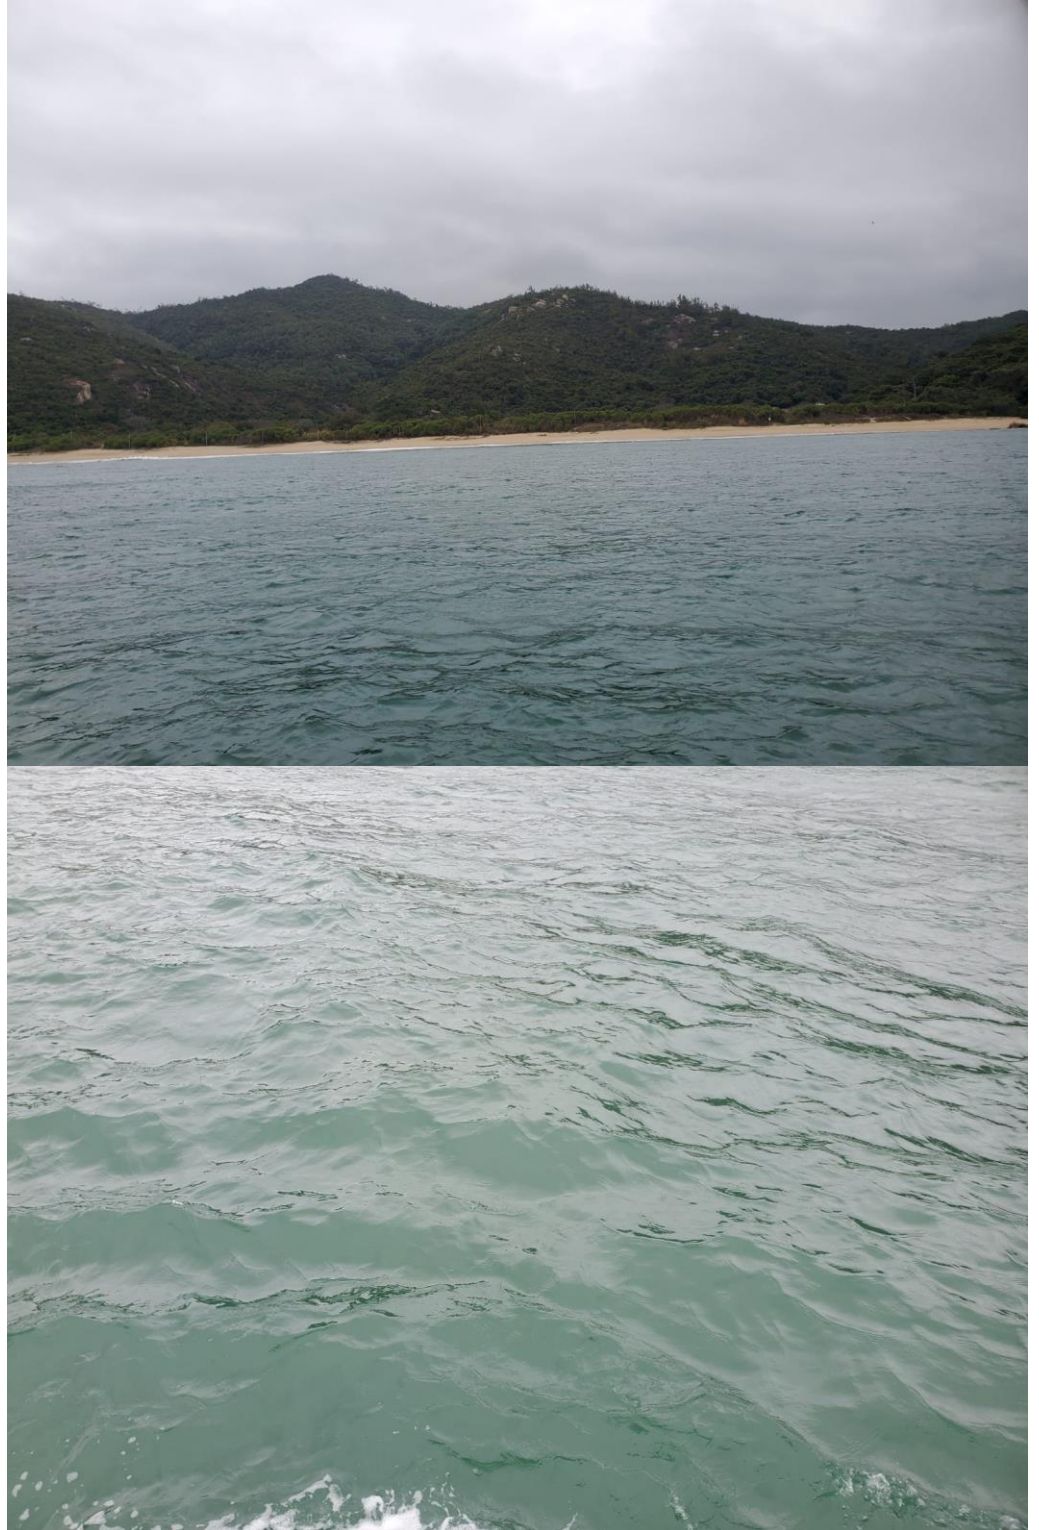
B4:

8.8 mg/L (B4) 15.3 mg/L (H1) 12.8 mg/L (M1) 11.8 mg/L (CR2)	17.2 mg/L (C1A) 6.5 mg/L (C2A)	5.3 mg/L (B1) 6.3 mg/L (B2) 5.5 mg/L (B3) 6.2 mg/L (F1A) 7.3 mg/L (CR1)
Possible reason for Action or Limit Level Non-compliance	<p>Works scheduled on site on 18 Feb 2022 include installation of concrete blocks at Seawall B Caisson 9, inspection works for underlayer rock at Caisson 53K, landfilling works for below +6.00mPD, landfilling works for above +6.00mPD, piling pre-drilling works, piling works, piling works for driven pile, piling works for pre-bored socketed H-pile, blockwork seawall and existing caisson extension.</p> <p>Dominant sea current direction was found to be from Southeast to Northwest at waters around Shek Kwu Chau.</p> <p>An exceedance of action level was found at B4 and exceedances of limit level were found at H1, M1 and CR2.</p> <p>B4, H1 and M1 are located at unrelated stream direction (neither upstream nor downstream, far away) to the works location. The exceedances are deemed to be unrelated to the Project.</p> <p>CR2 is located close to the works location within the Project site while no marine work was conducted on 18 Feb 2022.</p> <p>The installation of caisson No.19 was completed on 18 Mar 2021, the reclamation area was enclosed.</p>

<p>According to the field observation by sampling team during sampling event, no silt plume was observed in the Project site and the weather was fine during the sampling event.</p> <p>No major observation of improper site practices that contributed to the increase of the suspended solids was recorded during the weekly inspection on 17 Feb and 23 Feb 2022.</p> <p>After the investigation, the exceedances on 18 Feb 2022 at B4, H1, M1 and CR2 are deemed to be unrelated to the Project.</p>
--	---

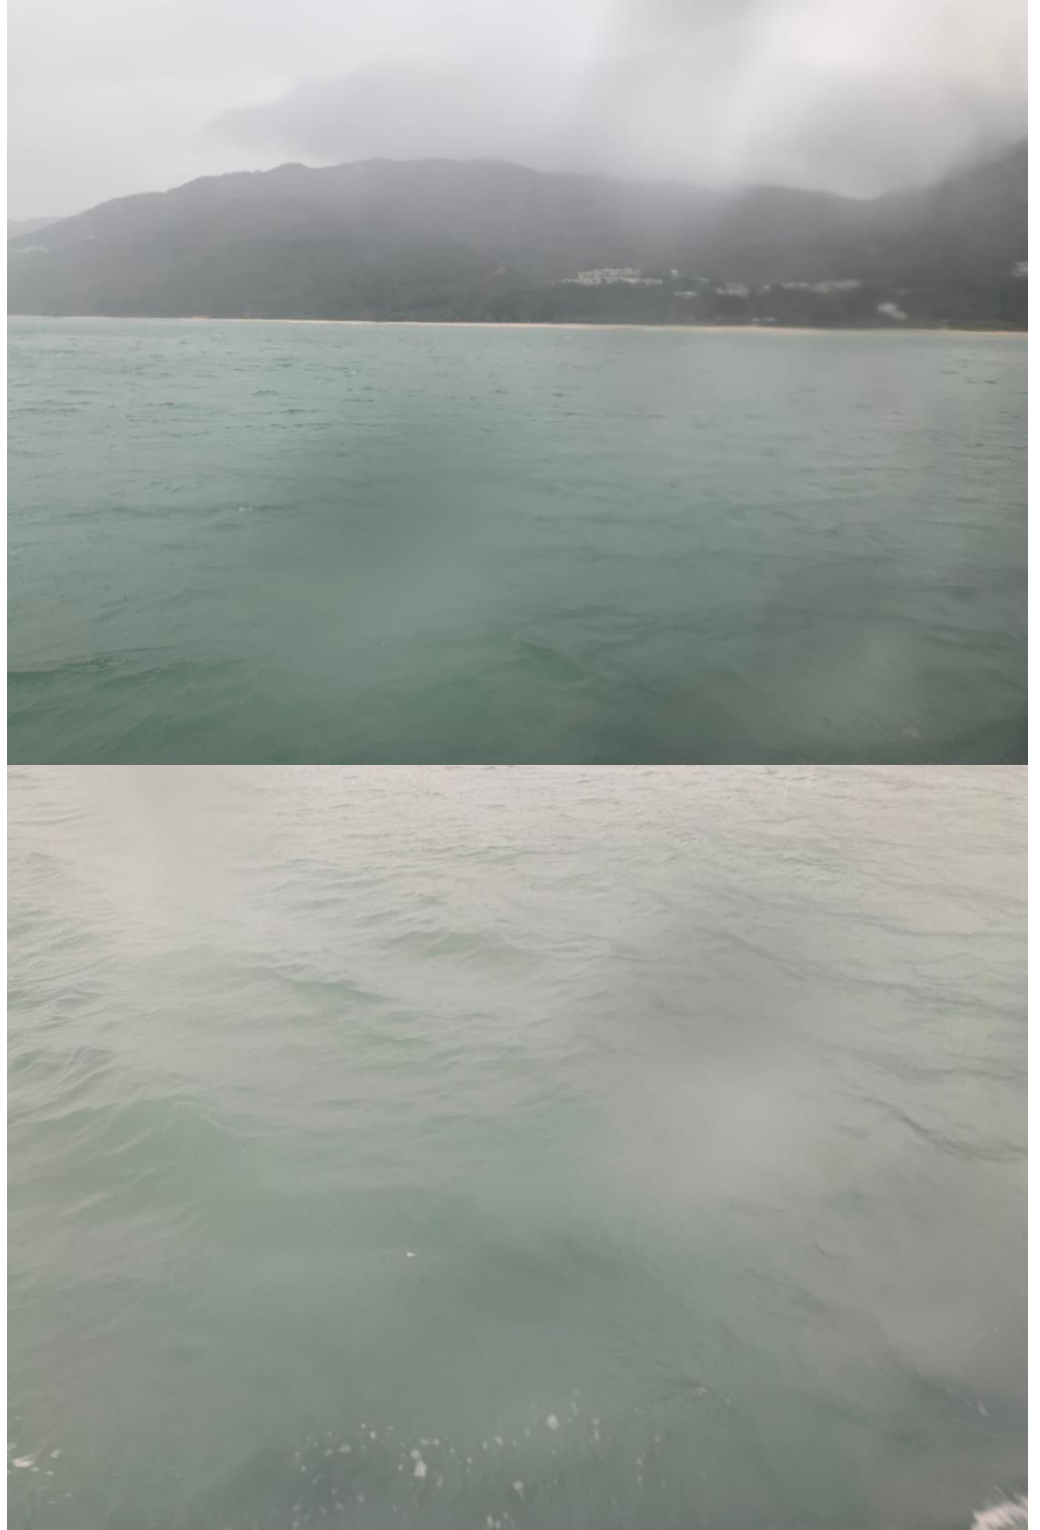
B1:

20.3 mg/L (B1) 21.3 mg/L (B2) 23.0 mg/L (B3) 30.5 mg/L (B4) 22.3 mg/L (H1) 20.3 mg/L (CR2)	16.5 mg/L (C1A) 16.3 mg/L (C2A)	15.0 mg/L (F1A) 16.3 mg/L (M1) 16.0 mg/L (CR1)
Possible reason for Action or Limit Level Non-compliance	<p>Works scheduled on site on 21 Feb 2022 include infilling of caisson, received armour and underlayer rockfill from barge 振東 988, installation of caissons, piling pre-drilling works, piling works, piling works for driven pile, piling works for pre-bored socketed H-pile, blockwork seawall and existing caisson extension.</p> <p>Dominant sea current direction was found to be from Southeast to Northwest at waters around Shek Kwu Chau.</p> <p>Exceedances of action level were found at B1 and CR2; exceedances of limit level were found at B2, B3, B4 and H1.</p> <p>B1, B2, B3, B4 and H1 are located at unrelated stream direction (neither upstream nor downstream, far away) to the works location. Exceedances are deemed to be unrelated to the Project.</p>

<p>CR2 is located close to the works location within the Project site while no marine work was conducted on 21 Feb 2022.</p> <p>The installation of caisson No.19 was completed on 18 Mar 2021, the reclamation area was enclosed.</p> <p>According to the field observation by sampling team during sampling event, no silt plume was observed in the Project site and the weather was rainy during the sampling event.</p> <p>No major observation of improper site practices that contributed to the increase of the suspended solids was recorded during the weekly inspection on 23 Feb 2022.</p> <p>After the investigation, the exceedances on 21 Feb 2022 at B1, B2, B3, B4, H1 and CR2 are deemed to be unrelated to the Project.</p>
--	--
