Appendix N Exceedance Report

Incident Report on Action Level or Limit Level Non-compliance

Project	Integrated Waste Management Facilities, Phase 1		
Date	03 Feb 2022 (Lab result received on 10 Feb 2022)		
Time	12:25 – 15:55 (Mid-Ebb) 08:00 – 10:15 (Mid-Flood)		
Mid-Ebb			
Monitoring Location	<p>H1</p>		
Parameter	Suspended Solid (SS)		
Action & Limit Levels	Action Level		Limit Level
	≥ 17.8 mg/L (C1A of 120%)		≥ 19.3 mg/L (C1A of 130%)
Measurement Level	Impact Station(s) of Exceedance	Measurement Level	Impact Station(s) without Exceedance

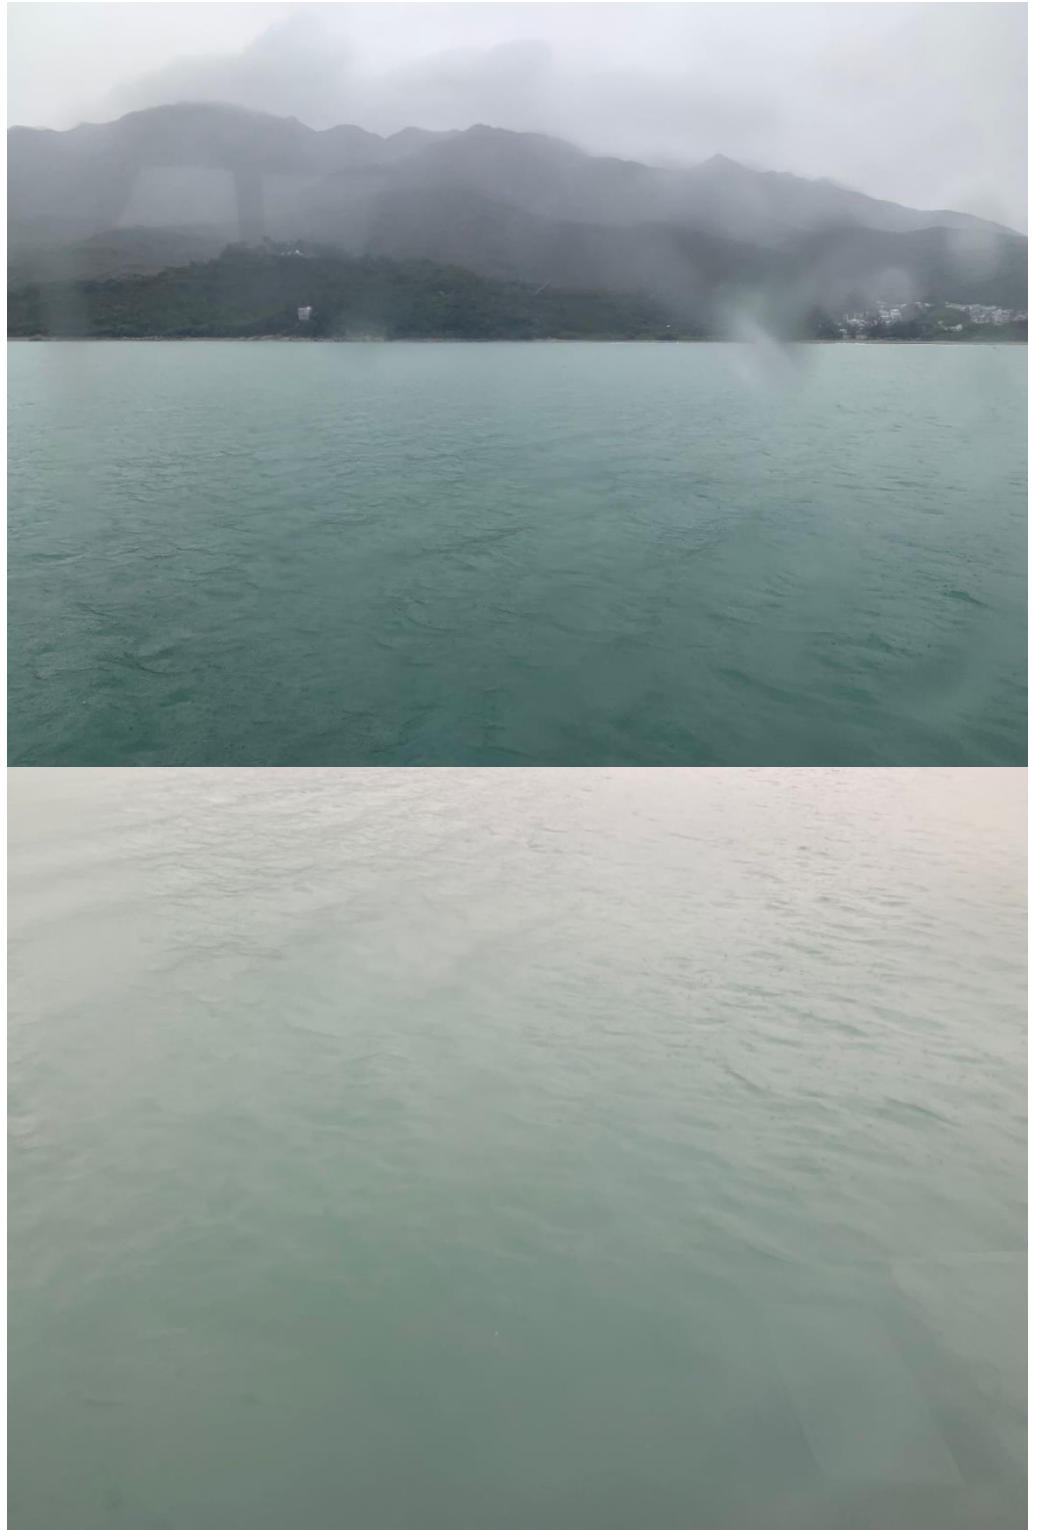
B2:

20.3 mg/L (B1) 21.3 mg/L (B2) 23.0 mg/L (B3) 30.5 mg/L (B4) 22.3 mg/L (H1) 20.3 mg/L (CR2)	16.5 mg/L (C1A) 16.3 mg/L (C2A)	15.0 mg/L (F1A) 16.3 mg/L (M1) 16.0 mg/L (CR1)
Possible reason for Action or Limit Level Non-compliance	<p>Works scheduled on site on 21 Feb 2022 include infilling of caisson, received armour and underlayer rockfill from barge 振東 988, installation of caissons, piling pre-drilling works, piling works, piling works for driven pile, piling works for pre-bored socketed H-pile, blockwork seawall and existing caisson extension.</p> <p>Dominant sea current direction was found to be from Southeast to Northwest at waters around Shek Kwu Chau.</p> <p>Exceedances of action level were found at B1 and CR2; exceedances of limit level were found at B2, B3, B4 and H1.</p> <p>B1, B2, B3, B4 and H1 are located at unrelated stream direction (neither upstream nor downstream, far away) to the works location. Exceedances are deemed to be unrelated to the Project.</p>

<p>CR2 is located close to the works location within the Project site while no marine work was conducted on 21 Feb 2022.</p> <p>The installation of caisson No.19 was completed on 18 Mar 2021, the reclamation area was enclosed.</p> <p>According to the field observation by sampling team during sampling event, no silt plume was observed in the Project site and the weather was rainy during the sampling event.</p> <p>No major observation of improper site practices that contributed to the increase of the suspended solids was recorded during the weekly inspection on 23 Feb 2022.</p> <p>After the investigation, the exceedances on 21 Feb 2022 at B1, B2, B3, B4, H1 and CR2 are deemed to be unrelated to the Project.</p>
--	--

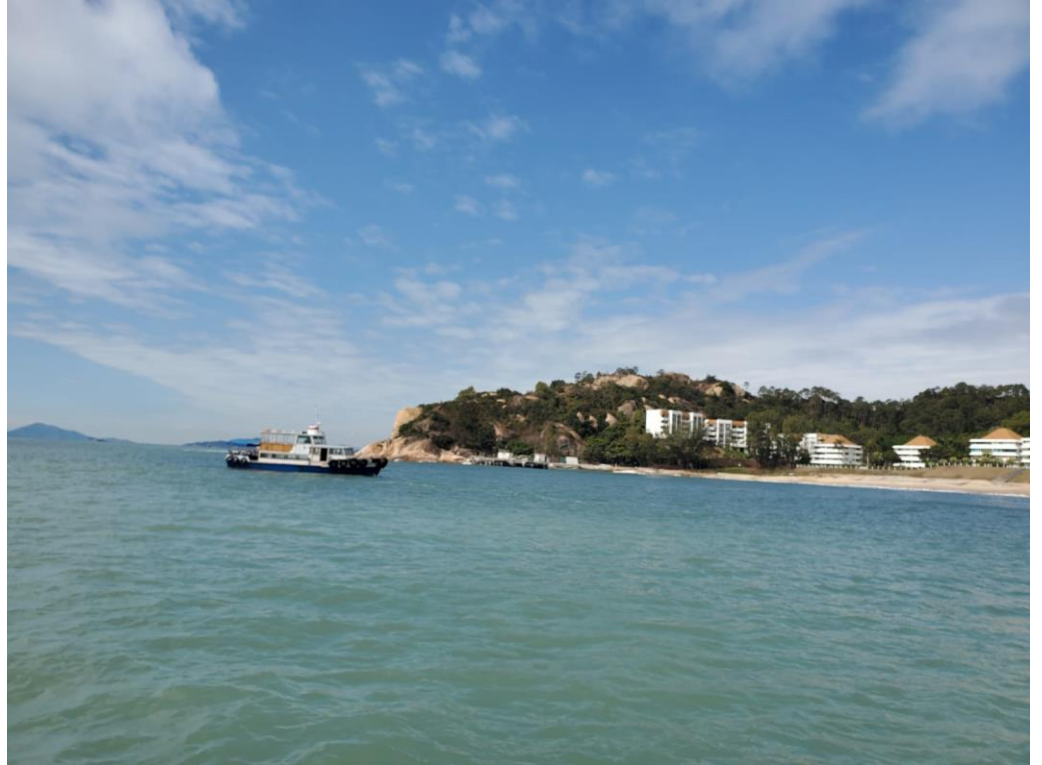
B3:

15.0 mg/L (B3) 13.8 mg/L (B4) 13.7 mg/L (F1A) 13.5 mg/L (CR1)	15.0 mg/L (C1A) 10.7 mg/L (C2A)	11.3 mg/L (B1) 8.8 mg/L (B2) 9.3 mg/L (M1) 10.2 mg/L (H1) 11.2 mg/L (CR2)
Possible reason for Action or Limit Level Non-compliance	<p>Works scheduled on site on 23 Feb 2022 include infilling of caisson, received armour and underlayer rockfill from Barge 振東 988, installation of caissons, landfilling works for below +6.00mPD, landfilling works for above +6.00mPD, piling pre-drilling works, piling works, piling works for driven pile, piling works for pre-bored socketed H-pile, blockwork seawall and existing caisson extension.</p> <p>Dominant sea current direction was found to be from Southeast to Northwest at waters around Shek Kwu Chau.</p> <p>Exceedances of action level were found at B4, F1A and CR1 and an exceedance of limit level was found at B3.</p> <p>B3, B4 and F1A are located at unrelated stream direction (neither upstream nor downstream, far away) to the works location. Exceedances are deemed to be unrelated to the Project.</p>

<p>CR1 is located close to the works location within the Project site while no marine work was conducted on 23 Feb 2022.</p> <p>The installation of caisson No.19 was completed on 18 Mar 2021, the reclamation area was enclosed.</p> <p>According to the field observation by sampling team during sampling event, no silt plume was observed in the Project site and the weather was fine during the sampling event.</p> <p>No major observation of improper site practices that contributed to the increase of the suspended solids was recorded during the weekly inspection on 23 Feb 2022.</p> <p>After the investigation, the exceedances on 23 Feb 2022 at B3, B4, F1A and CR1 are deemed to be unrelated to the Project.</p>
--	--

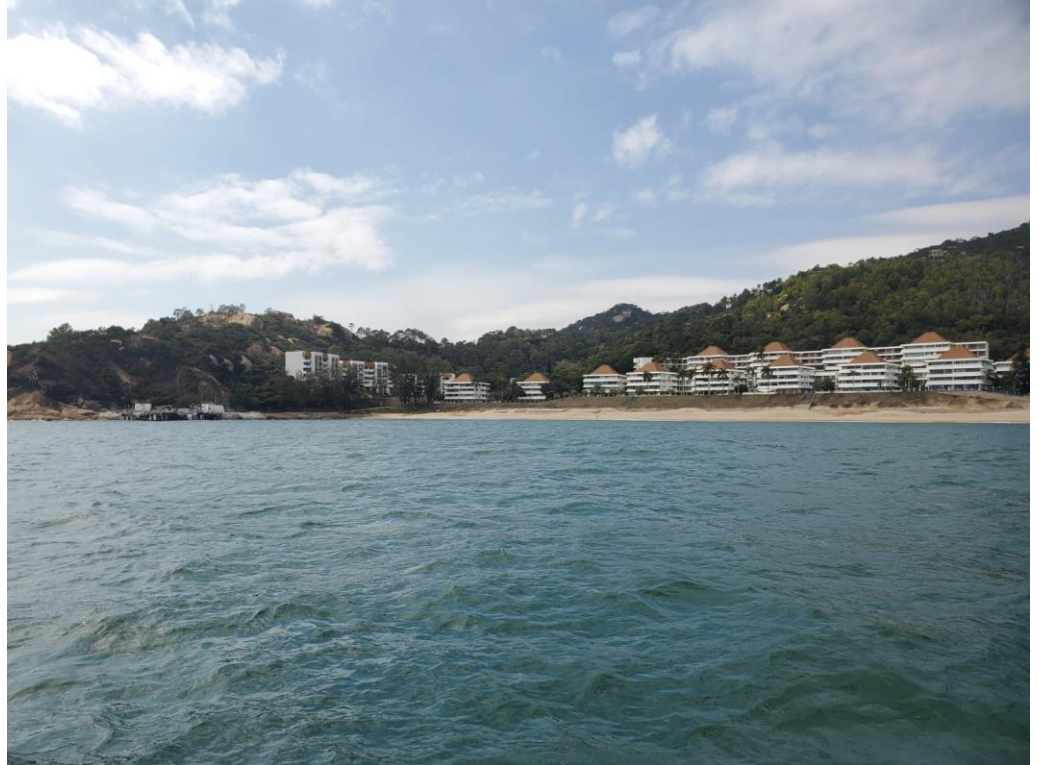
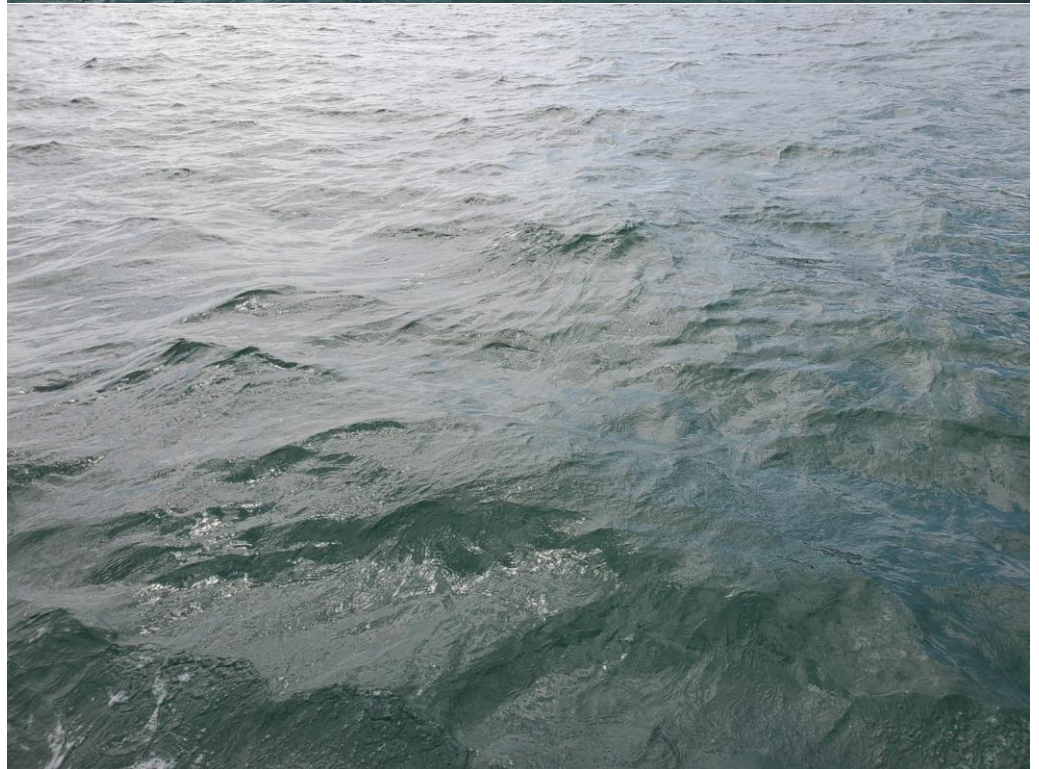
B3:

8.0 mg/L (B3)	5.0 mg/L (C1A) 5.5 mg/L (C2A)	6.3 mg/L (B1) 6.3 mg/L (B2) 7.0 mg/L (B4) 7.3 mg/L (F1A) 5.5 mg/L (H1) 6.0 mg/L (M1) 7.5 mg/L (CR1) 5.8 mg/L (CR2)
Possible reason for Action or Limit Level Non-compliance	<p>Works scheduled on site on 28 Feb 2022 include infilling of caisson, lifting of working platforms at Caisson 52, installation of caissons, landfilling works for below +6.00mPD, landfilling works for above +6.00mPD, piling pre-drilling works, piling works, piling works for driven pile, piling works for pre-bored socketed H-pile, blockwork seawall and existing caisson extension.</p> <p>Dominant sea current direction was found to be from Southeast to Northwest at waters around Shek Kwu Chau.</p> <p>Exceedance of action level was found at B3. B3 is located at unrelated stream direction (neither upstream nor downstream, far away) to the works location. Exceedance is deemed to be unrelated to the Project.</p>

<p>The installation of caisson No.19 was completed on 18 Mar 2021, the reclamation area was enclosed.</p> <p>According to the field observation by sampling team during sampling event, no silt plume was observed in the Project site and the weather was fine during the sampling event.</p> <p>No major observation of improper site practices that contributed to the increase of the suspended solids was recorded during the weekly inspection on 23 Feb 2022.</p> <p>After the investigation, the exceedance on 28 Feb 2022 at B3 is deemed to be unrelated to the Project.</p>
--	--
