Appendix N Exceedance Report

Incident Report on Action Level or Limit Level Non-compliance

Project	Integrated Waste Management Facilities, Phase 1		
Date	02 Mar 2022 (Lab result received on 09 Mar 2022)		
Time	10:55 – 14:25 (Mid-Ebb)		
Mid-Ebb			
Monitoring Location	B2, B4

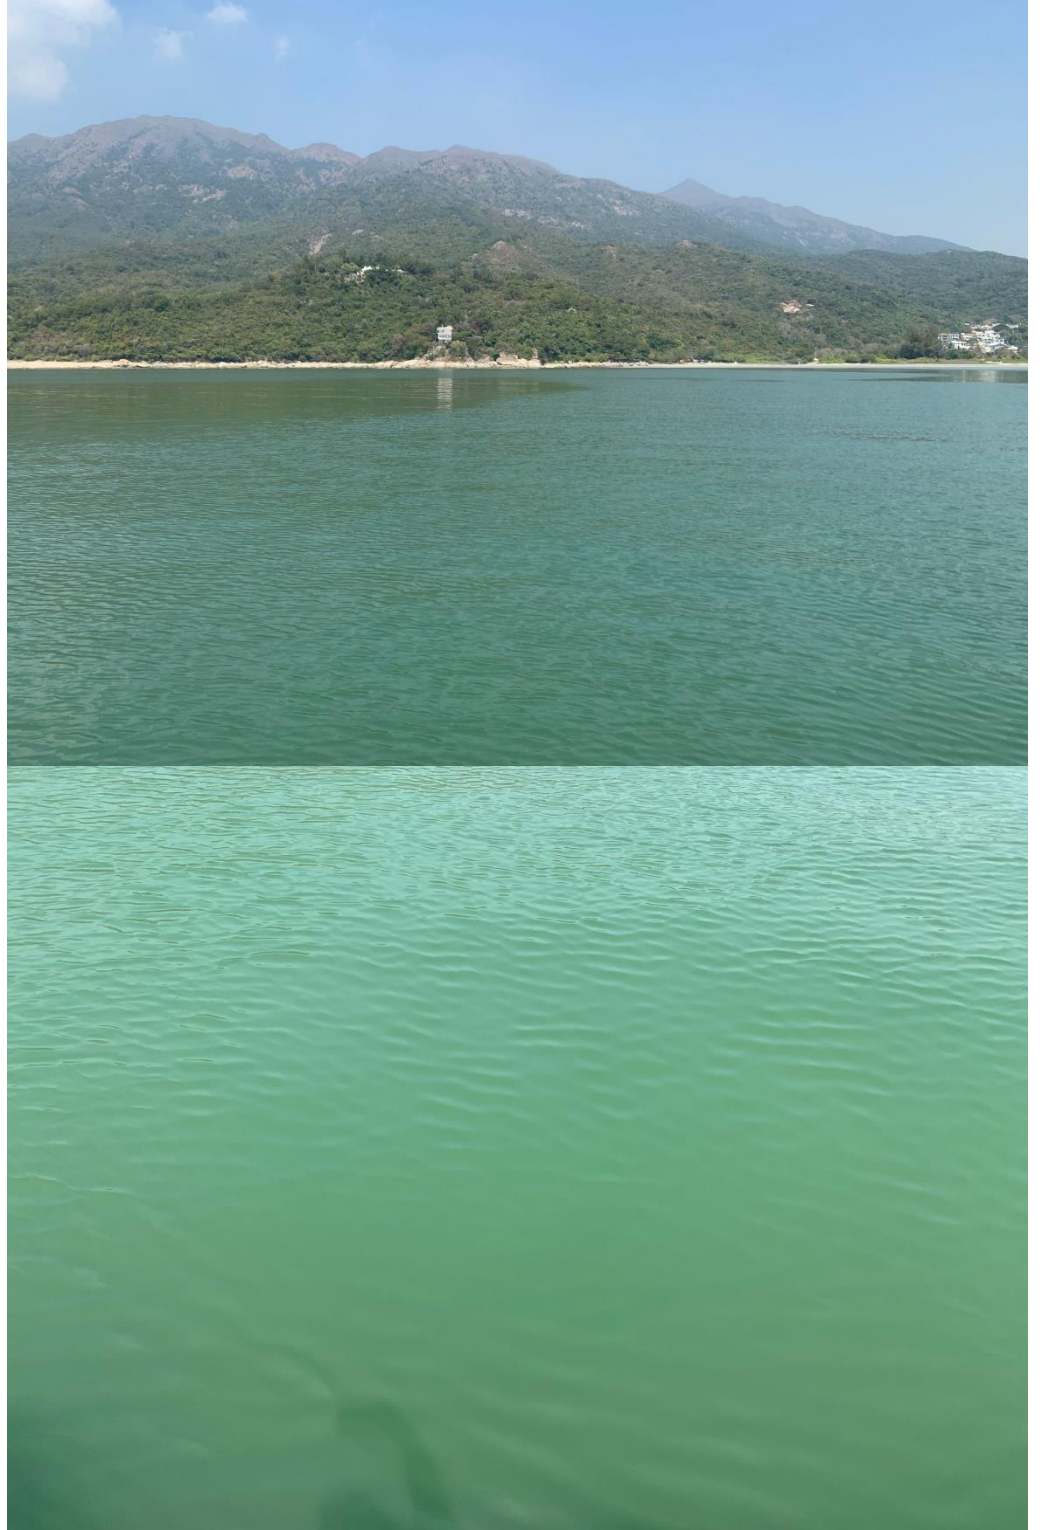
B2:

9.3 mg/L (B2) 8.5 mg/L (B4)	6.0 mg/L (C1A) 6.0 mg/L (C2A)	6.8 mg/L (B1) 7.5 mg/L (B3) 5.7 mg/L (F1A) 5.7 mg/L (H1) 5.3 mg/L (M1) 5.5 mg/L (CR1) 5.8 mg/L (CR2)
Possible reason for Action or Limit Level Non-compliance	<p>Works scheduled on site on 02 Mar 2022 include infilling of caisson, caisson installation, lifting of working platforms at Caisson 54K2B, levelling of 1 T armour rock at Seawall B Caisson 8 - 10, landfilling works for below +6.00mPD, landfilling works for above +6.00mPD, piling pre-drilling works, piling works, piling works for driven pile, piling works for pre-bored socketed H-pile, blockwork seawall and existing caisson extension.</p> <p>Dominant sea current direction was found to be from Northwest to Southeast at waters around Shek Kwu Chau.</p> <p>Exceedances of action level were found at B2 and B4.</p> <p>B2 and B4 are located at unrelated stream direction (neither upstream nor downstream, far away) to the works location. Exceedances are deemed to be unrelated to the Project.</p>

<p>The installation of caisson No.19 was completed on 18 Mar 2021, the reclamation area was enclosed.</p> <p>According to the field observation by sampling team during sampling event, no silt plume was observed in the Project site and the weather was fine during the sampling event.</p> <p>No major observation of improper site practices that contributed to the increase of the suspended solids was recorded during the weekly inspection on 01 Mar 2022.</p> <p>After the investigation, the exceedances on 02 Mar 2022 at B2 and B4 are deemed to be unrelated to the Project.</p>
--	---

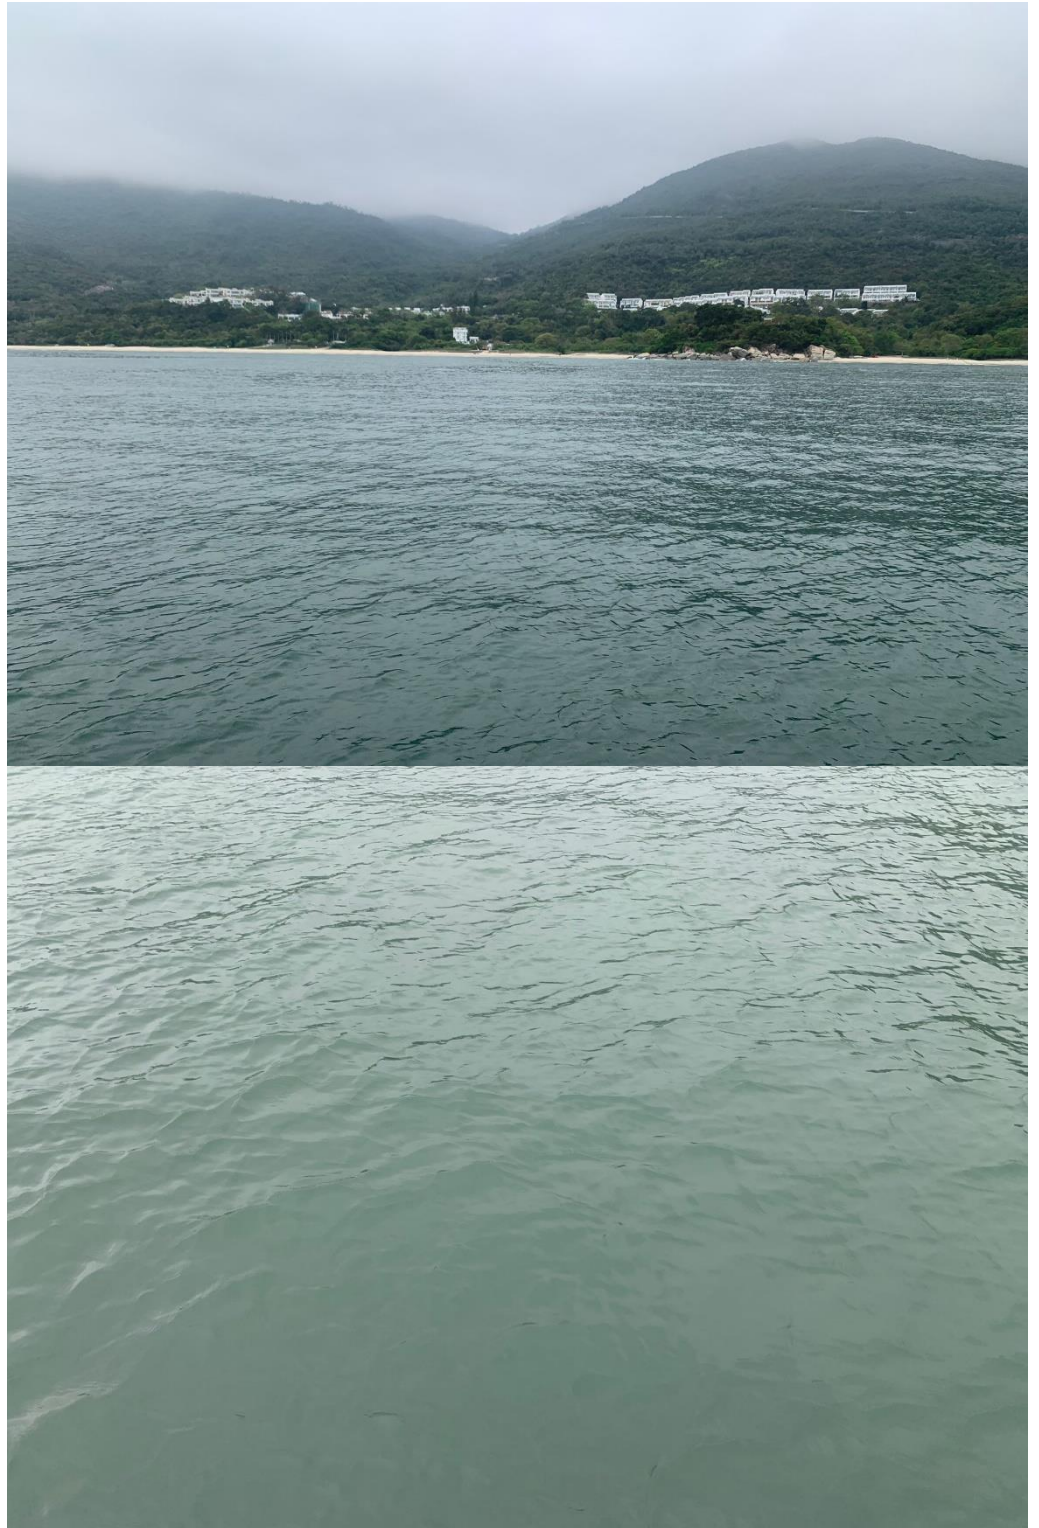
B1:

9.8 mg/L (B1) 11.8 mg/L (B2) 11.5 mg/L (B3) 8.8 mg/L (B4)	7.2 mg/L (C1A) 7.2 mg/L (C2A)	8.0 mg/L (F1A) 7.8 mg/L (H1) 6.5 mg/L (M1) 4.7 mg/L (CR1) 6.3 mg/L (CR2)
Possible reason for Action or Limit Level Non-compliance	<p>Works scheduled on site on 21 Mar 2022 include infilling of caisson, caisson installation, levelling of underlayer by diver at Breakwater A CH1036 - CH1050, landfilling works for below +6.00mPD, landfilling works for above +6.00mPD, installation of instrumentation, piling pre-drilling works, piling works, piling works for driven pile, piling works for pre-bored socketed H-pile, piling works for bored pile, blockwork seawall and existing caisson extension.</p> <p>Dominant sea current direction was found to be from Northwest to Southeast at waters around Shek Kwu Chau.</p> <p>Exceedances of action level were found at B1 and B4 and exceedances of limit level were found at B2 and B3.</p>

<p>B1, B2, B3 and B4 are located at unrelated stream direction (neither upstream nor downstream, far away) to the works location. Exceedances are deemed to be unrelated to the Project.</p> <p>The installation of caisson No.19 was completed on 18 Mar 2021, the reclamation area was enclosed.</p> <p>According to the field observation by sampling team during sampling event, no silt plume was observed in the Project site and the weather was rainy during the sampling event.</p> <p>No major observation of improper site practices that contributed to the increase of the suspended solids was recorded during the weekly inspection on 22 Mar 2022.</p> <p>After the investigation, the exceedances on 21 Mar 2022 at B1, B2, B3 and B4 are deemed to be unrelated to the Project.</p>
--	---

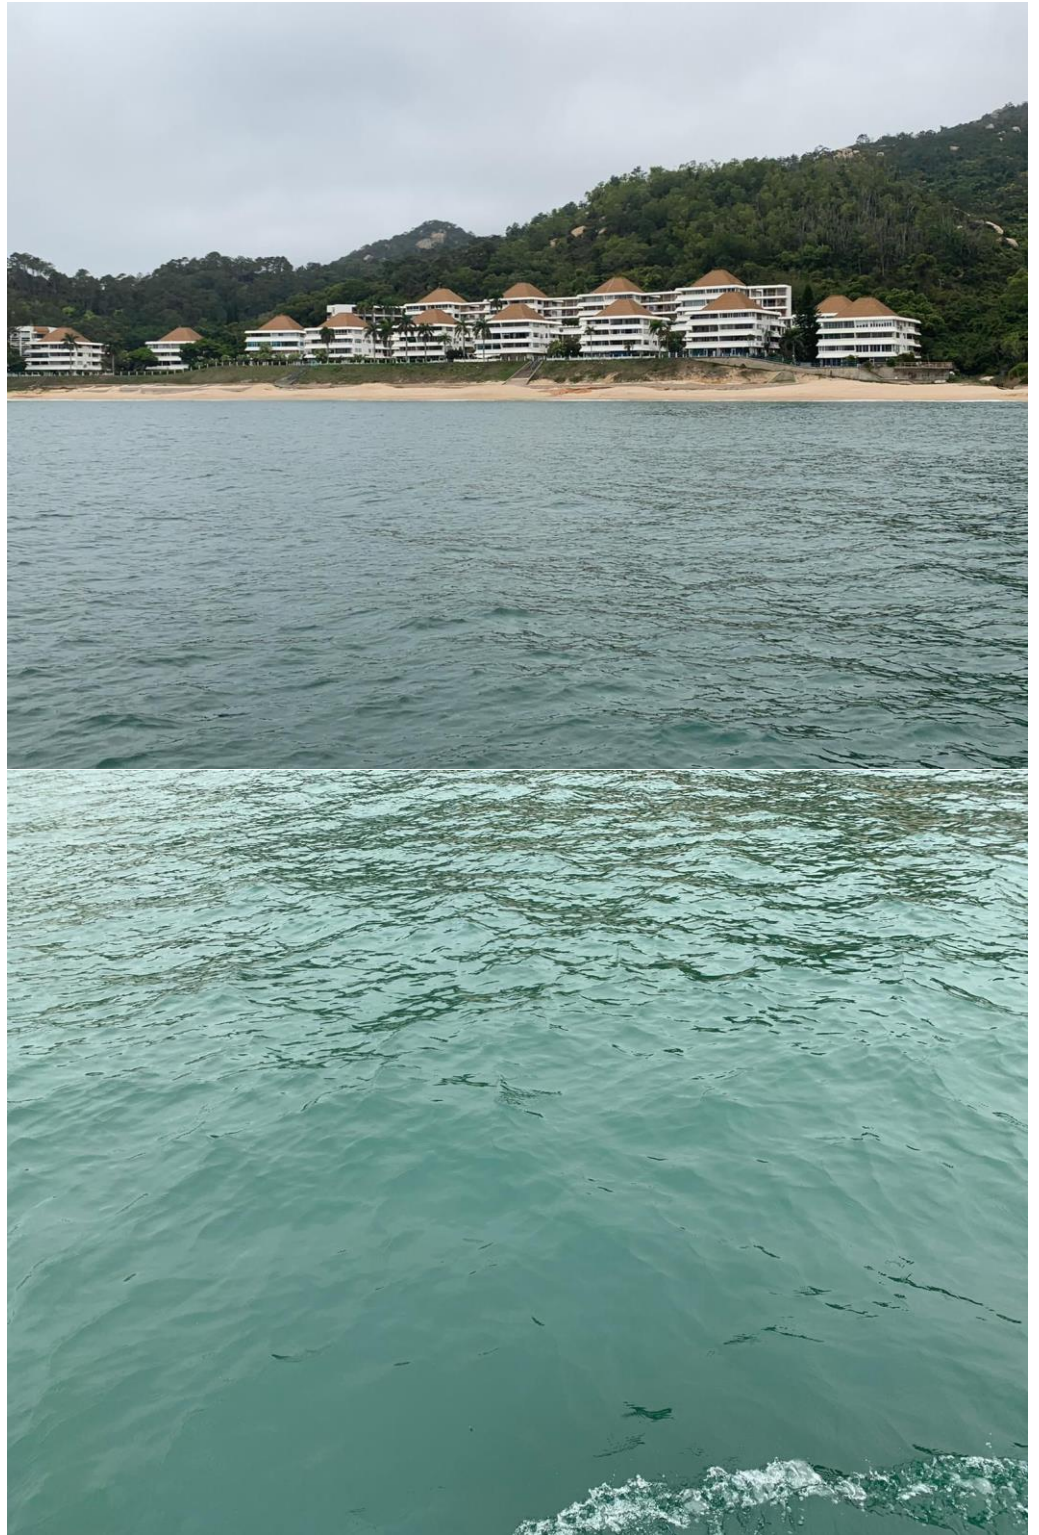
B3:

9.5 mg/L (B3) 9.5 mg/L (B4) 10.2 mg/L (F1A) 8.8 mg/L (M1) 9.0 mg/L (CR1) 10.3 mg/L (CR2)	7.2 mg/L (C1A) 6.5 mg/L (C2A)	6.5 mg/L (B1) 7.5 mg/L (B2) 6.8 mg/L (H1)
Possible reason for Action or Limit Level Non-compliance	<p>Works scheduled on site on 21 Mar 2022 include infilling of caisson, caisson installation, levelling of underlayer by diver at Breakwater A CH1036 - CH1050, landfilling works for below +6.00mPD, landfilling works for above +6.00mPD, installation of instrumentation, piling pre-drilling works, piling works, piling works for driven pile, piling works for pre-bored socketed H-pile, piling works for bored pile, blockwork seawall and existing caisson extension.</p> <p>Dominant sea current direction was found to be from Southeast to Northwest at waters around Shek Kwu Chau.</p> <p>Exceedances of action level were found at B3, B4, M1 and CR1 and exceedances of limit level were found at F1A and CR2.</p> <p>CR1 and CR2 are located close to the works location within the Project site while no major marine work was conducted on 21 Mar 2022.</p> <p>B3, B4, M1 and F1A are located at unrelated stream direction (neither upstream nor downstream, far away) to the works location. Exceedances are deemed to be unrelated to the Project.</p>

<p>The installation of caisson No.19 was completed on 18 Mar 2021, the reclamation area was enclosed.</p> <p>According to the field observation by sampling team during sampling event, no silt plume was observed in the Project site and the weather was rainy during the sampling event.</p> <p>No major observation of improper site practices that contributed to the increase of the suspended solids was recorded during the weekly inspection on 22 Mar 2022.</p> <p>After the investigation, the exceedances on 21 Mar 2022 at B3, B4, F1A, M1, CR1 and CR2 are deemed to be unrelated to the Project.</p>
--	---
