## Appendix N Exceedance Report

**Incident Report on Action Level or Limit Level Non-compliance**

Project	Integrated Waste Management Facilities, Phase 1		
Date	08 August 2022 (Lab result received on 16 August 2022)		
Time	14:45 – 18:15 (Mid-Flood)		
Monitoring Location	Mid-Flood B2, B3, B4		
Parameter	Suspended Solid (SS)		
Action & Limit Levels	Action Level		Limit Level
	≥ 12.0 mg/L		≥ 14.0 mg/L
Measurement Level	Impact Station(s) of Exceedance	Control Stations	Impact Station(s) without Exceedance

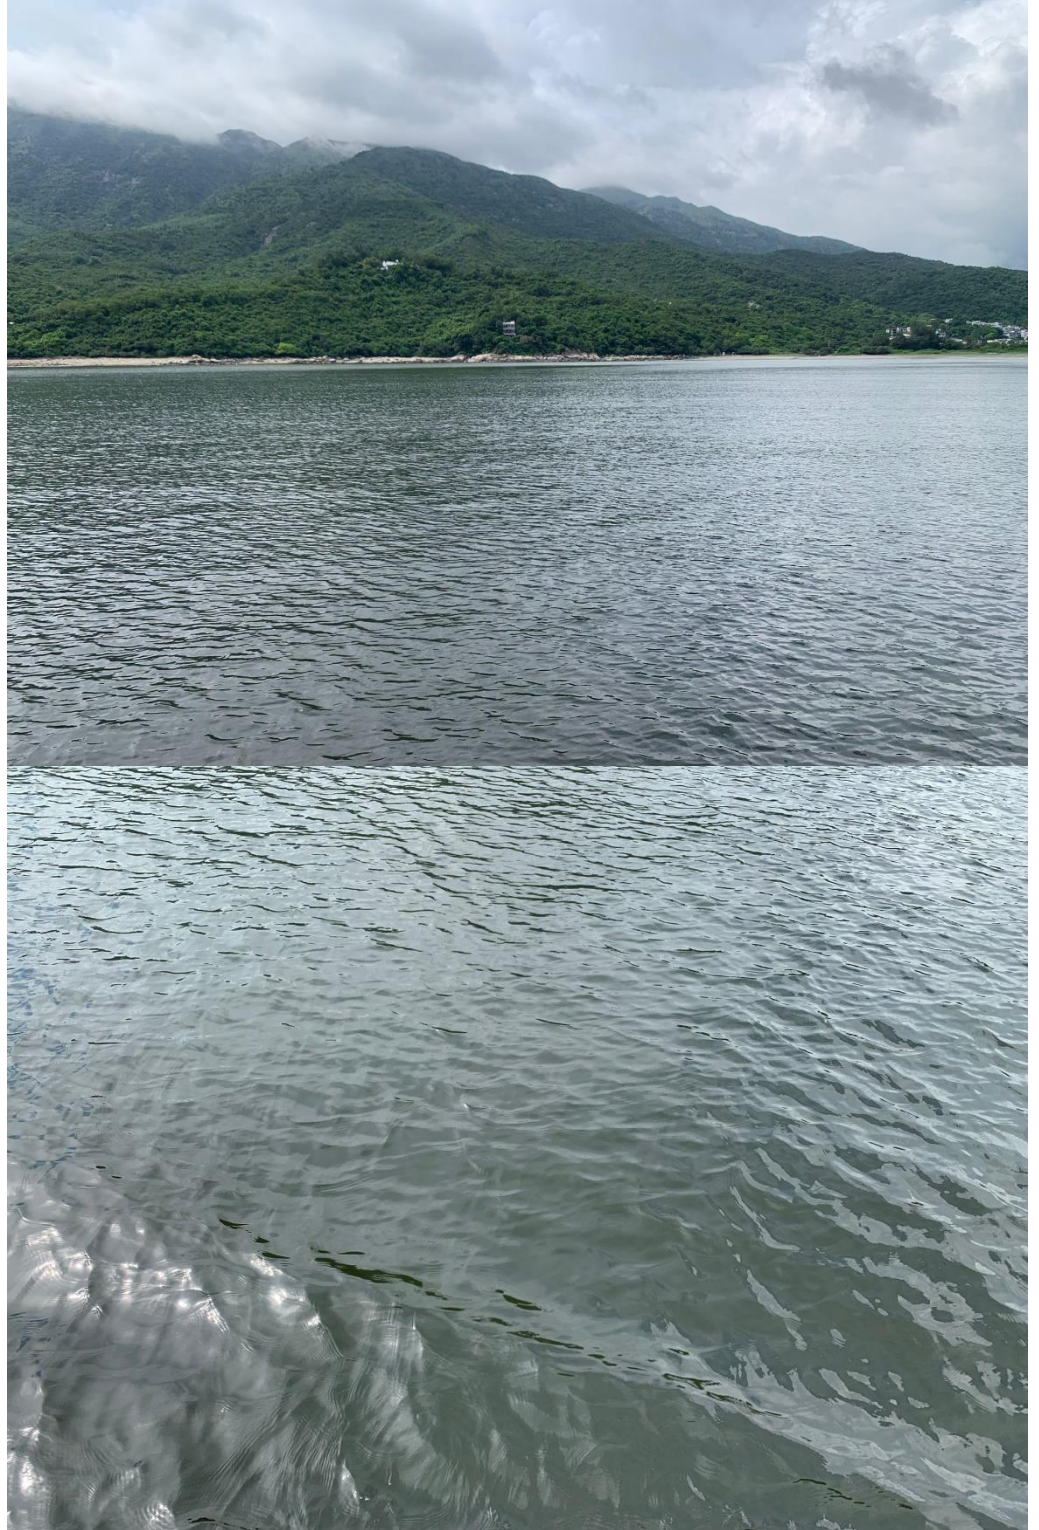
B2:

12.8 mg/L (B2) 15.8 mg/L (B3) 14.8 mg/L (B4)	3.8 mg/L (C1A) 2.9 mg/L (C2A)	10.5 mg/L (B1) 3.3 mg/L (F1A) 8.3 mg/L (H1) 9.0 mg/L (M1) 6.0 mg/L (CR1) 5.5 mg/L (CR2)
Possible reason for Action or Limit Level Non-compliance	<p>Works scheduled on site on 08 Aug 2022 include infilling of caisson, performing weighing test on 1.85T armour rock, laying 1.85T armour rock at Caisson 58 - 60, landfilling works for below +6.00mPD, landfilling works for above +6.00mPD, installation of instrumentation, piling pre-drilling works, piling works, piling works for driven pile, piling works for pre-bored socketed H-pile, piling works for bored pile, pile cap construction, blockwork seawall and existing caisson extension.</p> <p>Dominant sea current direction was found to be from Southeast to Northwest at waters around Shek Kwu Chau.</p> <p>An exceedance of action level was found at B2, exceedances of limit level were found at B3 and B4.</p>

<p>B2, B3 and B4 are located at unrelated stream direction (neither upstream nor downstream, far away) to the works location. Exceedances are deemed to be unrelated to the Project.</p> <p>The installation of caisson No.19 was completed on 18 Mar 2021, the reclamation area was enclosed.</p> <p>According to the field observation by sampling team during sampling event, no silt plume was observed in the Project site and the weather was cloudy during the sampling event.</p> <p>No major observation of improper site practices that contributed to the increase of the suspended solids was recorded during the weekly inspection on 09 August 2022.</p> <p>After the investigation, the exceedances on 08 August 2022 at B2, B3 and B4 are deemed to be unrelated to the Project.</p>
--	--

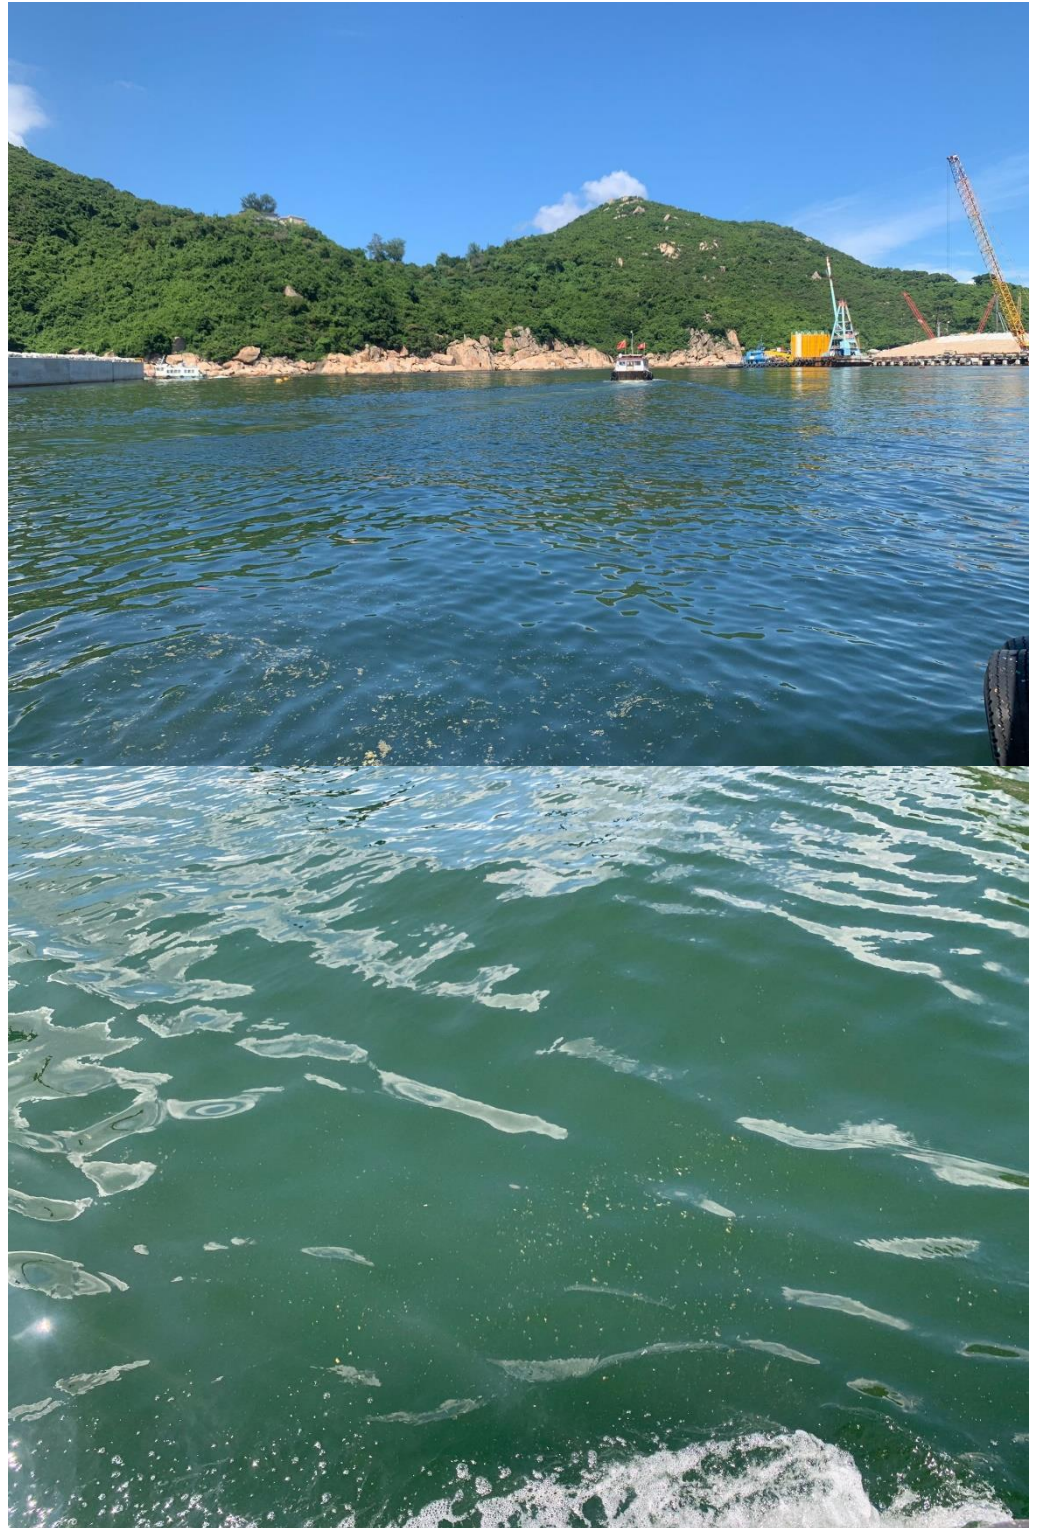
CR2:

17.8 mg/L (CR2)	4.3 mg/L (C1A) 5.4 mg/L (C2A)	4.8 mg/L (B1) 5.0 mg/L (B2) 5.0 mg/L (B3) 4.3 mg/L (B4) 8.8 mg/L (F1A) 4.5 mg/L (H1) 11.3 mg/L (M1) 9.0 mg/L (CR1)
Possible reason for Action or Limit Level Non-compliance	<p>Works scheduled on site on 16 Aug 2022 include infilling of caisson, infilling of 1.85T armour at Caisson 57 - 60, infilling of G200 Rock fill at Caisson 62 - 63, installation of Stoppers at Breakwater A CH670 - CH720, installation of Stopper, landfilling works for below +6.00mPD, landfilling works for above +6.00mPD, installation of instrumentation, piling pre-drilling works, piling works, piling works for driven pile, piling works for pre-bored socketed H-pile, piling works for bored pile, pile cap construction, blockwork seawall and existing caisson extension.</p> <p>Dominant sea current direction was found to be from Northeast to Southwest at waters around Shek Kwu Chau.</p> <p>An exceedance of SS limit level was found at CR2.</p>

<p>CR2 is located close to the works location within the Project site while no marine work was conducted on 16 Aug 2022.</p> <p>The installation of caisson No.19 was completed on 18 Mar 2021, the reclamation area was enclosed.</p> <p>According to the field observation by sampling team during sampling event, no silt plume was observed in the Project site and the weather was sunny during the sampling event.</p> <p>No major observation of improper site practices that contributed to the increase of the suspended solids was recorded during the weekly inspection on 23 Aug 2022.</p> <p>After the investigation, the exceedance on 16 Aug 2022 at CR2 is deemed to be unrelated to the Project.</p>
--	---
