## Appendix N Exceedance Report

**Incident Report on Action Level or Limit Level Non-compliance**

Project	Integrated Waste Management Facilities, Phase 1		
Date	05 October 2022 (Lab result received on 12 October 2022)		
Time	08:43 – 12:13 (Mid-Ebb)		
Mid-Ebb			
Monitoring Location	<p>B4</p>		
Parameter	Suspended Solid (SS)		
Action & Limit Levels	Action Level		Limit Level
	≥ 8.0 mg/L		≥ 10.0 mg/L
Measurement Level	Impact Station(s) of Exceedance	Control Stations	Impact Station(s) without Exceedance

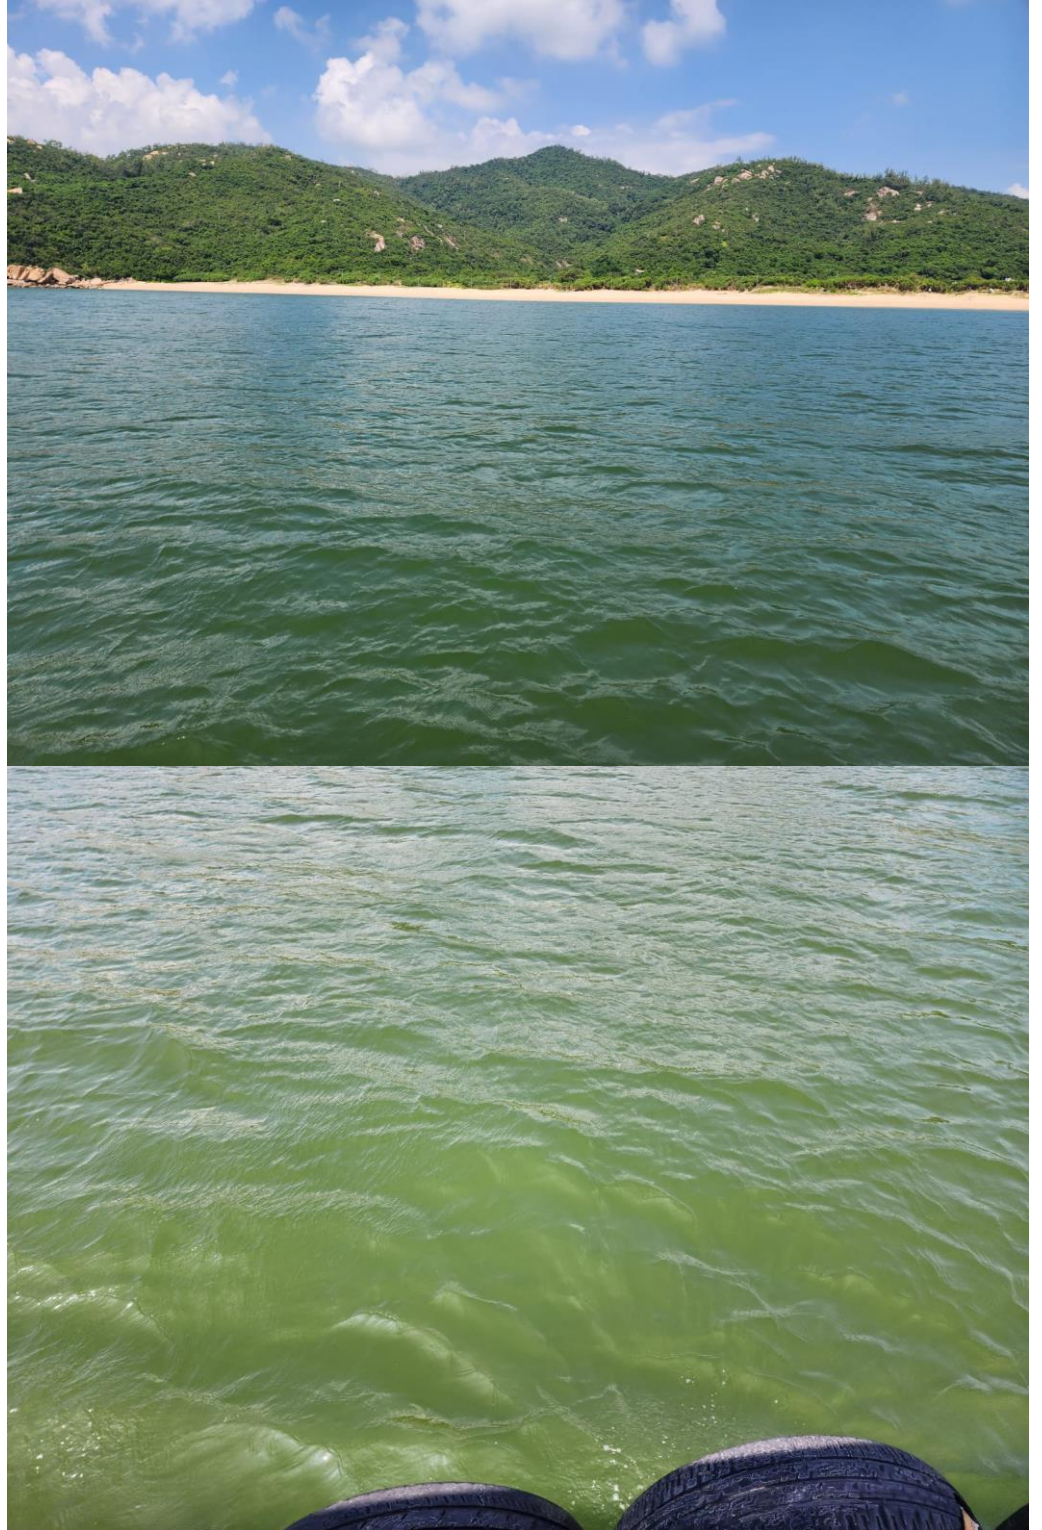
B4:

8.8 mg/L (B4)	2.8 mg/L (C1A) 2.6 mg/L (C2A)	2.6 mg/L (B1) 2.6 mg/L (B2) 3.4 mg/L (B3) 2.6 mg/L (F1A) 3.8 mg/L (H1) 2.6 mg/L (M1) 2.8 mg/L (CR1) 2.5 mg/L (CR2)
Possible reason for Action or Limit Level Non-compliance	<p>Works scheduled on site on 05 Oct 2022 include laying of 900kg underlayer rocks at Breakwater seaside between CH1100 - CH1120, laying of 900kg underlayer rocks at Breakwater landside between CH750 - CH850, laying of 500kg armour rocks at Breakwater at CH750, installation of stoppers at Breakwater landside between CH1000 - CH1120, landfilling works for above +6.00mPD, piling pre-drilling works, piling works, piling works for driven pile, piling works for pre-bored socketed H-pile, pile cap construction, blockwork seawall and existing caisson extension, Process Building construction works.</p> <p>Dominant sea current direction was found to be from Northwest to Southeast at waters around Shek Kwu Chau.</p>

<p>An exceedance of action level was found at B4. B4 is located at unrelated stream direction (neither upstream nor downstream, far away) to the works location. The exceedance is deemed to be unrelated to the Project.</p> <p>The installation of caisson No.19 was completed on 18 Mar 2021, the reclamation area was enclosed.</p> <p>According to the field observation by sampling team during sampling event, no silt plume was observed in the Project site and the weather was sunny during the sampling event.</p> <p>No major observation of improper site practices that contributed to the increase of the suspended solids was recorded during the weekly inspection on 05 October 2022.</p> <p>After the investigation, the exceedance on 05 October 2022 at B4 is deemed to be unrelated to the Project.</p>
--	---

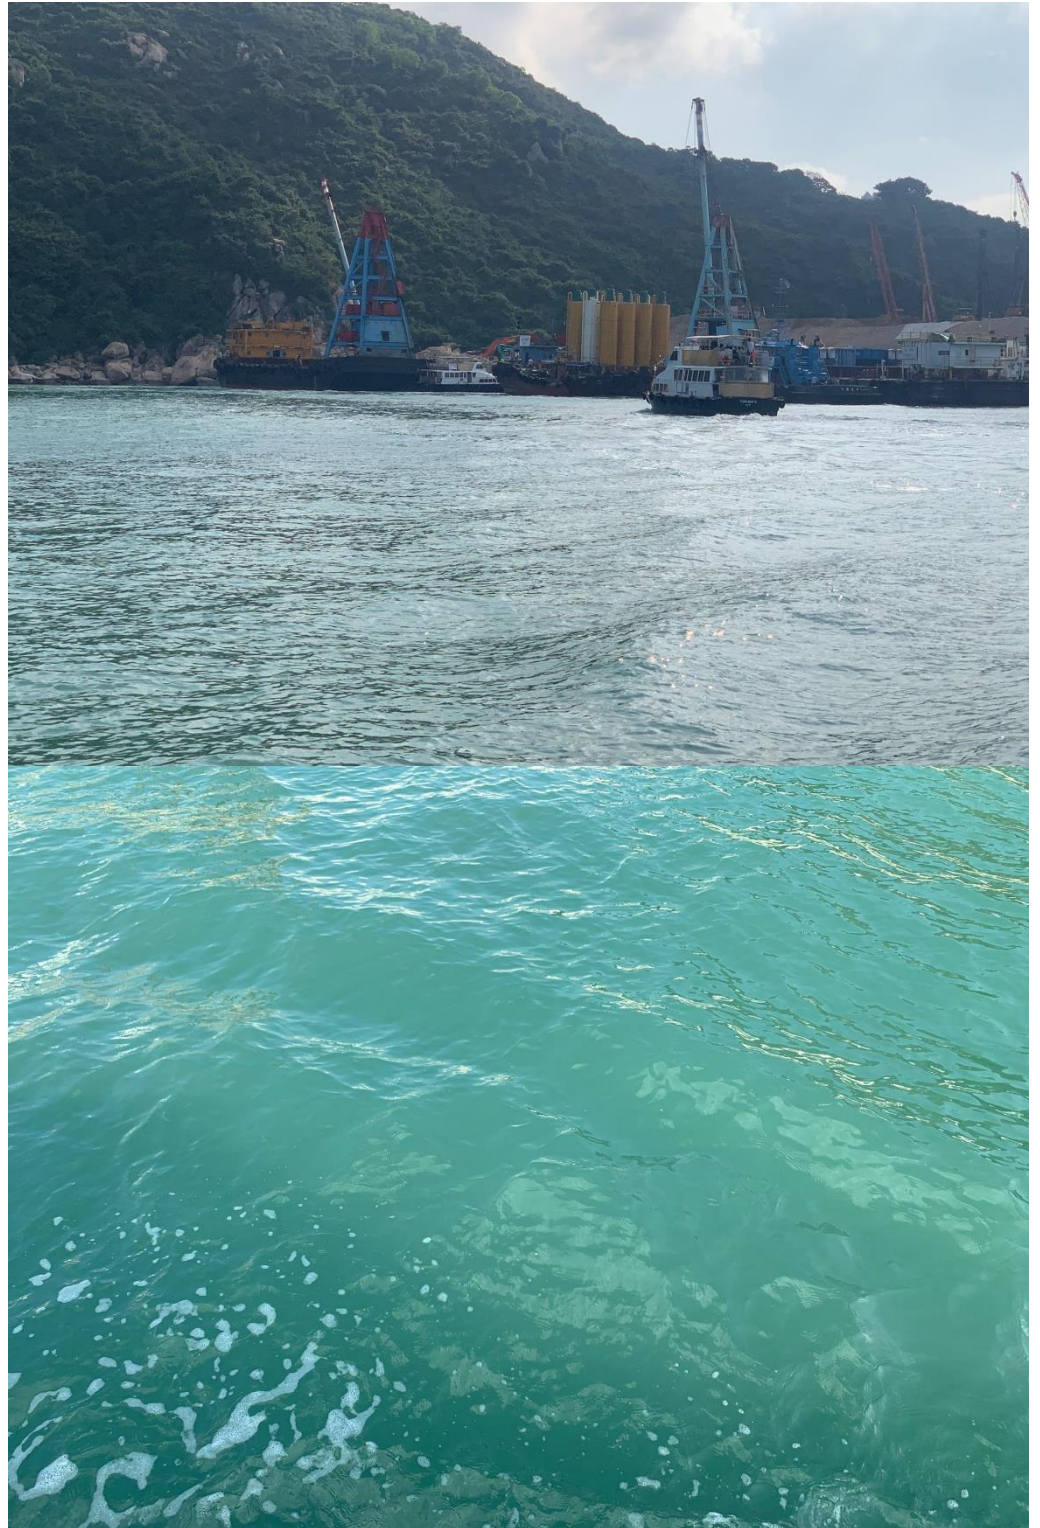
CR2:

9.5 mg/L (CR2)	11.3 mg/L (C1A) 3.8 mg/L (C2A)	7.3 mg/L (B1) 6.5 mg/L (B2) 6.3 mg/L (B3) 5.5 mg/L (B4) 5.4 mg/L (M1) 4.8 mg/L (F1A) 6.1 mg/L (H1) 4.3 mg/L (CR1)
Possible reason for Action or Limit Level Non-compliance	<p>Works scheduled on site on 14 Oct 2022 include weighing of 2.5T armour rocks at Breakwater A and B, laying of 2.5T armour rocks at Breakwater seaside between CH190 - CH220, installation of Chinese pods between Caisson No.58 and No.60, installation of stoppers at Breakwater landside between CH720 - CH800, landfilling works for above +6.00mPD, piling works, piling works for driven pile, piling works for pre-bored socketed H-pile, pile cap construction, blockwork seawall and existing caisson extension, Process Building construction works.</p> <p>Dominant sea current direction was found to be from Southeast to Northwest at waters around Shek Kwu Chau.</p> <p>An exceedance of action level was found at CR2.</p>

<p>The installation of caisson No.19 was completed on 18 Mar 2021, the reclamation area was enclosed.</p> <p>According to the field observation by sampling team during sampling event, no silt plume was observed in the Project site and the weather was sunny during the sampling event.</p> <p>No major observation of improper site practices that contributed to the increase of the suspended solids was recorded during the weekly inspection on 11 October 2022.</p> <p>After the investigation, the exceedance on 14 October 2022 at CR2 is deemed to be unrelated to the Project.</p>
--	--

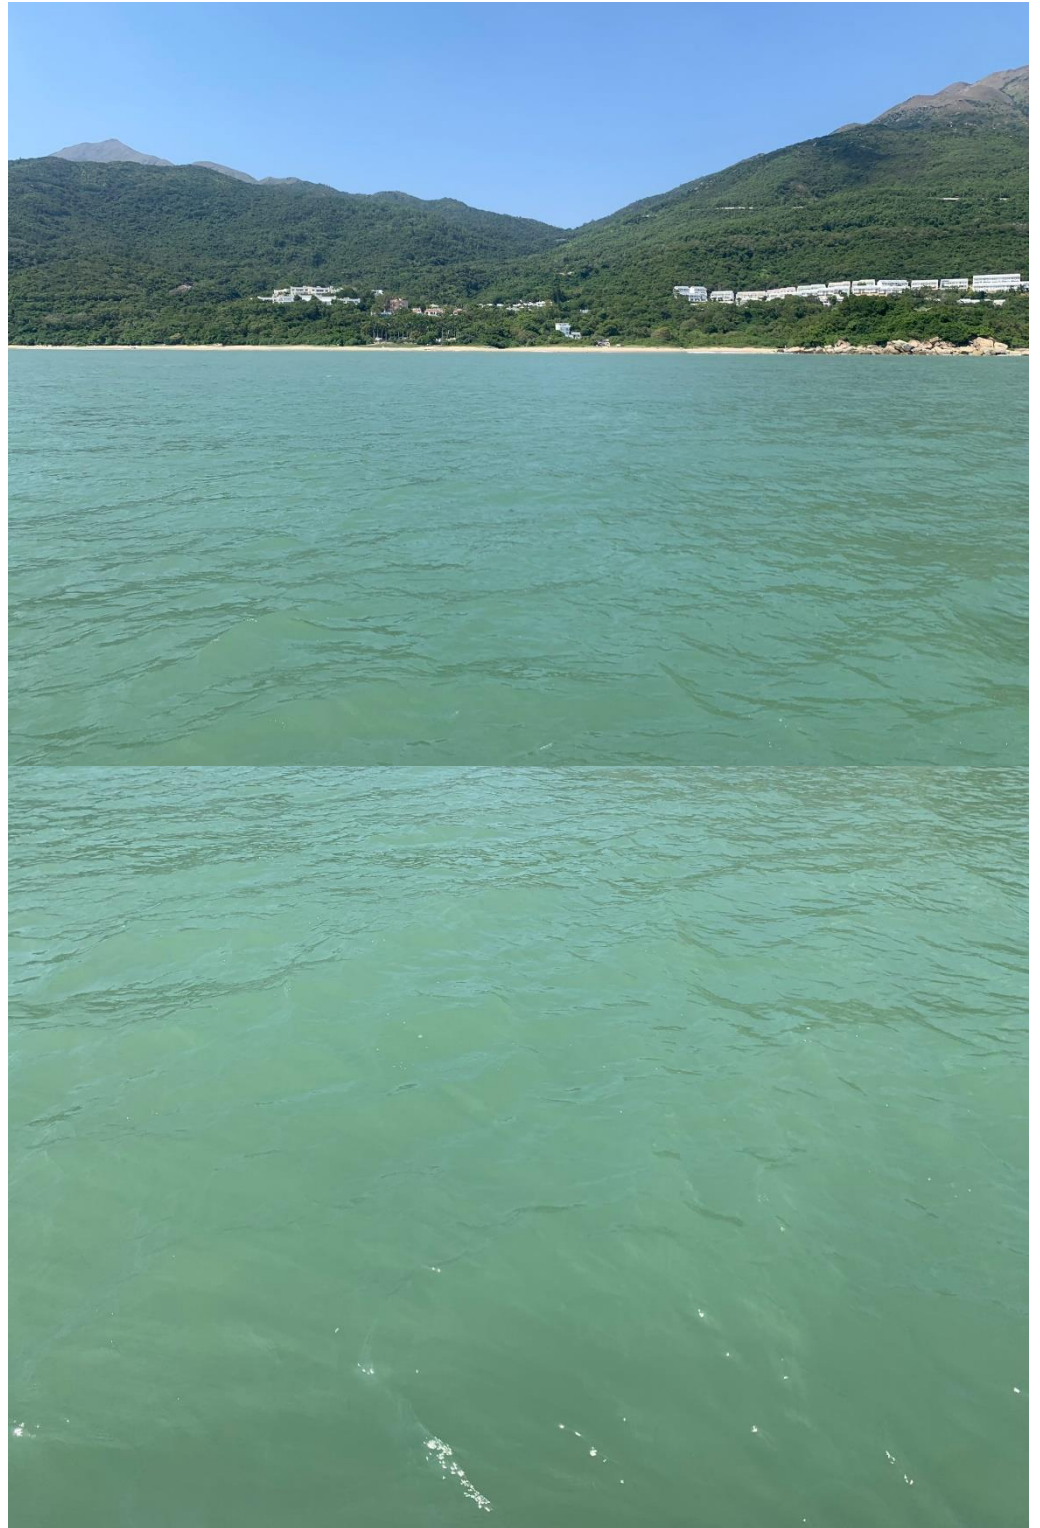
B1:

10.8 mg/L (B1) 8.0 mg/L (F1A) 10.3 mg/L (M1) 10.5 mg/L (CR1)	4.9 mg/L (C1A) 3.2 mg/L (C2A)	4.3 mg/L (B2) 4.4 mg/L (B3) 4.6 mg/L (B4) 2.8 mg/L (H1) 6.8 mg/L (CR2)
Possible reason for Action or Limit Level Non-compliance	<p>Works scheduled on site on 14 Oct 2022 include weighing of 2.5T armour rocks at Breakwater A and B, laying of 2.5T armour rocks at Breakwater seaside between CH190 - CH220, installation of Chinese pods between Caisson No.58 and No.60, installation of stoppers at Breakwater landside between CH720 - CH800, landfilling works for above +6.00mPD, piling works, piling works for driven pile, piling works for pre-bored socketed H-pile, pile cap construction, blockwork seawall and existing caisson extension, Process Building construction works.</p> <p>Dominant sea current direction was found to be from Northwest to Southeast at waters around Shek Kwu Chau.</p> <p>An exceedance of action level was found at F1A, and exceedances of limit level were found at B1, M1 and CR1.</p> <p>B1, M1 and F1A are located at unrelated stream direction (neither upstream nor downstream, far away) to the works location. Exceedances are deemed to be unrelated to the Project.</p> <p>The installation of caisson No.19 was completed on 18 Mar 2021, the reclamation area was enclosed.</p>

<p>According to the field observation by sampling team during sampling event, no silt plume was observed in the Project site and the weather was sunny during the sampling event.</p> <p>No major observation of improper site practices that contributed to the increase of the suspended solids was recorded during the weekly inspection on 11 October 2022.</p> <p>After the investigation, the exceedances on 14 October 2022 at B1, F1A, M1 and CR1 are deemed to be unrelated to the Project.</p>
--	--

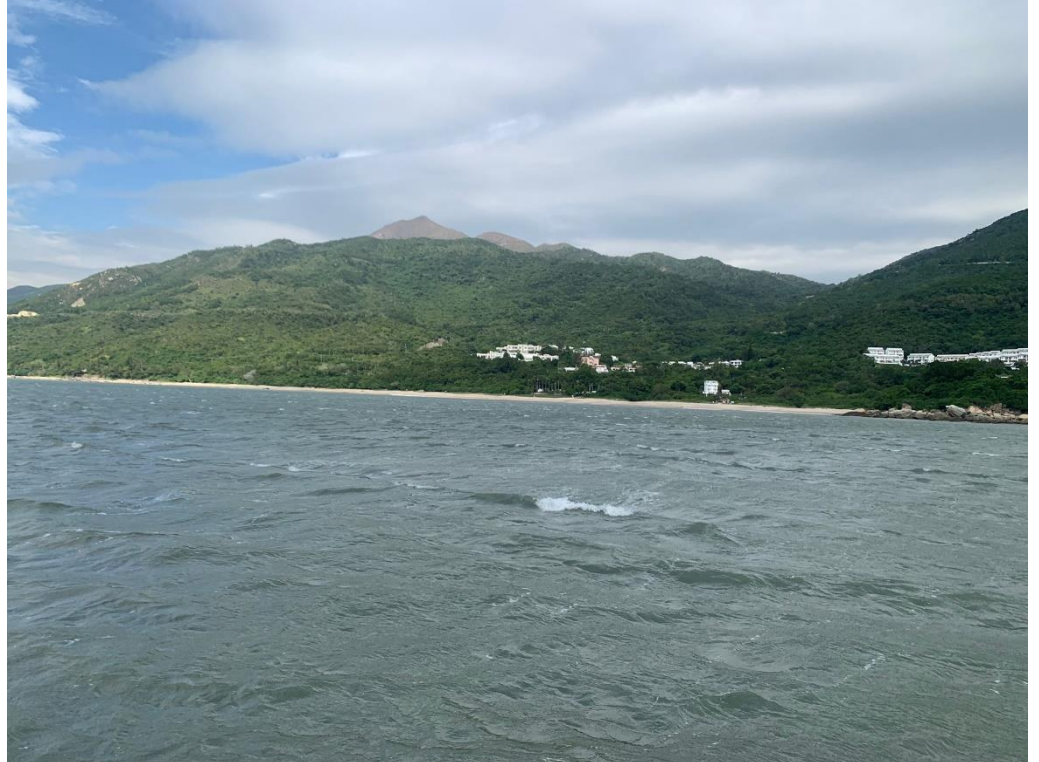
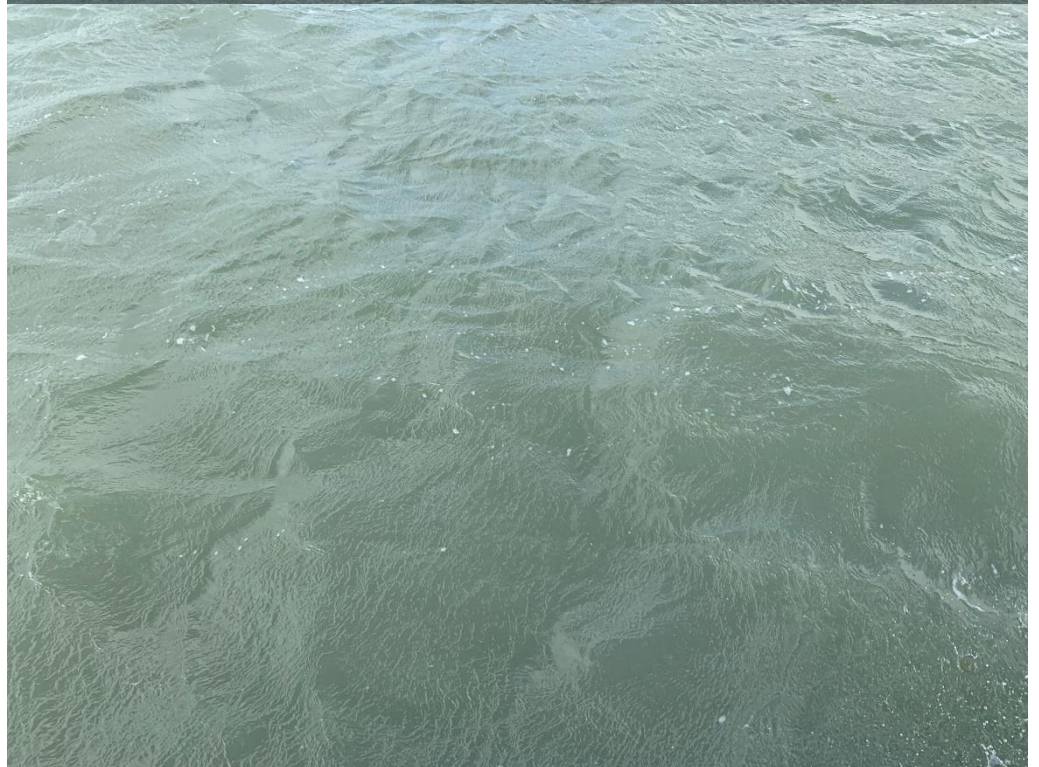
B1:

17.5 mg/L (B1) 24.3 mg/L (B2) 21.3 mg/L (B3) 21.3 mg/L (CR2)	14.5 mg/L (C1A) 14.7 mg/L (C2A)	17.3 mg/L (B4) 17.3 mg/L (F1A) 13.8 mg/L (H1) 16.3 mg/L (M1) 10.0 mg/L (CR1)
Possible reason for Action or Limit Level Non-compliance	<p>Works scheduled on site on 17 Oct 2022 include landfilling works for above +6.00mPD, piling works, piling works for driven pile, piling works for pre-bored socketed H-pile, pile cap construction, blockwork seawall and existing caisson extension and Process Building construction works.</p> <p>Dominant sea current direction was found to be from Northwest to Southeast at waters around Shek Kwu Chau.</p> <p>An exceedance of action level was found at B1, and exceedances of limit level were found at B2, B3 and CR2.</p> <p>B1, B2 and B3 were located at unrelated stream direction (neither upstream nor downstream, far away) to the works location. The exceedance is deemed to be unrelated to the Project.</p>

<p>The installation of caisson No.19 was completed on 18 Mar 2021, the reclamation area was enclosed.</p> <p>According to the field observation by sampling team during sampling event, no silt plume was observed in the Project site and the weather was cloudy during the sampling event.</p> <p>No major observation of improper site practices that contributed to the increase of the suspended solids was recorded during the site weekly inspection on 20 October 2022.</p> <p>After the investigation, the exceedances on 17 October 2022 at B1, B2, B3 and CR2 are deemed to be unrelated to the Project.</p>
--	---

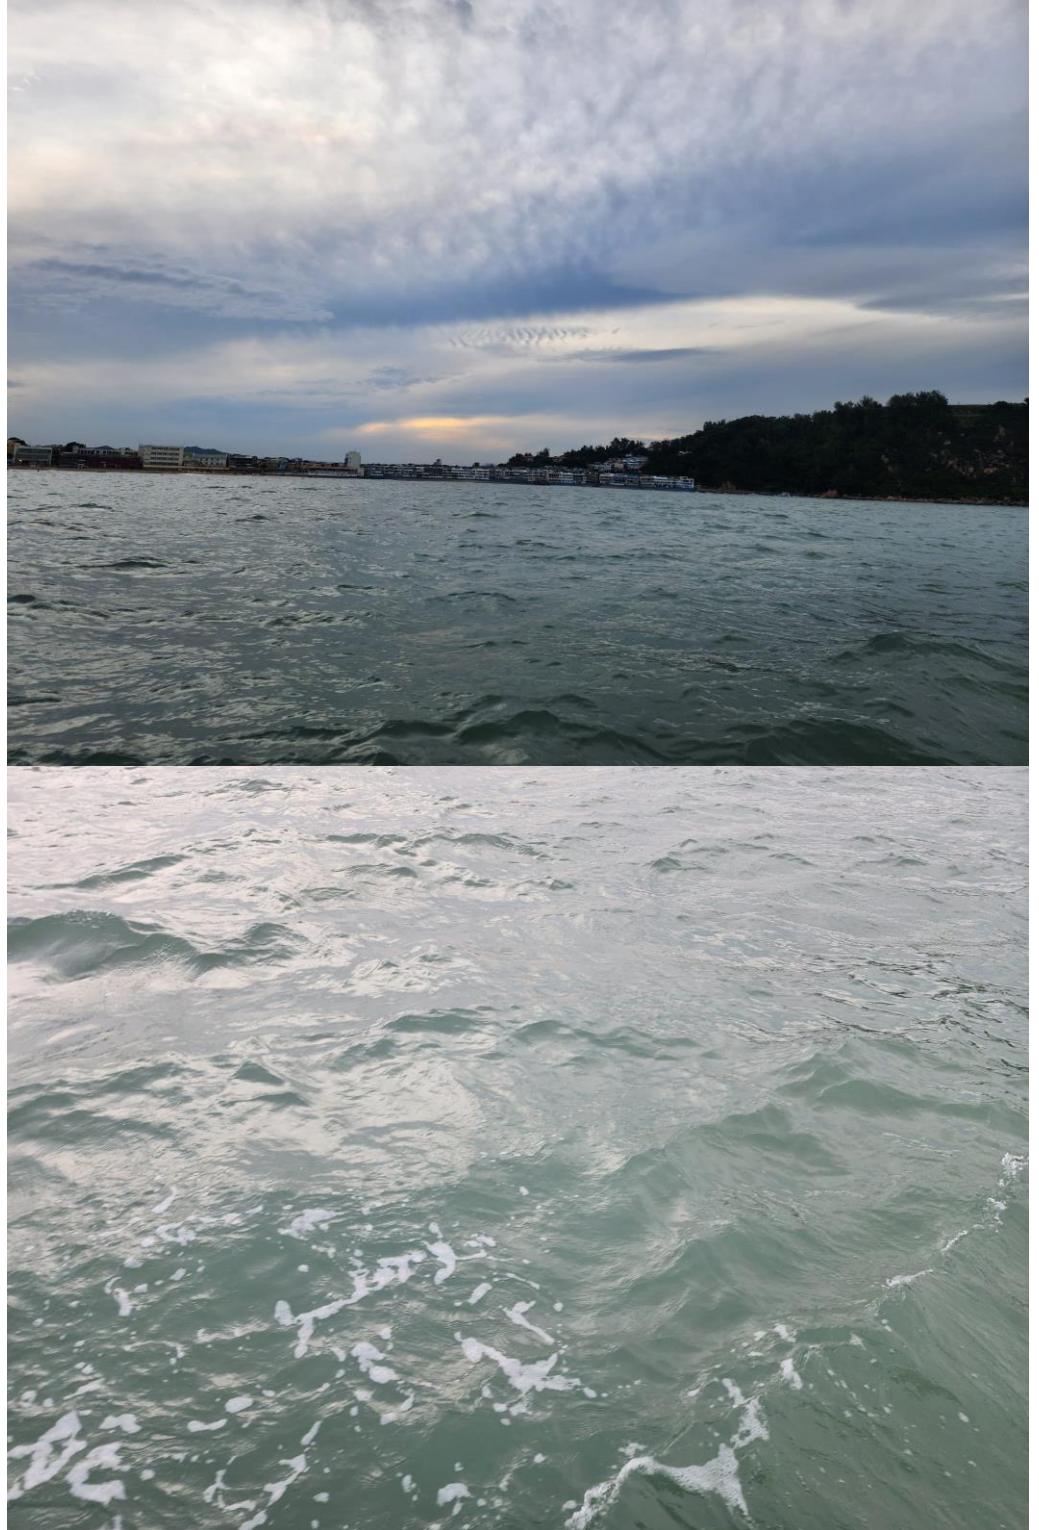
M1:

21.8 mg/L (M1)	12.2 mg/L (C1A) 17.3 mg/L (C2A)	8.3 mg/L (B1) 16.0 mg/L (B2) 16.8 mg/L (B3) 10.8 mg/L (B4) 18.7 mg/L (F1A) 14.0 mg/L (H1) 19.7 mg/L (CR1) 17.2 mg/L (CR2)
Possible reason for Action or Limit Level Non-compliance	<p>Works scheduled on site on 19 Oct 2022 include landfilling works for above +6.00mPD, piling works, piling works for driven pile, piling works for pre-bored socketed H-pile, pile cap construction, blockwork seawall and existing caisson extension and Process Building construction works.</p> <p>Dominant sea current direction was found to be from Southeast to Northwest at waters around Shek Kwu Chau.</p> <p>An exceedance of action level was found at M1.</p> <p>M1 was located at unrelated stream direction (neither upstream nor downstream, far away) to the works location. The exceedance is deemed to be unrelated to the Project.</p>

<p>The installation of caisson No.19 was completed on 18 Mar 2021, the reclamation area was enclosed.</p> <p>According to the field observation by sampling team during sampling event, no silt plume was observed in the Project site and the weather was cloudy during the sampling event.</p> <p>No major observation of improper site practices that contributed to the increase of the suspended solids was recorded during the site weekly inspection on 20 October 2022.</p> <p>After the investigation, the exceedance on 19 October 2022 at M1 is deemed to be unrelated to the Project.</p>
--	---

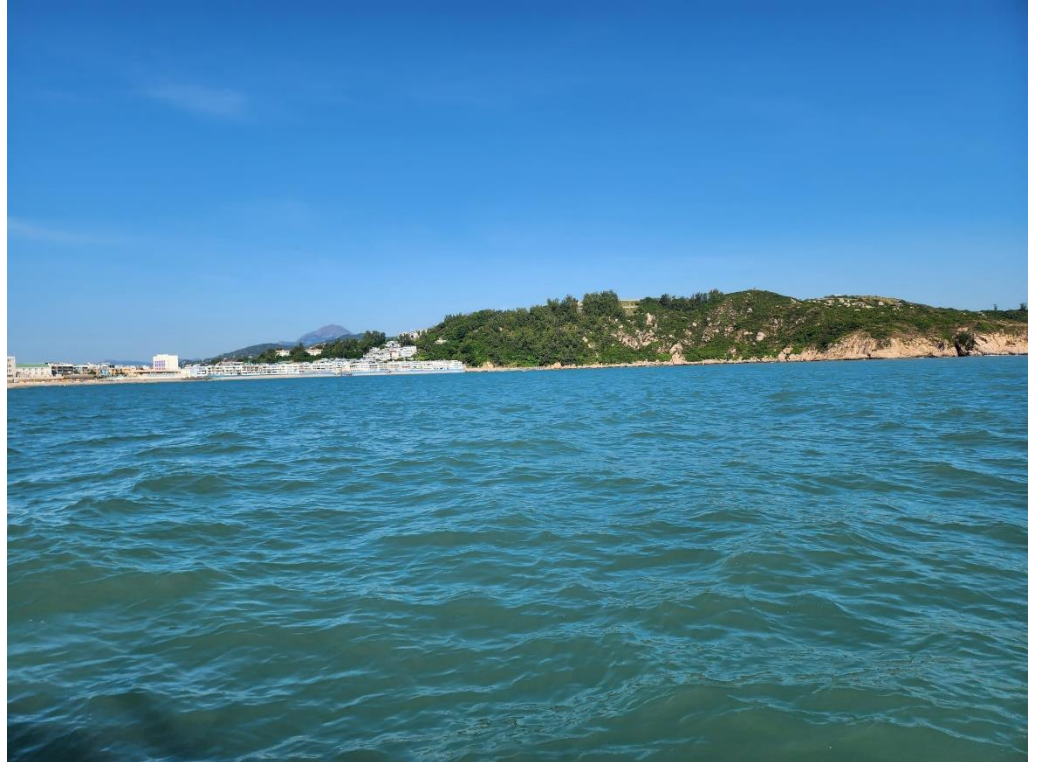
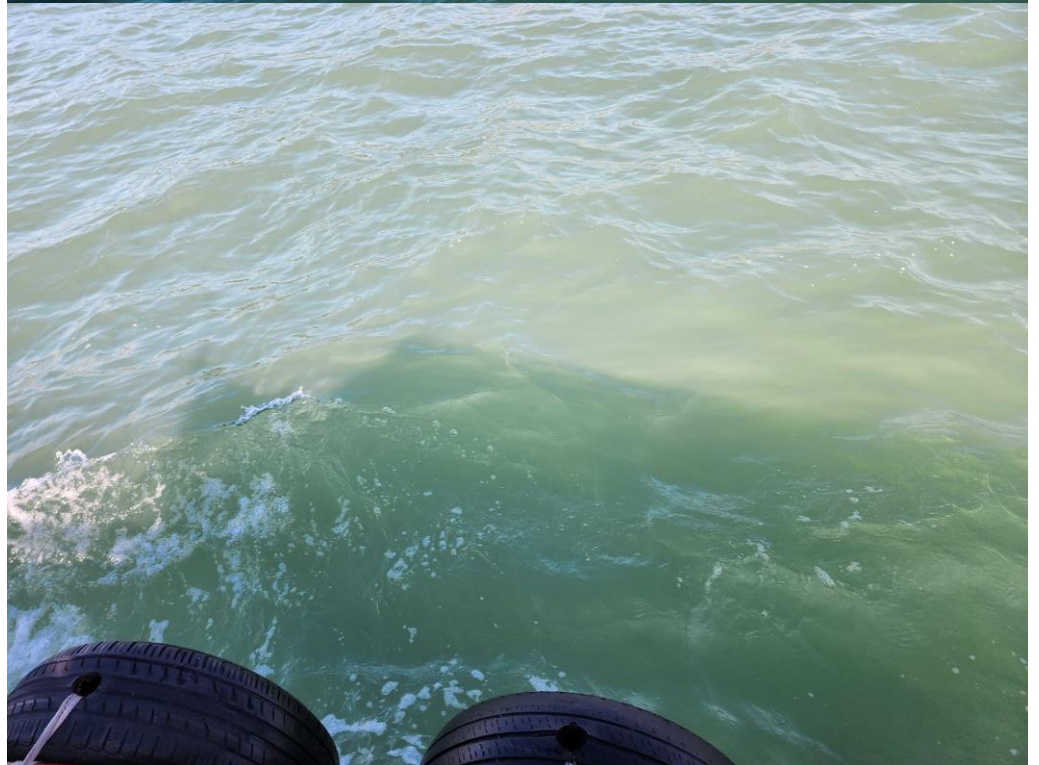
M1:

21.2 mg/L (M1)	17.3 mg/L (C1A) 19.3 mg/L (C2A)	14.0 mg/L (B1) 18.5 mg/L (B2) 12.5 mg/L (B3) 17.8 mg/L (B4) 19.8 mg/L (F1A) 16.3 mg/L (H1) 15.0 mg/L (CR1) 14.5 mg/L (CR2)
Possible reason for Action or Limit Level Non-compliance	<p>Works scheduled on site on 21 Oct 2022 include installation of Chinese pods at Breakwater A CH1000 - CH1120, laying of 900kg underlayer rocks at Breakwater A Seaside CH750 - CH850, infilling of G200 rocks at Caisson 65, laying of armour rocks, installation of stoppers, landfilling works for below +6.00mPD, landfilling works for above +6.00mPD, piling works, piling works for driven pile, piling works for pre-bored socketed H-pile, pile cap construction, blockwork seawall and existing caisson extension, and Process Building construction works.</p> <p>Dominant sea current direction was found to be from Northwest to Southeast at waters around Shek Kwu Chau.</p>

<p>An exceedance of action level was found at M1. M1 was located at unrelated stream direction (neither upstream nor downstream, far away) to the works location. The exceedance is deemed to be unrelated to the Project.</p> <p>The installation of caisson No.19 was completed on 18 Mar 2021, the reclamation area was enclosed.</p> <p>According to the field observation by sampling team during sampling event, no silt plume was observed in the Project site and the weather was sunny during the sampling event.</p> <p>No major observation of improper site practices that contributed to the increase of the suspended solids was recorded during the site weekly inspection on 20 October 2022.</p> <p>After the investigation, the exceedance on 21 October 2022 at M1 is deemed to be unrelated to the Project.</p>
--	---

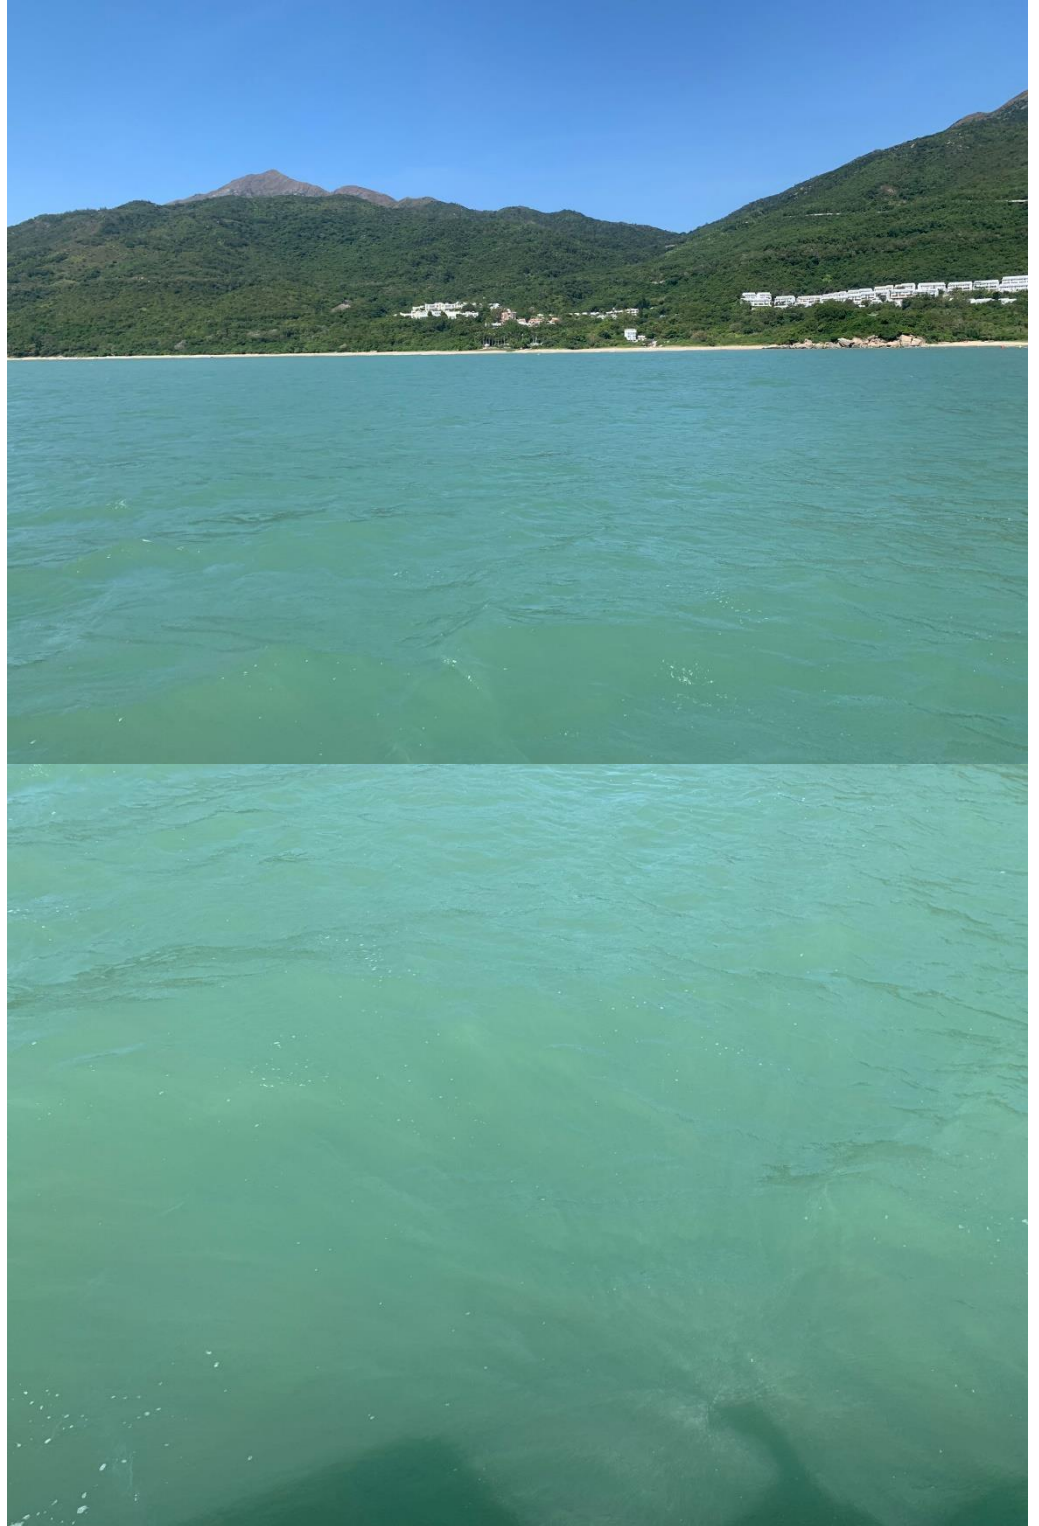
B1:

20.0 mg/L (B1) 19.3 mg/L (B2) 19.7 mg/L (CR1)	16.0 mg/L (C1A) 18.3 mg/L (C2A)	18.0 mg/L (B3) 17.8 mg/L (B4) 19.0 mg/L (F1A) 18.0 mg/L (H1) 17.8 mg/L (M1) 18.7 mg/L (CR2)
Possible reason for Action or Limit Level Non-compliance	<p>Works scheduled on site on 26 Oct 2022 include infilling of G200 rock at Caissons 63 – 65, landfilling works for above +6.00mPD, piling works, piling works for driven pile, piling works for pre-bored socketed H-pile, pile cap construction, blockwork seawall and existing caisson extension, and Process Building construction works.</p> <p>Dominant sea current direction was found to be from Northwest to Southeast at waters around Shek Kwu Chau.</p> <p>Exceedances of action level were found at B1, B2 and CR1.</p> <p>B1 and B2 were located at unrelated stream direction (neither upstream nor downstream, far away) to the works location. Exceedances are deemed to be unrelated to the Project. The installation of caisson No.19 was completed on 18 Mar 2021, the reclamation area was enclosed.</p>

<p>According to the field observation by sampling team during sampling event, no silt plume was observed in the Project site and the weather was sunny during the sampling event.</p> <p>No major observation of improper site practices that contributed to the increase of the suspended solids was recorded during the site weekly inspection on 03 November 2022.</p> <p>After the investigation, the exceedances on 26 October 2022 at B1, B2 and CR1 are deemed to be unrelated to the Project.</p>
--	---

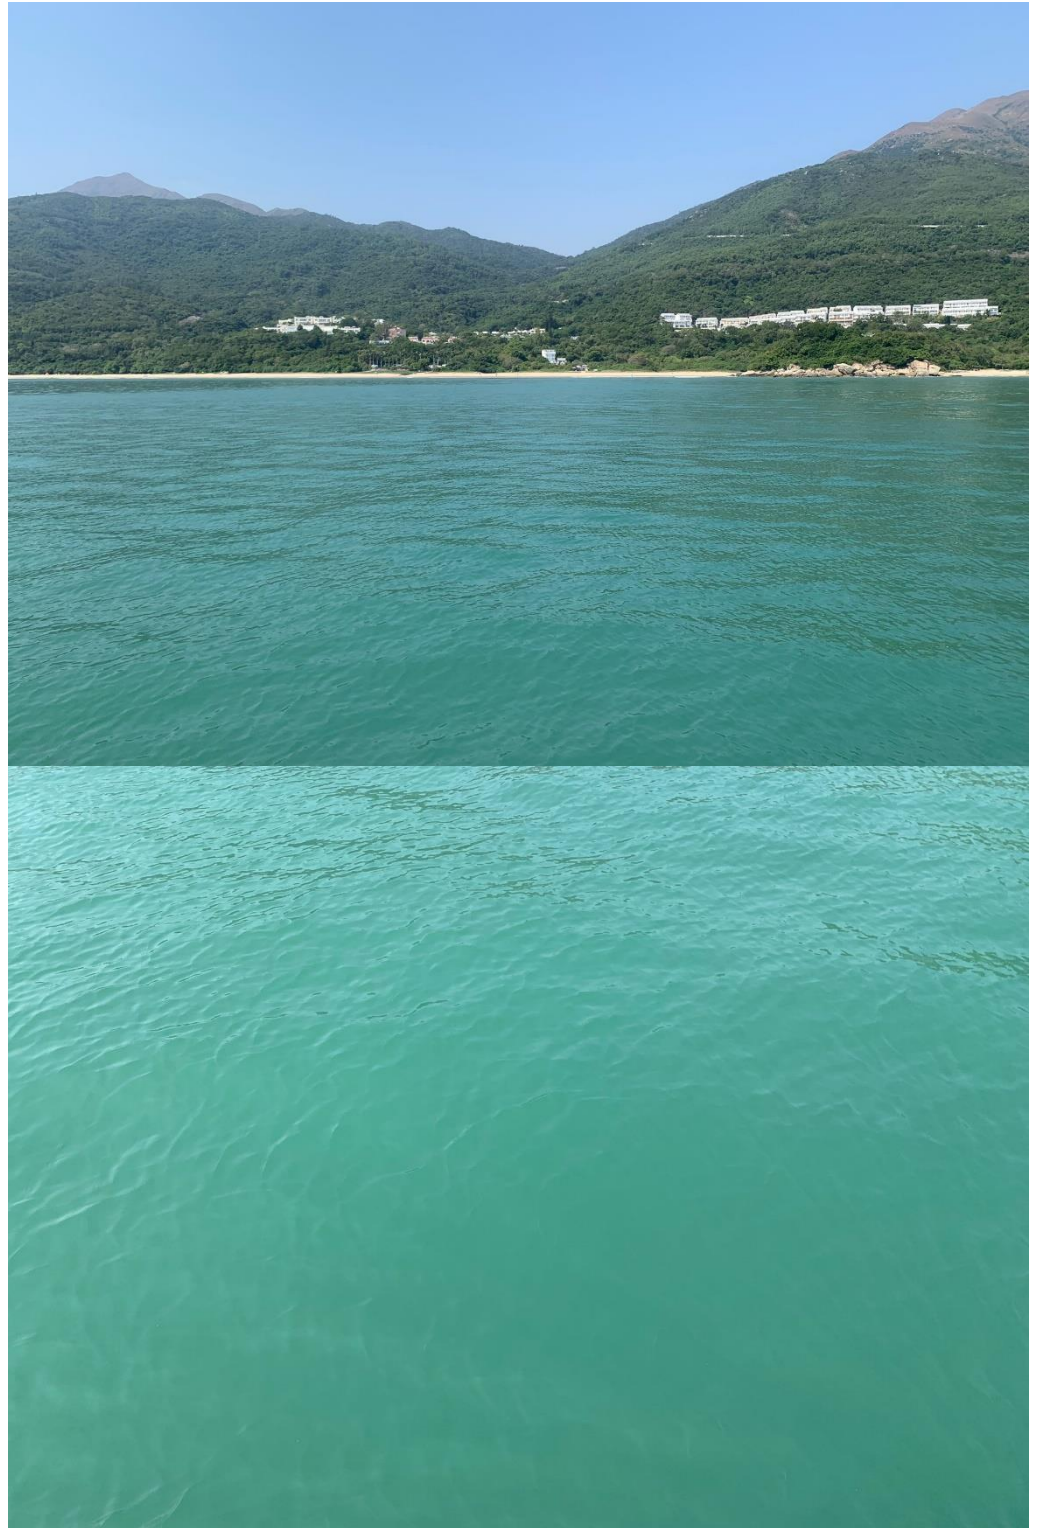
B1:

24.5 mg/L (B1)	17.3 mg/L (C1A) 16.8 mg/L (C2A)	9.3 mg/L (B2) 18.5 mg/L (B3) 17.5 mg/L (B4) 17.3 mg/L (F1A) 19.2 mg/L (H1) 17.2 mg/L (M1) 14.0 mg/L (CR1) 16.2 mg/L (CR2)
Possible reason for Action or Limit Level Non-compliance	<p>Works scheduled on site on 28 Oct 2022 include laying of 900kg underlayer rock at Seawall A seaside CH80 - CH200, installation of stoppers at Caissons 55 – 59, infilling of G200 rock at Caisson 45 – 47, landfilling works for below +6.00mPD, piling works, piling works for driven pile, piling works for pre-bored socketed H-pile, pile cap construction, blockwork seawall and existing caisson extension, and Process Building construction works.</p> <p>Dominant sea current direction was found to be from Northwest to Southeast at waters around Shek Kwu Chau.</p> <p>An exceedance of limit level was found at B1. B1 was located at unrelated stream direction (neither upstream nor downstream, far away) to the works location. The exceedance is deemed to be unrelated to the Project.</p>

<p>The installation of caisson No.19 was completed on 18 Mar 2021, the reclamation area was enclosed.</p> <p>According to the field observation by sampling team during sampling event, no silt plume was observed in the Project site and the weather was sunny during the sampling event.</p> <p>No major observation of improper site practices that contributed to the increase of the suspended solids was recorded during the site weekly inspection on 03 November 2022.</p> <p>After the investigation, the exceedance on 28 October 2022 at B1 is deemed to be unrelated to the Project.</p>
--	---
