## Appendix N Exceedance Report

## Statistical Summary of Exceedances in the Reporting Period

**Incident Report on Action Level or Limit Level Non-compliance**

| Project | Integrated Waste Management Facilities, Phase 1 | | |

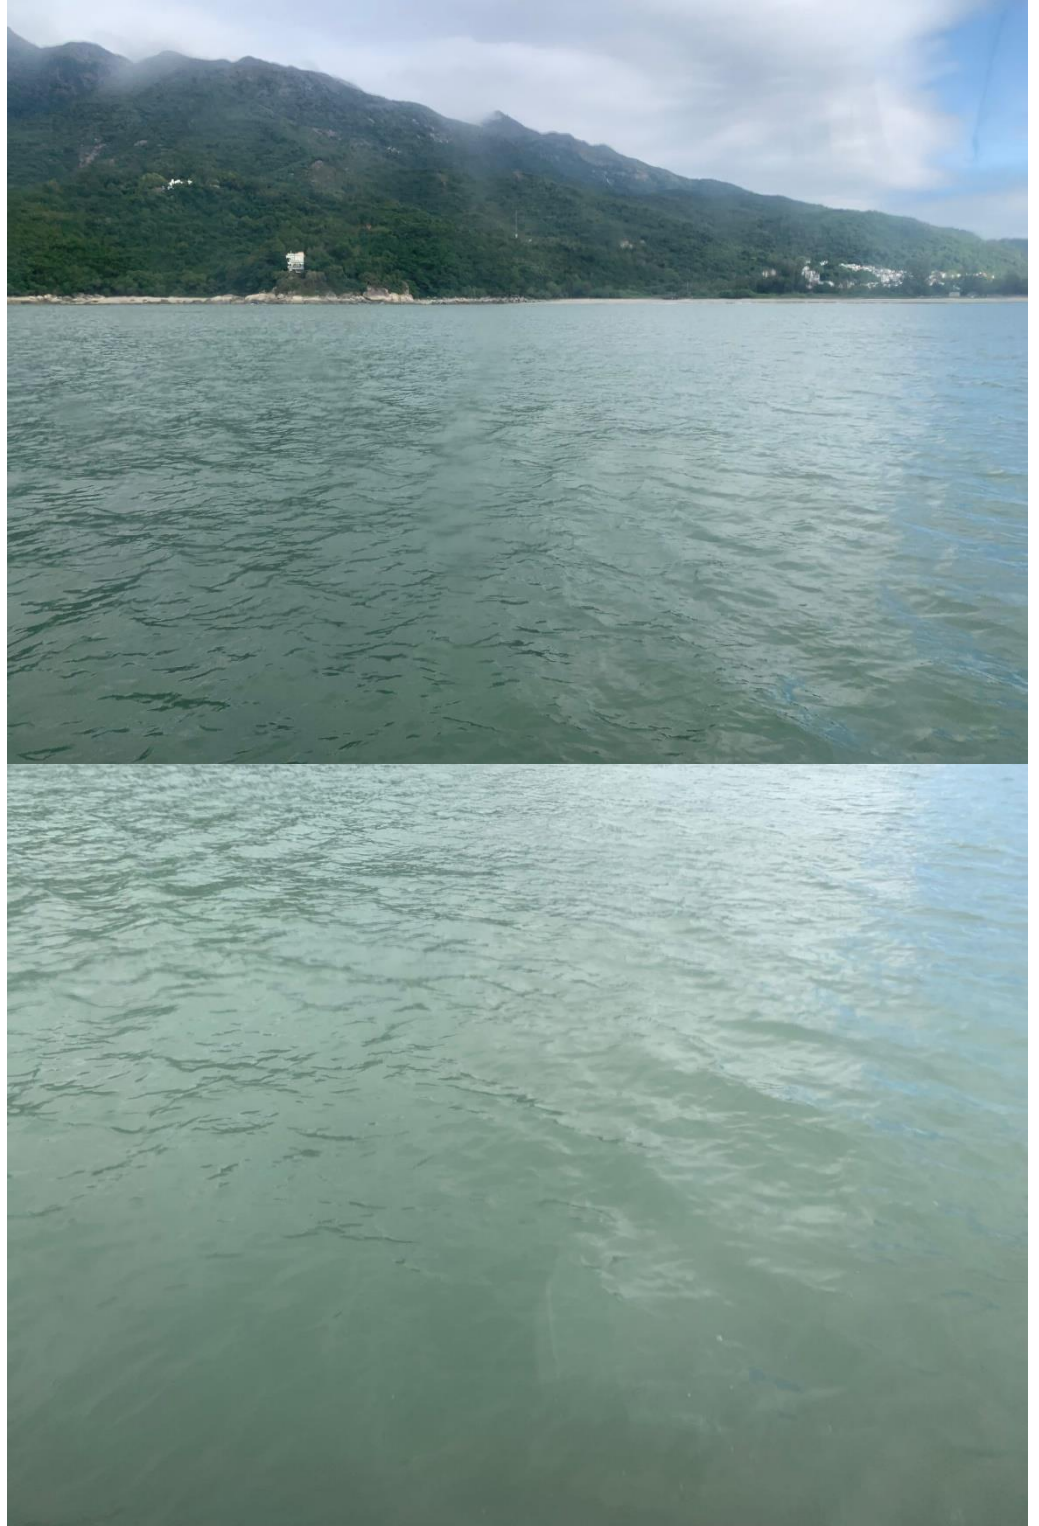
CR2:

| | 22.2 mg/L (CR2) | 17.7 mg/L (C1A)<br>18.0 mg/L (C2A) | 12.8 mg/L (B1)<br>16.5 mg/L (B2)<br>19.3 mg/L (B3)<br>20.8 mg/L (B4)<br>19.5 mg/L (H1)<br>15.0 mg/L (F1A)<br>19.3 mg/L (M1)<br>19.3 mg/L (CR1) |
| Possible reason for Action or Limit Level Non-compliance | <p>Works scheduled on site on 02 Dec 2022 include laying of 900kg underlayer rock at Seawall A Seaside CH 20 – CH 70, laying of G200 rockfills at Caisson 46 - 47, transfer of surcharge at zone 6 to flat top barge Hong Kong 3132, piling works, piling works for driven pile, piling works for pre-bored socketed H-pile, pile cap construction, blockwork seawall and existing caisson extension, and Process Building construction works.</p> <p>Dominant sea current direction was found to be from Northwest to Southeast at waters around Shek Kwu Chau.</p> <p>An exceedance of action level was found at CR2.</p> | | |

| | <p>The installation of caisson No.19 was completed on 18 Mar 2021, the reclamation area was enclosed.</p> <p>According to the field observation by sampling team during sampling event, no silt plume was observed in the Project site and the weather was fine during the sampling event.</p> <p>No major observation of improper site practices that contributed to the increase of the suspended solids was recorded during the weekly site inspection on 06 December 2022.</p> <p>After the investigation, the exceedance on 02 December 2022 during ebb tide at CR2 is deemed to be unrelated to the Project.</p> |

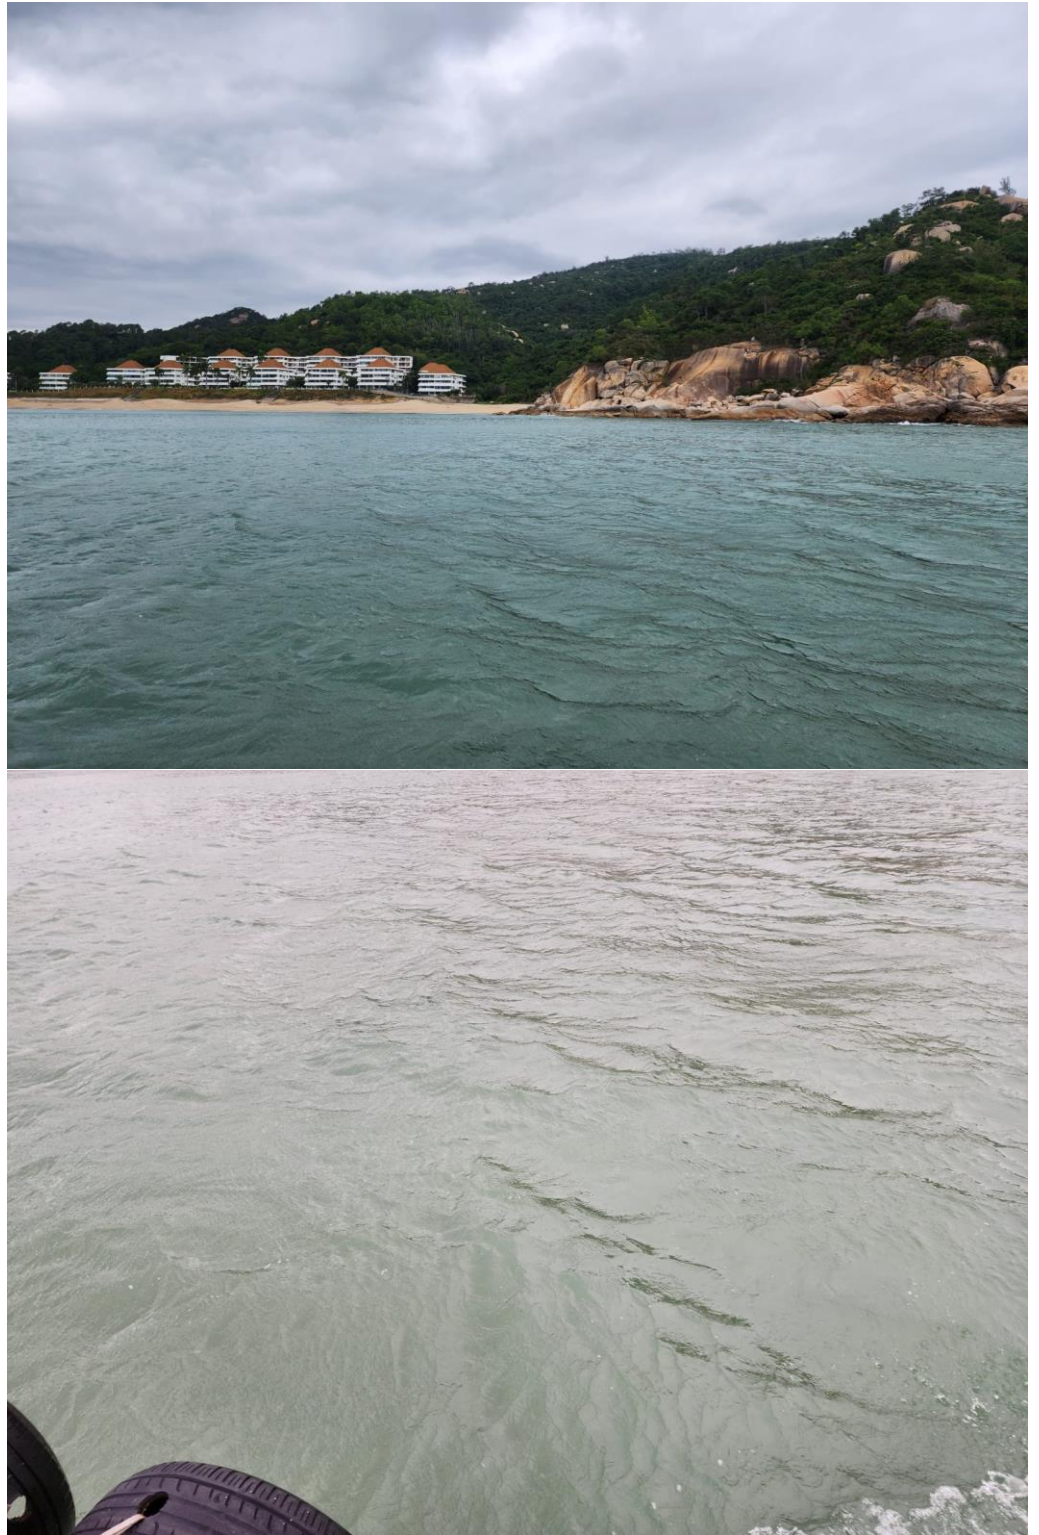
B3:

| | 12.4 mg/L (B3)<br>14.3 mg/L (B4)<br>9.5 mg/L (H1)<br>11.0 mg/L (M1)<br>9.5 mg/L (F1A)<br>12.5 mg/L (CR2) | 5.8 mg/L (C1A)<br>11.7 mg/L (C2A) | 7.8 mg/L (B1)<br>6.0 mg/L (B2)<br>5.5 mg/L (CR1) |
| Possible reason for Action or Limit Level Non-compliance | <p>Works scheduled on site on 05 Dec 2022 include installation of stoppers at Breakwater A CH 1120 A - D, weighing test of 2.5T armour rock, piling works, piling works for driven pile, piling works for pre-bored socketed H-pile, pile cap construction, blockwork seawall and existing caisson extension, and Process Building construction works.</p> <p>Dominant sea current direction was found to be from Northwest to Southeast at waters around Shek Kwu Chau.</p> <p>Exceedances of action level were found at H1 and F1A and exceedances of limit level were found at B3, B4, M1 and CR2.</p> <p>B3, B4, H1, M1 and F1A are located at unrelated stream direction (neither upstream nor downstream) to the works location. Exceedances at B3, B4, H1, M1 and F1A are deemed to be unrelated to the Project.</p> | | |

| | <p>The installation of caisson No.19 was completed on 18 Mar 2021, the reclamation area was enclosed.</p> <p>According to the field observation by sampling team during sampling event, no silt plume was observed in the Project site and the weather was rainy during the sampling event.</p> <p>No major observation of improper site practices that contributed to the increase of the suspended solids was recorded during the weekly site inspection on 06 December 2022.</p> <p>After the investigation, the exceedances on 05 December 2022 during ebb tide at B3, B4, F1A, H1, M1 and CR2 are deemed to be unrelated to the Project.</p> |

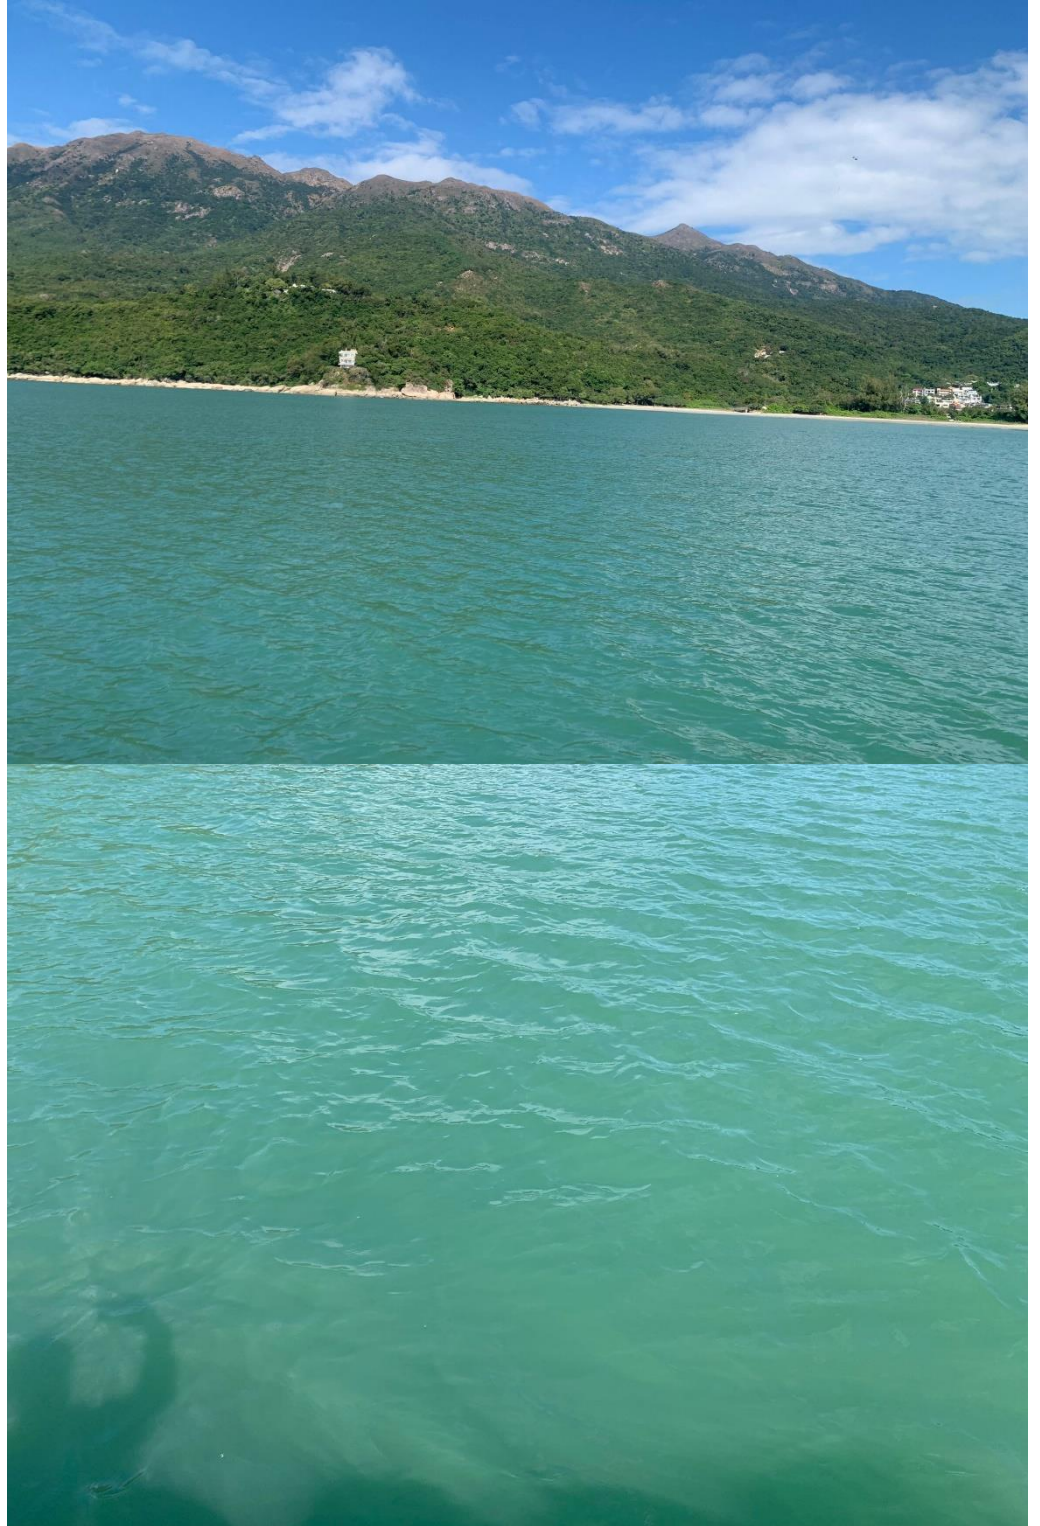
B2:

| | 18.8 mg/L (B2)<br>17.8 mg/L (CR2) | 14.0 mg/L (C1A)<br>16.7 mg/L (C2A) | 7.8 mg/L (B1)<br>7.8 mg/L (B3)<br>15.5 mg/L (B4)<br>13.5 mg/L (H1)<br>16.0 mg/L (F1A)<br>15.5 mg/L (M1)<br>16.2 mg/L (CR1) |
| Possible reason for Action or Limit Level Non-compliance | <p>Works scheduled on site on 07 Dec 2022 include inspection works of Chinese pods at Seawall A seaside CH600 - CH720, laying of 4T armour rock at Breakwater A CH1120 A - D, piling works, piling works for driven pile, piling works for pre-bored socketed H-pile, pile cap construction, blockwork seawall and existing caisson extension, and Process Building construction works.</p> <p>Dominant sea current direction was found to be from Northwest to Southeast at waters around Shek Kwu Chau.</p> <p>An exceedance of action level was found at CR2, and an exceedance of limit level was found B2.</p> | | |

| | <p>B2 is located at unrelated stream direction (neither upstream nor downstream, far away) to the works location. The exceedance at B2 is deemed to be unrelated to the Project.</p> <p>The installation of caisson No.19 was completed on 18 Mar 2021, the reclamation area was enclosed.</p> <p>According to the field observation by sampling team during sampling event, no silt plume was observed in the Project site and the weather was fine during the sampling event.</p> <p>No major observation of improper site practices that contributed to the increase of the suspended solids was recorded during the weekly site inspection on 13 December 2022.</p> <p>After the investigation, the exceedances on 07 December 2022 during ebb tide at B2 and CR2 are deemed to be unrelated to the Project.</p> |

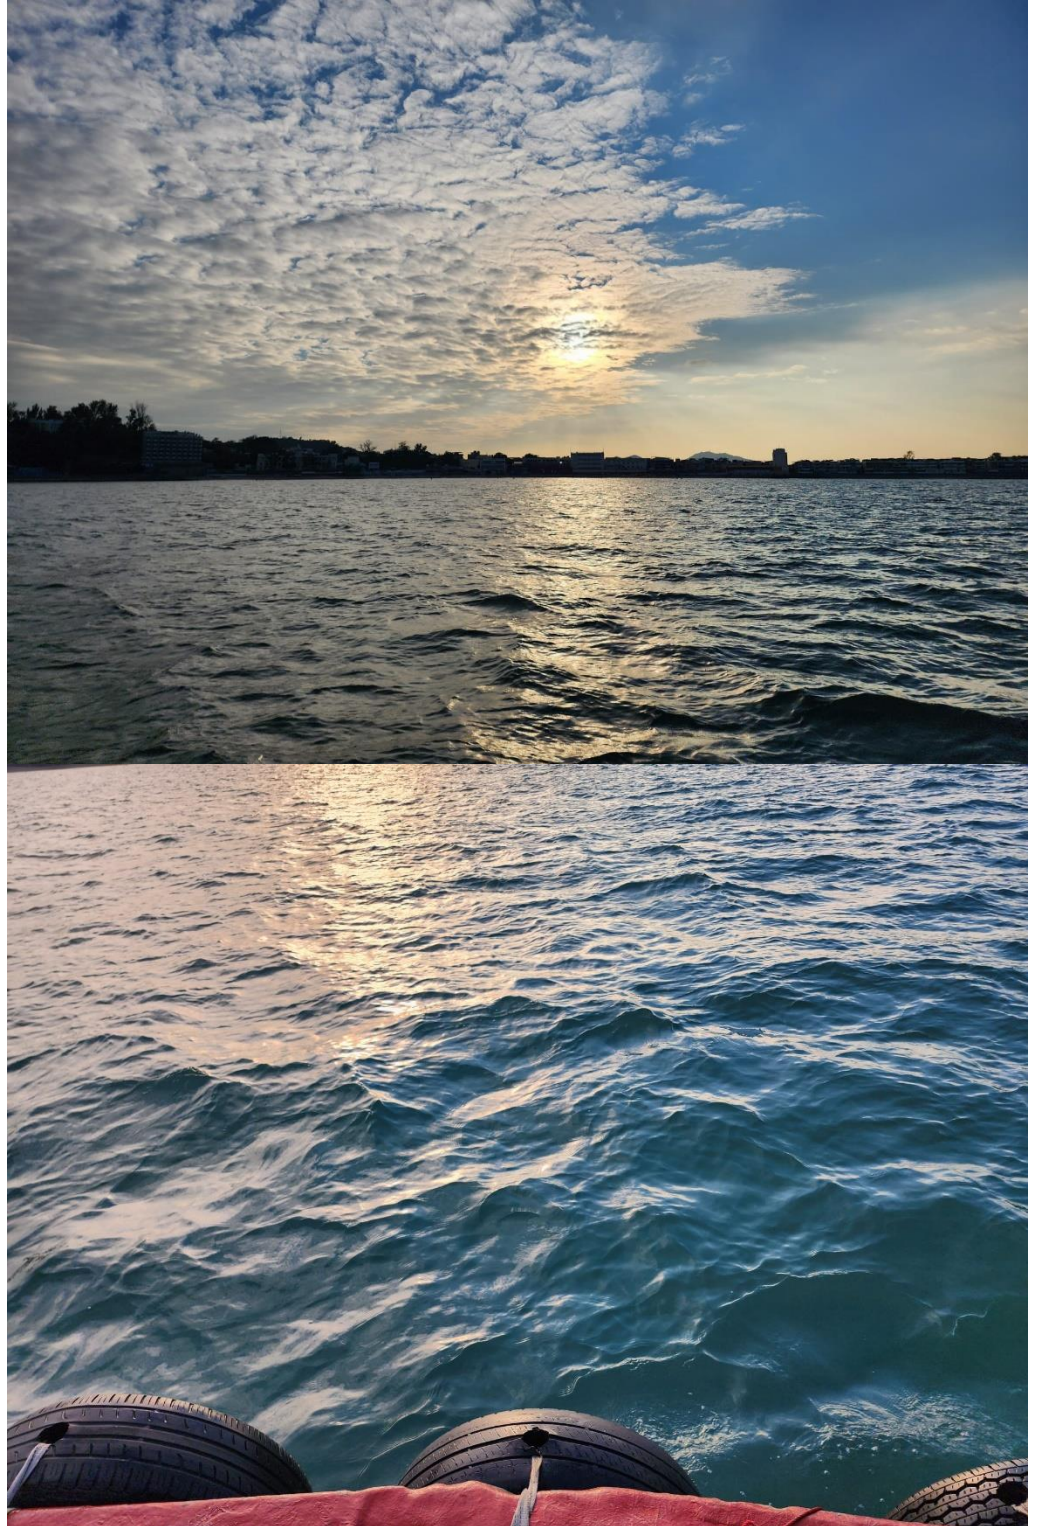
M1:

| Mid-Flood | | | |
|--|---|---|--|
| | 15.3 mg/L (M1)<br>15.8 mg/L (CR1) | 10.7 mg/L (C1A)<br>11.8 mg/L (C2A) | 8.0 mg/L (B1)<br>10.3 mg/L (B2)<br>7.0 mg/L (B3)<br>12.5 mg/L (B4)<br>12.2 mg/L (F1A)<br>13.3 mg/L (H1)<br>12.5 mg/L (CR2) |
| Possible reason for Action or Limit Level Non-compliance | <p>Works scheduled on site on 07 Dec 2022 include inspection works of Chinese pods at Seawall A seaside CH600 - CH720, laying of 4T armour rock at Breakwater A CH1120 A - D, piling works, piling works for driven pile, piling works for pre-bored socketed H-pile, pile cap construction, blockwork seawall and existing caisson extension, and Process Building construction works.</p> <p>Dominant sea current direction was found to be from Southeast to Northwest at waters around Shek Kwu Chau.</p> <p>An exceedance of action level was found at M1, and an exceedance of limit level was found at CR1.</p> <p>M1 is located at unrelated stream direction (neither upstream nor downstream) to the works location. The exceedance at M1 is deemed to be unrelated to the Project.</p> <p>The installation of caisson No.19 was completed on 18 Mar 2021, the reclamation area was enclosed.</p> | | |

| | <p>According to the field observation by sampling team during sampling event, no silt plume was observed in the Project site and the weather was fine during the sampling event.</p> <p>No major observation of improper site practices that contributed to the increase of the suspended solids was recorded during the weekly site inspection on 13 December 2022.</p> <p>After the investigation, the exceedances on 07 December 2022 during flood tide at M1 and CR1 are deemed to be unrelated to the Project.</p> |

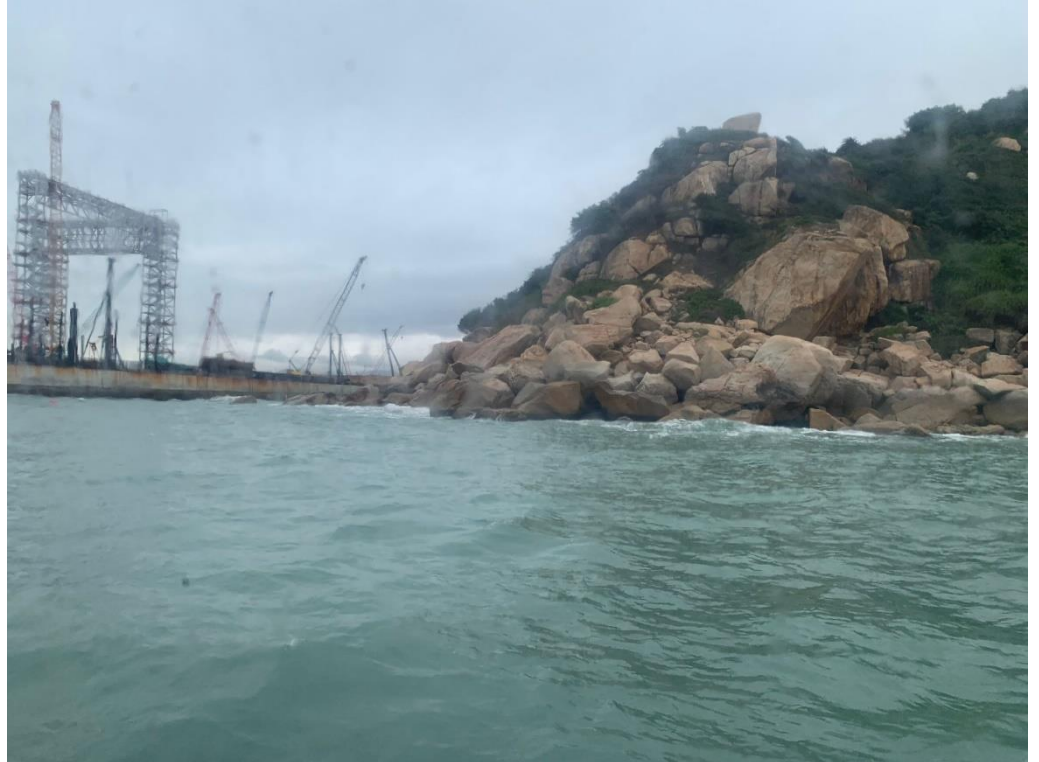
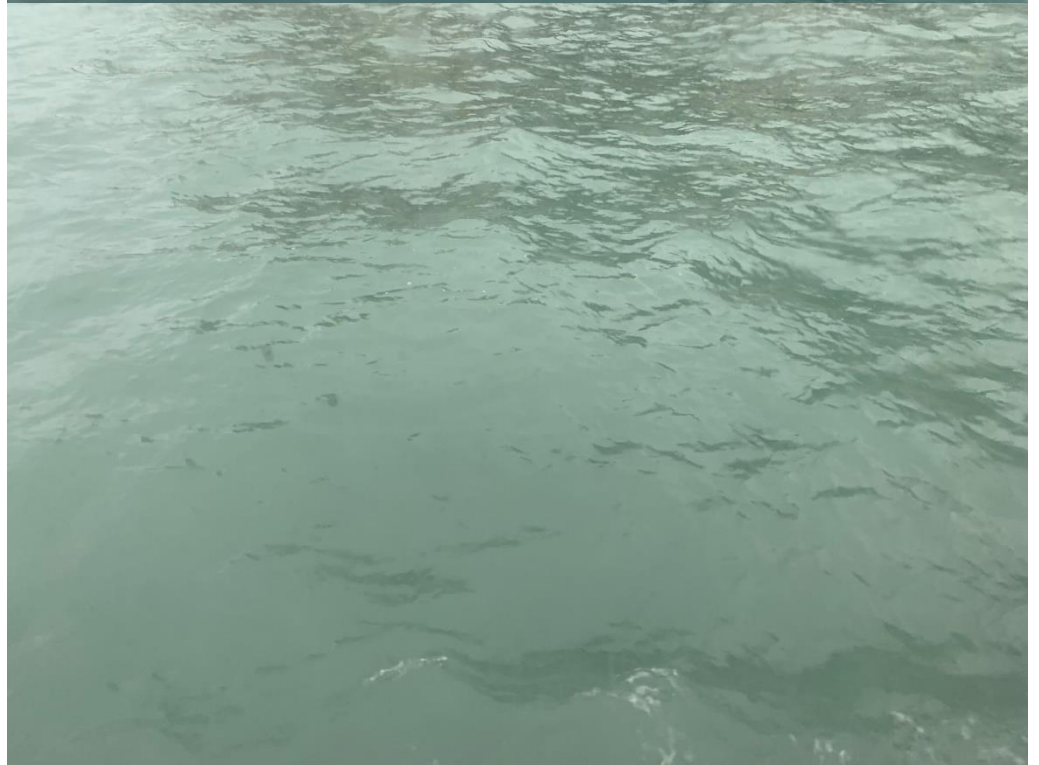
CR1:

| | 8.7 mg/L (CR1) | 7.2 mg/L (C1A)<br>5.1 mg/L (C2A) | 4.5 mg/L (B1)<br>4.8 mg/L (B2)<br>5.0 mg/L (B3)<br>5.0 mg/L (B4)<br>4.1 mg/L (H1)<br>6.0 mg/L (F1A)<br>6.2 mg/L (M1)<br>6.8 mg/L (CR2) |
| Possible reason for Action or Limit Level Non-compliance | <p>Works scheduled on site on 16 Dec 2022 include laying of 900kg underlayer rock at Seawall A seaside CH300 - CH400, inspection works of Chinese pods at Seawall A seaside CH480 - CH570, laying of 2.5T armour rock at Breakwater A seaside CH1000 - CH1100, piling works, piling works for driven pile, piling works for pre-bored socketed H-pile, pile cap construction, blockwork seawall and existing caisson extension, and Process Building construction works.</p> <p>Dominant sea current direction was found to be from Southeast to Northwest at waters around Shek Kwu Chau.</p> <p>An exceedance of action level was found at CR1.</p> | | |

| | <p>According to the field observation by sampling team during sampling event, no silt plume was observed in the Project site.</p> <p>The installation of caisson No.19 was completed on 18 Mar 2021, the reclamation area was enclosed.</p> <p>According to the field observation by sampling team during sampling event, no silt plume was observed in the Project site and the weather was fine during the sampling event.</p> <p>No major observation of improper site practices that contributed to the increase of the suspended solids was recorded during the weekly site inspection on 20 December 2022.</p> <p>After the investigation, the exceedance on 16 December 2022 during flood tide at CR1 is deemed to be unrelated to the Project.</p> |

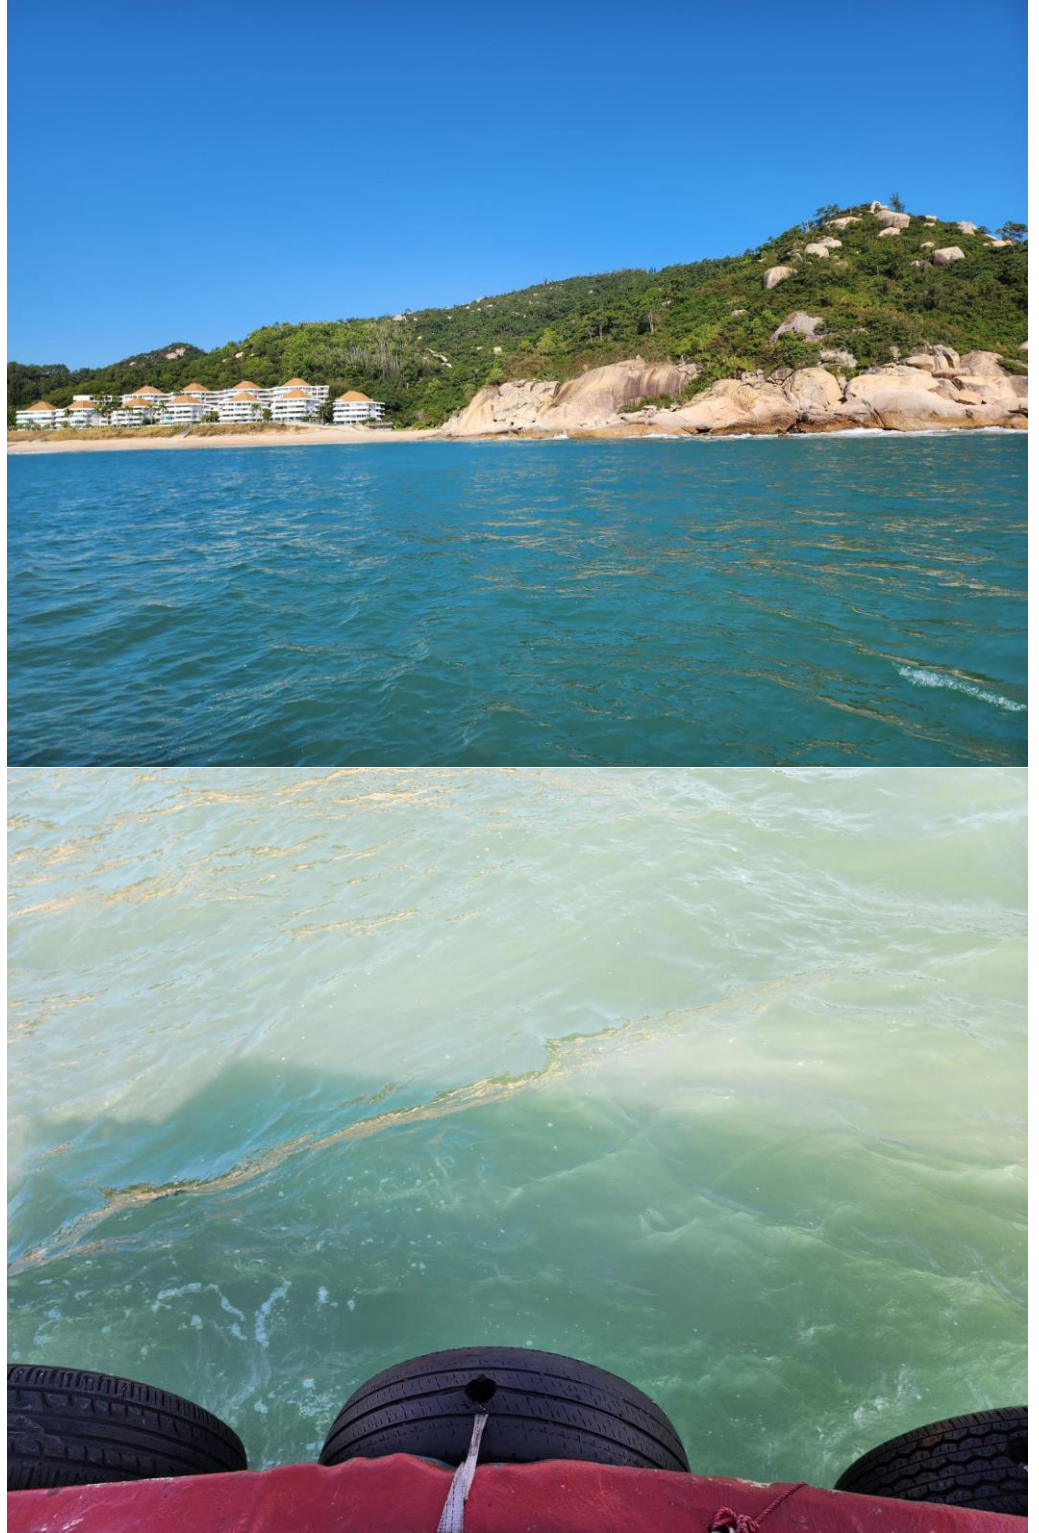
B3:

| | 11.0 mg/L (B3)<br>20.8 mg/L (B4)<br>16.7 mg/L (H1)<br>10.3 mg/L (M1) | 6.8 mg/L (C1A)<br>8.2 mg/L (C2A) | 8.0 mg/L (B1)<br>6.3 mg/L (B2)<br>7.5 mg/L (F1A)<br>6.8 mg/L (CR1)<br>5.7 mg/L (CR2) |
| Possible reason for Action or Limit Level Non-compliance | <p>Works scheduled on site on 19 Dec 2022 include laying of 500kg underlayer rock at Breakwater B landside CH200, laying of 2.5T armour rock at Breakwater A seaside CH1000 - CH1050, laying of 900kg underlayer rock at Seawall A seaside CH330 - CH430, piling works, piling works for driven pile, piling works for pre-bored socketed H-pile, pile cap construction, blockwork seawall and existing caisson extension, and Process Building construction works.</p> <p>Dominant sea current direction was found to be from Northwest to Southeast at waters around Shek Kwu Chau.</p> <p>Exceedances of limit level were found at B3, B4, H1 and M1. B3, B4, H1 and M1 are located at unrelated stream direction (neither upstream nor downstream) to the works location.</p> | | |

| | <p>According to the field observation by sampling team during sampling event, no silt plume was observed in the Project site.</p> <p>The installation of caisson No.19 was completed on 18 Mar 2021, the reclamation area was enclosed.</p> <p>According to the field observation by sampling team during sampling event, no silt plume was observed in the Project site and the weather was fine during the sampling event.</p> <p>No major observation of improper site practices that contributed to the increase of the suspended solids was recorded during the weekly site inspection on 20 December 2022.</p> <p>After the investigation, the exceedances on 19 December 2022 during ebb tide at B3, B4, H1 and M1 are deemed to be unrelated to the Project.</p> |

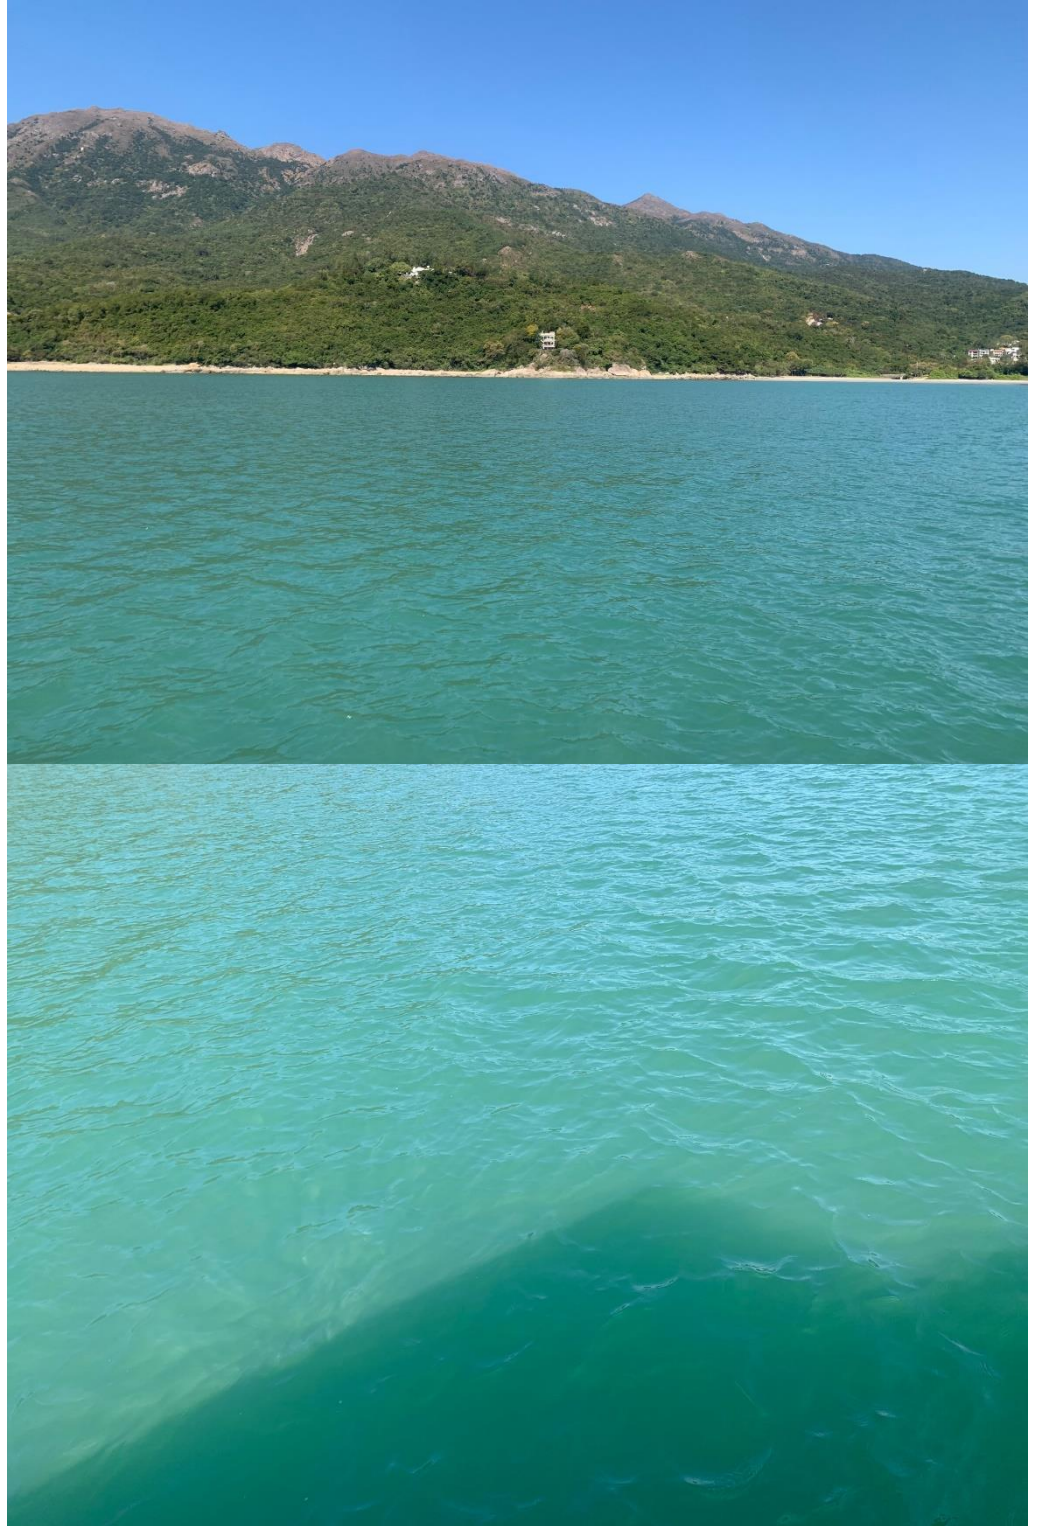
B2:

| | 10.3 mg/L (B2) | 8.5 mg/L (C1A)<br>8.2 mg/L (C2A) | 6.3 mg/L (B1)<br>7.5 mg/L (B3)<br>6.8 mg/L (B4)<br>6.5 mg/L (H1)<br>7.2 mg/L (M1)<br>8.5 mg/L (F1A)<br>7.7 mg/L (CR1)<br>7.2 mg/L (CR2) |
| Possible reason for Action or Limit Level Non-compliance | <p>Works scheduled on site on 23 Dec 2022 include laying of 900kg underlayer rock at Breakwater B landside CH940, laying of 900kg underlayer rock at Seawall A seaside CH550 - CH670, laying of 2.5T armour rock at Breakwater A seaside CH1000 - CH1100, piling works, piling works for driven pile, piling works for pre-bored socketed H-pile, pile cap construction, blockwork seawall and existing caisson extension, and Process Building construction works.</p> <p>Dominant sea current direction was found to be from Southeast to Northwest at waters around Shek Kwu Chau.</p> <p>An exceedance of action level was found at B2. B2 is located at unrelated stream direction (neither upstream nor downstream) to the works location.</p> | | |

| | <p>According to the field observation by sampling team during sampling event, no silt plume was observed in the Project site.<br/>The installation of caisson No.19 was completed on 18 Mar 2021, the reclamation area was enclosed.</p> <p>According to the field observation by sampling team during sampling event, no silt plume was observed in the Project site and the weather was fine during the sampling event.</p> <p>No major observation of improper site practices that contributed to the increase of the suspended solids was recorded during the weekly site inspection on 28 December 2022.</p> <p>After the investigation, the exceedance on 23 December 2022 during ebb tide at B2 is deemed to be unrelated to the Project.</p> |

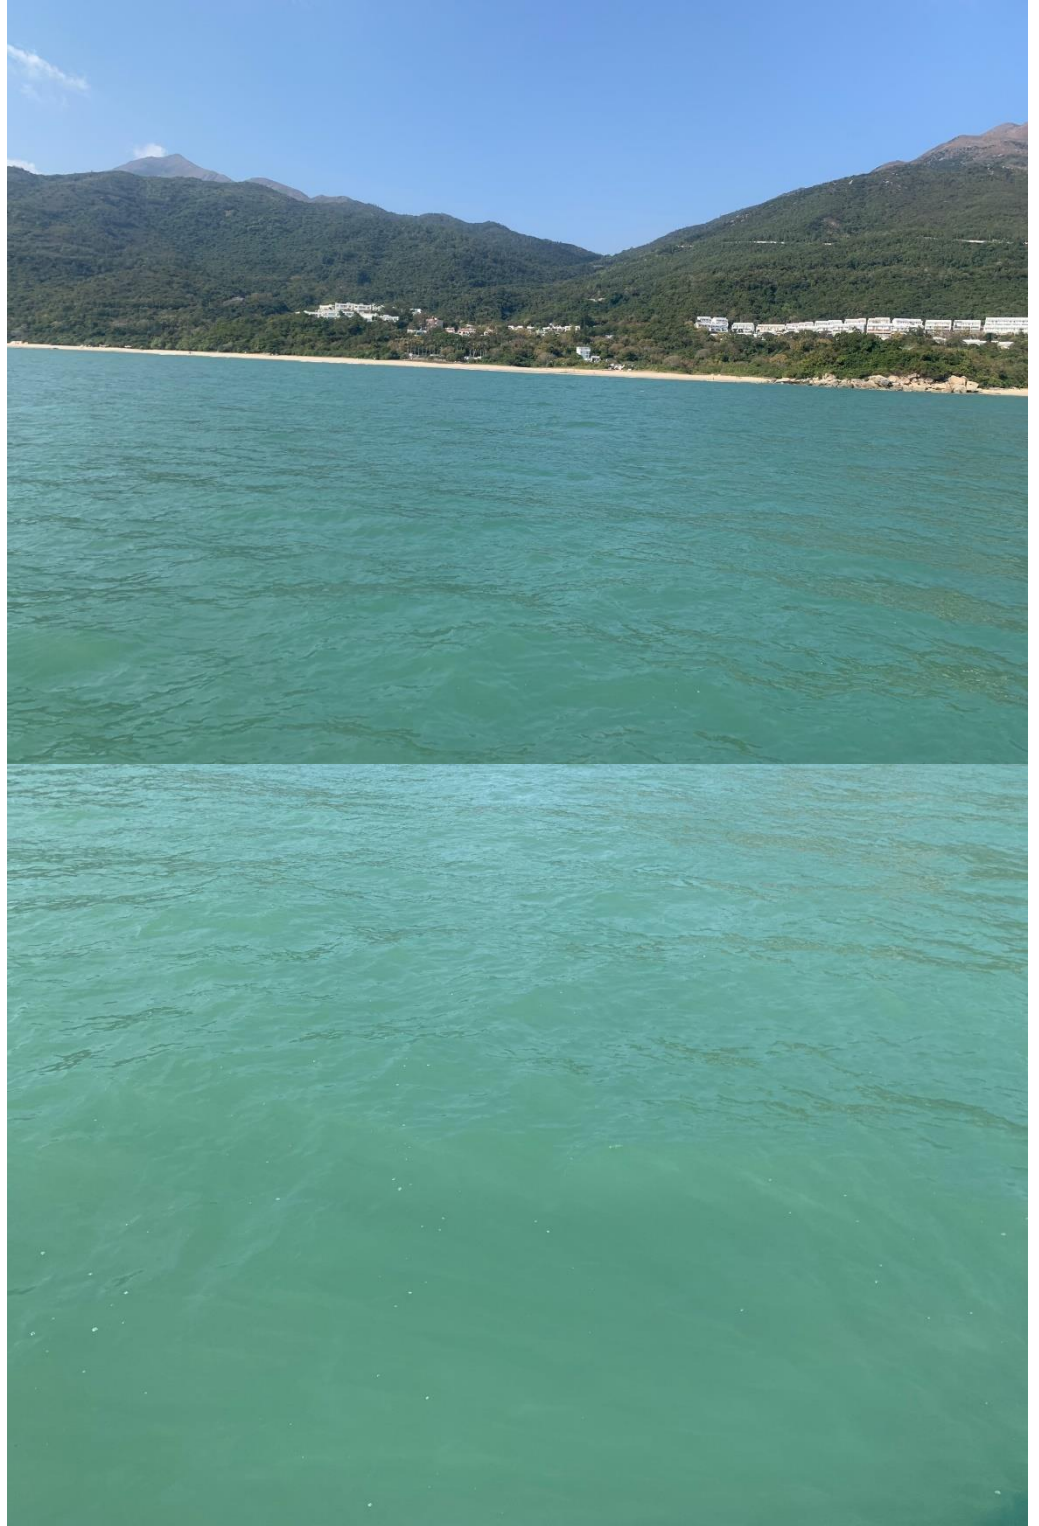
B1:

| | 9.8 mg/L (B1)<br>8.5 mg/L (B2)<br>8.8 mg/L (B3)<br>9.5 mg/L (B4)<br>11.3 mg/L (H1) | 6.0 mg/L (C1A)<br>6.5 mg/L (C2A) | 7.7 mg/L (M1)<br>7.3 mg/L (F1A)<br>6.0 mg/L (CR1)<br>6.3 mg/L (CR2) |
| Possible reason for Action or Limit Level Non-compliance | <p>Works scheduled on site on 26 Dec 2022 include laying of 4.0T armour rock at Breakwater A landside Caisson 65, laying of 900kg underlayer rock at Seawall A seaside CH590 - CH700, piling works, piling works for pre-bored socketed H-pile, pile cap construction, blockwork seawall and existing caisson extension, and Process Building construction works.</p> <p>Dominant sea current direction was found to be from Northwest to Southeast at waters around Shek Kwu Chau.</p> <p>Exceedances of action level were found at B1, B2, B3 and B4, and an exceedance of limit level was found at H1. B1, B2, B3, B4 and H1 are located at unrelated stream direction (neither upstream nor downstream) to the works location.</p> <p>According to the field observation by sampling team during sampling event, no silt plume was observed in the Project site.</p> | | |

| | <p>The installation of caisson No.19 was completed on 18 Mar 2021, the reclamation area was enclosed.</p> <p>According to the field observation by sampling team during sampling event, no silt plume was observed in the Project site and the weather was fine during the sampling event.</p> <p>No major observation of improper site practices that contributed to the increase of the suspended solids was recorded during the weekly site inspection on 28 December 2022.</p> <p>After the investigation, the exceedances on 26 December 2022 during ebb tide at B1, B2, B3, B4 and H1 are deemed to be unrelated to the Project.</p> |

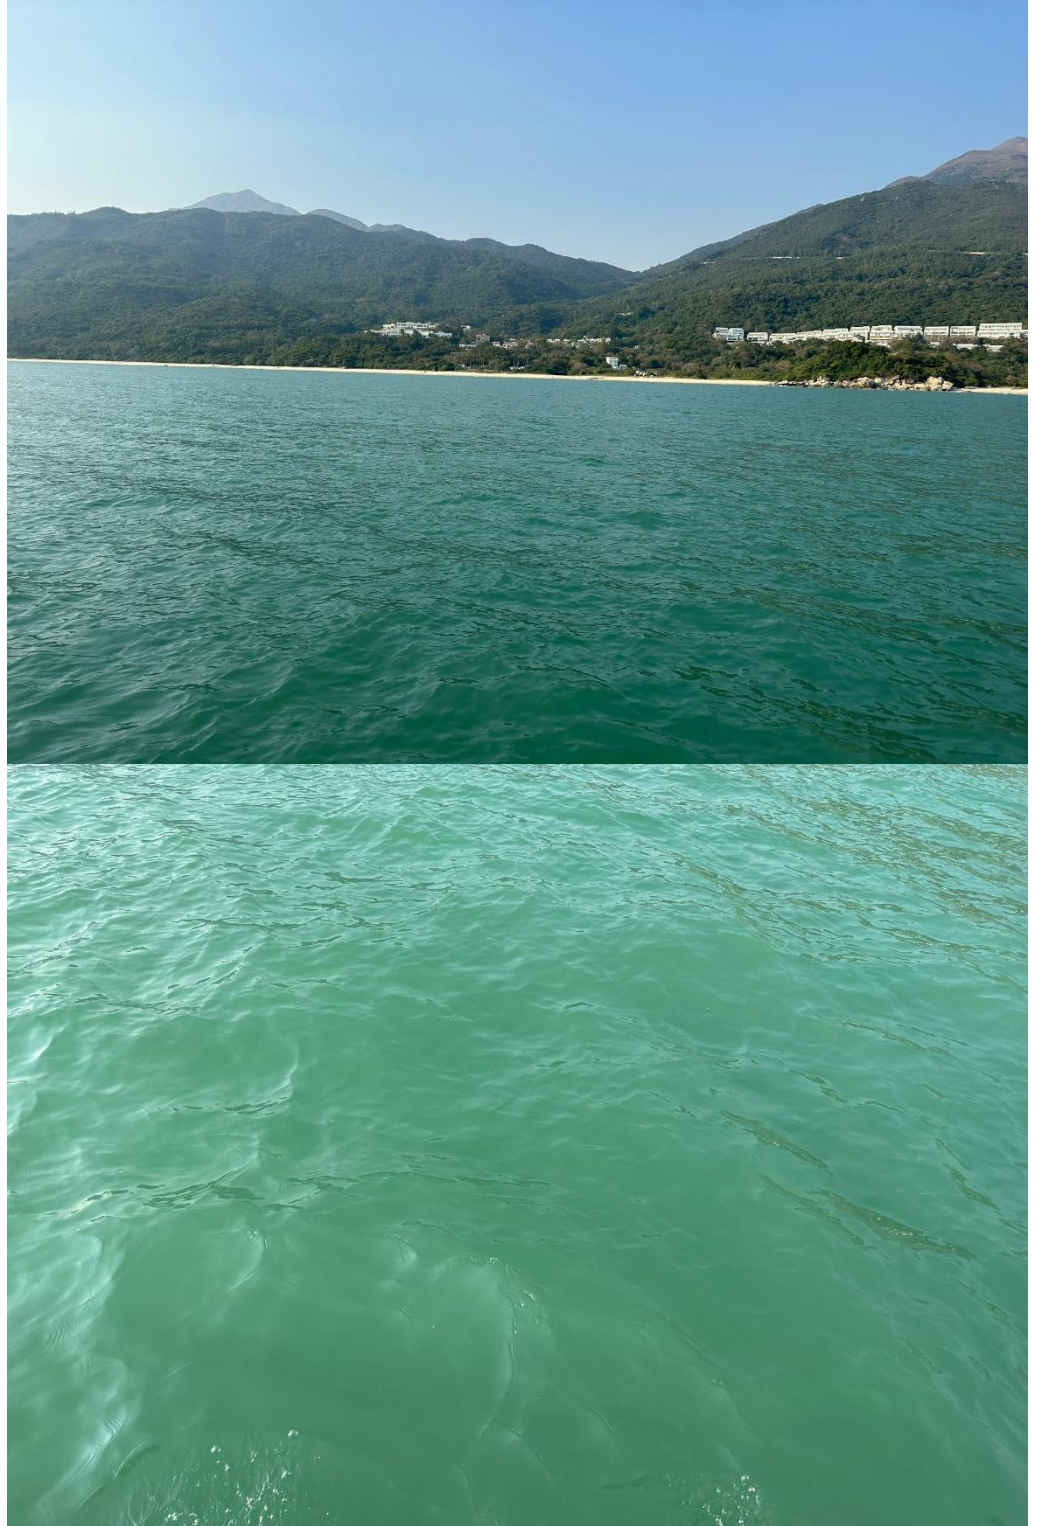
B1:

| Possible reason for Action or Limit Level Non-compliance | <p>Works scheduled on site on 28 Dec 2022 include laying of 4.0T armour rock at Breakwater A landside Caisson 65, laying of G200 rockfill at Caisson 47, piling works, piling works for pre-bored socketed H-pile, pile cap construction, blockwork seawall and existing caisson extension, and Process Building construction works.</p> <p>Dominant sea current direction was found to be from Northwest to Southeast at waters around Shek Kwu Chau.</p> <p>An exceedance of action level was found at B3, and an exceedance of limit level was found at B1.</p> <p>B1 and B3 are located at unrelated stream direction (neither upstream nor downstream) to the works location.</p> | | |

| | <p>The installation of caisson No.19 was completed on 18 Mar 2021, the reclamation area was enclosed.</p> <p>According to the field observation by sampling team during sampling event, no silt plume was observed in the Project site and the weather was sunny during the sampling event.</p> <p>No major observation of improper site practices that contributed to the increase of the suspended solids was recorded during the weekly site inspection on 28 December 2022.</p> <p>After the investigation, the exceedances on 28 December 2022 during ebb tide at B1 and B3 are deemed to be unrelated to the Project.</p> |

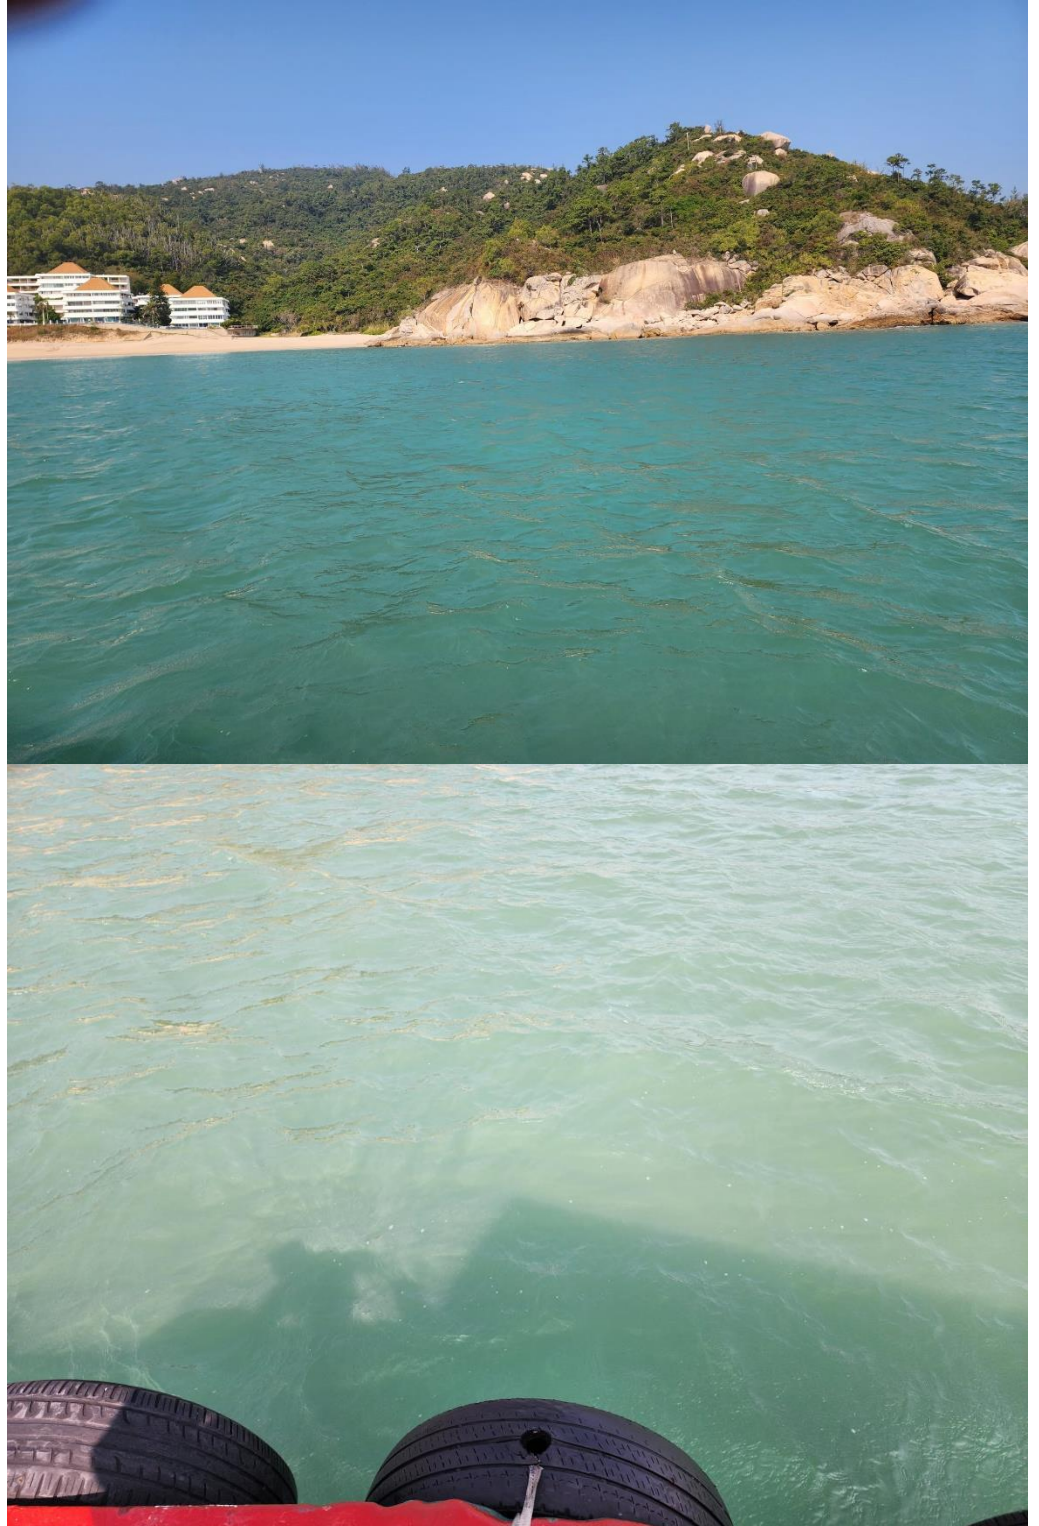
B3:

| | <p>An exceedance of action level was found at B3, and an exceedance of limit level was found CR2. B3 is located at unrelated stream direction (neither upstream nor downstream, far away) to the works location. The exceedance at B3 is deemed to be unrelated to the Project.</p> <p>The installation of caisson No.19 was completed on 18 Mar 2021, the reclamation area was enclosed.</p> <p>According to the field observation by sampling team during sampling event, no silt plume was observed in the Project site and the weather was fine during the sampling event.</p> <p>No major observation of improper site practices that contributed to the increase of the suspended solids was recorded during the weekly site inspection on 03 January 2023.</p> <p>After the investigation, the exceedances on 30 December 2022 during flood tide at B3 and CR2 are deemed to be unrelated to the Project.</p> |

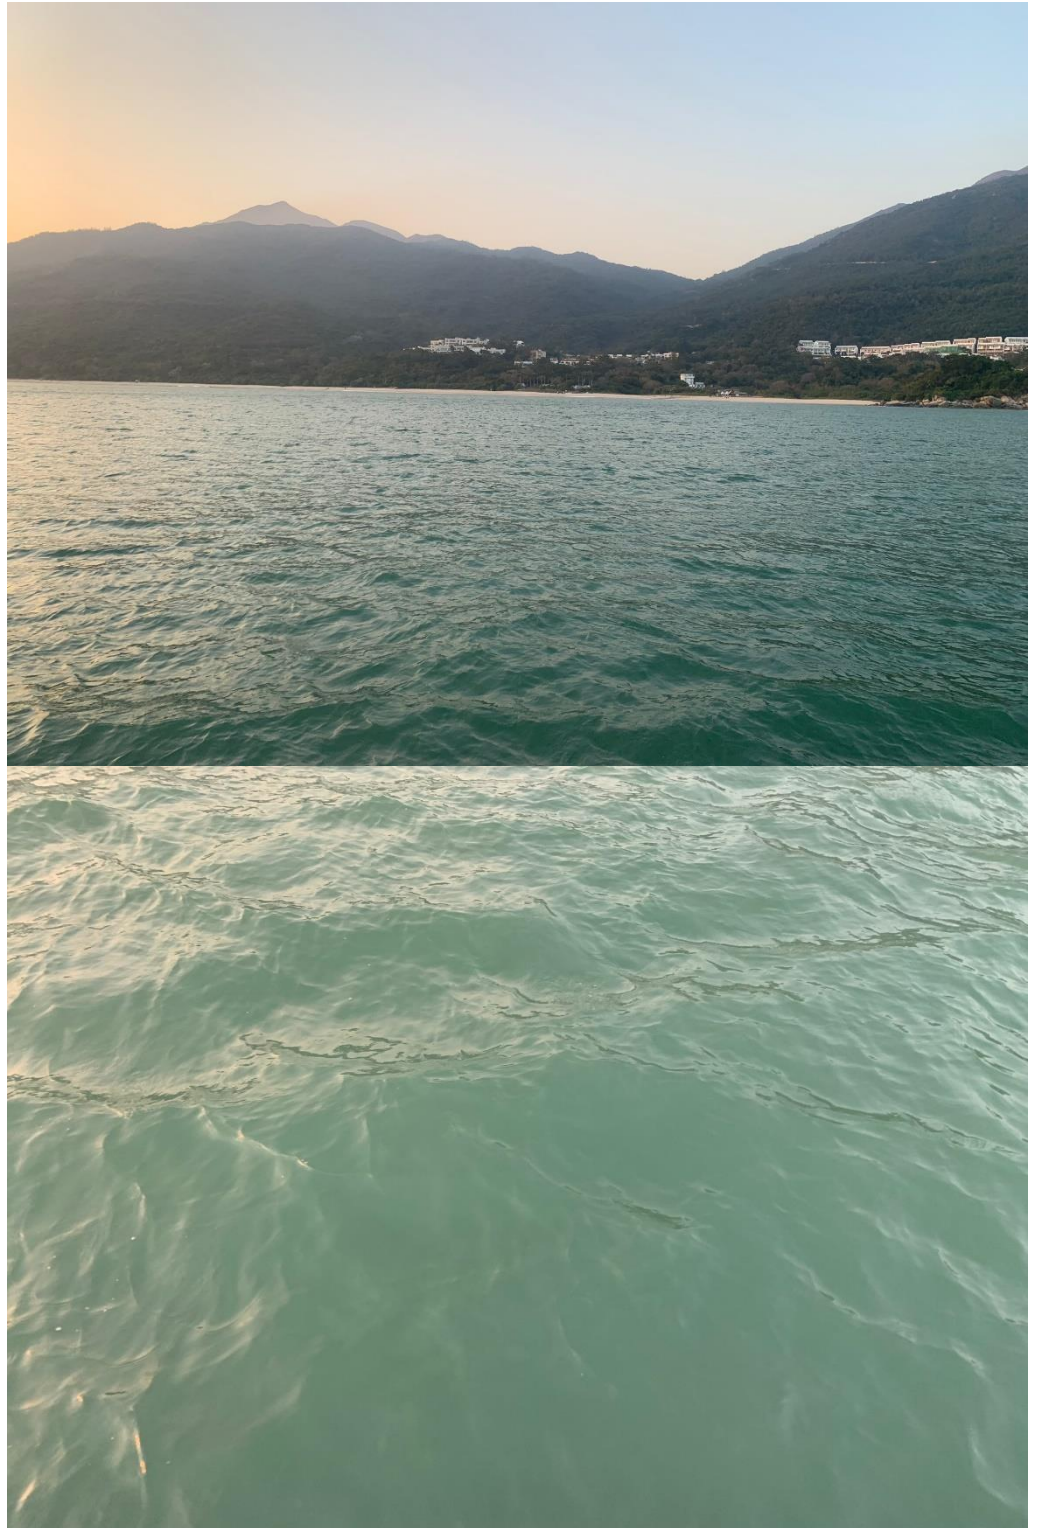
B1:

| | <p>According to the field observation by sampling team during sampling event, no silt plume was observed in the Project site and the weather was fine during the sampling event.</p> <p>No major observation of improper site practices that contributed to the increase of the suspended solids was recorded during the weekly site inspection on 03 January 2023.</p> <p>After the investigation, the exceedance on 30 December 2022 during ebb tide at B1 is deemed to be unrelated to the Project.</p> |
