Appendix N Exceedance Report

Incident Report on Action Level or Limit Level Non-compliance

Project	Integrated Waste Management Facilities, Phase 1		
Date	04 Jan 2023 (Lab result received on 13 January 2023)		
Time	09:49 – 11:56 (Mid-Ebb) 14:07 – 17:37 (Mid-Flood)		
Mid-Ebb			
Monitoring Location	B1, B2, B3, B4, H1, M1, CR1, CR2		
Parameter	Suspended Solid (SS)		
Action & Limit Levels	Action Level		Limit Level
	≥ 11.6 mg/L (120% of C1A)		≥ 12.6 mg/L (130% of C1A)
Measurement Level	Impact Station(s) of Exceedance	Control Stations	Impact Station(s) without Exceedance

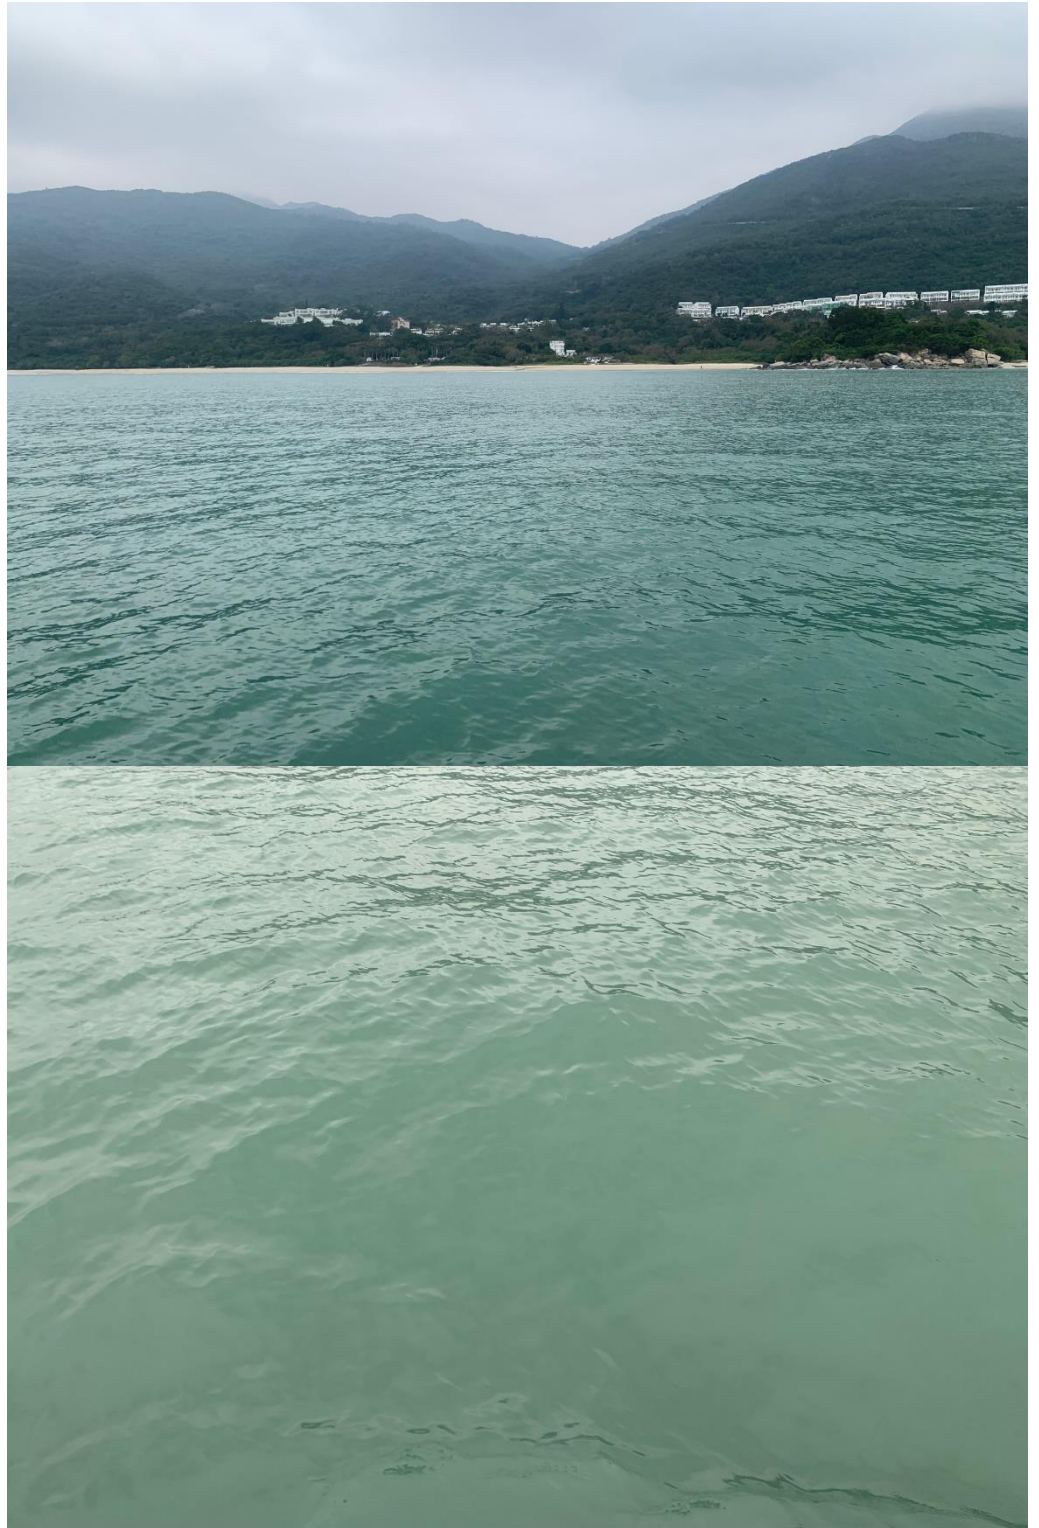
B1:

<p>Exceedances of limit level were found B1, B2, B3, B4, H1, M1, CR1 and CR2. B1, B2, B3, B4, H1 and M1 are located at unrelated stream direction (neither upstream nor downstream, far away) to the works location. Exceedances at B1, B2, B3, B4, H1 and M1 are deemed to be unrelated to the Project.</p> <p>The installation of caisson No.19 was completed on 18 Mar 2021, the reclamation area was enclosed.</p> <p>According to the field observation by sampling team during sampling event, no silt plume was observed in the Project site and the weather was overcast during the sampling event.</p> <p>No major observation of improper site practices that contributed to the increase of the suspended solids was recorded during the weekly site inspection on 10 January 2023. After the investigation, the exceedances on 04 January 2023 during ebb tide at B1, B2, B3, B4, H1, M1, CR1 and CR2 are deemed to be unrelated to the Project.</p>

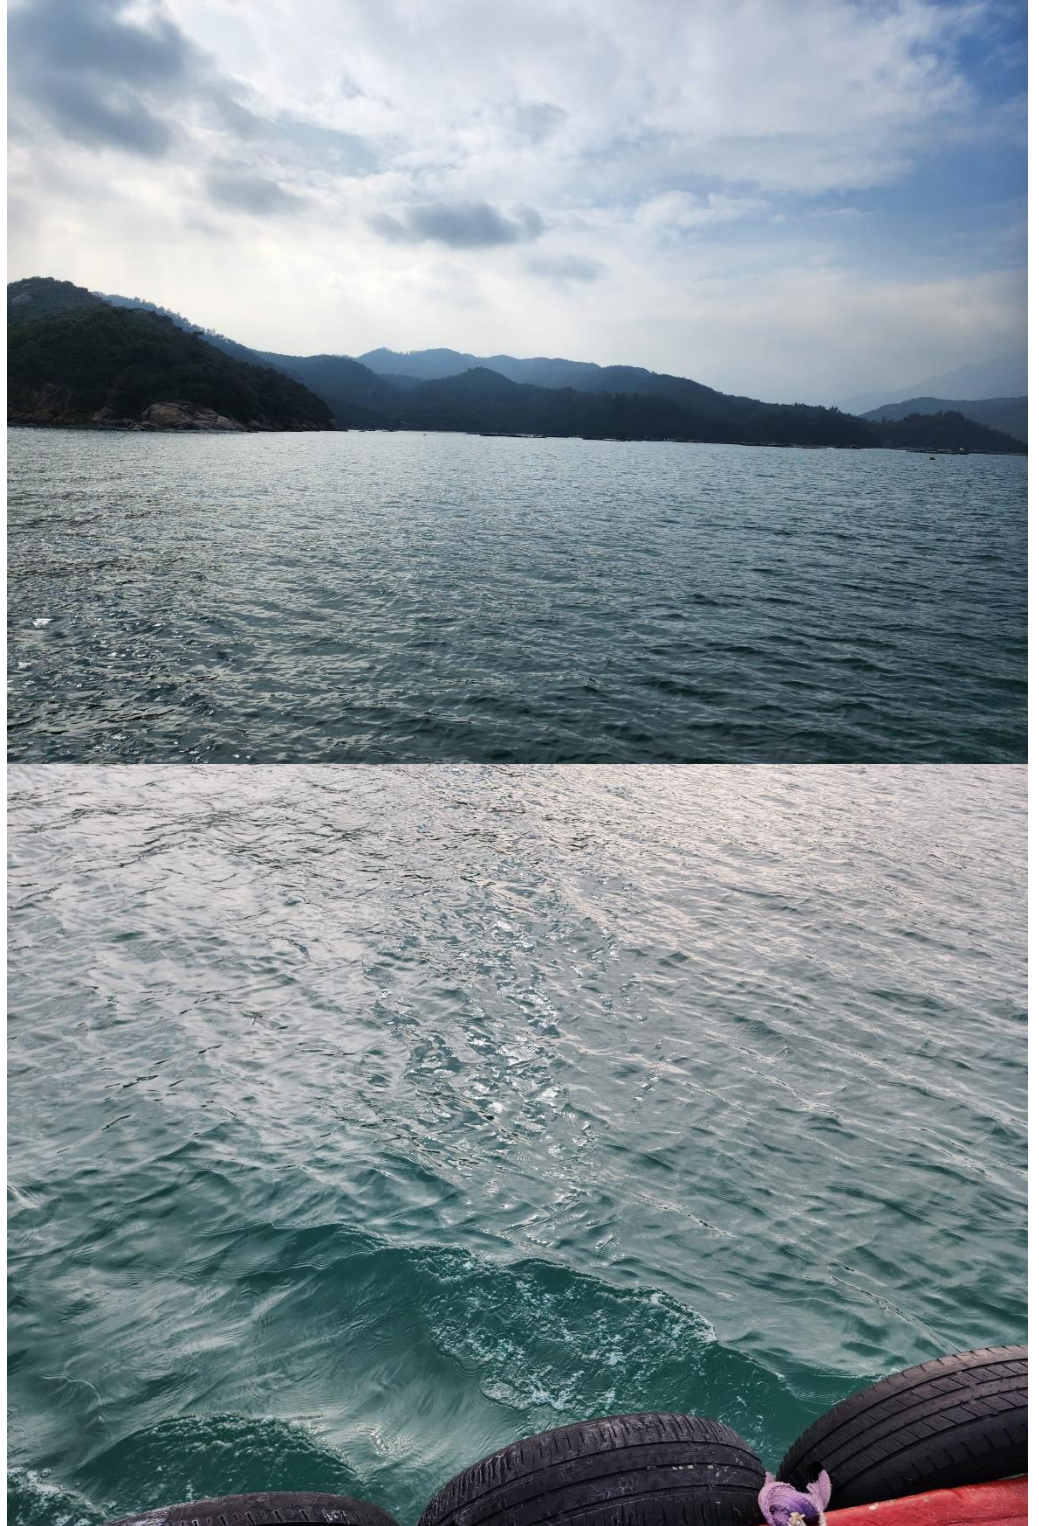
F1A:

<p>According to the field observation by sampling team during sampling event, no silt plume was observed in the Project site and the weather was fine during the sampling event.</p> <p>No major observation of improper site practices that contributed to the increase of the suspended solids was recorded during the weekly site inspection on 10 January 2023.</p> <p>After the investigation, the exceedances on 04 January 2023 during flood tide at F1A, H1 and CR2 are deemed to be unrelated to the Project.</p>
--	--

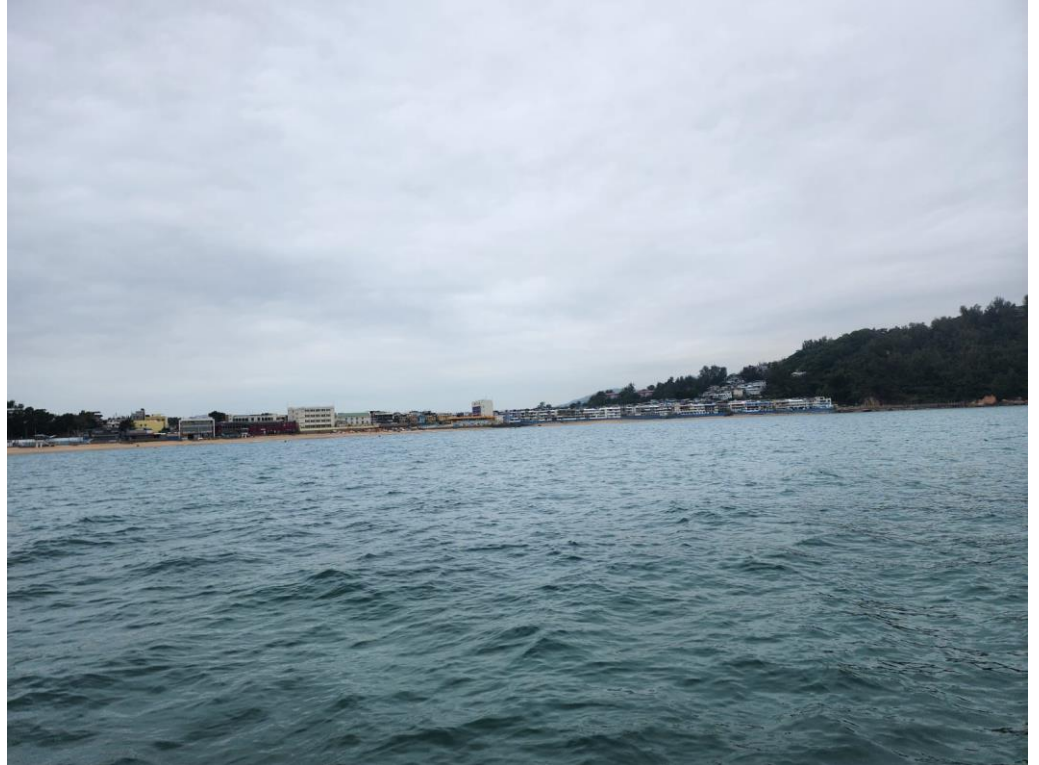
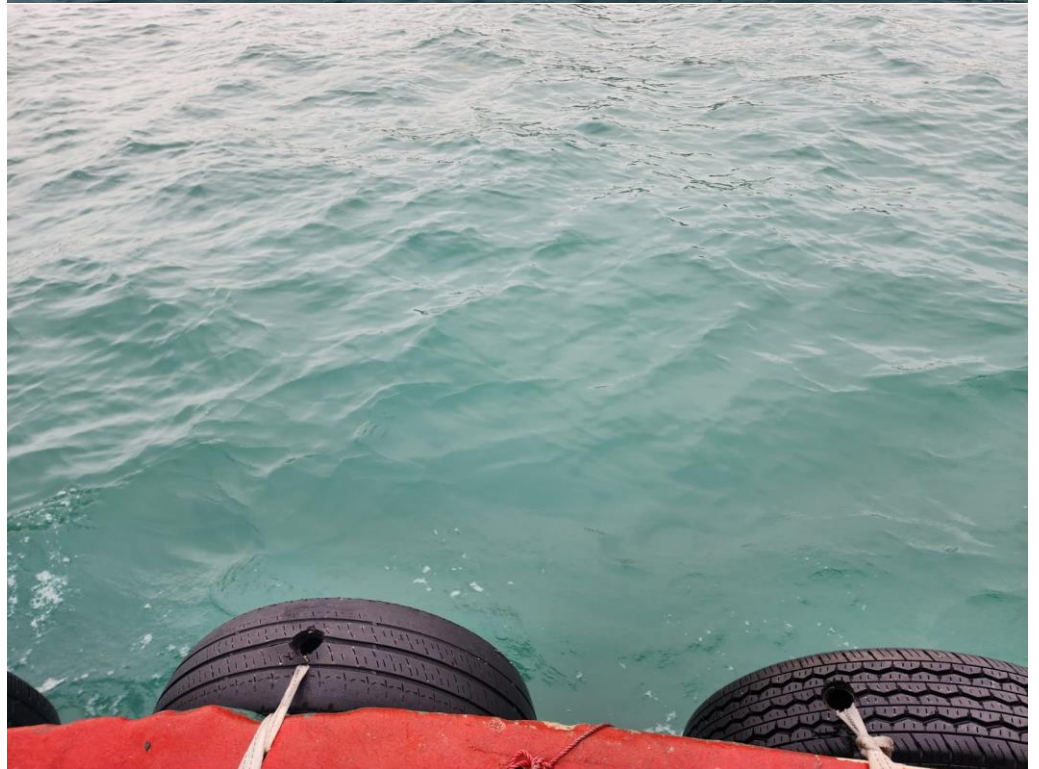
M1:

<p>The installation of caisson No.19 was completed on 18 Mar 2021, the reclamation area was enclosed.</p> <p>According to the field observation by sampling team during sampling event, no silt plume was observed in the Project site and the weather was overcast during the sampling event.</p> <p>No major observation of improper site practices that contributed to the increase of the suspended solids was recorded during the weekly site inspection on 10 January 2023.</p> <p>After the investigation, the exceedances on 09 January 2023 during ebb tide at M1 and CR2 are deemed to be unrelated to the Project.</p>
--	---

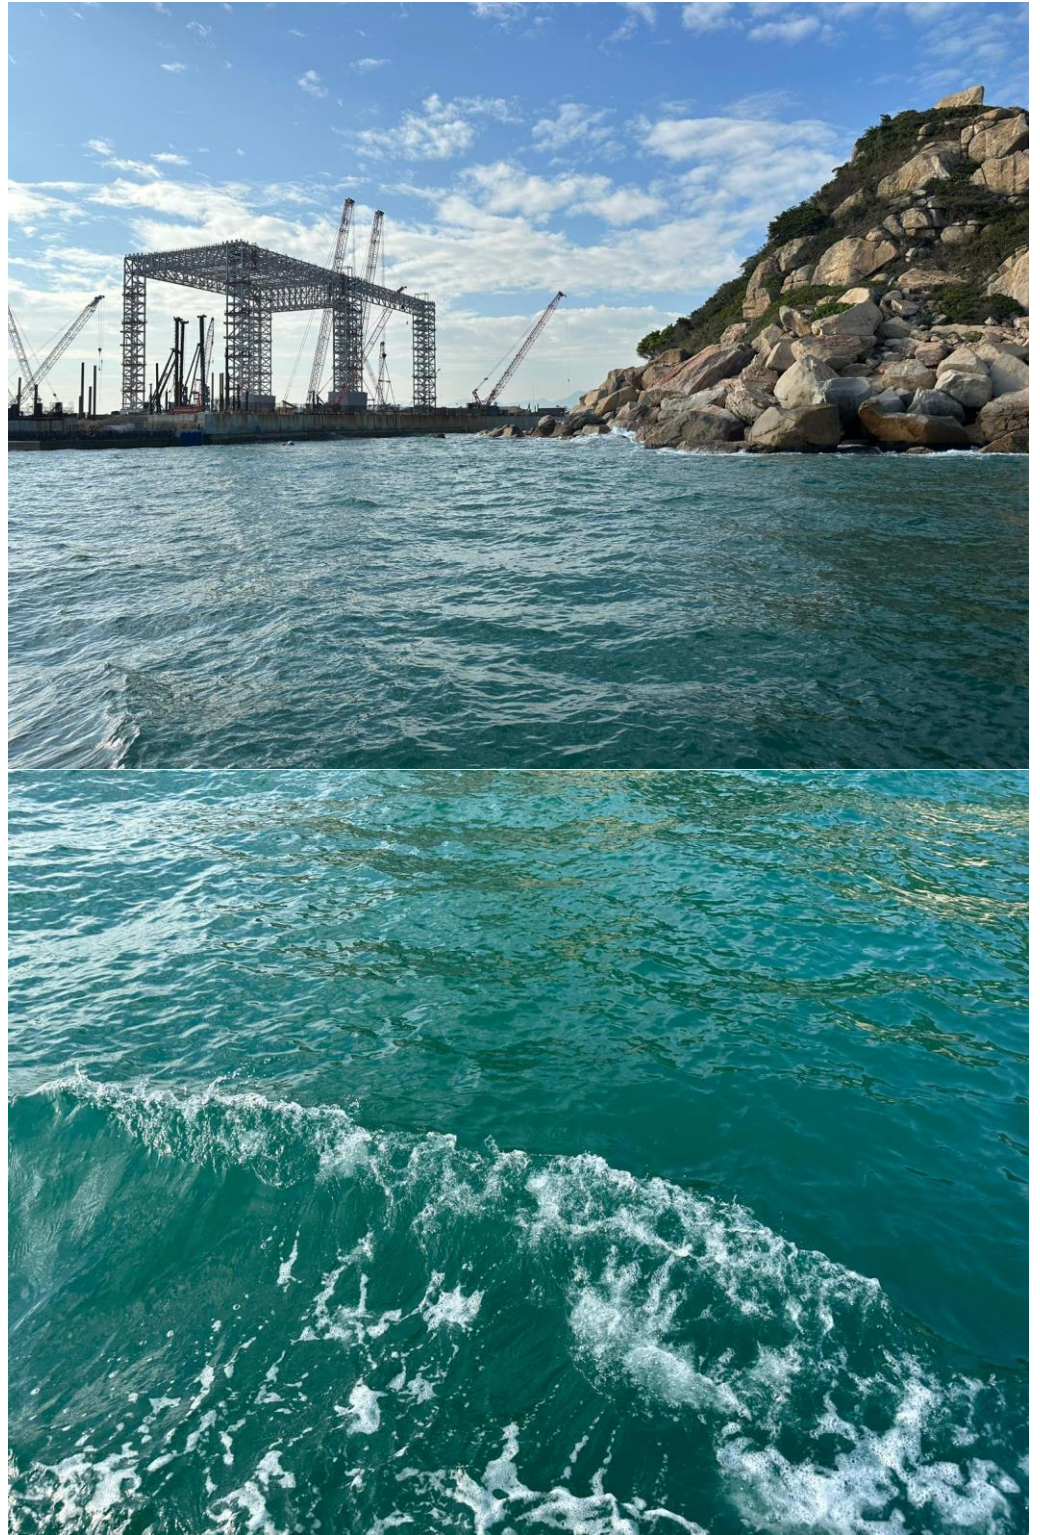
CR1:

<p>According to the field observation by sampling team during sampling event, no silt plume was observed in the Project site and the weather was fine during the sampling event.</p> <p>No major observation of improper site practices that contributed to the increase of the suspended solids was recorded during the weekly site inspection on 26 January 2023.</p> <p>After the investigation, the exceedance on 20 January 2023 during flood tide at CR1 is deemed to be unrelated to the Project.</p>
--	--

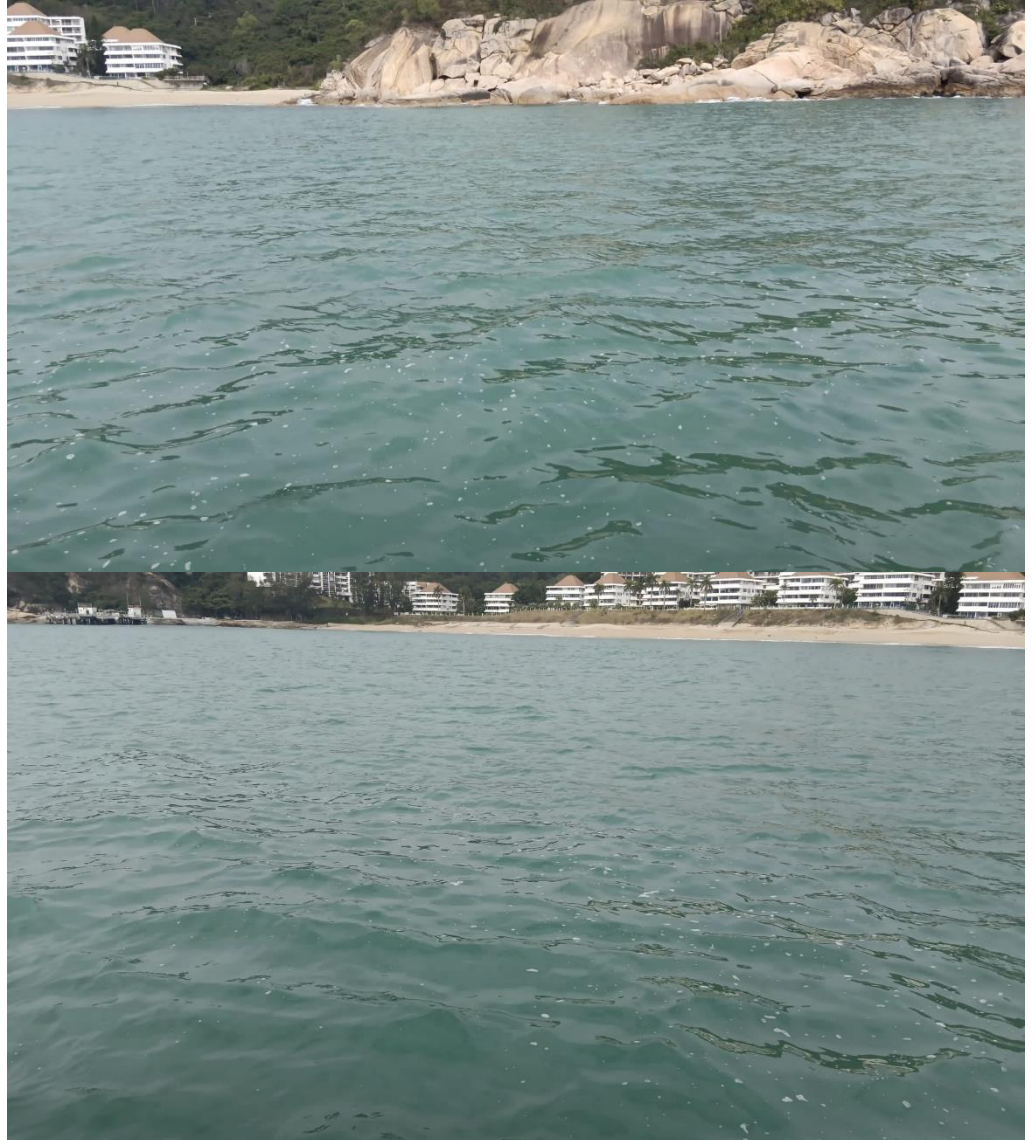
B3:

<p>No major observation of improper site practices that contributed to the increase of the suspended solids was recorded during the weekly site inspection on 31 January 2023.</p> <p>After the investigation, the exceedance on 26 January 2023 during flood tide at B3 is deemed to be unrelated to the Project.</p>
--	--

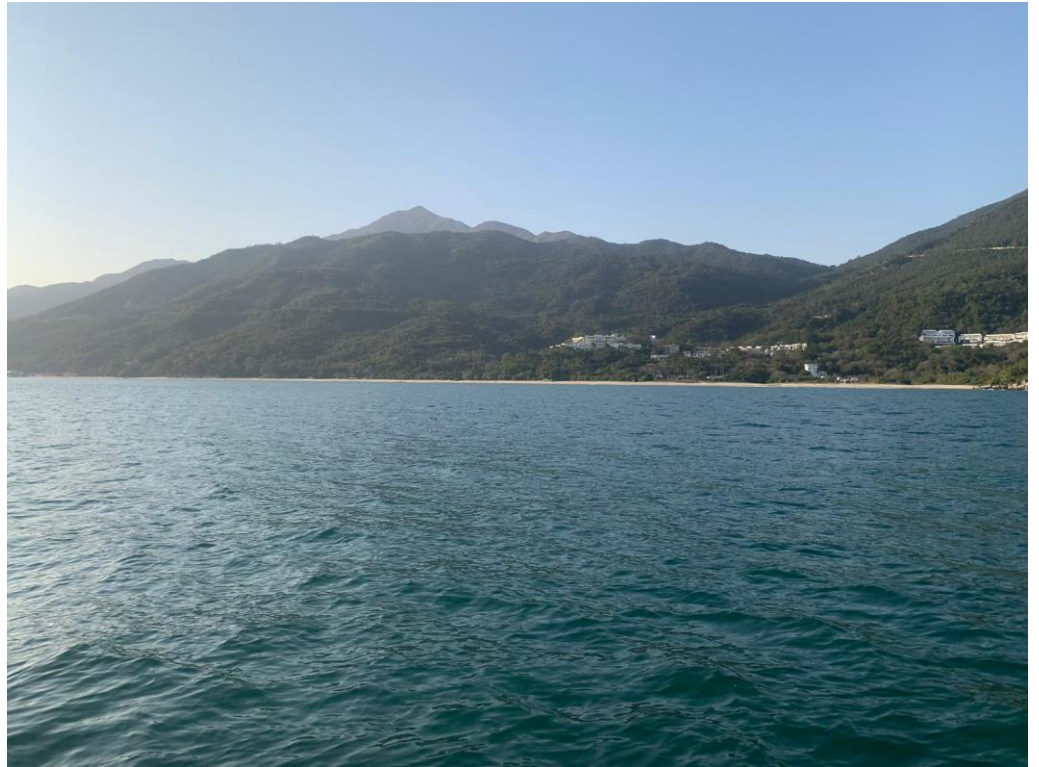
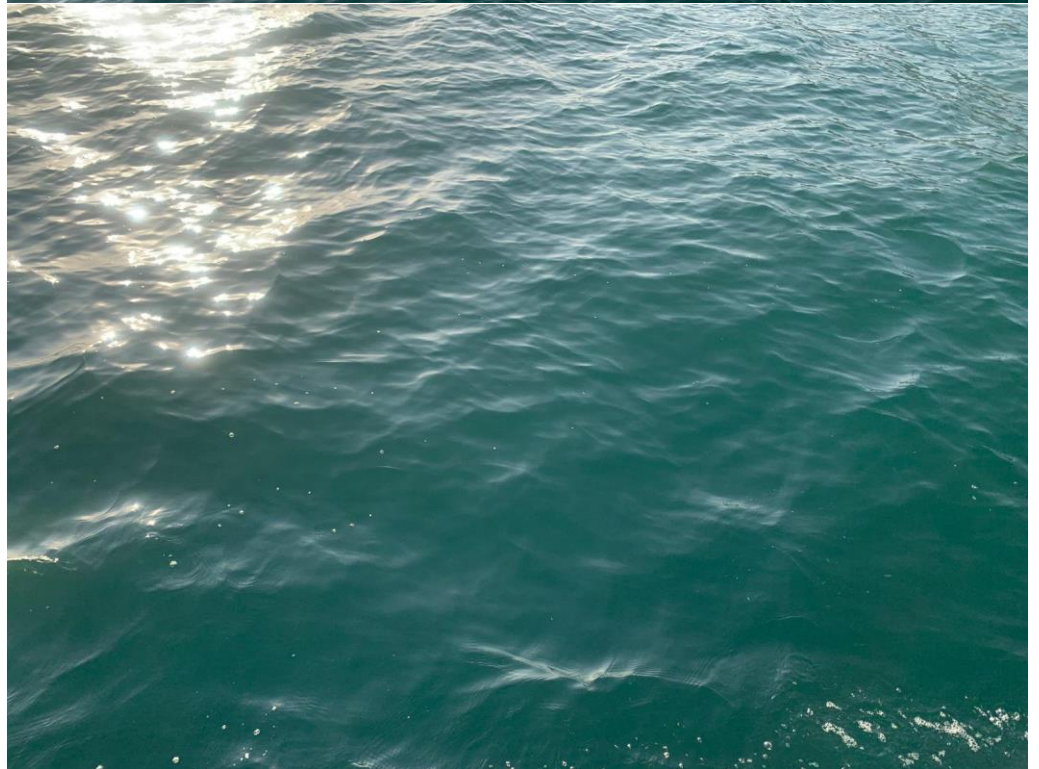
B1:

<p>According to the field observation by sampling team during sampling event, no silt plume was observed in the Project site and the weather was fine during the sampling event.</p> <p>No major observation of improper site practices that contributed to the increase of the suspended solids was recorded during the weekly site inspection on 31 January 2023.</p> <p>After the investigation, the exceedances on 28 January 2023 during ebb tide at B1, B3, H1 and M1 are deemed to be unrelated to the Project.</p>
--	--
