Contract No. EP/SP/66 Integrated Waste Mana	/12 gement Facilities, Phase 1	Keppel Seghers – Zhen Hua Joint Venture
Appendix N	Exceedance Report

Incident Report on Action Level or Limit Level Non-compliance

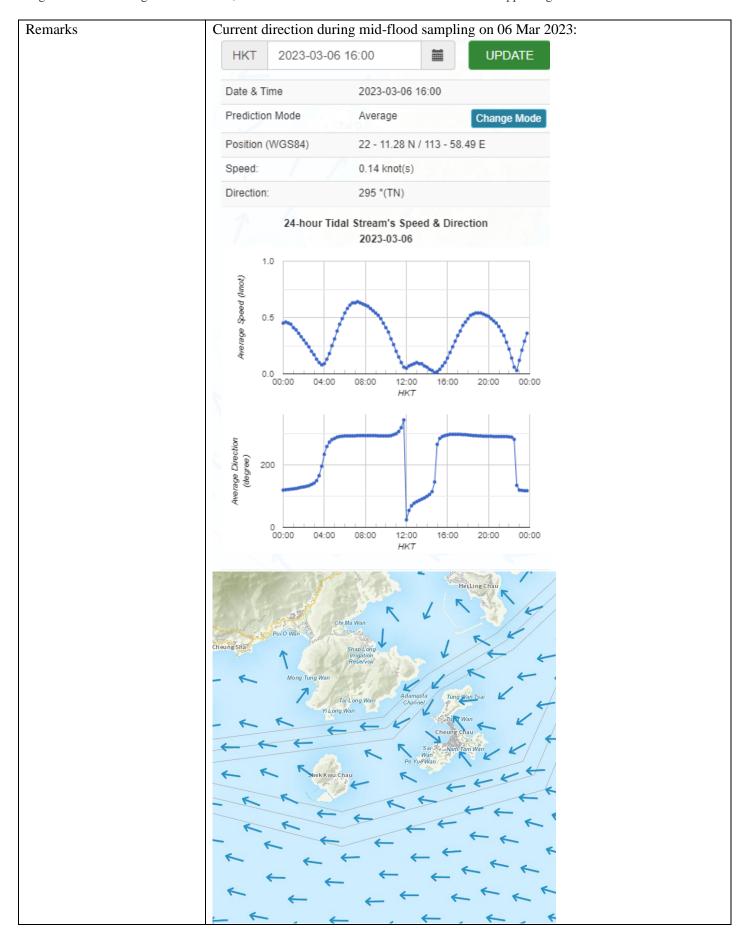
Monitoring photos of stations with exceedance B1:

15.3 mg/L (B1)	3.7 mg/L (C1A) 2.8 mg/L (C2A)	5.0 mg/L (B2) 2.9 mg/L (B3) 4.0 mg/L (B4) 3.0 mg/L (H1) 3.2 mg/L (F1A) 4.1 mg/L (CR1) 3.9 mg/L (CR2) 3.6 mg/L (M1)		
Possible reason for Action or Limit Level Non-compliance	pile, piling works for pre-b seawall and existing caisson of Dominant sea current direction around Shek Kwu Chau. An exceedance of limit level of (neither upstream nor downs B1 is deemed to be unrelated	206 Mar 2023 include piling woored socketed H-pile, pile of extension, and Process Buildi on was found to be from Southwas found at B1. B1 is located stream, far away) to the works to the Project.	cap construction, blockwork ng construction works. theast to Northwest at waters at unrelated stream direction is location. An exceedance at

According to the field observation by sampling team during sampling event, no silt plume was observed in the Project site and the weather was fine during the sampling event.
No major observation of improper site practices that contributed to the increase of the suspended solids was recorded during the weekly site inspection on 07 March 2023.
After the investigation, the exceedance on 06 March 2023 during flood tide at B1 is deemed to be unrelated to the Project.

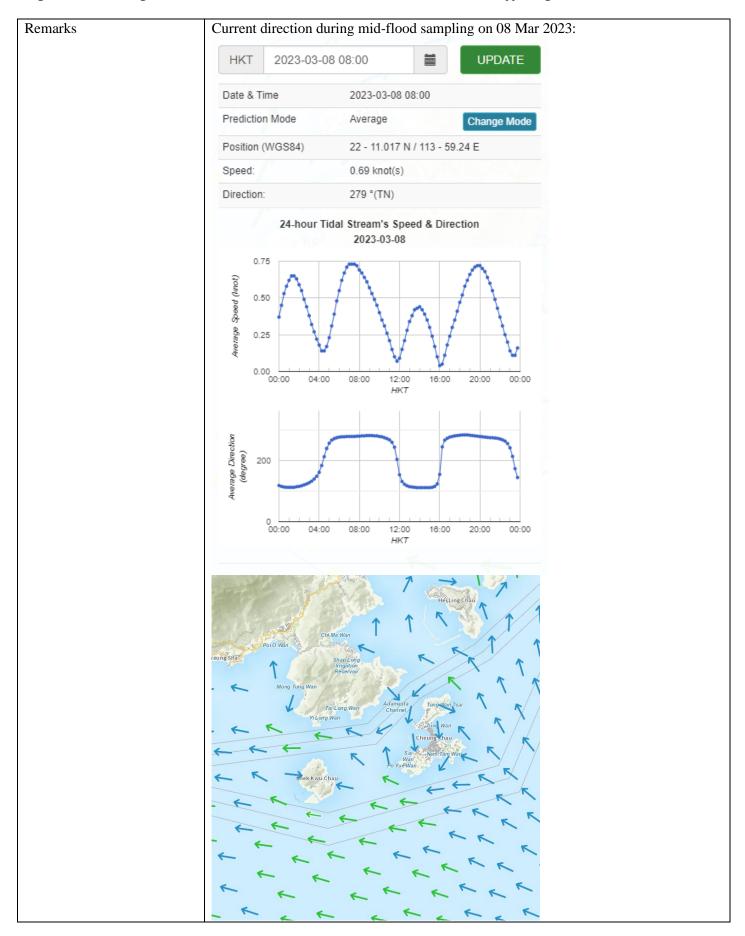
Monitoring photos of stations with exceedance B2:

2.5 mg/L (CR2)		
Possible reason for Action or Limit Level Non-compliance	1 0 1				
	The installation of caisson Newas enclosed.	o.19 was completed on 18	Mar 2021, the reclamation area

According to the field observation by sampling team during sampling event, no silt plume was observed in the Project site and the weather was fine during the sampling event.
No major observation of improper site practices that contributed to the increase of the suspended solids was recorded during the weekly site inspection on 14 March 2023.
After the investigation, the exceedance on 08 March 2023 during flood tide at B2 is deemed to be unrelated to the Project.

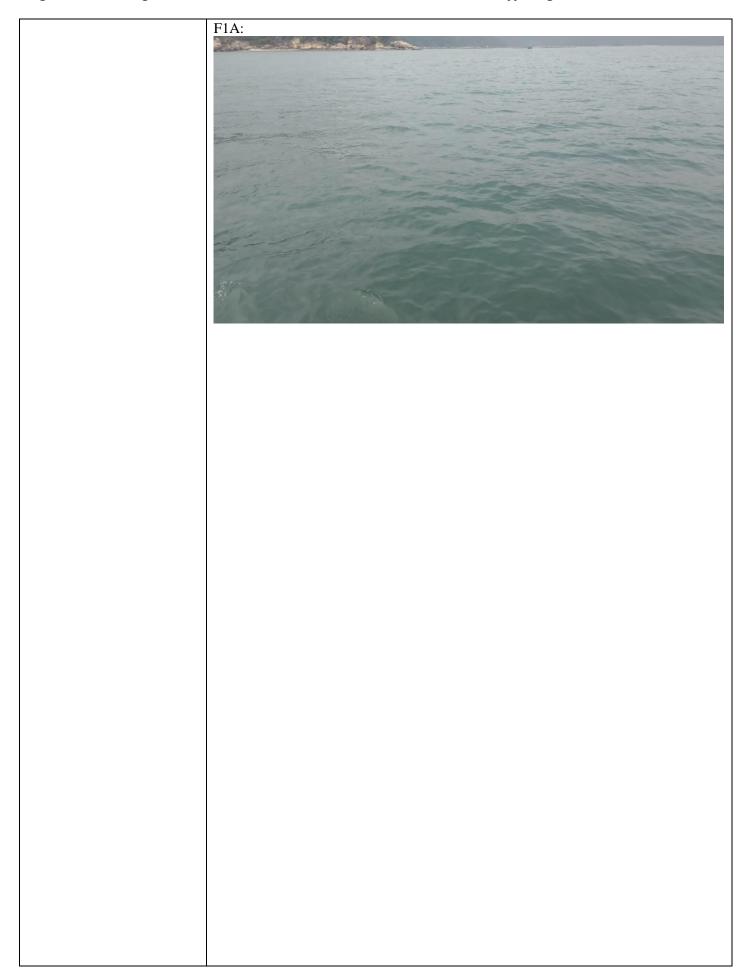
Keppel Seghers – Zhen Hua Joint Venture Monitoring photos of stations with exceedance B2:

8.5 mg/L (F1A)	3.3 mg/L (C		4.3 mg/L (B3) 4.0 mg/L (B4) 4.8 mg/L (H1) 3.3 mg/L (M1) 7.5 mg/L (CR1) 4.8 mg/L (CR2)
Possible reason for Action or Limit Level Non-compliance	Works scheduled on site on 2 pile, piling works for pre-beseawall and existing caisson of Dominant sea current direction	ored socketed extension, and	H-pile, pile c Process Buildin	ap construction, blockwork ng construction works.
	around Shek Kwu Chau. Exceedances of action level unrelated stream direction (n location. Exceedances at B2 at the installation of caisson Nowas enclosed.	were found a either upstrea and F1A are d	at B2 and F1A. m nor downstre eemed to be uni	B2 and F1A are located at eam, far away) to the works related to the Project.

According to the field observation by sampling team during sampling event, no silt plume was observed in the Project site and the weather was overcast during the sampling event.
No major observation of improper site practices that contributed to the increase of the suspended solids was recorded during the weekly site inspection on 21 March 2023.
After the investigation, the exceedances on 20 March 2023 during ebb tide at B2 and F1A are deemed to be unrelated to the Project.
