Appendix L Complaint Log

Statistical Summary of Environmental Complaints

COMPLAINT DETAILS

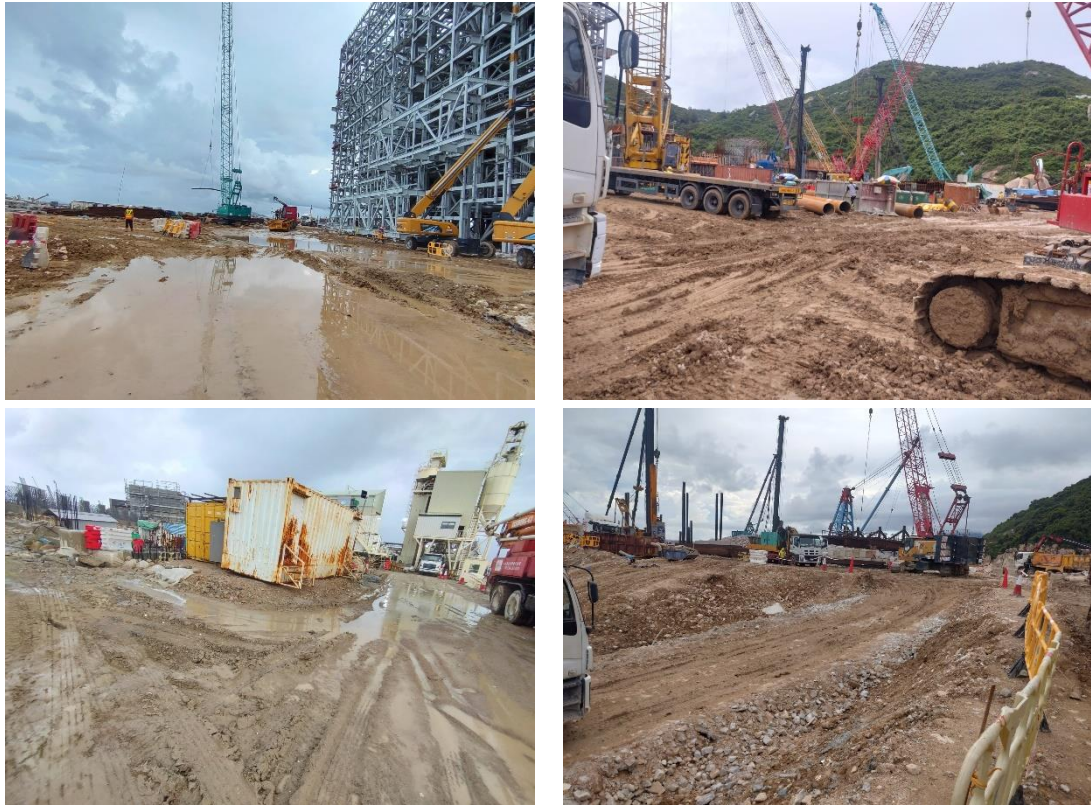
In view of recent weather condition, heavy showers and squally thunderstorms were frequently recorded in June 2023 with reference to Monthly Weather Summary from Hong Kong Observatory^[1]. Main haul roads within the site boundary were mainly in slurry condition. Site photos of haul road condition provided by the Contractor are given in **Figure 2**.

Figure 2: Site Photos of Main Haul Roads within Site Boundary

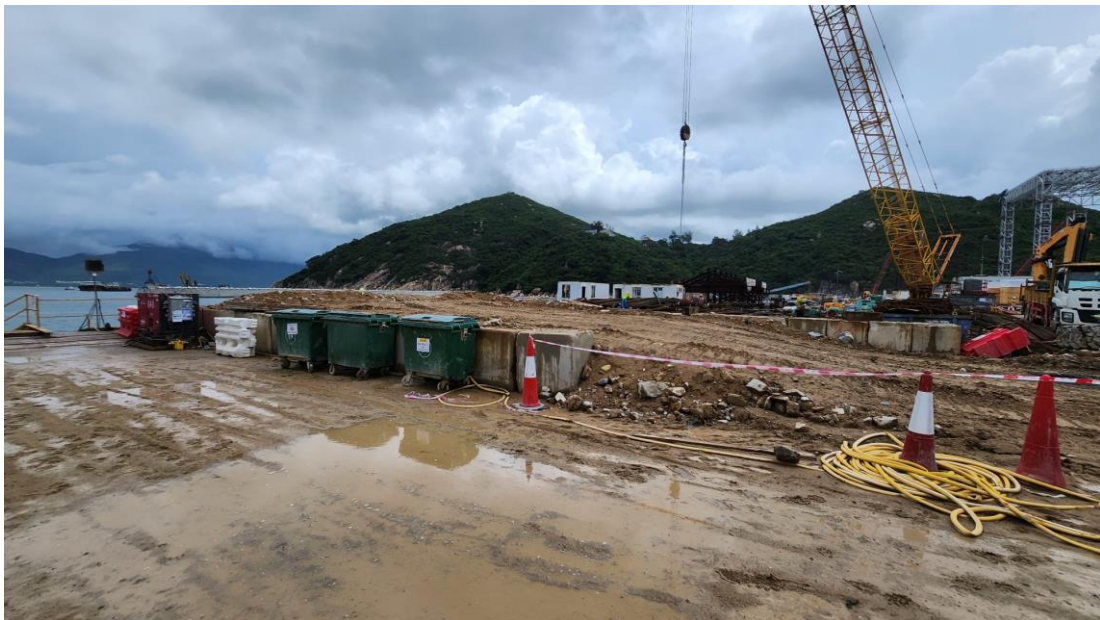
Weekly inspections were conducted in June 2023 (i.e. 06 June 2023, 12 June 2023, 20 June 2023 and 27 June 2023). No fugitive dust generated from construction work or vehicle movement was observed during the site inspection in June 2023. Site photos of main haul roads taken during each site inspection are given in **Figure 3**, **Figure 4**, **Figure 5** and **Figure 6** respectively.

Figure 3: Site Photo of Main Haul Road Taken during Site Inspection on 06 June 2023

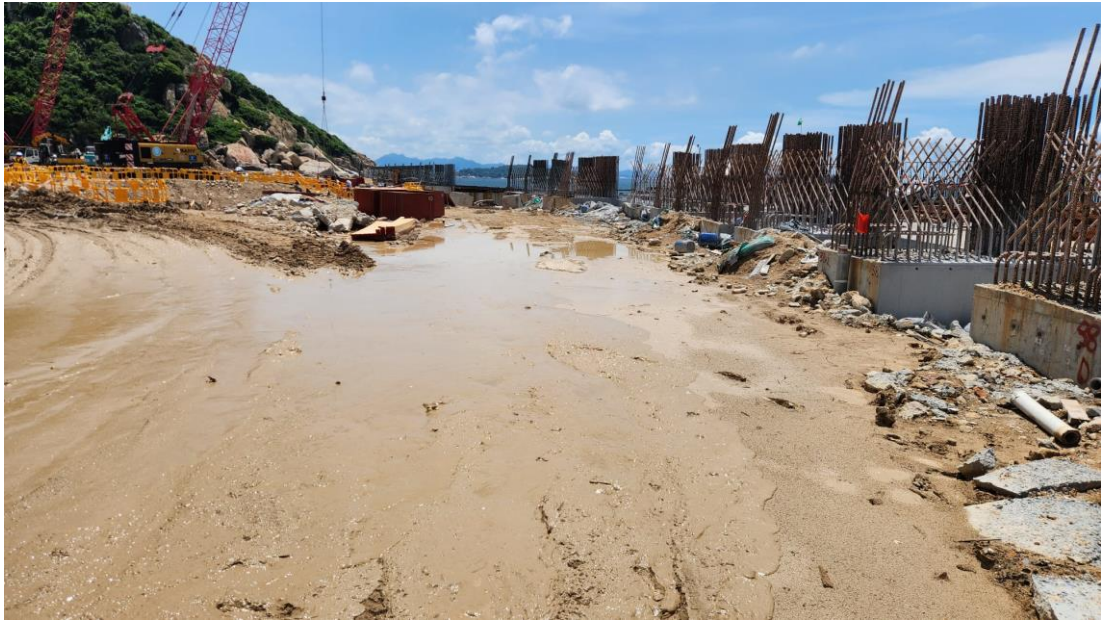
Figure 4: Site Photo of Main Haul Road Taken during Site Inspection on 12 June 2023

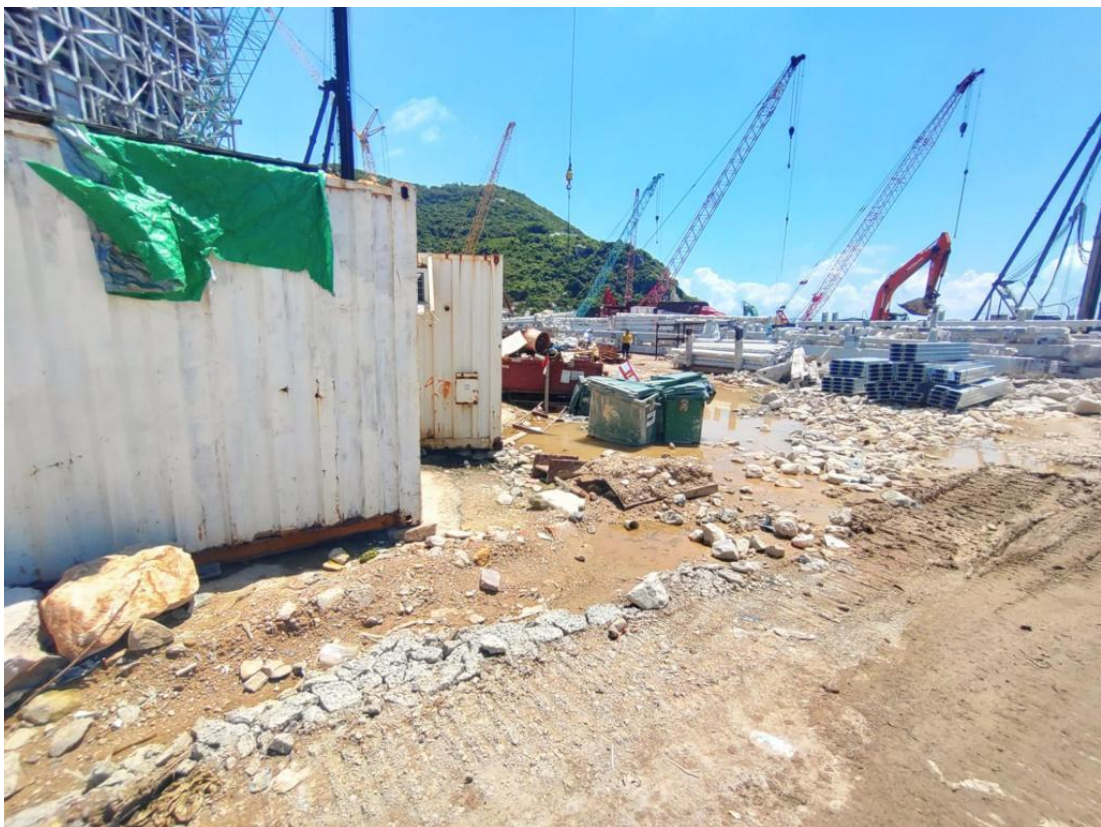
Figure 5: Site Photo of Main Haul Road Taken during Site Inspection on 19 June 2023

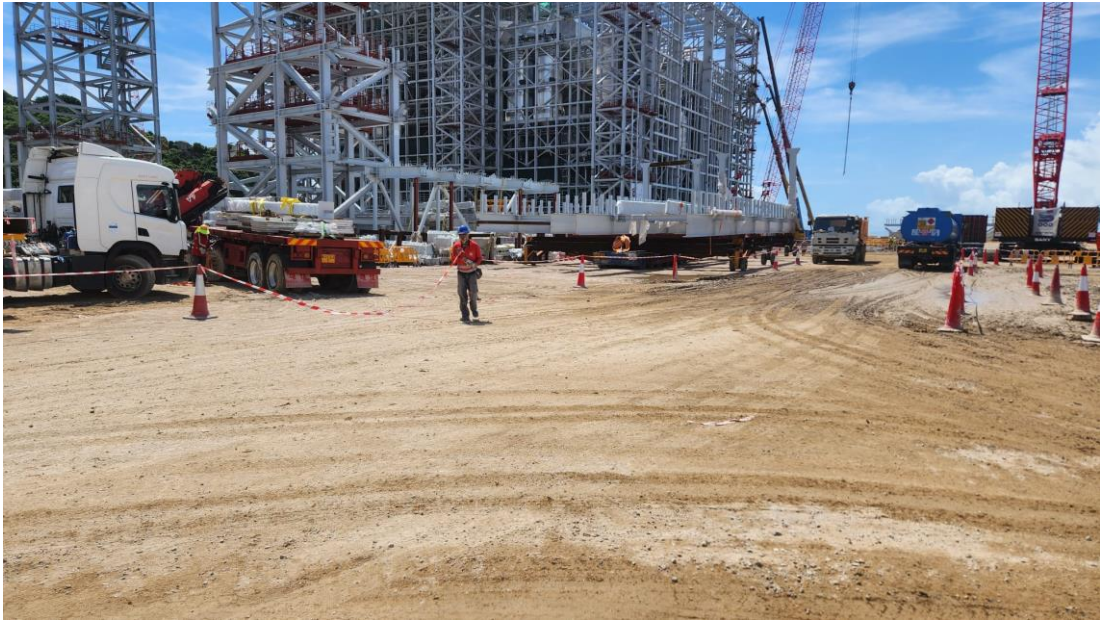
Figure 6: Site Photo of Main Haul Road Taken during Site Inspection on 26 June 2023

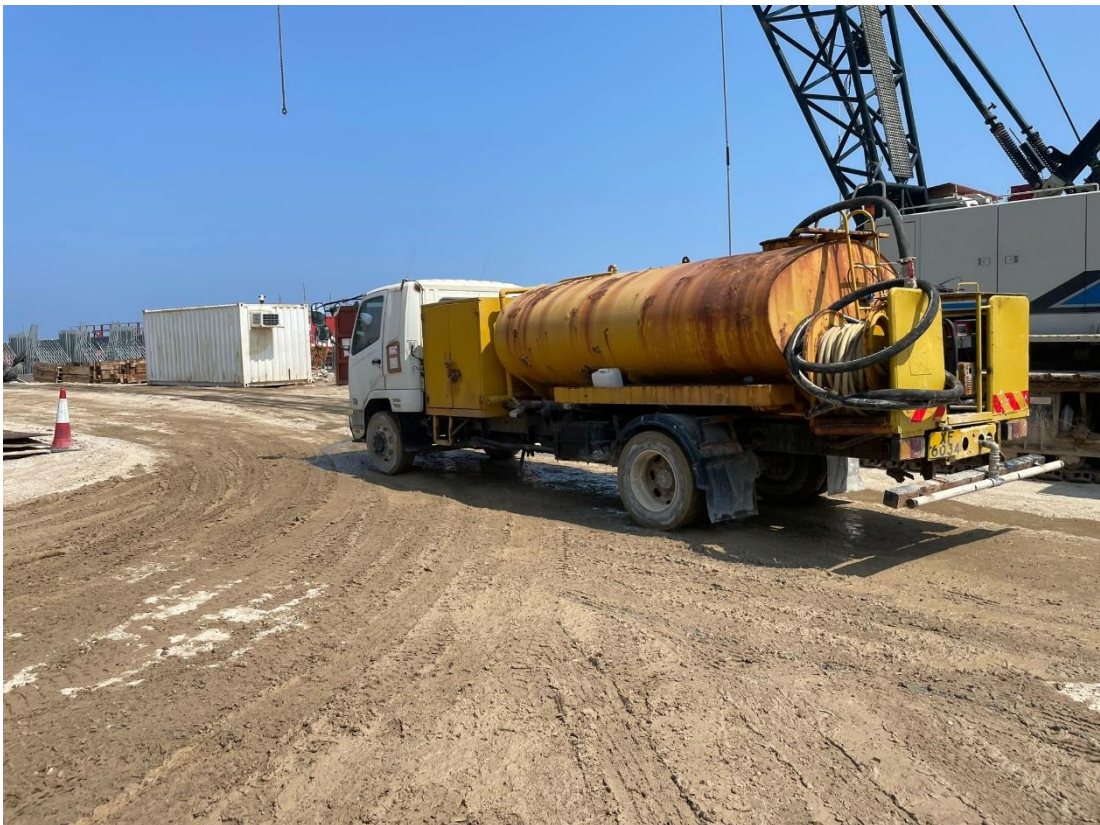
For the issue of insufficient dust suppression measure, three major dust suppression measures were implemented by the Contractor as far as practicable in the site area, including deployment of water bowser for regular watering to main haul road, scheduling workers to frequently spray water to work areas that involved high dust emission construction works and covering dusty material with impervious sheet entirely. Two water bowsers were deployed on artificial island. Photo records of using water bowser to water main haul road and covering dusty material with impervious sheet entirely are given in **Figure 7** and **Figure 8** respectively.

Figure 7: Photo Record of Using Water Bowser to Water Main Haul Road

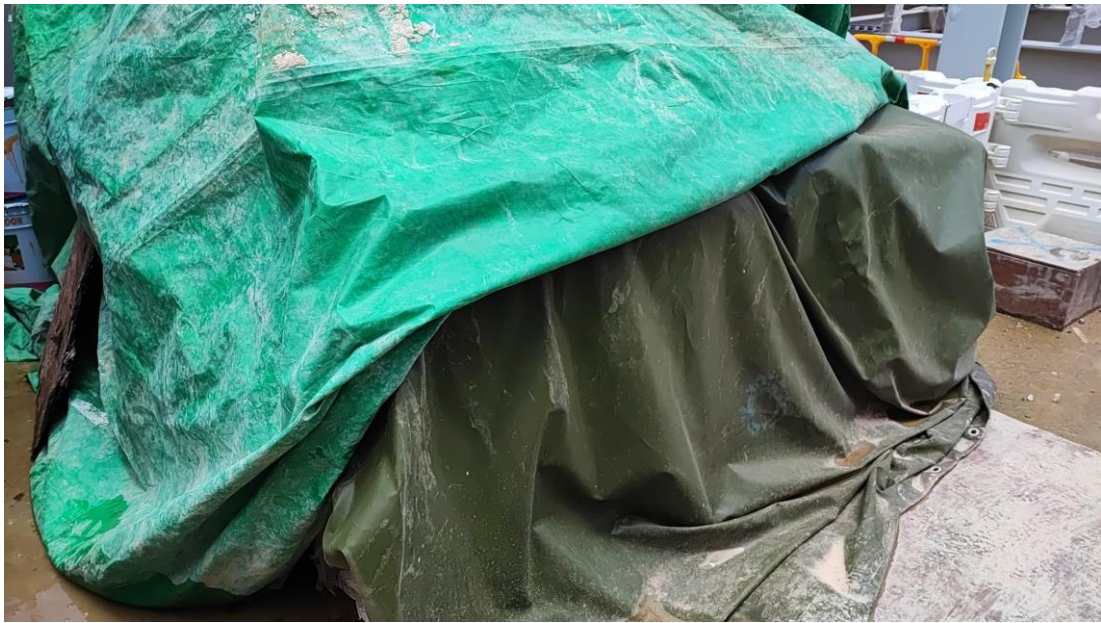
Figure 8: Photo Record of Covering Dusty Material with Impervious Sheet Entirely

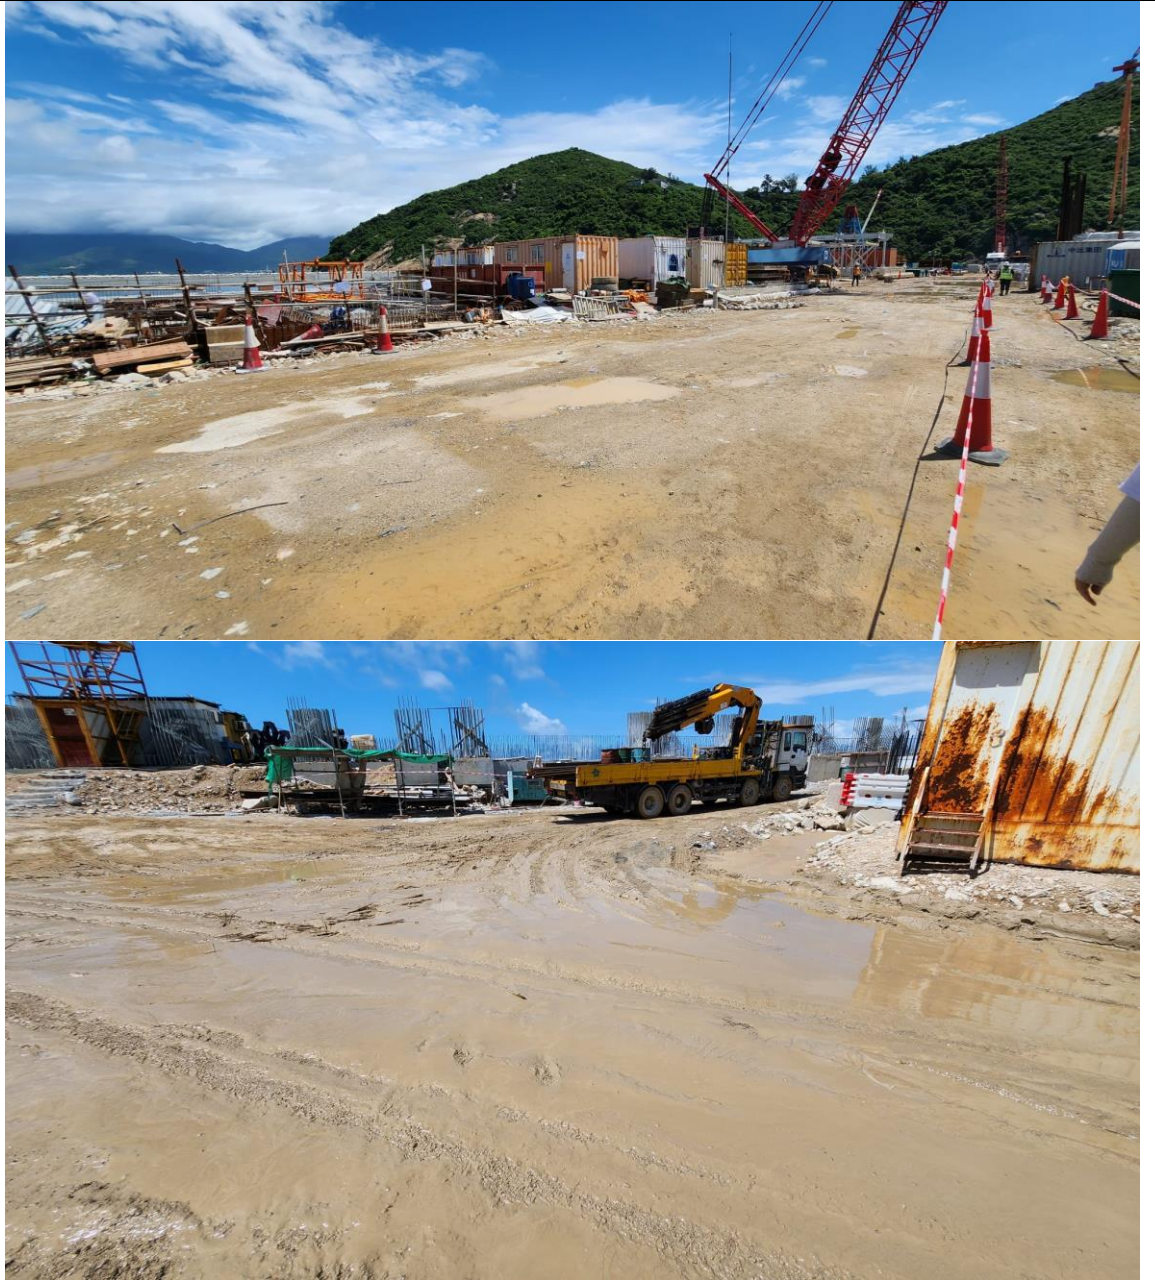
Date	Status / Observation
04 July 2023 (Weekly site inspection)	No fugitive dust generated from construction work or vehicle movement was observed during the site inspection. Almost all main haul roads remain in slurry condition during site inspection. Site photos of the condition of main haul roads during site inspection are given in Figure 9 . Water spraying to main haul road was observed during site inspection and the photo record is given in Figure 10 .

Figure 9: Site Photo of Main Haul Road Taken during Site Inspection on 04 July 2023

1. Regular and/or random site inspection by SO/ the Contractor/ the ET to ensure proper implementation of dust suppression measures, including but not limited to coving dusty material with impervious sheet entirely, watering main haul roads frequently during dry season or sunny days and deploying sufficient number of bowzers to ensure all sections of main haul road remain in wet condition.
2. Conduct induction/ refresher training and tool-box talks of mitigation measures for dust suppression. Records of training should be kept by the Contractor for future audit.
3. Review the efficiency of the implemented dust suppression measure timely, enhancement should be made on those measures if necessary.
4. Review the construction process to minimize the emission of fugitive dust and suggest practicable dust suppression measure before the commencement of high dust emission works.

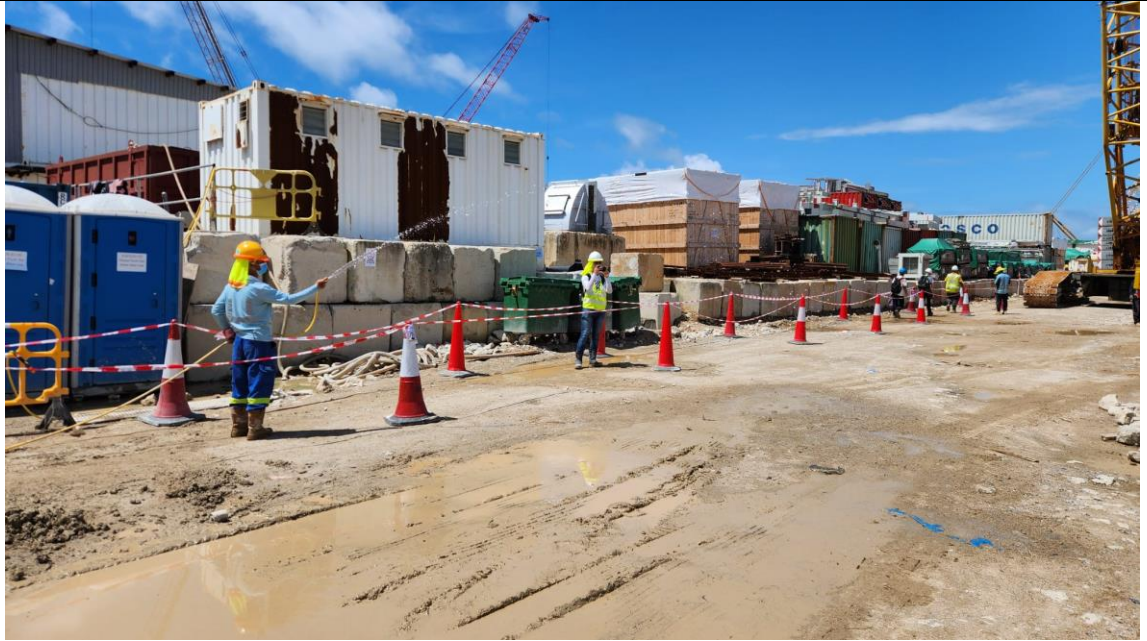
Figure 10: Photo Record of Spraying Water to Main Haul Road

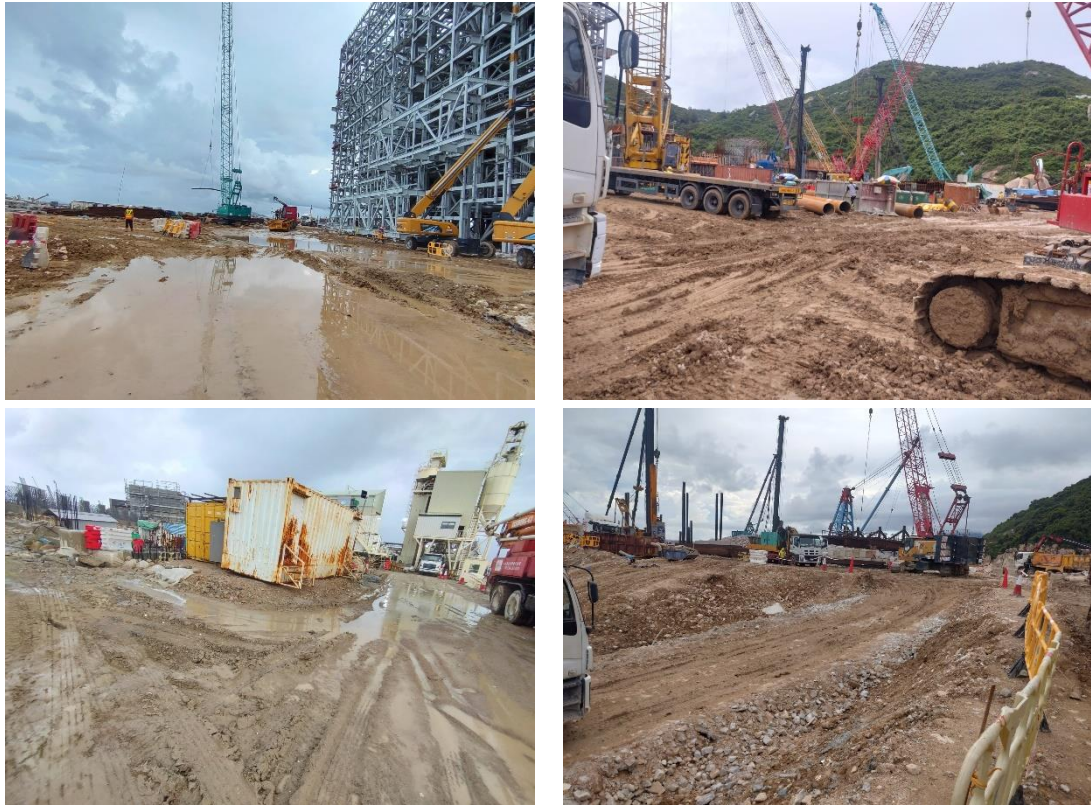
In view of recent weather condition, heavy showers and squally thunderstorms were frequently recorded in June 2023 with reference to Monthly Weather Summary from Hong Kong Observatory^[1]. Main haul roads within the site boundary were mainly in slurry condition. Site photos of haul road condition provided by the Contractor are given in **Figure 2**.

Figure 2: Site Photos of Main Haul Roads within Site Boundary

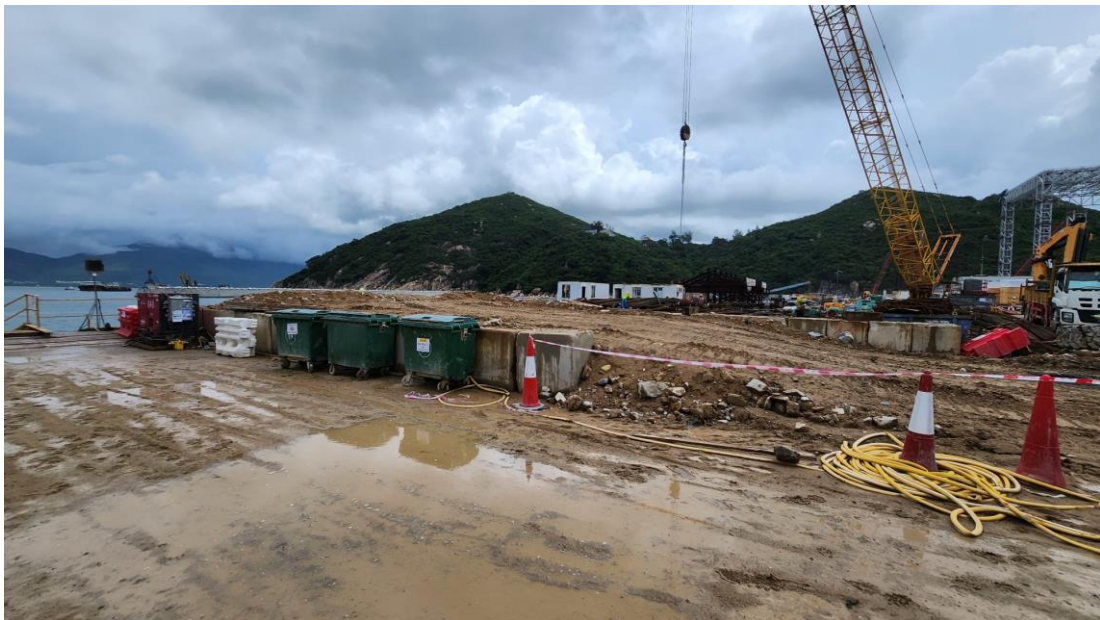
Weekly inspections were conducted in June 2023 (i.e. 06 June 2023, 12 June 2023, 20 June 2023 and 27 June 2023). No fugitive dust generated from construction work or vehicle movement was observed during the site inspection in June 2023. Site photos of main haul roads taken during each site inspection are given in **Figure 3**, **Figure 4**, **Figure 5** and **Figure 6** respectively.

Figure 3: Site Photo of Main Haul Road Taken during Site Inspection on 06 June 2023

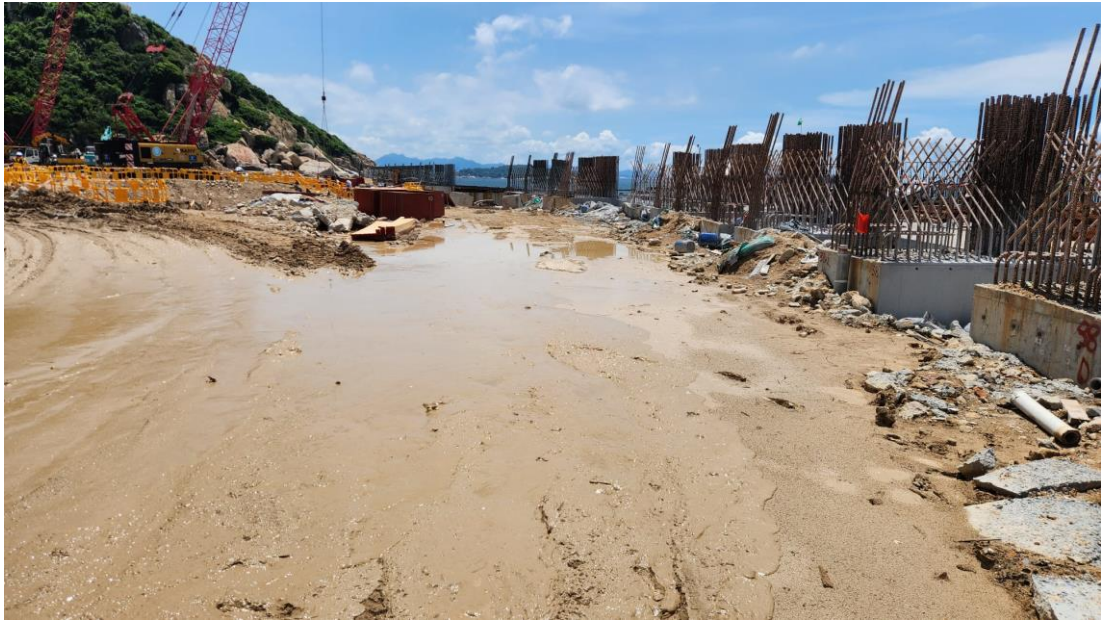
Figure 4: Site Photo of Main Haul Road Taken during Site Inspection on 12 June 2023

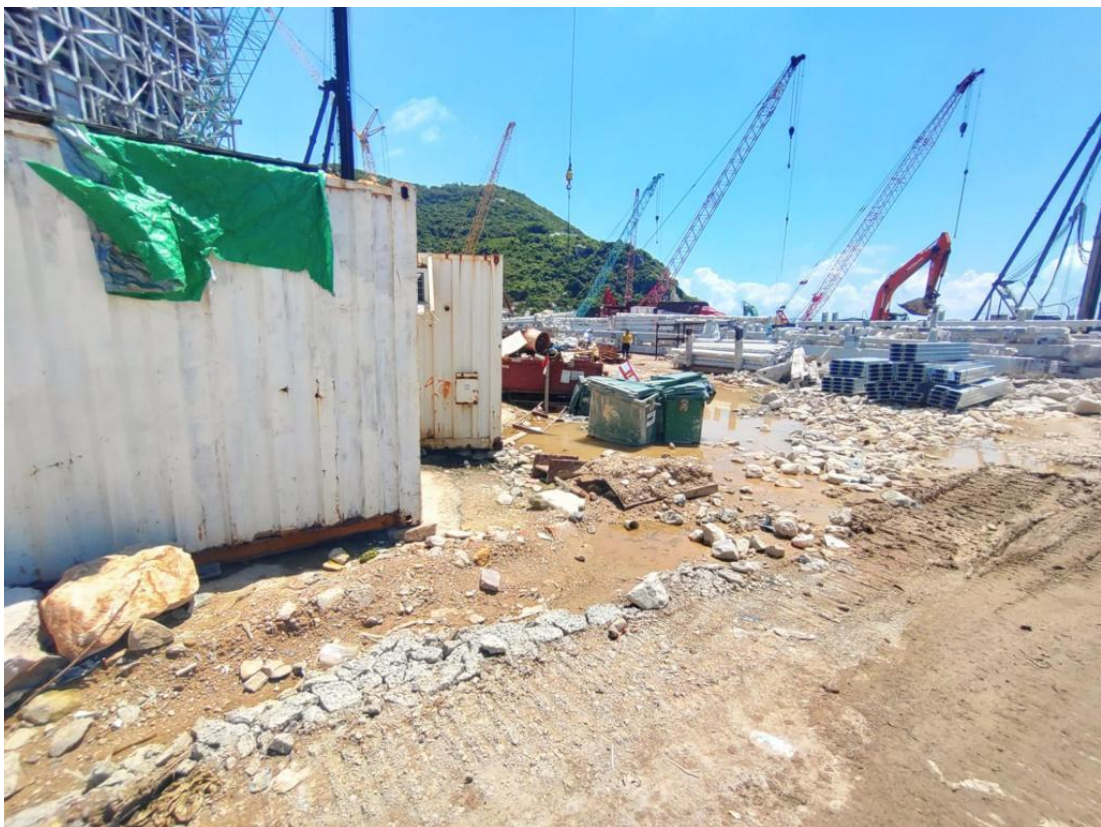
Figure 5: Site Photo of Main Haul Road Taken during Site Inspection on 19 June 2023

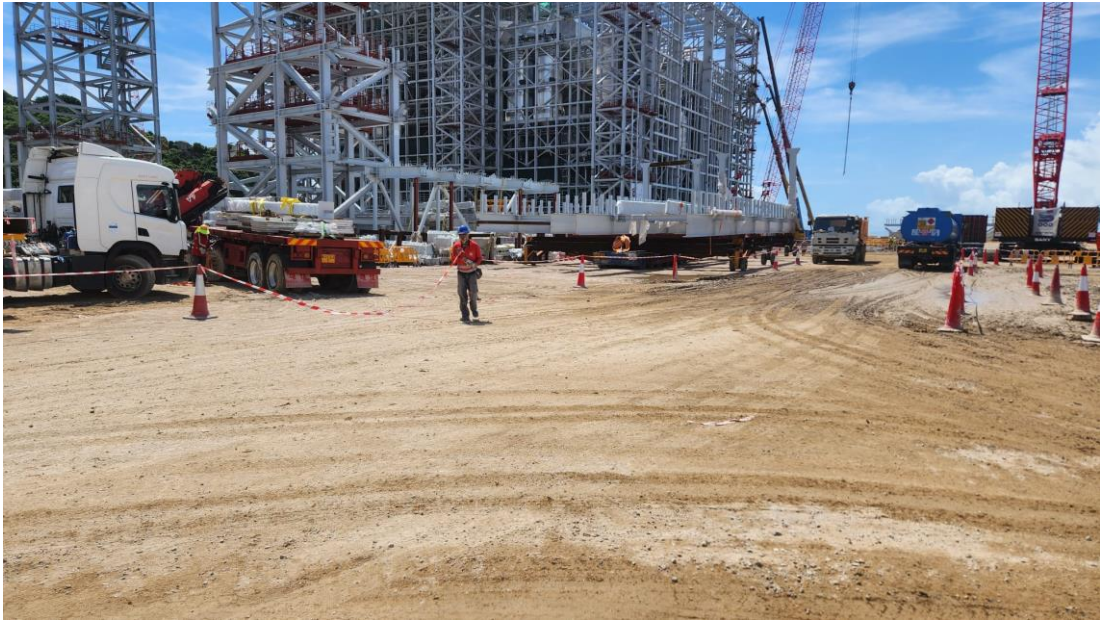
Figure 6: Site Photo of Main Haul Road Taken during Site Inspection on 26 June 2023

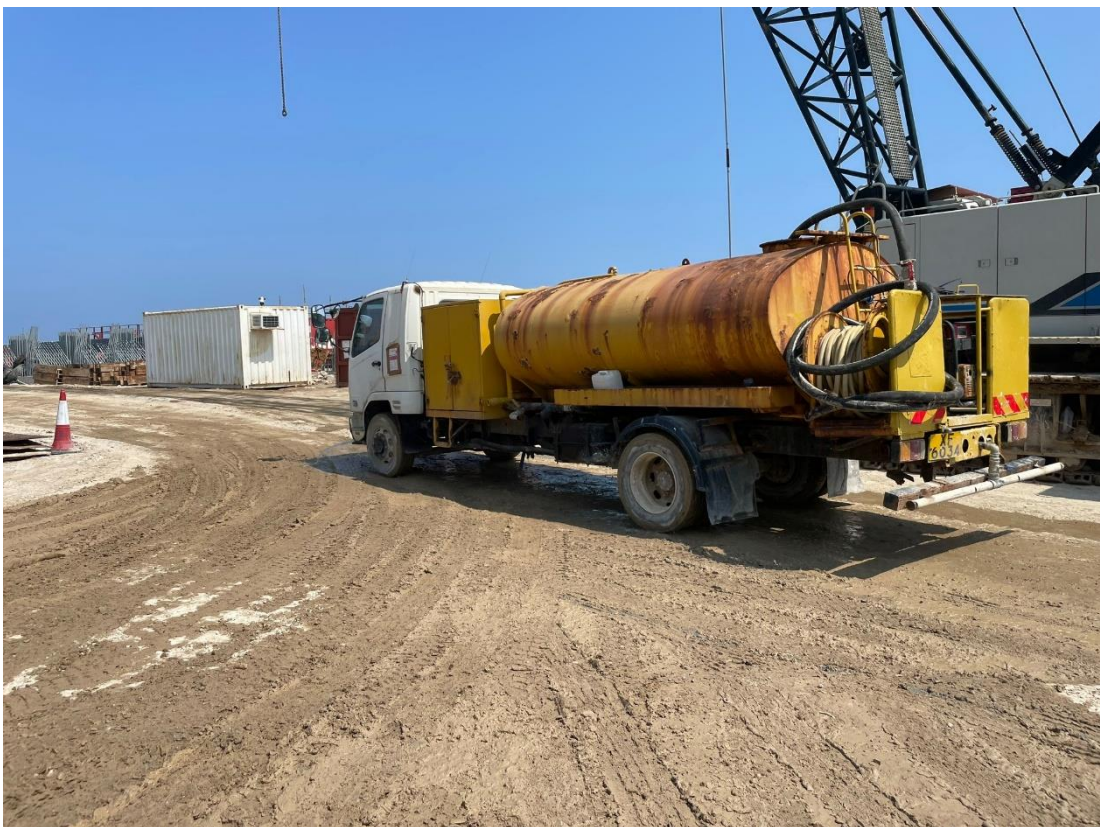
For the issue of insufficient dust suppression measure, three major dust suppression measures were implemented by the Contractor as far as practicable in the site area, including deployment of water bowser for regular watering to main haul road, scheduling workers to frequently spray water to work areas that involved high dust emission construction works and covering dusty material with impervious sheet entirely. Two water bowsers were deployed on artificial island. Photo records of using water bowser to water main haul road and covering dusty material with impervious sheet entirely are given in **Figure 7** and **Figure 8** respectively.

Figure 7: Photo Record of Using Water Bowser to Water Main Haul Road

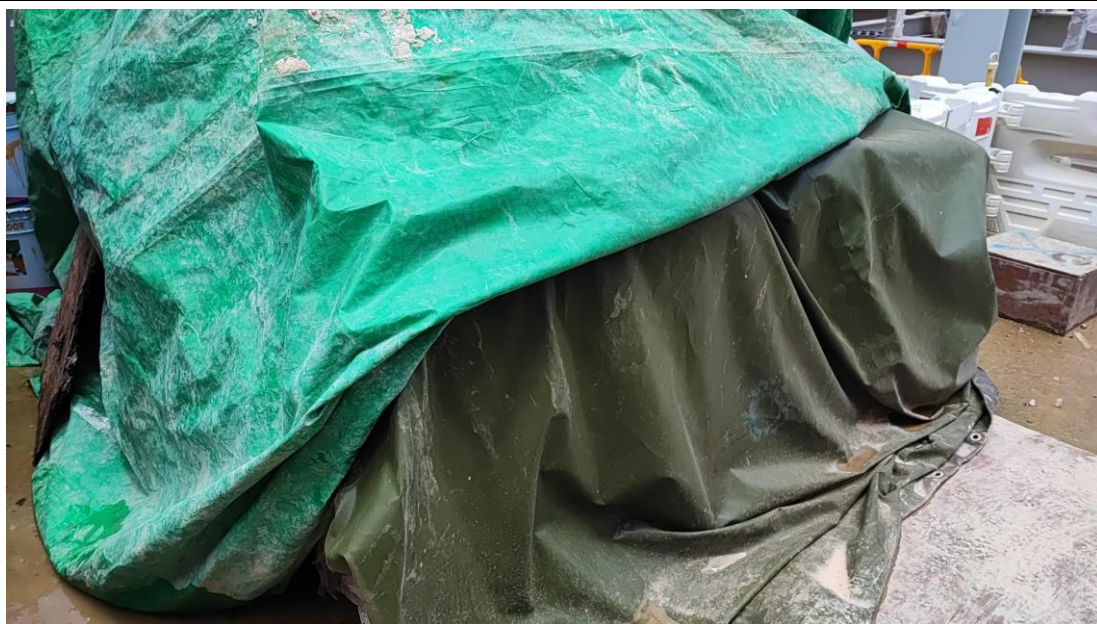
Figure 8: Photo Record of Covering Dusty Material with Impervious Sheet Entirely

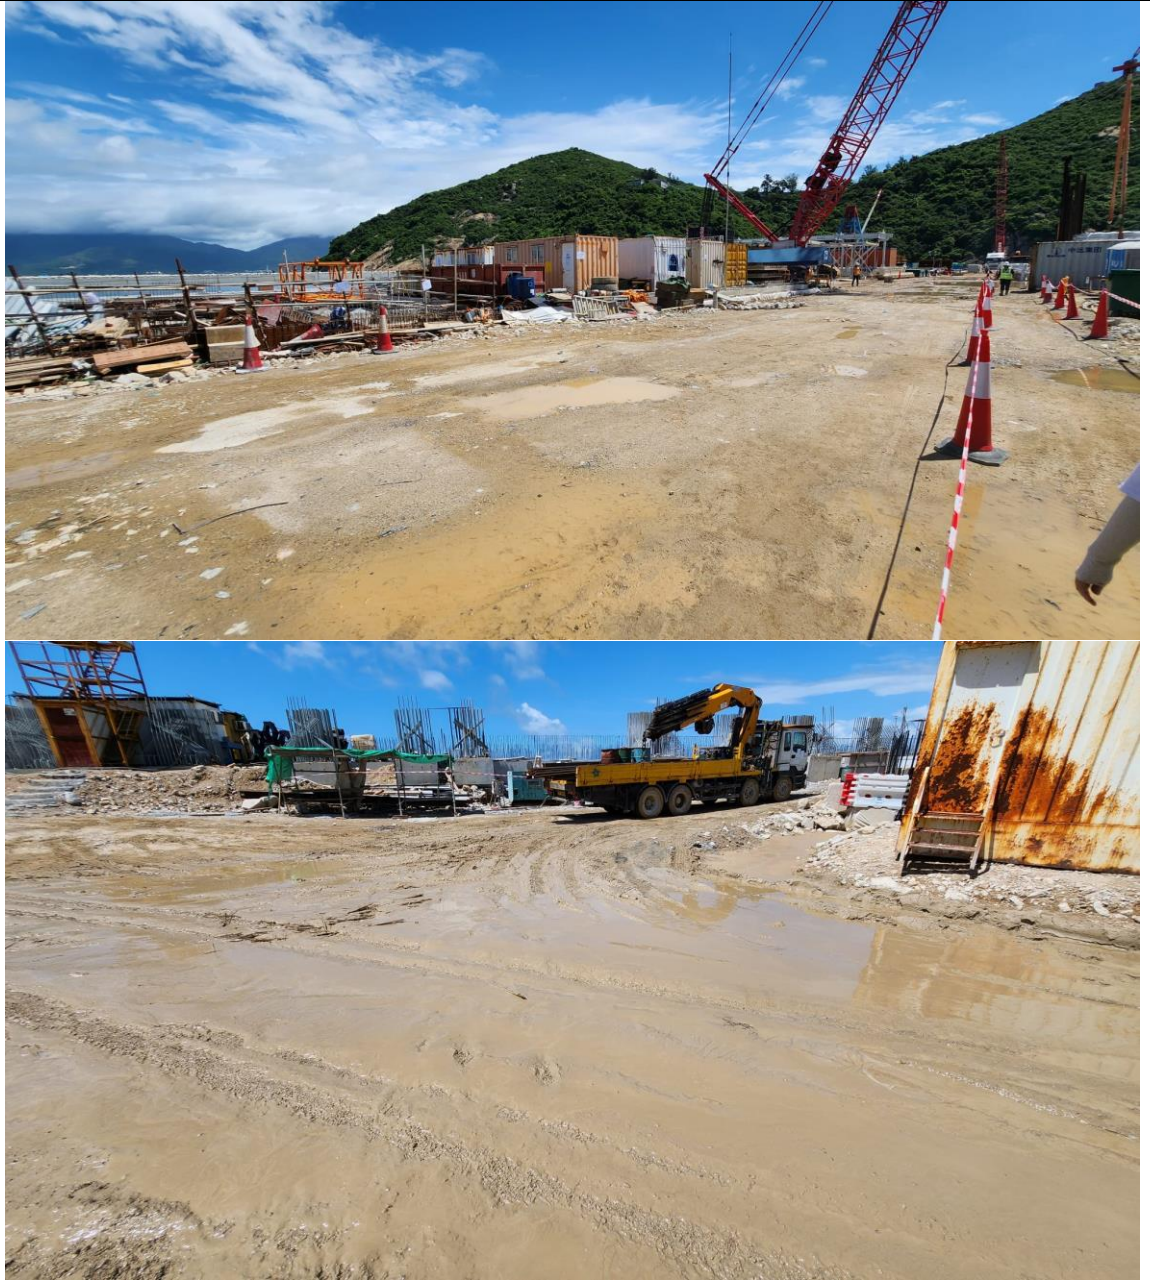
Date	Status / Observation
04 July 2023 (Weekly site inspection)	No fugitive dust generated from construction work or vehicle movement was observed during the site inspection. Almost all main haul roads remain in slurry condition during site inspection. Site photos of the condition of main haul roads during site inspection are given in Figure 9 . Water spraying to main haul road was observed during site inspection and the photo record is given in Figure 10 .

Figure 9: Site Photo of Main Haul Road Taken during Site Inspection on 04 July 2023

1. Regular and/or random site inspection by SO/ the Contractor/ the ET to ensure proper implementation of dust suppression measures, including but not limited to coving dusty material with impervious sheet entirely, watering main haul roads frequently during dry season or sunny days and deploying sufficient number of bowzers to ensure all sections of main haul road remain in wet condition.
2. Conduct induction/ refresher training and tool-box talks of mitigation measures for dust suppression. Records of training should be kept by the Contractor for future audit.
3. Review the efficiency of the implemented dust suppression measure timely, enhancement should be made on those measures if necessary.
4. Review the construction process to minimize the emission of fugitive dust and suggest practicable dust suppression measure before the commencement of high dust emission works.

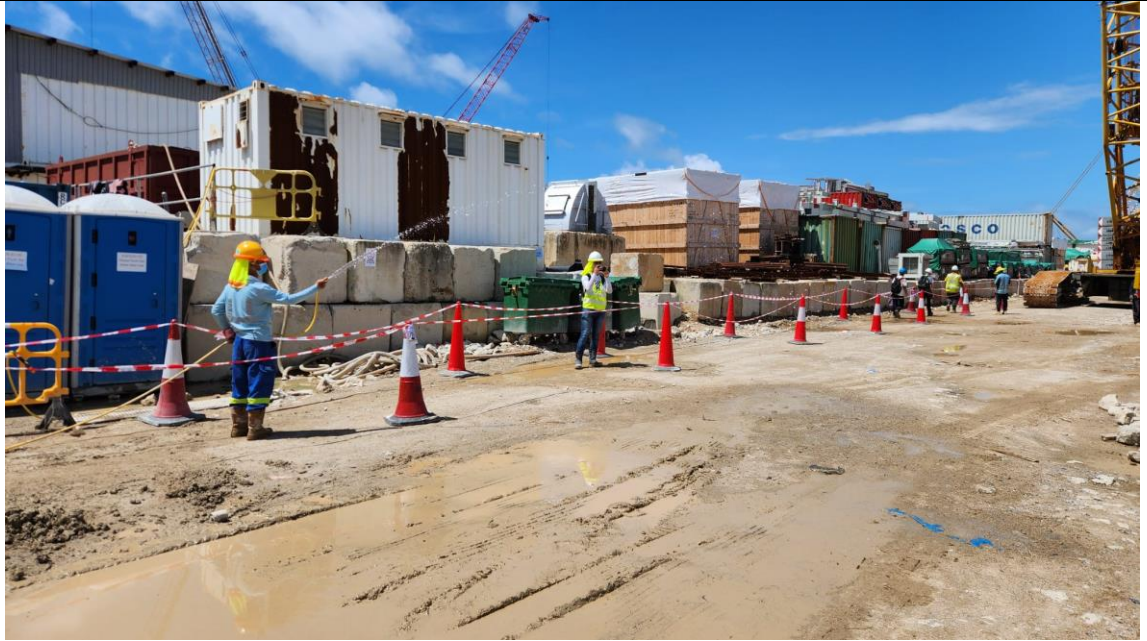
Figure 10: Photo Record of Spraying Water to Main Haul Road
