## Appendix L Complaint Log

**COMPLAINT DETAILS**

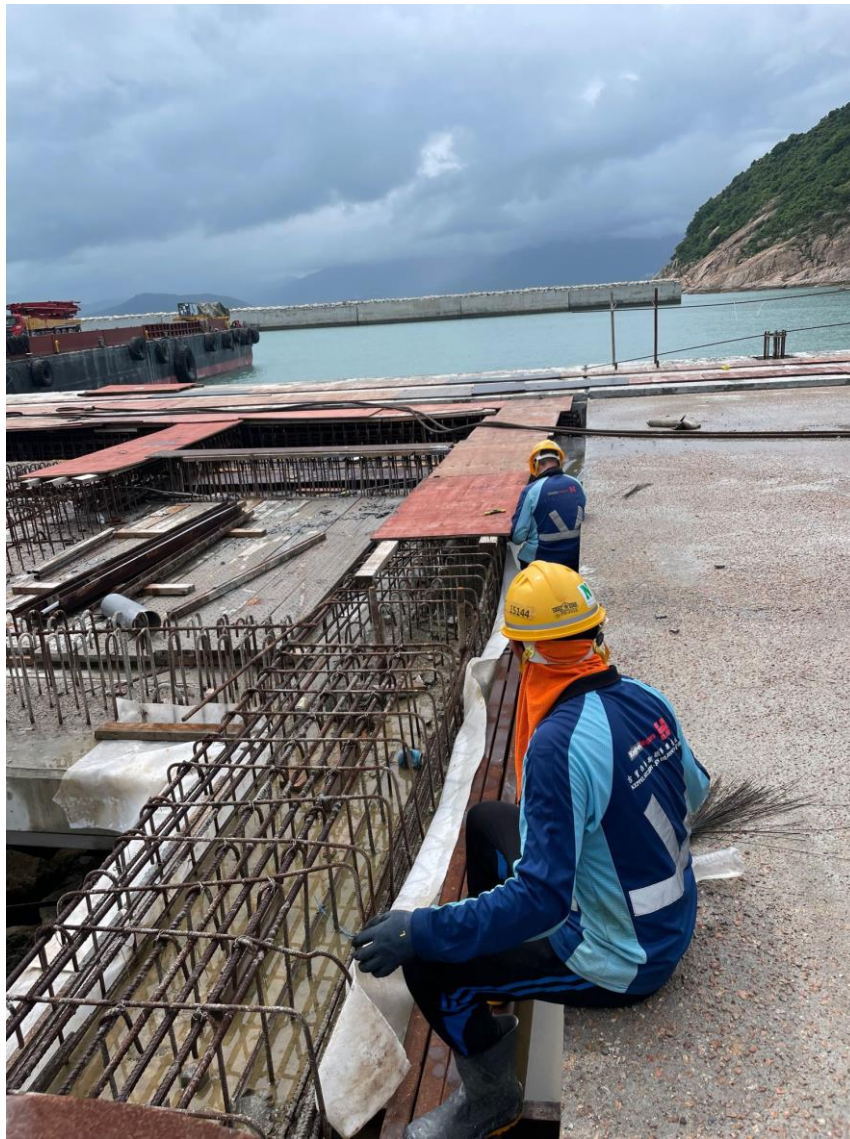
<p><b>Actions taken / to be taken:</b></p> <ul style="list-style-type: none"> <li>- ET notified the Contractor and requested for more information on 06 September 2023.</li> <li>- Information had been provided by Contractor on 06 September 2023.</li> <li>- Field investigations were conducted on 07, 12 and 19 September 2023.</li> <li>- Leakage test with fluorescent dye at pits near the shore of artificial island was conducted on 19 September 2023.</li> </ul>	
<p><b>Investigation Findings:</b></p> <p>With reference to the information provided by the Contractor, the location of alleged discharge of cement water is in the vicinity of caisson 7. As the land based concrete batching plant was still not in operation and no leakage was reported and observed at the concrete batching barge on 05 September 2023, no cement water shall be generated or observed in the work areas adjacent to caisson 7.</p> <p>In view of impossibility of the existence of cement water at the work areas adjacent to caisson 7, the accidentally discharged effluent claimed in the complaint was suspected to be the surface runoff along haul road near caisson 7. The accidental discharge might be caused by the minor leakage from the damaged geotextile at caisson 7.</p> <p>As reported by the Contractor, damaged geotextile at caisson 7 was observed during the post typhoon inspection on 05 September 2023 and the damaged geotextile had been repaired immediately after the post inspection. The photo record of the replacing the damaged geotextile is given in <b>Figure 1</b>. The damage was possibly due to adverse weather under Super Typhoon “SAOLA”<sup>[1]</sup>.</p>

**Figure 1** Replacement of Damaged Geotextile on 05 September 2023

Based on the information provided by the Contractor and collected from the site inspections, and the outcome of the leakage test, it is considered that the leakage of muddy water was induced by the damaged geotextile at caisson 7. The damaged geotextile had been repaired immediately and no further leakage was reported or observed afterwards.

1. Regular and/or random site inspection by SO/ the Contractor/ the ET to ensure that the geotextile is in good condition and deployed at proper location. The geotextile should be repaired immediately if damage on geotextile is observed.
2. Conduct induction/ refresher training and tool-box talks of proper maintenance of temporary drainage system, including the maintenance and repair of geotextile and removal of general waste / sludge inside the temporary drainage system. Records of training should be kept by the Contractor for future audit.

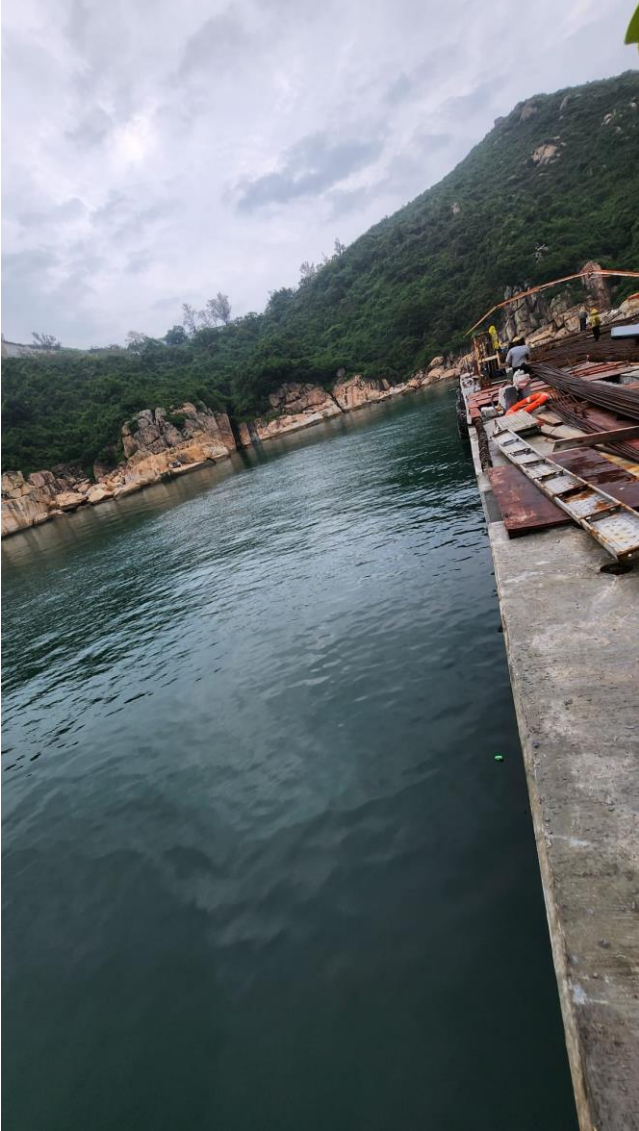
Date	Status / Observation
07, 12 and 19 September 2023  (Weekly site inspection)	<p data-bbox="341 232 1493 376">No silt plume was observed on the sea surface along the seawall B during the site inspection on 07, 12 and 19 September 2023. The site photo records of seawall B during site inspection on 07, 12 and 19 September 2023 are given in <b>Figure 2</b>, <b>Figure 3</b> and <b>Figure 4</b> respectively.</p>

<p data-bbox="376 1547 1458 1615"><b>Figure 2</b> Shore Condition along Seawall B during Site Inspection on 07 September 2023</p>

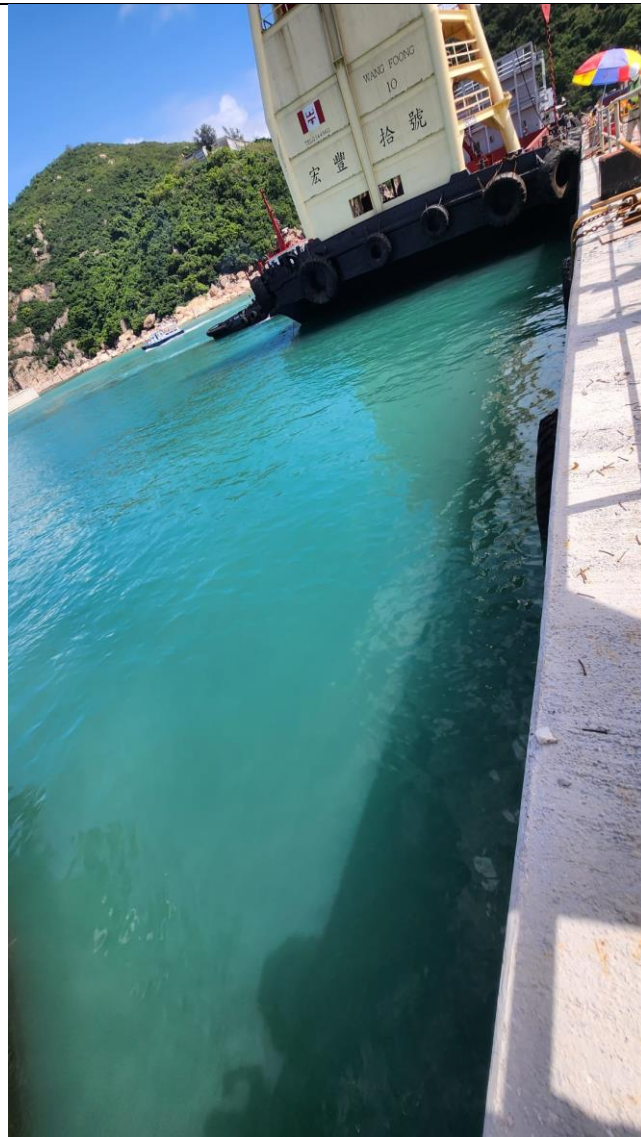
**Figure 3** Shore Condition along Seawall B during Site Inspection on 12 September 2023

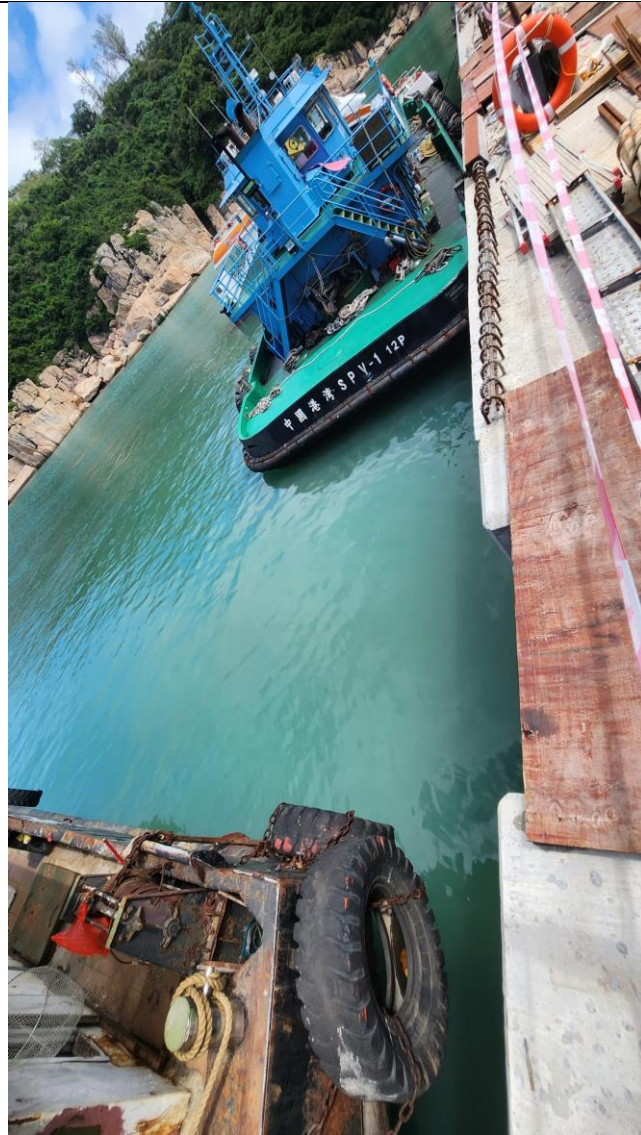
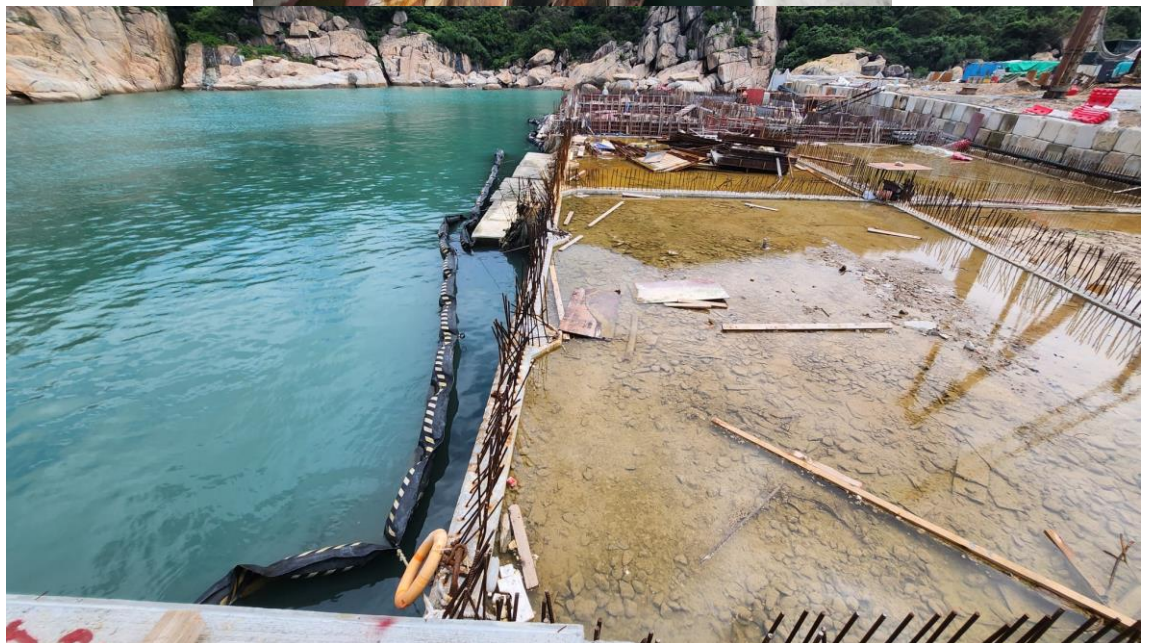
**Figure 4** Shore Condition along Seawall B during Site Inspection on 19 September 2023

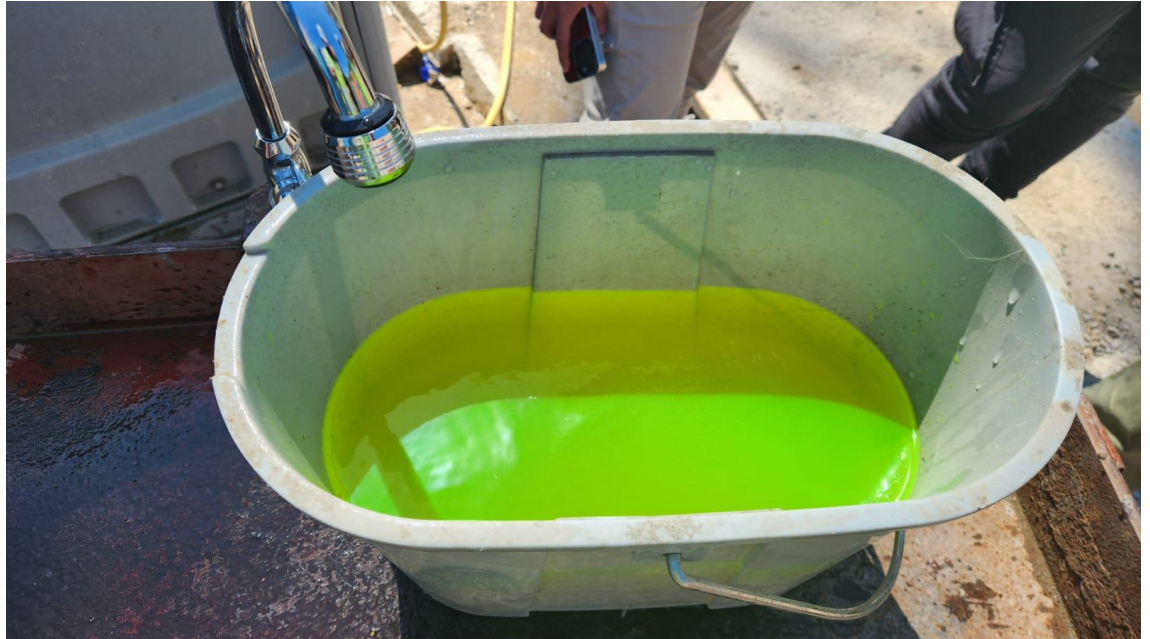
**Figure 5** Dilution of Fluorescent Dye with Water

In an attempt to identify the source of effluent discharge, a leakage test with fluorescent dye was conducted on 19 September 2023. The pits at caisson 5 and water channel at caisson A2, which are other potential sources of alleged effluent discharge, were selected for the leakage test. The fluorescent dye was diluted with ratio of 1.5mL dye to 1L water. The diluted dye was then poured into the selected pit or water channel. The sea condition near the shore of seawall B was inspected around 1 hour later after the diluted dye was poured. No fluorescent dye was observed during the inspection along the seawall B. The photo records of diluting fluorescent dye, pouring dye into selected test locations and sea condition along seawall B after leakage test are given in **Figure 5**, **Figure 6** and **Figure 7** respectively.

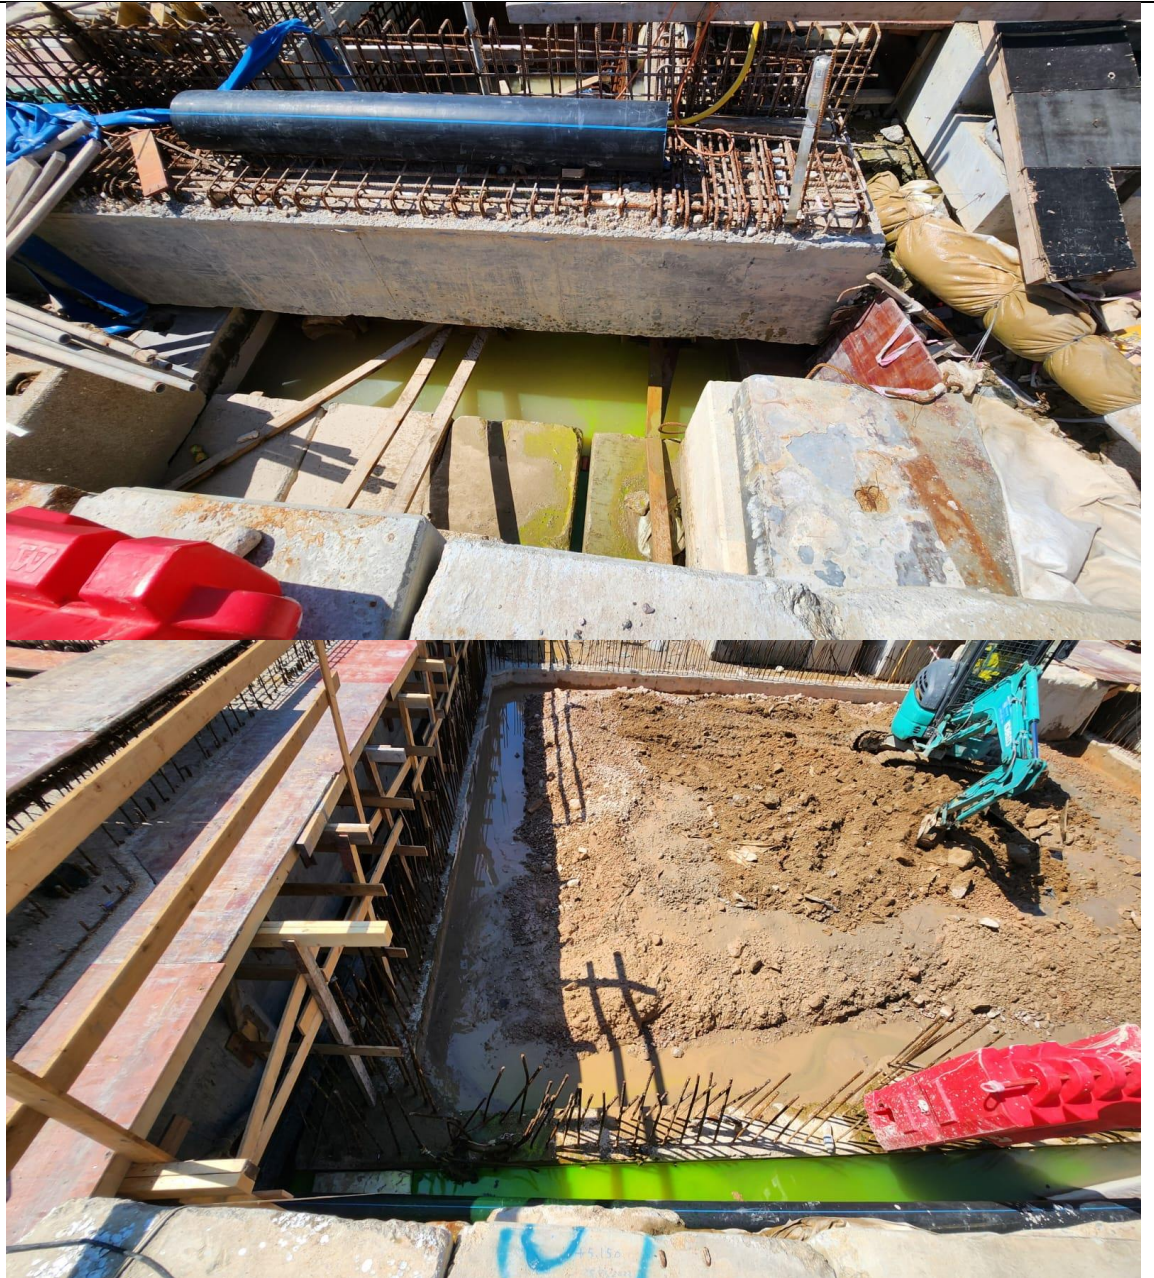
**Figure 6** Leakage Test at Caisson 5 and Caisson A2

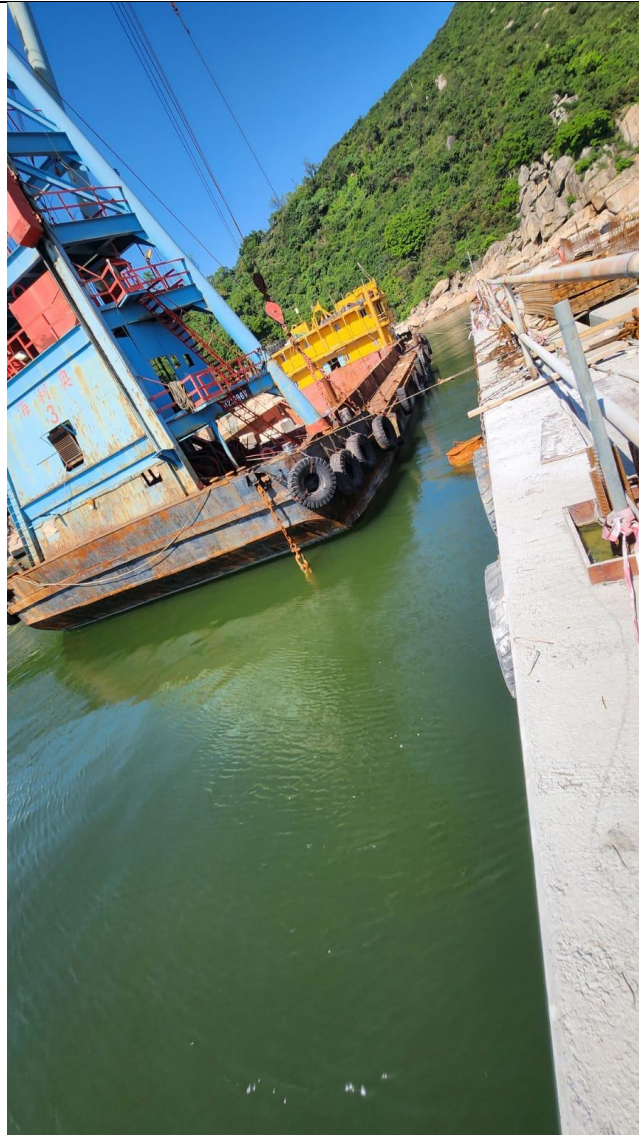
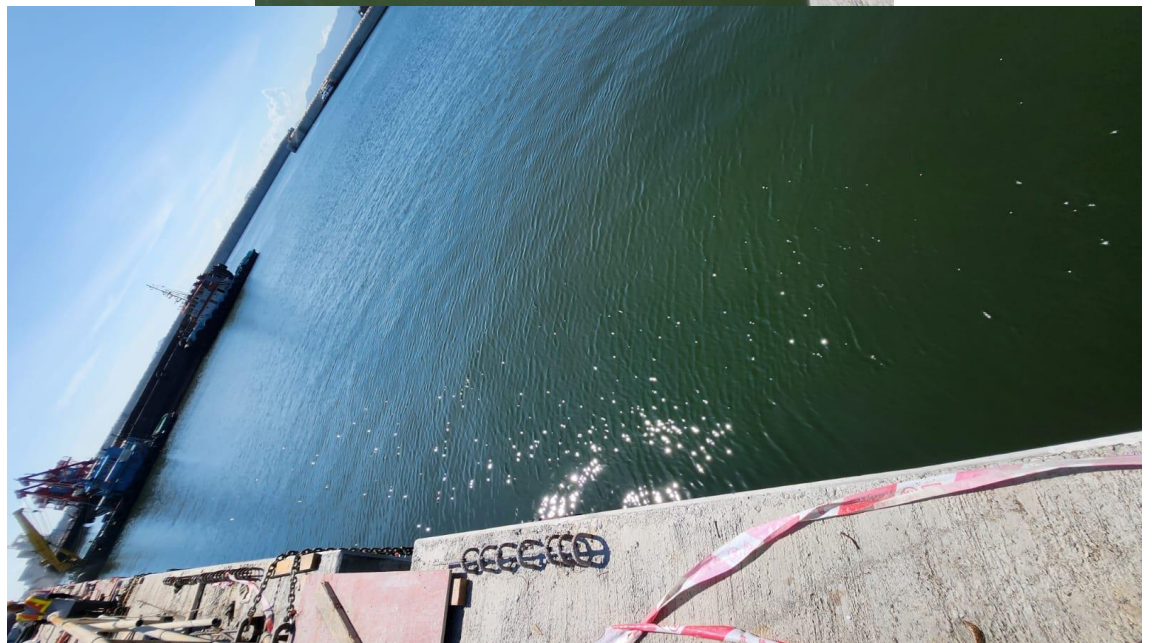
**Figure 7** Inspection along Seawall B after Leakage Test
