Appendix N Exceedance Report

Incident Report on Action Level or Limit Level Non-compliance

Project	Integrated Waste Management Facilities, Phase 1		
Date	11 November 2024 (Lab result received on 18 November 2024)		
Time	13:40 - 17:10 (Mid-Flood)		
Monitoring Location	Mid-Flood F1A, CR1		
Parameter	Suspended Solid (SS)		
Action & Limit Levels	Action Level		Limit Level
	≥ 8.0 mg/L		≥ 10 mg/L
Measurement Level	Impact Station(s) of Exceedance	Control Stations	Impact Station(s) without Exceedance
	8.4 mg/L (F1A) 8.4 mg/L (CR1)	7.1 mg/L (C1A) 6.6 mg/L (C2A)	7.9 mg/L (B1) 7.3 mg/L (B2) 6.9 mg/L (B3) 8.0 mg/L (B4) 7.3 mg/L (H1) 7.7 mg/L (M1) 7.7 mg/L (CR2)

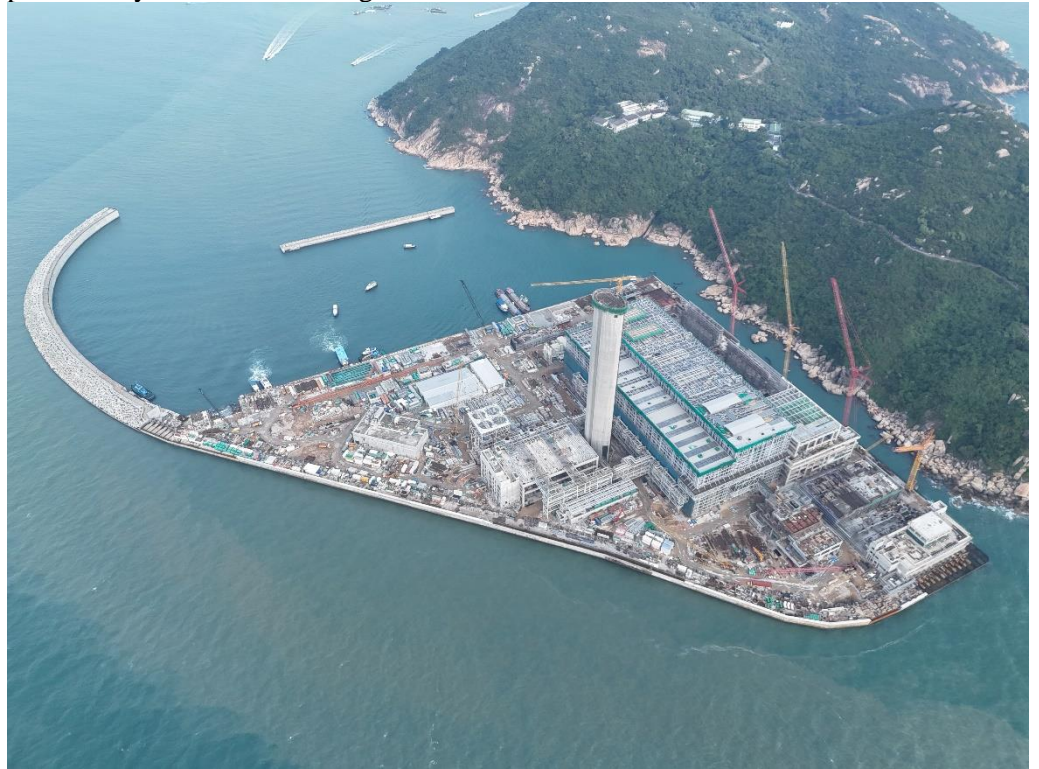
Aerial Photo Record of the Project Site

As reported by the Contractor, superstructure works were carried out and no surface runoff was observed on 11 November 2024. The aerial photo record of the Project Site provided by the Contractor is given below:

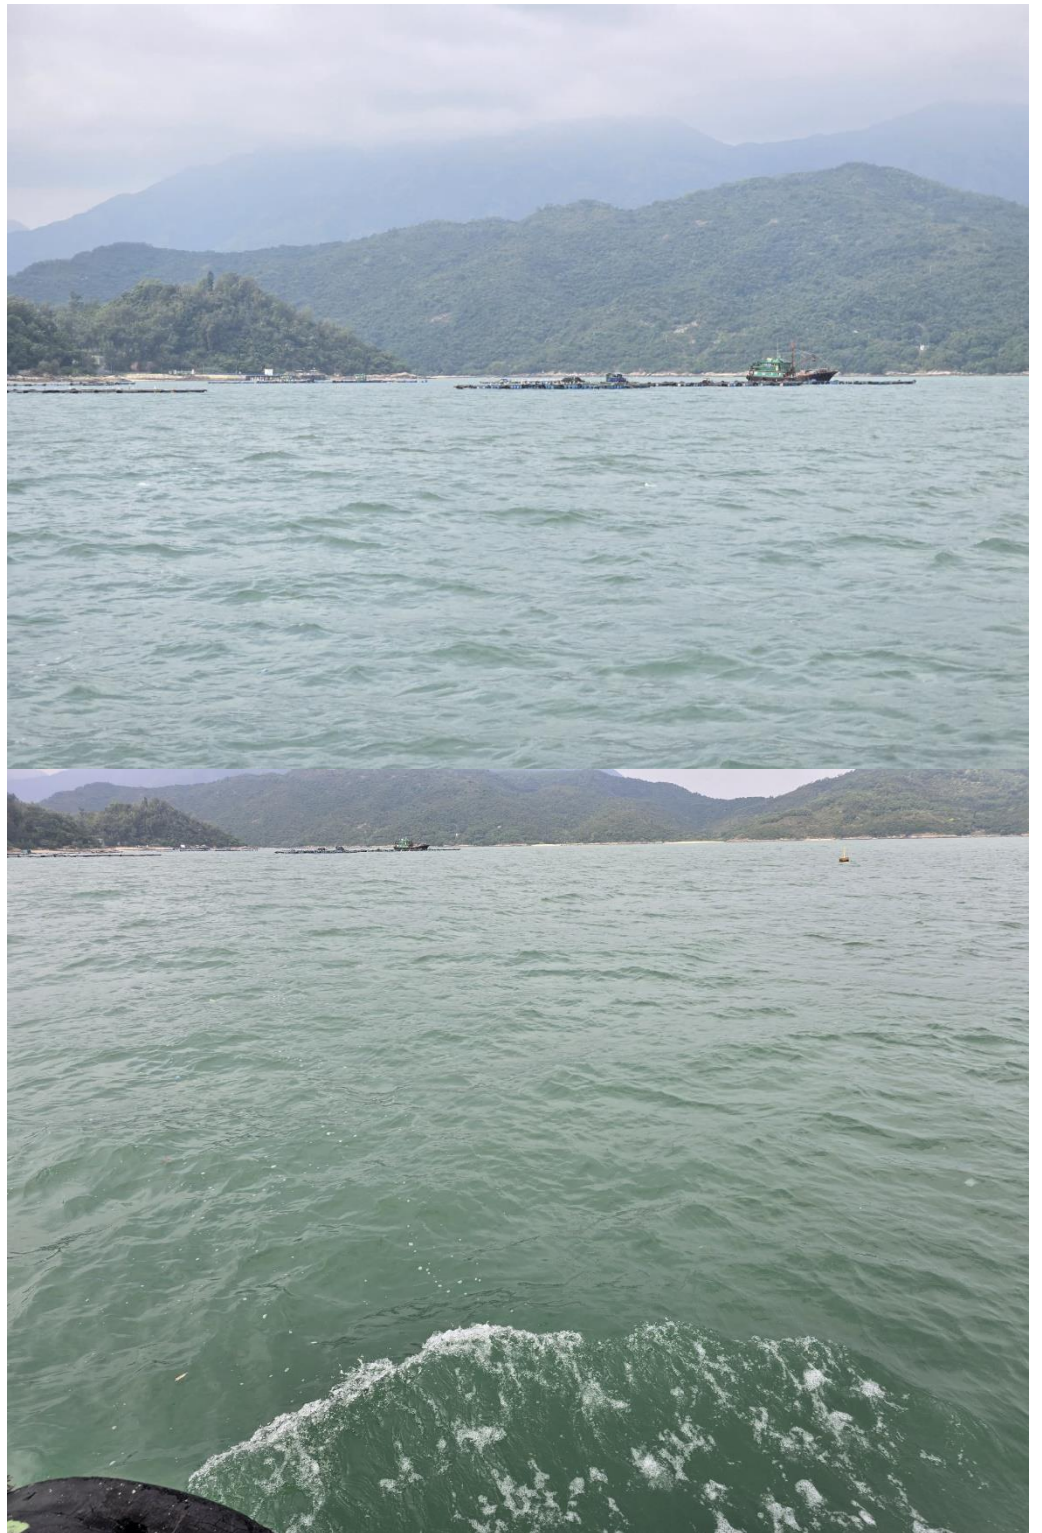
F1A:

Exceedances of action level were found at F1A and CR1, F1A and CR1 are located at unrelated stream direction (neither upstream nor downstream) to the works location during mid-flood tide, based on the dominant tidal flow.. Exceedances at the monitoring stations are deemed to be unrelated to the Project. In view of only slight exceedances were found at F1A and CR1, the exceedances at F1A and CR1 possibly caused by the disturbance of ocean current to seabed.

According to the field observation by sampling team during sampling event, no silt plume was observed in the Project site.

After the investigation, the exceedances on 11 November 2024 at F1A and CR1 are deemed to be unrelated to the Project.

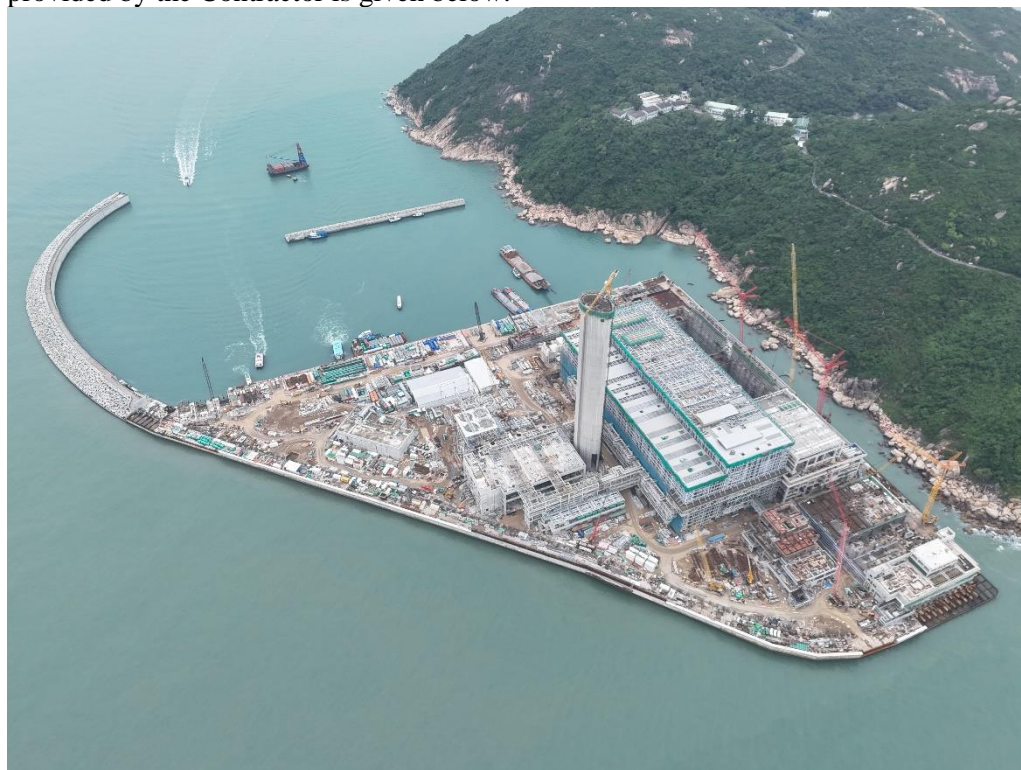
Aerial Photo Record of the Project Site

As reported by the Contractor, superstructure works were carried out and no surface runoff was observed on 22 November 2024. The aerial photo record of the Project Site provided by the Contractor is given below:

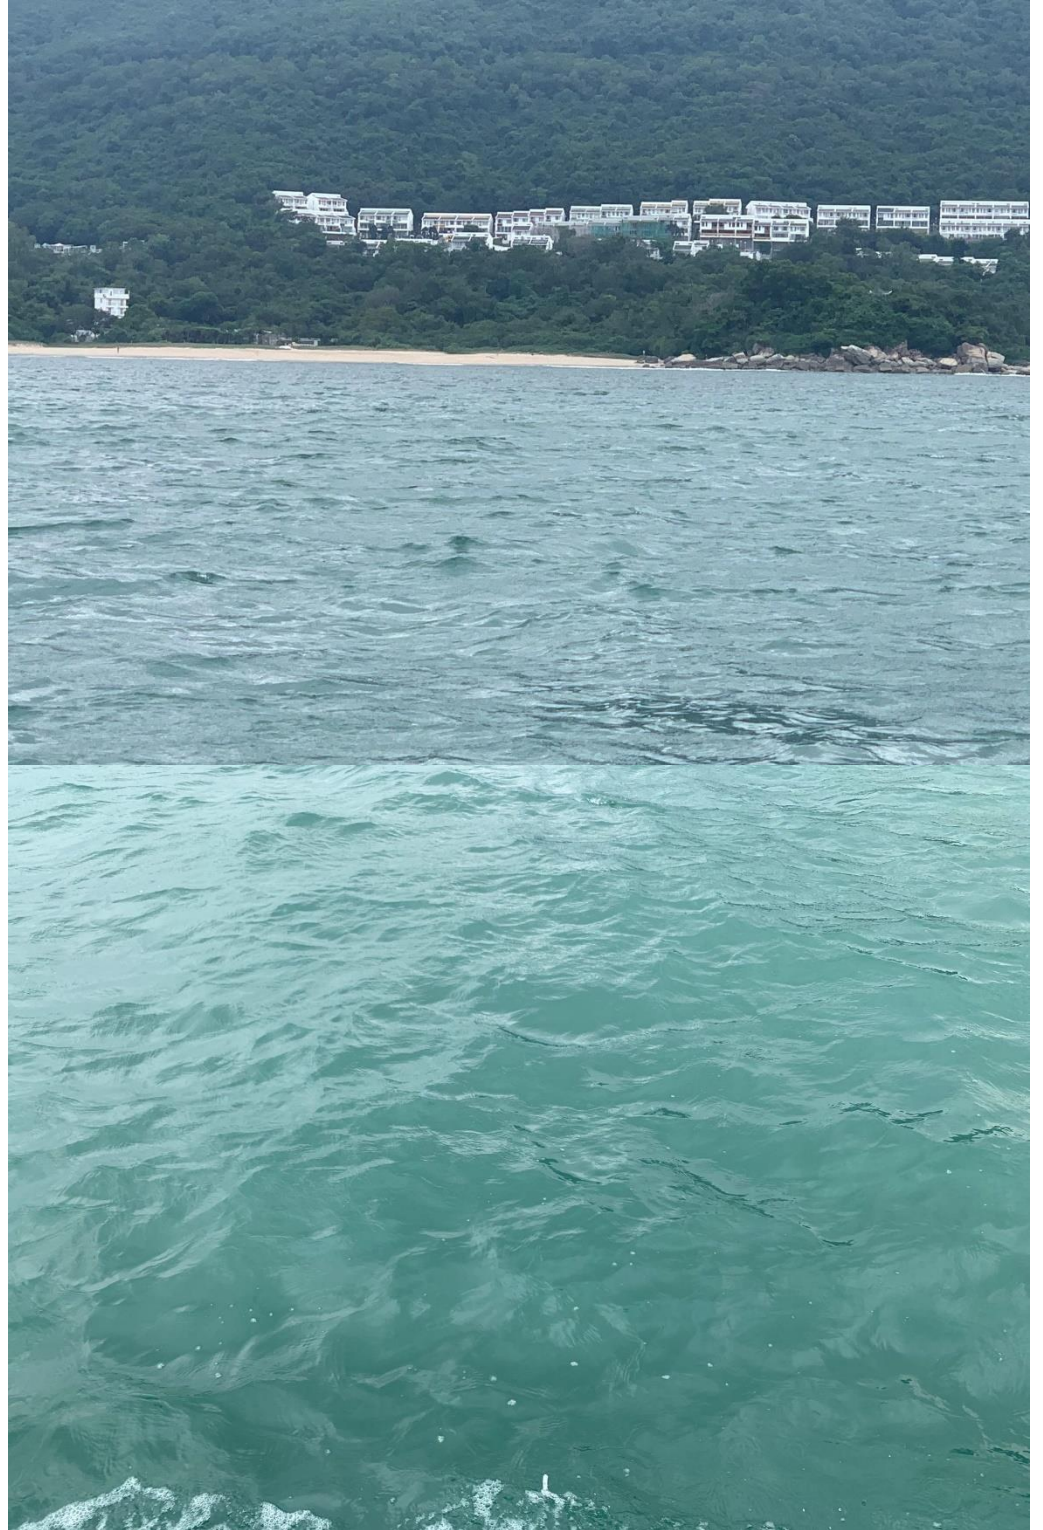
B1:

Exceedances of action level were found at B1, B2, B3 and B4, B1, B2, B3 and B4 are located at unrelated stream direction (neither upstream nor downstream) to the works location during mid-ebb tide, based on the dominant tidal flow. Exceedances at the monitoring stations are deemed to be unrelated to the Project.

According to the field observation by sampling team during sampling event, no silt plume was observed in the Project site.

After the investigation, the exceedances on 22 November 2024 at B1, B2, B3 and B4 are deemed to be unrelated to the Project.

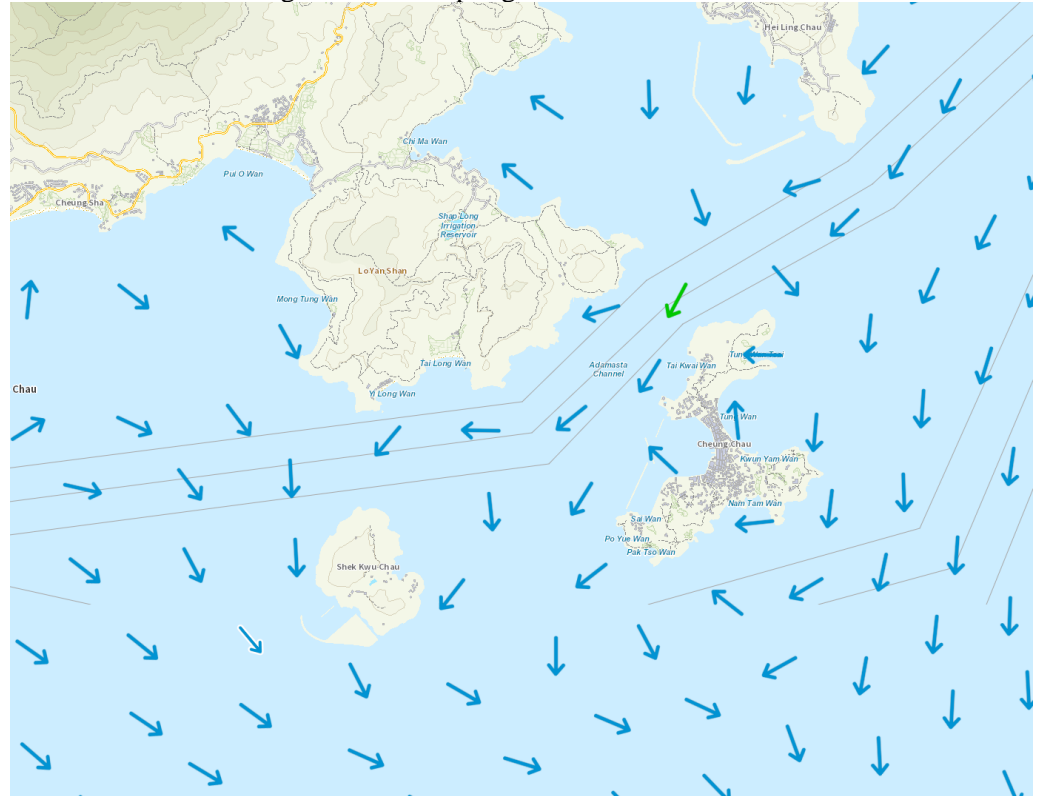
Current direction during mid-ebb sampling on 22 November 2024:

Dominant sea current direction was found to be from Northwest to Southeast at waters around Shek Kwu Chau.
