Appendix N Exceedance Report

Incident Report on Action Level or Limit Level Non-compliance

Project	Integrated Waste Management Facilities, Phase 1		
Date	31 May 2019 (Lab result received on 05 June 2019)		
Time	08:56 – 12:26 (Mid-Ebb)		
Monitoring Location	Mid-Ebb B1

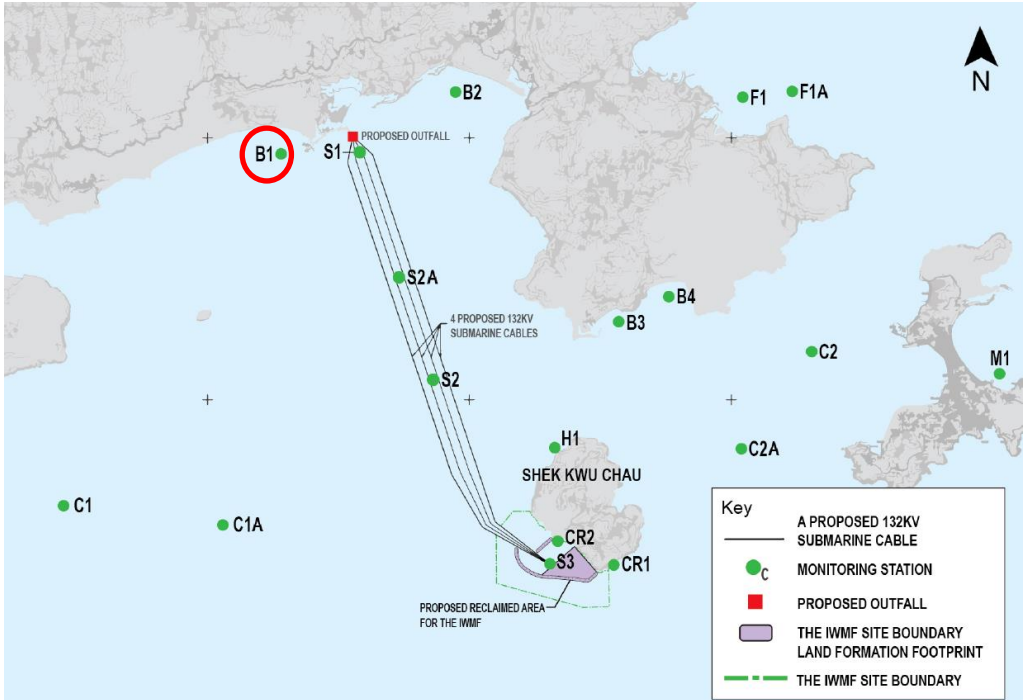
Parameter	Suspended Solid (SS)		
Action & Limit Levels	Action Level		Limit Level
	≥ 12.0 mg/L		≥ 14.0 mg/L
Measurement Level	Impact Station(s) of Exceedance	Control Stations	Impact Station(s) without Exceedance

12.0 mg/L (B1)	8.0 mg/L (C1A) 7.2 mg/L (C2A)	6.8 mg/L (B2) 6.0 mg/L (B3) 7.5 mg/L (B4) 8.2 mg/L (F1A) 7.8 mg/L (H1) 9.0 mg/L (M1) 7.5 mg/L (CR1) 6.0 mg/L (CR2) 6.3 mg/L (S1) 5.3 mg/L (S2A) 8.3 mg/L (S3)
Possible reason for Action or Limit Level Non-compliance	<p>Works scheduled on site on 31/05 include DCM main works, DCM sample coring for DCM main works, dredging at vertical seawall area, sand blanket laying works, cone penetration test and static loading test.</p> <p>Dominating sea current direction was found to be from Northwest to Southeast at waters around Shek Kwu Chau.</p> <p>B1 is located at unrelated stream direction (neither upstream nor downstream, far away) to the works location, exceedance of this monitoring station is deemed to be unrelated to the Project.</p>

<p>From MMO monitoring records on 31/05, MMO teams were arranged for two DCM barges (ESC-61 & ESC-62) and four derrick barges (GD-851, Penstone 1, DL-5 & 俊太 2) on that day while no deficiency of silt curtain was found before the start of construction activity.</p> <p>Silt curtain checking was implemented on ESC-62 (10:15), ESC-61 (16:25), Penstone 1 (07:30), DL-5 (10:00), GD-851 (08:30) & 俊太 2 (09:00) by the Contractor and checking results showed that no deficiency of silt curtain was found on that day.</p> <p>Site tidiness in the present barges in the Project site were checked during weekly site inspection on 28/05, where no major observation of improper site practice that might contribute to the increase in SS level was observed during the inspection.</p>
<p>Actions taken / to be taken</p>	<p>Examination of environmental performance of the Project will be continued during the weekly inspection, and the Contractor is reminded to implement all applicable mitigation measures as per the Updated EM&A Manual.</p>

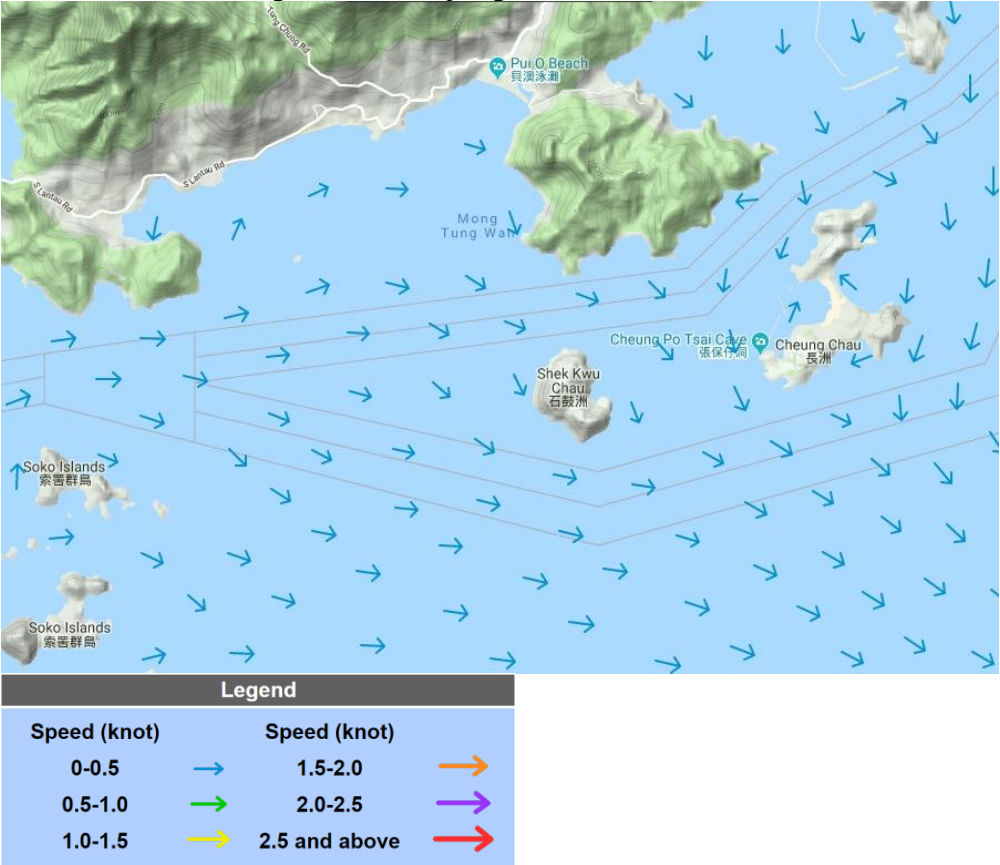
<p>Remarks</p>	<p>Current direction during mid-ebb sampling on 31/05:</p>
