Appendix N Exceedance Report

Incident Report on Action Level or Limit Level Non-compliance

Project	Integrated Waste Management Facilities, Phase 1		
Date	03 Jan 2022 (Lab result received on 08 Jan 2022)		
Time	11:25 – 14:55 (Mid-Ebb) 08:00 – 10:59 (Mid-Flood)		
Mid-Ebb			
Monitoring Location	<div>CR2</div>

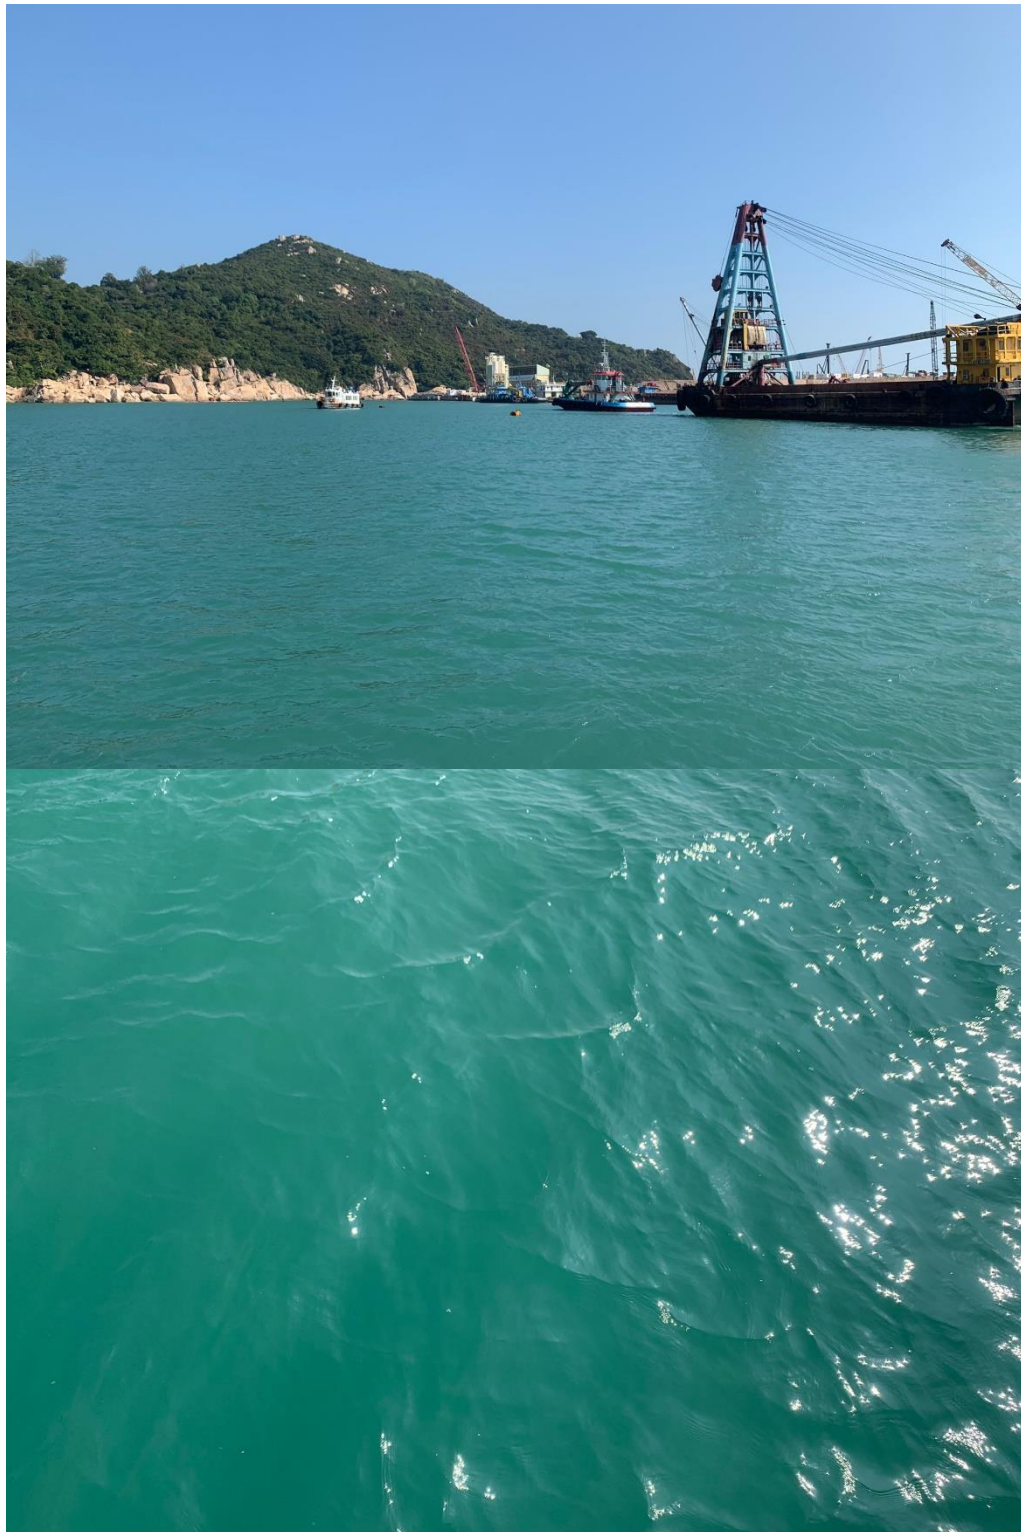
CR2:

13.7 mg/L (CR2)	8.2 mg/L (C1A) 9.7 mg/L (C2A)	6.0 mg/L (B1) 6.0 mg/L (B2) 6.8 mg/L (B3) 7.0 mg/L (B4) 7.2 mg/L (H1) 7.7 mg/L (M1) 5.7 mg/L (F1A) 8.0 mg/L (CR1)
Possible reason for Action or Limit Level Non-compliance	<p>Works scheduled on site on 03 Jan 2022 include levelling of scour apron on Breakwater B CH60 - CH180, levelling of 100kg - 150kg underlayer rock at Breakwater B CH0 - CH40, leveling of underlayer rock at Breakwater A CH960 - CH1000, installation of blockwork for marine access facility, landfilling works for below +6.00mPD, landfilling works for above +6.00mPD, installation of instrumentation, piling pre-drilling works, piling works, piling works for driven pile, piling works for pre-bored socketed H-pile and existing caisson extension and armour scour protection.</p> <p>Dominant sea current direction was found to be from Northeast to Southwest at waters around Shek Kwu Chau.</p>

<p>An exceedance of limit level was found at CR2.</p> <p>CR2 is located close to the works location within the Project site while no marine work was conducted on 03 Jan 2022.</p> <p>The installation of caisson No.19 was completed on 18 Mar 2021, the reclamation area was enclosed.</p> <p>According to the field observation by sampling team during sampling event, no silt plume was observed in the Project site and the weather was fine during the sampling event.</p> <p>No major observation of improper site practices that contributed to the increase of the suspended solids was recorded during the weekly inspection on 04 Jan 2022.</p> <p>After the investigation, the exceedance on 03 Jan 2022 at CR2 is deemed to be unrelated to the Project.</p>
--	--

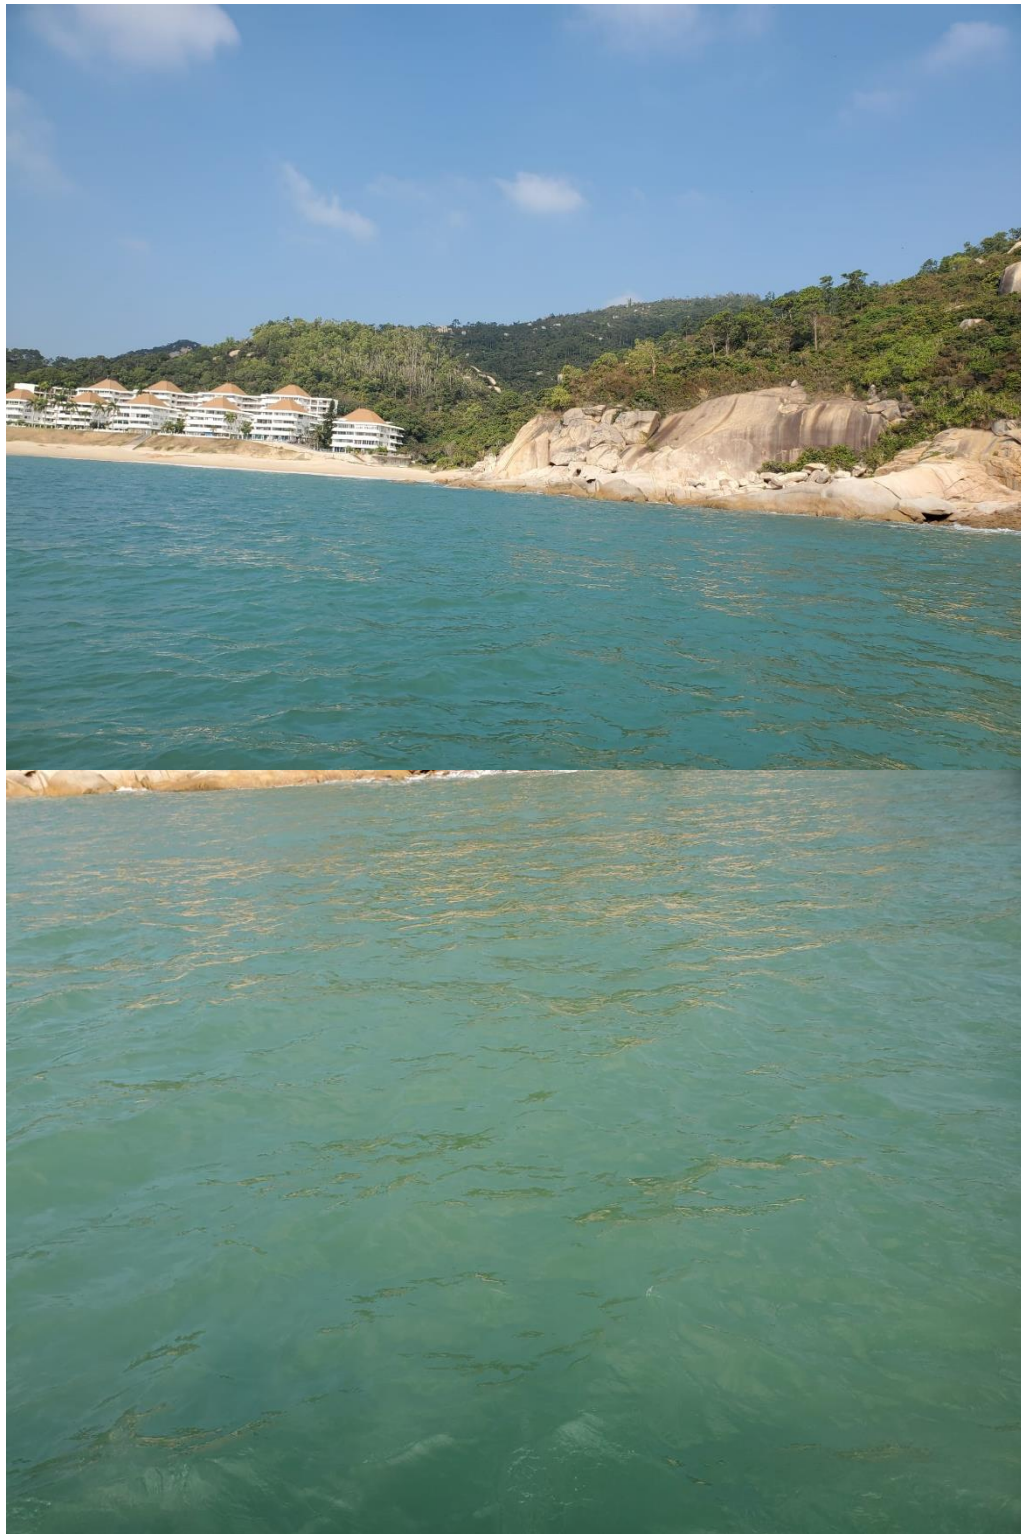
B3:

9.0 mg/L (B3)	7.8 mg/L (C1A) 7.2 mg/L (C2A)	6.3 mg/L (B1) 7.8 mg/L (B2) 4.8 mg/L (B4) 8.2 mg/L (F1A) 6.5 mg/L (H1) 6.7 mg/L (M1) 6.0 mg/L (CR1) 8.2 mg/L (CR2)
Possible reason for Action or Limit Level Non-compliance	<p>Works scheduled on site on 03 Jan 2022 include levelling of scour apron on Breakwater B CH60 - CH180, levelling of 100kg - 150kg underlayer rock at Breakwater B CH0 - CH40, leveling of underlayer rock at Breakwater A CH960 - CH1000, installation of blockwork for marine access facility, landfilling works for below +6.00mPD, landfilling works for above +6.00mPD, installation of instrumentation, piling pre-drilling works, piling works, piling works for driven pile, piling works for pre-bored socketed H-pile and existing caisson extension and armour scour protection.</p> <p>Dominant sea current direction was found to be from Southeast to Northwest at waters around Shek Kwu Chau.</p> <p>An exceedance of action level was found at B3.</p> <p>B3 is located at unrelated stream direction (neither upstream nor downstream, far away) to the works location. The exceedance at this monitoring station is deemed to be unrelated to the Project.</p>

<p>The installation of caisson No.19 was completed on 18 Mar 2021, the reclamation area was enclosed.</p> <p>According to the field observation by sampling team during sampling event, no silt plume was observed in the Project site and the weather was fine during the sampling event.</p> <p>No major observation of improper site practices that contributed to the increase of the suspended solids was recorded during the weekly inspection on 04 Jan 2022.</p> <p>After the investigation, the exceedance on 03 Jan 2022 at B3 is deemed to be unrelated to the Project.</p>
--	--

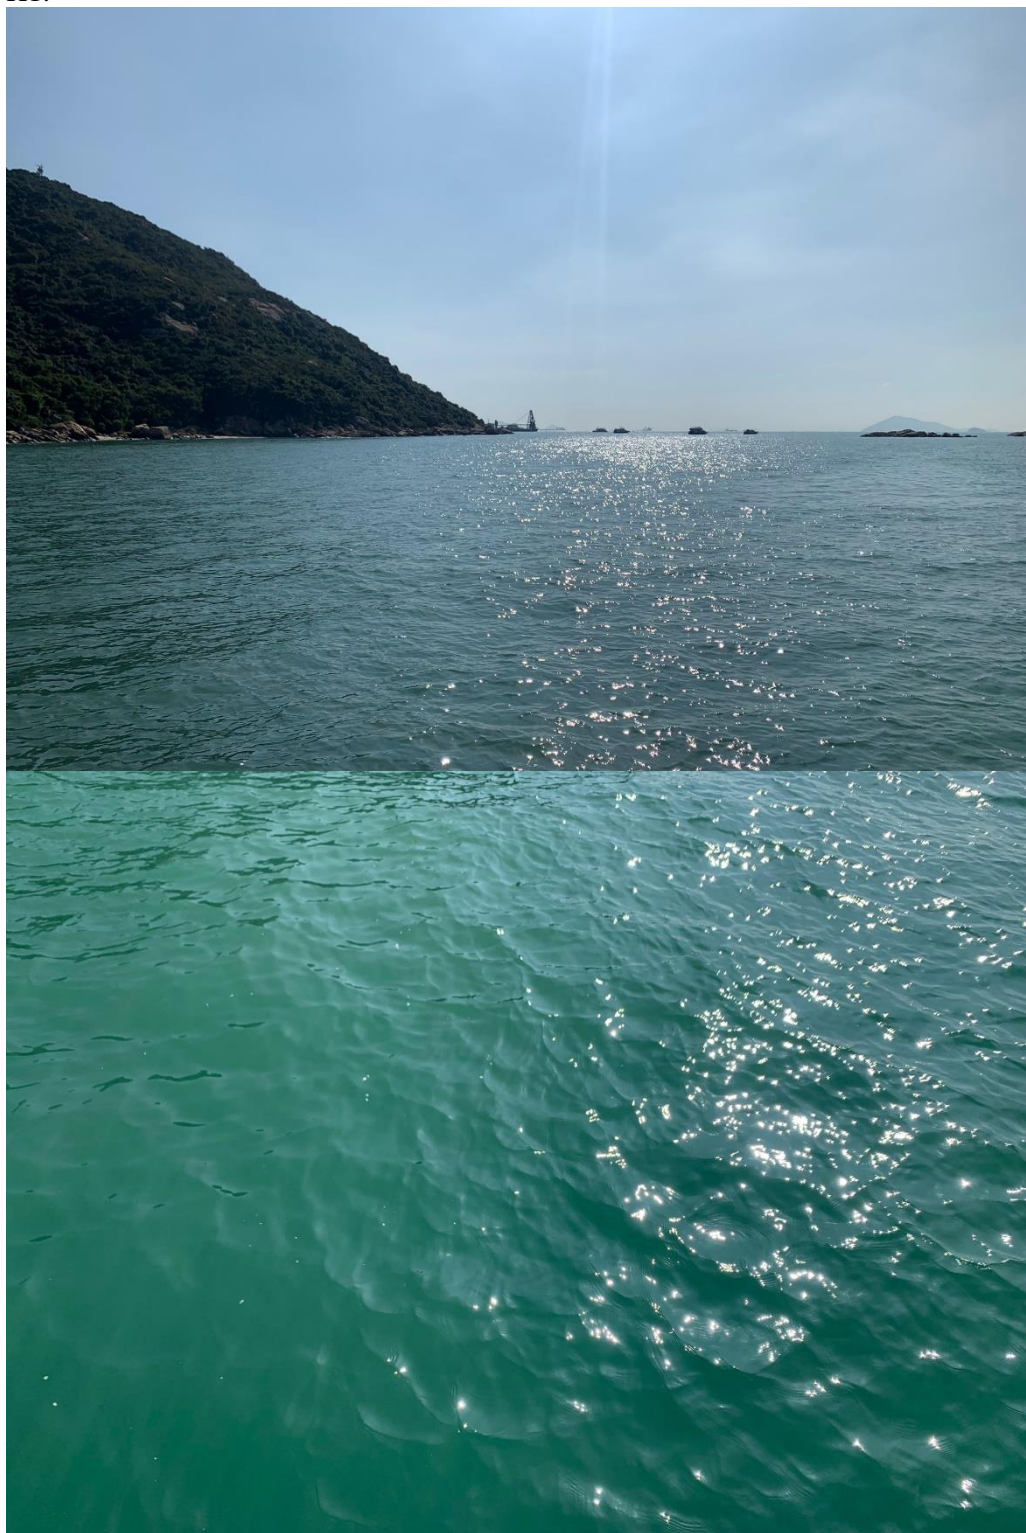
H1:

8.3 mg/L (H1)	5.0 mg/L (C1A) 3.7 mg/L (C2A)	6.3 mg/L (B1) 5.0 mg/L (B2) 6.0 mg/L (B3) 5.3 mg/L (B4) 5.5 mg/L (M1) 4.2 mg/L (F1A) 7.7 mg/L (CR1) 6.7 mg/L (CR2)
Possible reason for Action or Limit Level Non-compliance	<p>Works scheduled on site on 05 Jan 2022 include levelling of 100kg - 150kg underlayer rock at Breakwater B (CH60 - CH150; CH100 - CH180), leveling of underlayer rock at Breakwater A CH980 - CH1020, installation of blockwork for marine access facility, landfilling works for below +6.00mPD, installation of instrumentation, piling pre-drilling works, piling works, piling works for driven pile, piling works for pre-bored socketed H-pile and existing caisson extension and armour scour protection.</p> <p>Dominant sea current direction was found to be from Northwest to Southeast at waters around Shek Kwu Chau.</p> <p>An exceedance of Action level was found at H1.</p>

<p>H1 is located at unrelated stream direction (neither upstream nor downstream) to the works location. The exceedance is deemed to be unrelated to the Project.</p> <p>The installation of caisson No.19 was completed on 18 Mar 2021, the reclamation area was enclosed.</p> <p>According to the field observation by sampling team during sampling event, no silt plume was observed in the Project site and the weather was fine during the sampling event.</p> <p>No major observation of improper site practices that contributed to the increase of the suspended solids was recorded during the weekly inspection on 04 and 11 Jan 2022.</p> <p>After the investigation, the exceedance on 05 Jan 2022 at H1 is deemed to be unrelated to the Project.</p>
--	--

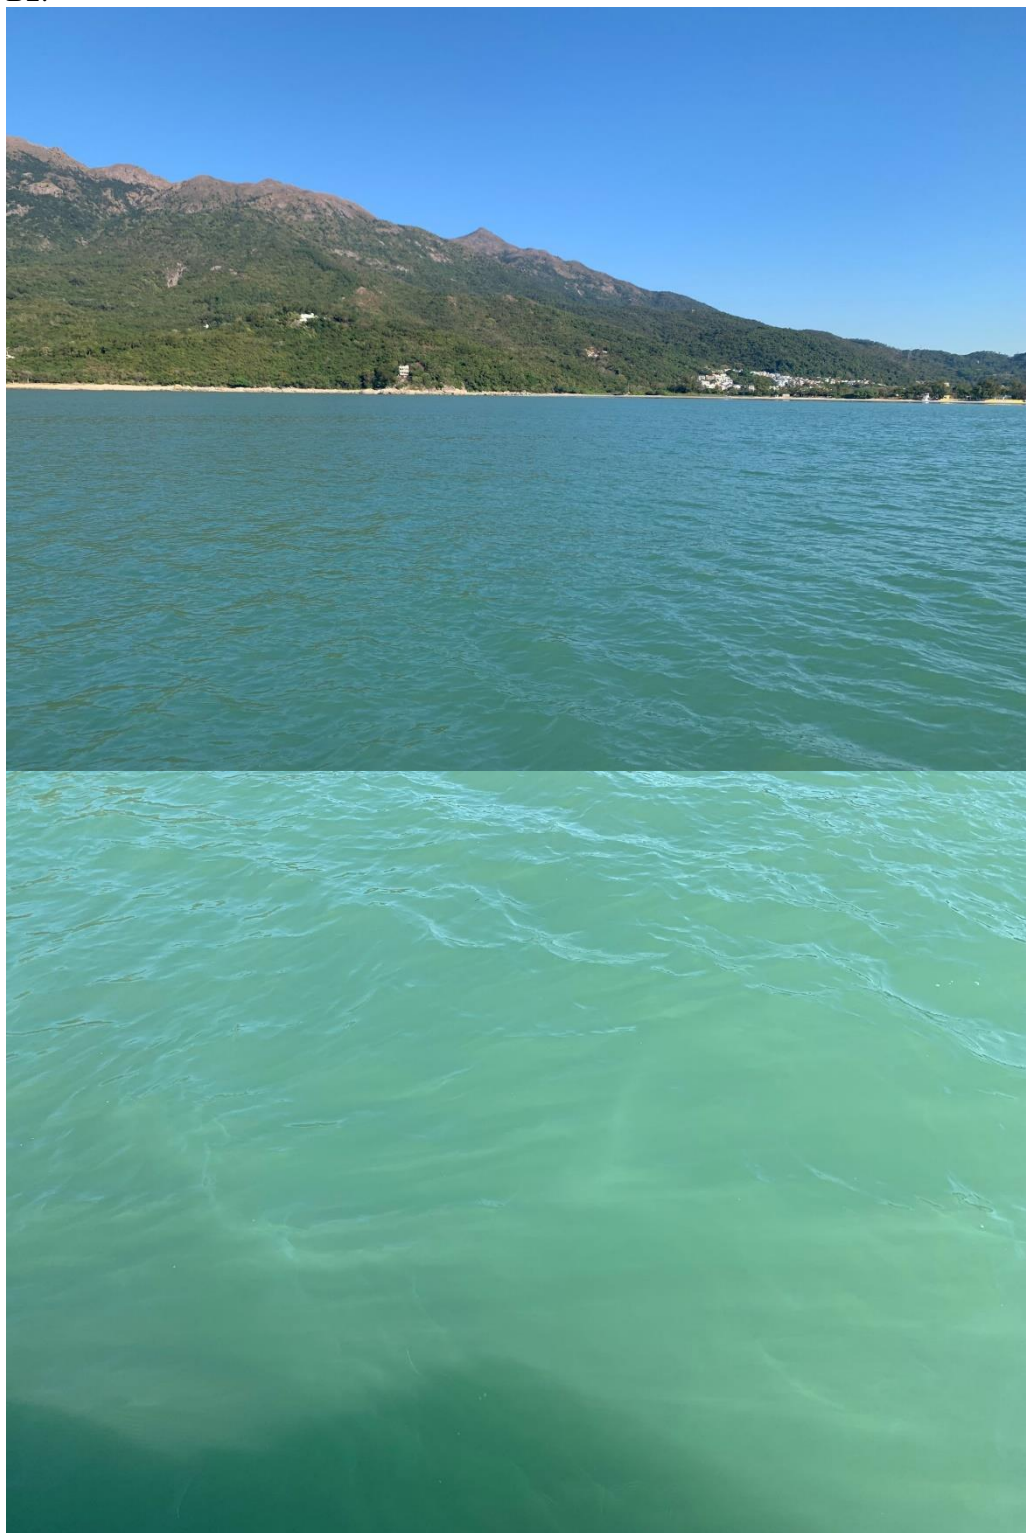
B2:

9.8 mg/L (B2) 11.5 mg/L (B3) 10.5 mg/L (CR2)	6.7 mg/L (C1A) 8.0 mg/L (C2A)	4.8 mg/L (B1) 7.3 mg/L (B4) 7.5 mg/L (F1A) 6.3 mg/L (H1) 5.8 mg/L (M1) 6.0 mg/L (CR1)
Possible reason for Action or Limit Level Non-compliance	<p>Works scheduled on site on 05 Jan 2022 include levelling of 100kg - 150kg underlayer rock at Breakwater B (CH60 - CH150; CH100 - CH180), leveling of underlayer rock at Breakwater A CH980 - CH1020, installation of blockwork for marine access facility, landfilling works for below +6.00mPD, installation of instrumentation, piling pre-drilling works, piling works, piling works for driven pile, piling works for pre-bored socketed H-pile and existing caisson extension and armour scour protection.</p> <p>Dominant sea current direction was found to be from Southeast to Northwest at waters around Shek Kwu Chau.</p> <p>An exceedance of action level was found at B2 and exceedances of limit level were found at B3 and CR2.</p> <p>B2 and B3 are located at unrelated stream direction (neither upstream nor downstream, far away) to the works location. The exceedance at this monitoring station is deemed to be unrelated to the Project.</p> <p>CR2 is located close to the works location within the Project site while no marine work was conducted on 05 Jan 2022.</p>

<p>The installation of caisson No.19 was completed on 18 Mar 2021, the reclamation area was enclosed.</p> <p>According to the field observation by sampling team during sampling event, no silt plume was observed in the Project site and the weather was fine during the sampling event.</p> <p>No major observation of improper site practices that contributed to the increase of the suspended solids was recorded during the weekly inspection on 04 and 11 Jan 2022.</p> <p>After the investigation, the exceedance on 05 Jan 2022 at B2, B3 and CR2 are deemed to be unrelated to the Project.</p>
--	--

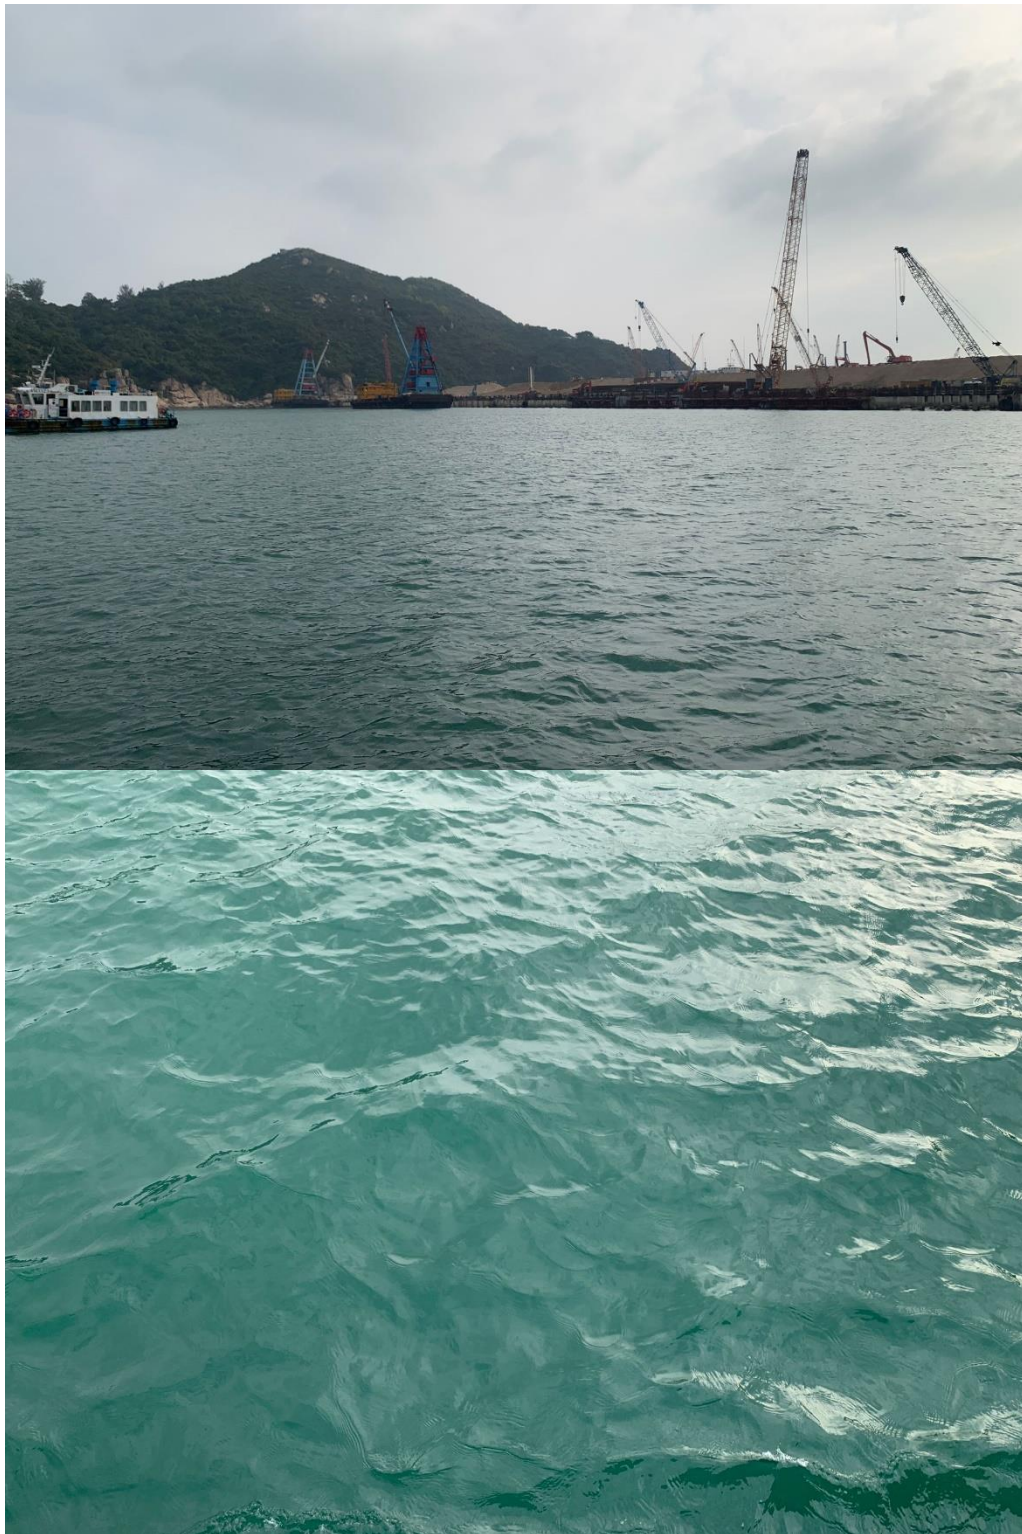
CR2:

8.3 mg/L (CR2)	6.8 mg/L (C1A) 5.0 mg/L (C2A)	5.0 mg/L (B1) 5.3 mg/L (B2) 5.5 mg/L (B3) 5.5 mg/L (B4) 5.8 mg/L (H1) 4.7 mg/L (M1) 4.3 mg/L (F1A) 7.8 mg/L (CR1)
Possible reason for Action or Limit Level Non-compliance	<p>Works scheduled on site on 07 Jan 2022 include levelling of 100kg - 150kg underlayer rock at Breakwater B CH60 - CH100, leveling of underlayer rock at Breakwater A CH950 - CH1100, landfilling works for below +6.00mPD, landfilling works for above +6.00mPD, installation of instrumentation, piling pre-drilling works, piling works, piling works for driven pile, piling works for pre-bored socketed H-pile and existing caisson extension and armour scour protection.</p> <p>Dominant sea current direction was found to be from Southeast to Northwest at waters around Shek Kwu Chau.</p> <p>An exceedance of action level was found at CR2.</p>

<p>The installation of caisson No.19 was completed on 18 Mar 2021, the reclamation area was enclosed.</p> <p>CR2 is located close to the works location within the Project site while no marine work was conducted on 7 Jan 2022.</p> <p>According to the field observation by sampling team during sampling event, no silt plume was observed in the Project site and the weather was fine during the sampling event.</p> <p>No major observation of improper site practices that contributed to the increase of the suspended solids was recorded during the weekly inspection on 04 and 11 Jan 2022.</p> <p>After the investigation, the exceedance on 07 Jan 2022 at CR2 is deemed to be unrelated to the Project.</p>
--	--

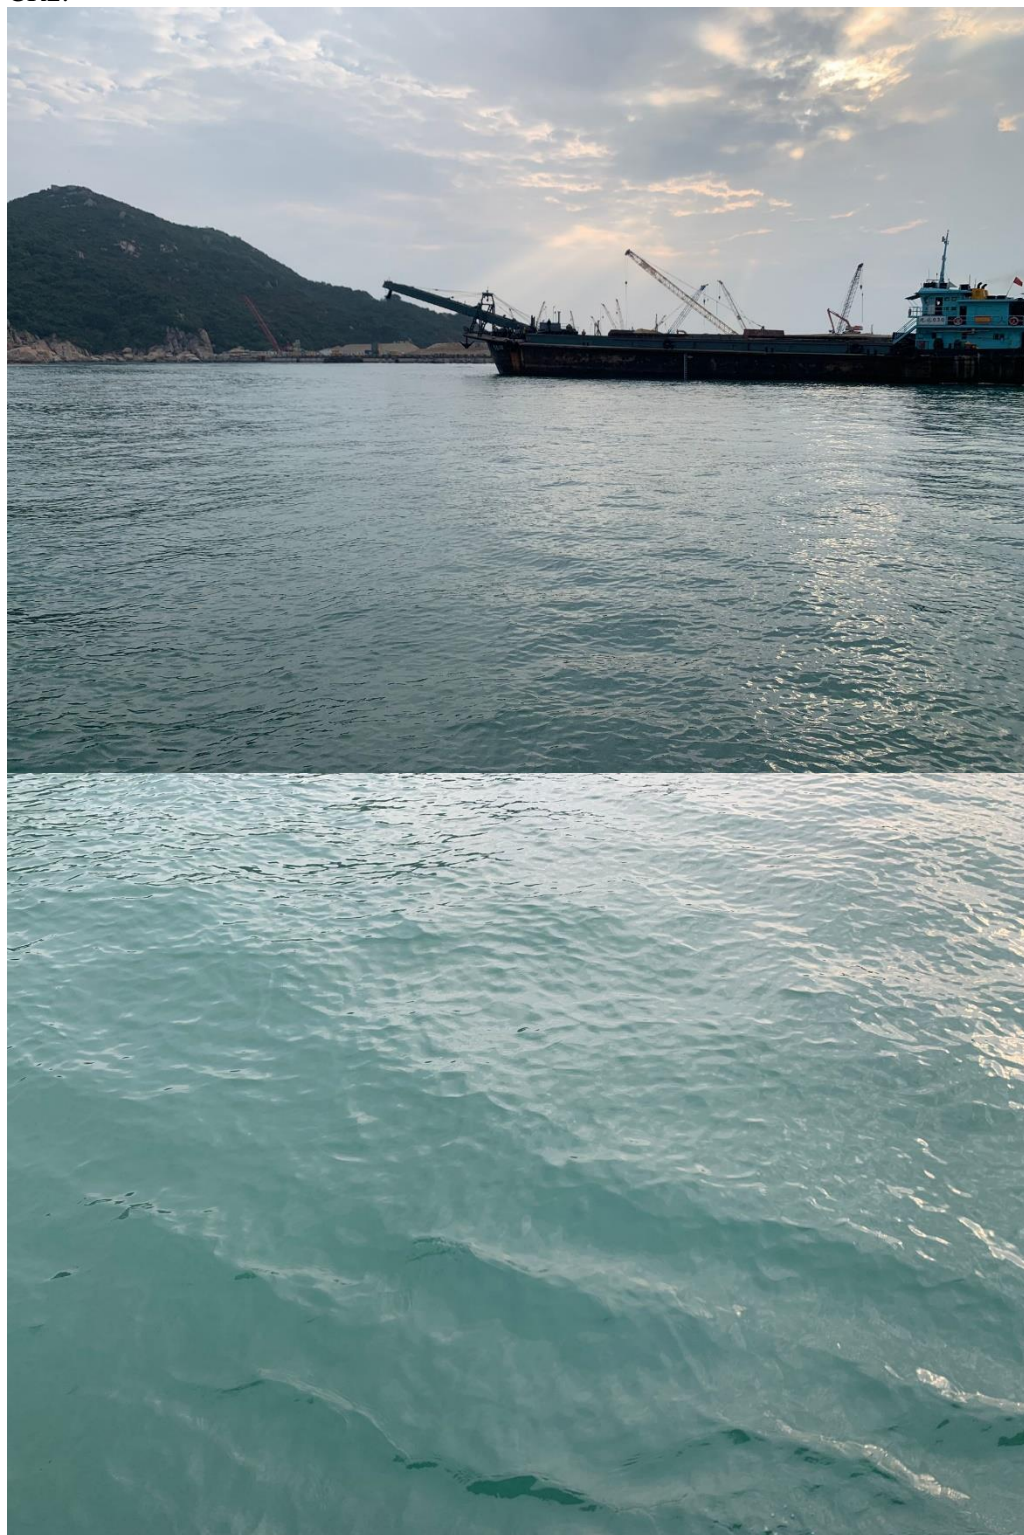
CR2:

10.8 mg/L (CR2)	6.5 mg/L (C1A) 6.5 mg/L (C2A)	7.0 mg/L (B1) 5.5 mg/L (B2) 5.8 mg/L (B3) 5.0 mg/L (B4) 4.7 mg/L (M1) 5.2 mg/L (F1A) 5.2 mg/L (H1) 3.6 mg/L (CR1)
Possible reason for Action or Limit Level Non-compliance	<p>Works scheduled on site on 10 Jan 2022 include leveling of 100kg - 150kg underlayer rock at Breakwater B CH200 - CH300, leveling of underlayer rock at Breakwater A CH720 - CH780, leveling of underlayer rock at Breakwater A CH1070 - CH1120, infilling of caisson, landfilling works for below +6.00mPD, landfilling works for above +6.00mPD, installation of instrumentation, piling pre-drilling works, piling works, piling works for driven pile, piling works for pre-bored socketed H-pile and existing caisson extension and armour scour protection.</p> <p>Dominant sea current direction was found to be from Northwest to Southeast at waters around Shek Kwu Chau.</p> <p>An exceedance of limit level was found at CR2.</p>

<p>The installation of caisson No.19 was completed on 18 Mar 2021, the reclamation area was enclosed.</p> <p>CR2 is located close to the works location within the Project site while no marine work was conducted on 10 Jan 2022.</p> <p>According to the field observation by sampling team during sampling event, no silt plume was observed in the Project site and the weather was fine during the sampling event.</p> <p>No major observation of improper site practices that contributed to the increase of the suspended solids was recorded during the weekly inspection on 11 Jan 2022.</p> <p>After the investigation, the exceedance on 10 Jan 2022 at CR2 is deemed to be unrelated to the Project.</p>
--	--

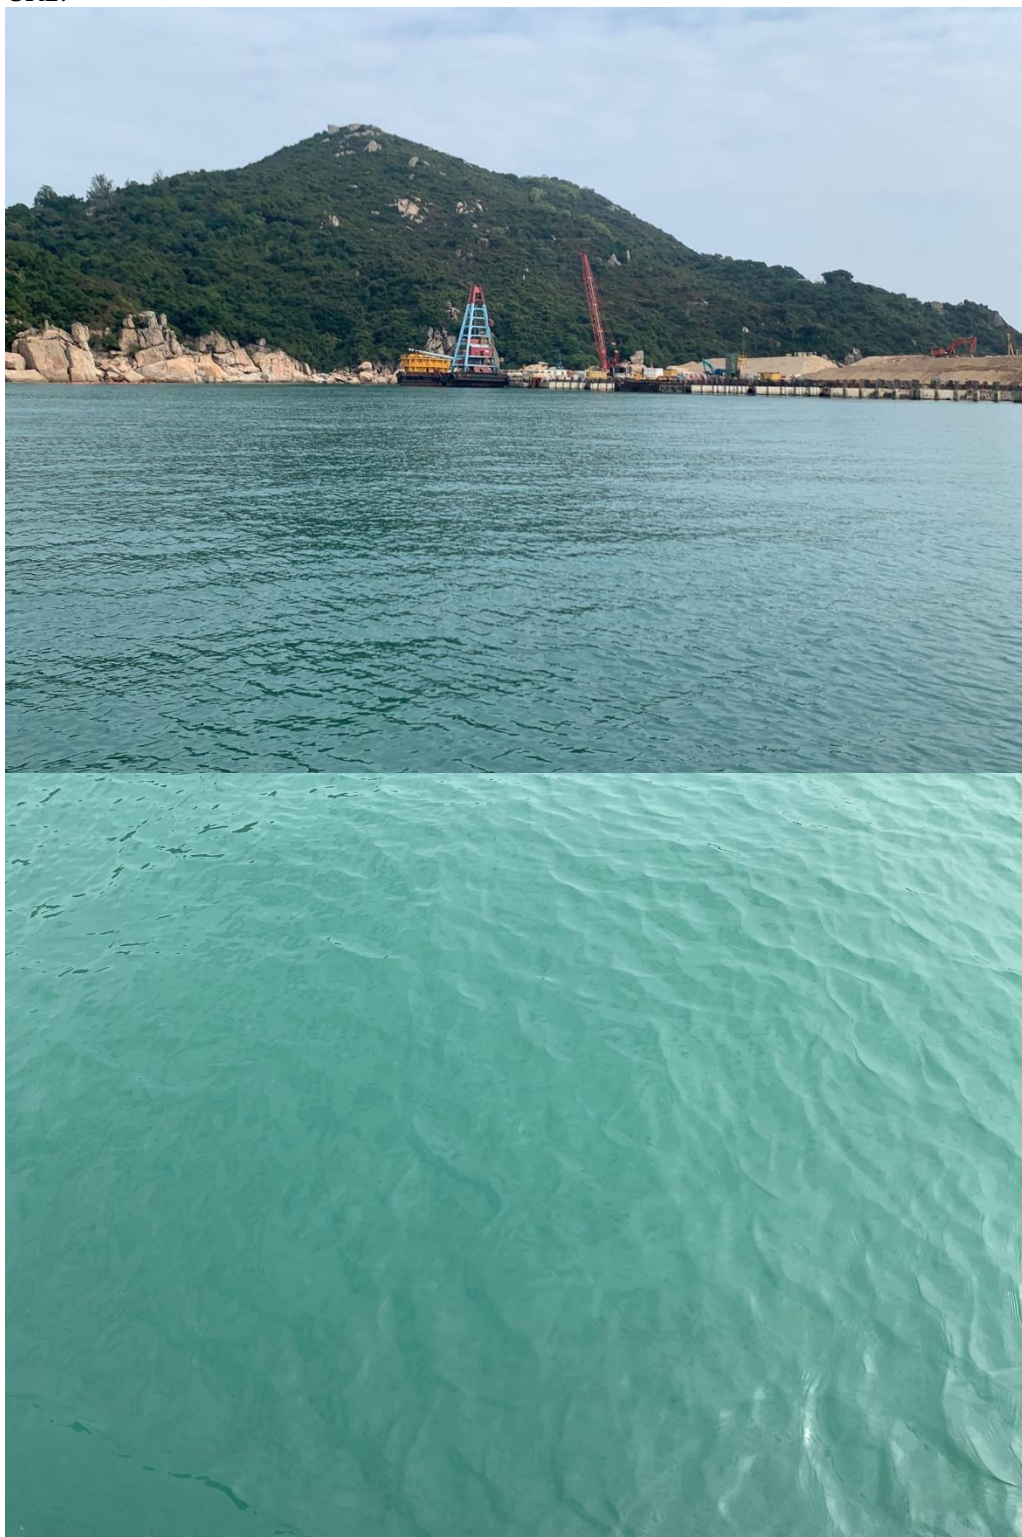
CR2:

10.2 mg/L (CR2)	4.7 mg/L (C1A) 5.0 mg/L (C2A)	5.0 mg/L (B1) 4.0 mg/L (B2) 3.3 mg/L (B3) 7.0 mg/L (B4) 6.3 mg/L (F1A) 3.7 mg/L (H1) 7.3 mg/L (M1) 6.3 mg/L (CR1)
Possible reason for Action or Limit Level Non-compliance	<p>Works scheduled on site on 10 Jan 2022 include leveling of 100kg - 150kg underlayer rock at Breakwater B CH200 - CH300, leveling of underlayer rock at Breakwater A CH720 - CH780, leveling of underlayer rock at Breakwater A CH1070 - CH1120, landfilling works for below +6.00mPD, landfilling works for above +6.00mPD, installation of instrumentation, piling pre-drilling works, piling works, piling works for driven pile, piling works for pre-bored socketed H-pile and existing caisson extension and armour scour protection.</p> <p>Dominant sea current direction was found to be from Southeast to Northwest at waters around Shek Kwu Chau.</p> <p>An exceedance of limit level was found at CR2.</p> <p>The installation of caisson No.19 was completed on 18 Mar 2021, the reclamation area was enclosed.</p> <p>CR2 is located close to the works location within the Project site while no marine work was conducted on 10 Jan 2022.</p>

<p>According to the field observation by sampling team during sampling event, no silt plume was observed in the Project site and the weather was fine during the sampling event.</p> <p>No major observation of improper site practices that contributed to the increase of the suspended solids was recorded during the weekly inspection on 11 Jan 2022.</p> <p>After the investigation, the exceedance on 10 Jan 2022 at CR2 is deemed to be unrelated to the Project.</p>
--	---

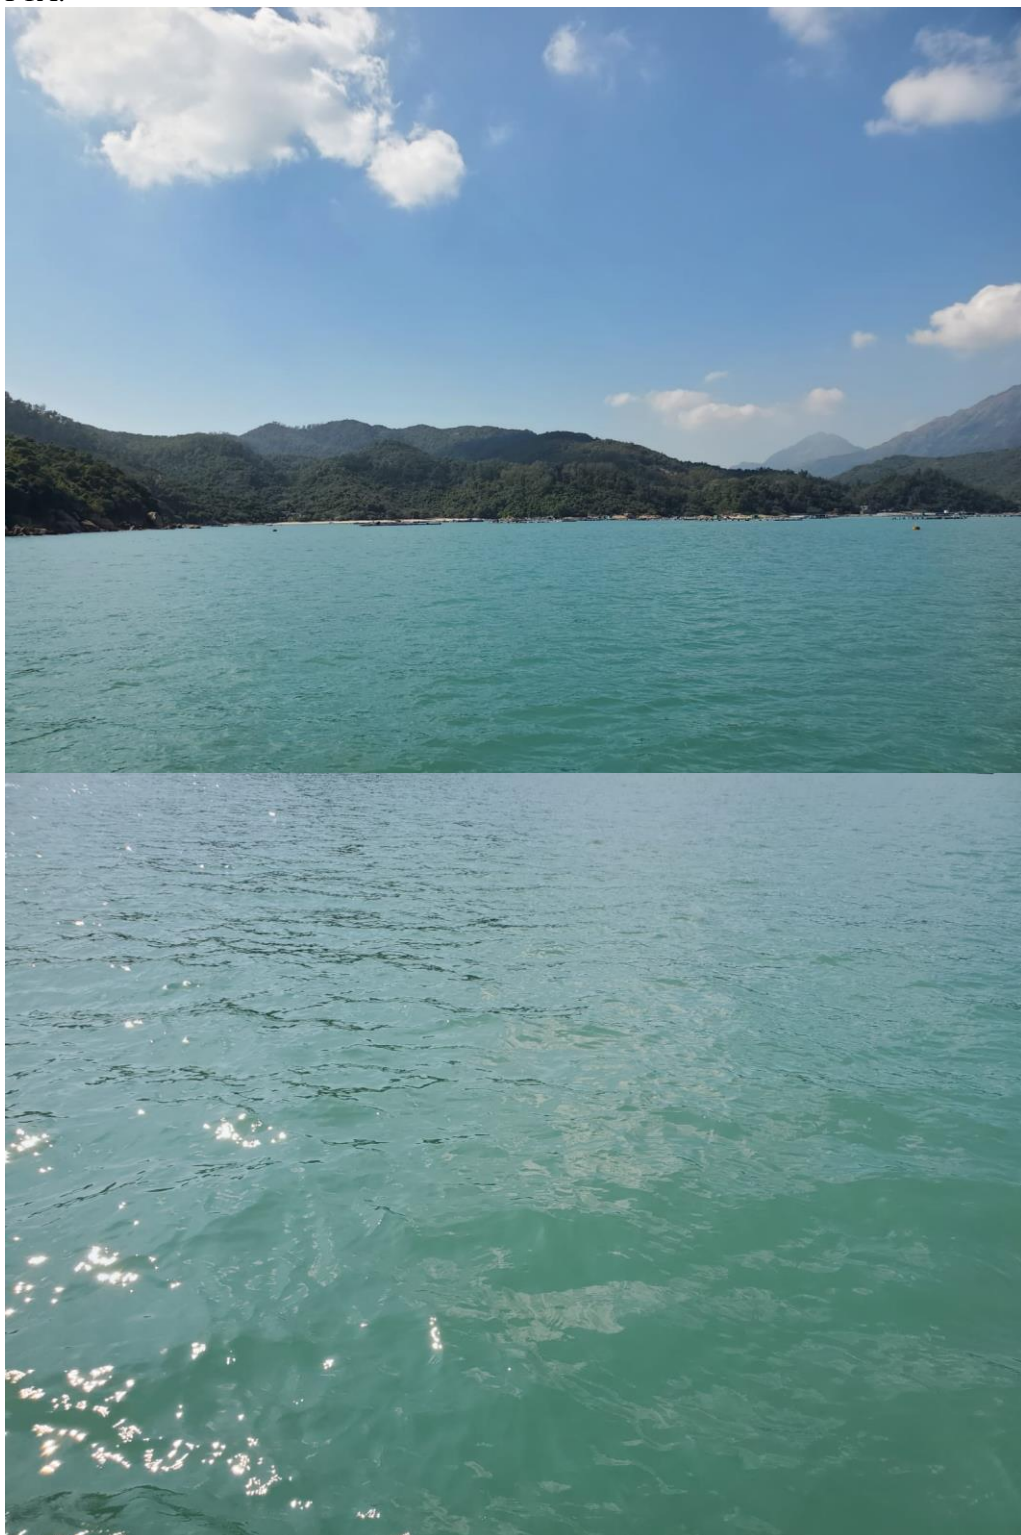
F1A:

8.2 mg/L (F1A) 9.3 mg/L (CR1) 10.0 mg/L (CR2)	6.0 mg/L (C1A) 10.3 mg/L (C2A)	5.8 mg/L (B1) 7.0 mg/L (B2) 6.5 mg/L (B3) 6.8 mg/L (B4) 7.0 mg/L (H1) 5.8 mg/L (M1)
Possible reason for Action or Limit Level Non-compliance	<p>Works scheduled on site on 19 Jan 2022 include diving works for levelling CLP cable trough unit foundation at Seawall B CH455 - CH466, diving works for installation of CLP cable trough unit at Seawall B CH455 - CH466, leveling of underlayer rock at Breakwater A CH720 - CH780, diving works for laying geotextile at Breakwater B CH0 - CH50, unloading ballast fill at Caisson No. 66 & 71, installation of block work at marine access facility, infilling of caisson, landfilling works for below +6.00mPD, piling pre-drilling works, piling works, piling works for driven pile, piling works for pre-bored socketed H-pile, blockwork seawall and existing caisson extension.</p> <p>Dominant sea current direction was found to be from Northwest to Southeast at waters around Shek Kwu Chau.</p> <p>Exceedances of action level were found at F1A and CR1 and an exceedance of limit level was found at CR2.</p>

<p>F1A is located at unrelated stream direction (neither upstream nor downstream, far away) to the works location. The exceedance at this monitoring station is deemed to be unrelated to the Project.</p> <p>The installation of caisson No.19 was completed on 18 Mar 2021, the reclamation area was enclosed.</p> <p>CR1 and CR2 are located close to the works location within the Project site while no marine work was conducted on 19 Jan 2022.</p> <p>According to the field observation by sampling team during sampling event, no silt plume was observed in the Project site and the weather was fine during the sampling event.</p> <p>No major observation of improper site practices that contributed to the increase of the suspended solids was recorded during the weekly inspection on 18 and 25 Jan 2022.</p> <p>After the investigation, the exceedances on 19 Jan 2022 at F1A, CR1 and CR2 are deemed to be unrelated to the Project.</p>

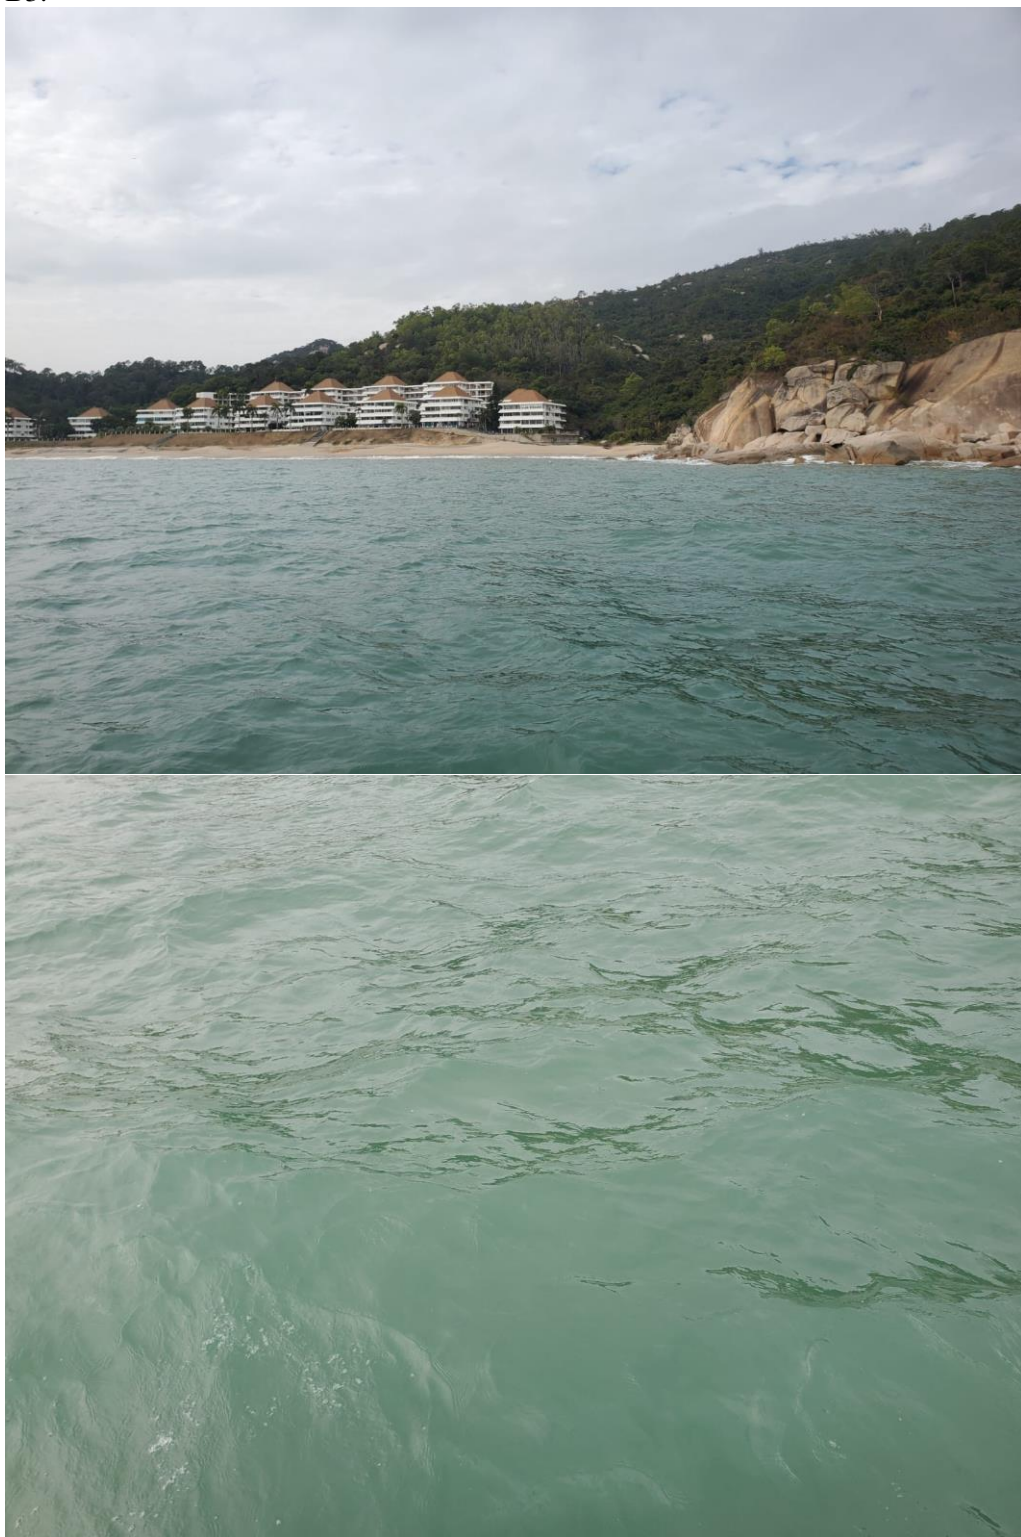
B3:

19.0 mg/L (B3) 13.5 mg/L (B4)	10.8 mg/L (C1A) 15.3 mg/L (C2A)	7.5 mg/L (B1) 9.8 mg/L (B2) 9.8 mg/L (H1) 12.8 mg/L (M1) 12.3 mg/L (F1A) 8.0 mg/L (CR1) 7.7 mg/L (CR2)
Possible reason for Action or Limit Level Non-compliance	<p>Works scheduled on site on 21 Jan 2022 include leveling underlayer rock at Breakwater B CH 190 - CH200, diving works for leveling underlayer rock at Breakwater A CH1000 - CH1020, loading of Ballast fill at Caisson J4, installation of block work at marine access facility, landfilling works for below +6.00mPD, landfilling works for above +6.00mPD, piling pre-drilling works, piling works, piling works for driven pile, piling works for pre-bored socketed H-pile, blockwork seawall and existing caisson extension.</p> <p>Dominant sea current direction was found to be from Northwest to Southeast at waters around Shek Kwu Chau.</p> <p>An exceedance of limit level was found at B3 and an exceedance of action level was found at B4.</p>

<p>B3 and B4 are located at unrelated stream direction (neither upstream nor downstream, far away) to the works location. The exceedances at these monitoring stations are deemed to be unrelated to the Project.</p> <p>The installation of caisson No.19 was completed on 18 Mar 2021, the reclamation area was enclosed.</p> <p>According to the field observation by sampling team during sampling event, no silt plume was observed in the Project site and the weather was cloudy during the sampling event.</p> <p>No major observation of improper site practices that contributed to the increase of the suspended solids was recorded during the weekly inspection on 18 and 25 Jan 2022.</p> <p>After the investigation, the exceedances on 21 Jan 2022 at B3 and B4 are deemed to be unrelated to the Project.</p>
--	--

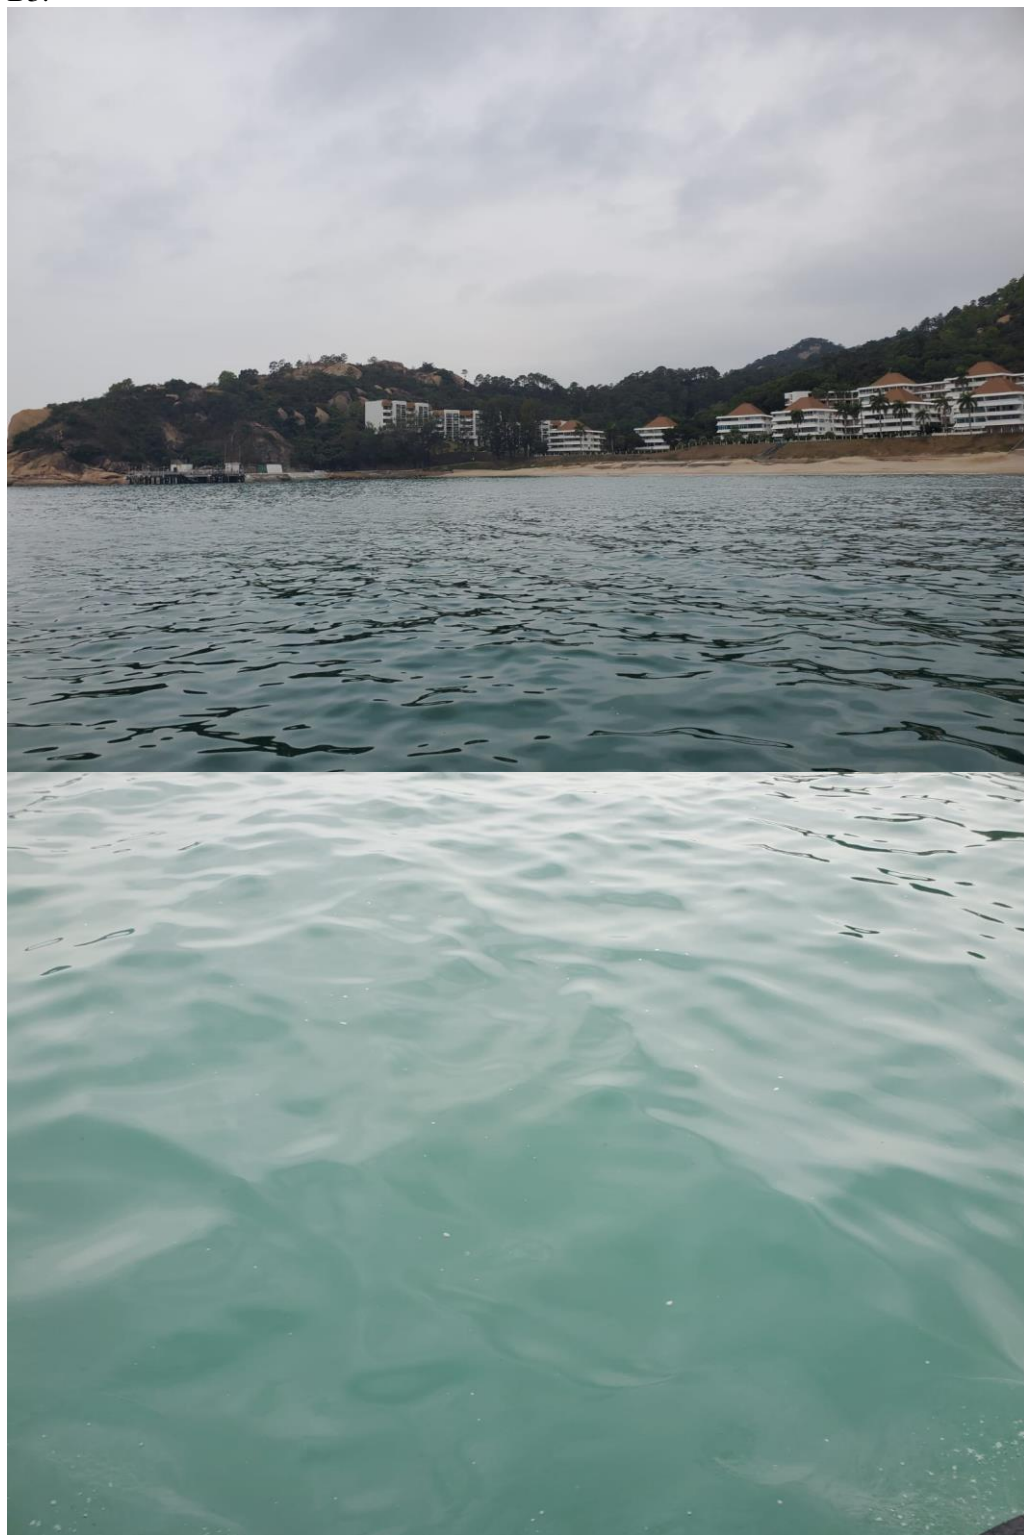
B3:

12.0 mg/L (B3) 8.3 mg/L (B4)	4.5 mg/L (C1A) 5.8 mg/L (C2A)	4.8 mg/L (B1) 4.0 mg/L (B2) 5.8 mg/L (H1) 7.2 mg/L (M1) 4.5 mg/L (F1A) 5.3 mg/L (CR1) 5.5 mg/L (CR2)
Possible reason for Action or Limit Level Non-compliance	<p>Works scheduled on site on 24 Jan 2022 include infilling of Caisson, leveling underlayer rock at Breakwater B CH 190 - CH230, diving works for leveling underlayer rock at Breakwater A CH970 - CH1000, installation of block work at marine access facility, landfilling works for below +6.00mPD, landfilling works for above +6.00mPD, piling pre-drilling works, piling works, piling works for driven pile, piling works for pre-bored socketed H-pile, blockwork seawall and existing caisson extension.</p> <p>Dominant sea current direction was found to be from Northwest to Southeast at waters around Shek Kwu Chau.</p> <p>An exceedance of limit level was found at B3 and an exceedance of action level was found at B4. B3 and B4 are located at unrelated stream direction (neither upstream nor downstream, far away) to the works location. Exceedances at these monitoring stations are deemed to be unrelated to the Project.</p>

<p>The installation of caisson No.19 was completed on 18 Mar 2021, the reclamation area was enclosed.</p> <p>According to the field observation by sampling team during sampling event, no silt plume was observed in the Project site and the weather was cloudy during the sampling event.</p> <p>No major observation of improper site practices that contributed to the increase of the suspended solids was recorded during the weekly inspection on 18 and 25 Jan 2022.</p> <p>After the investigation, the exceedances on 24 Jan 2022 at B3 and B4 are deemed to be unrelated to the Project.</p>
--	--

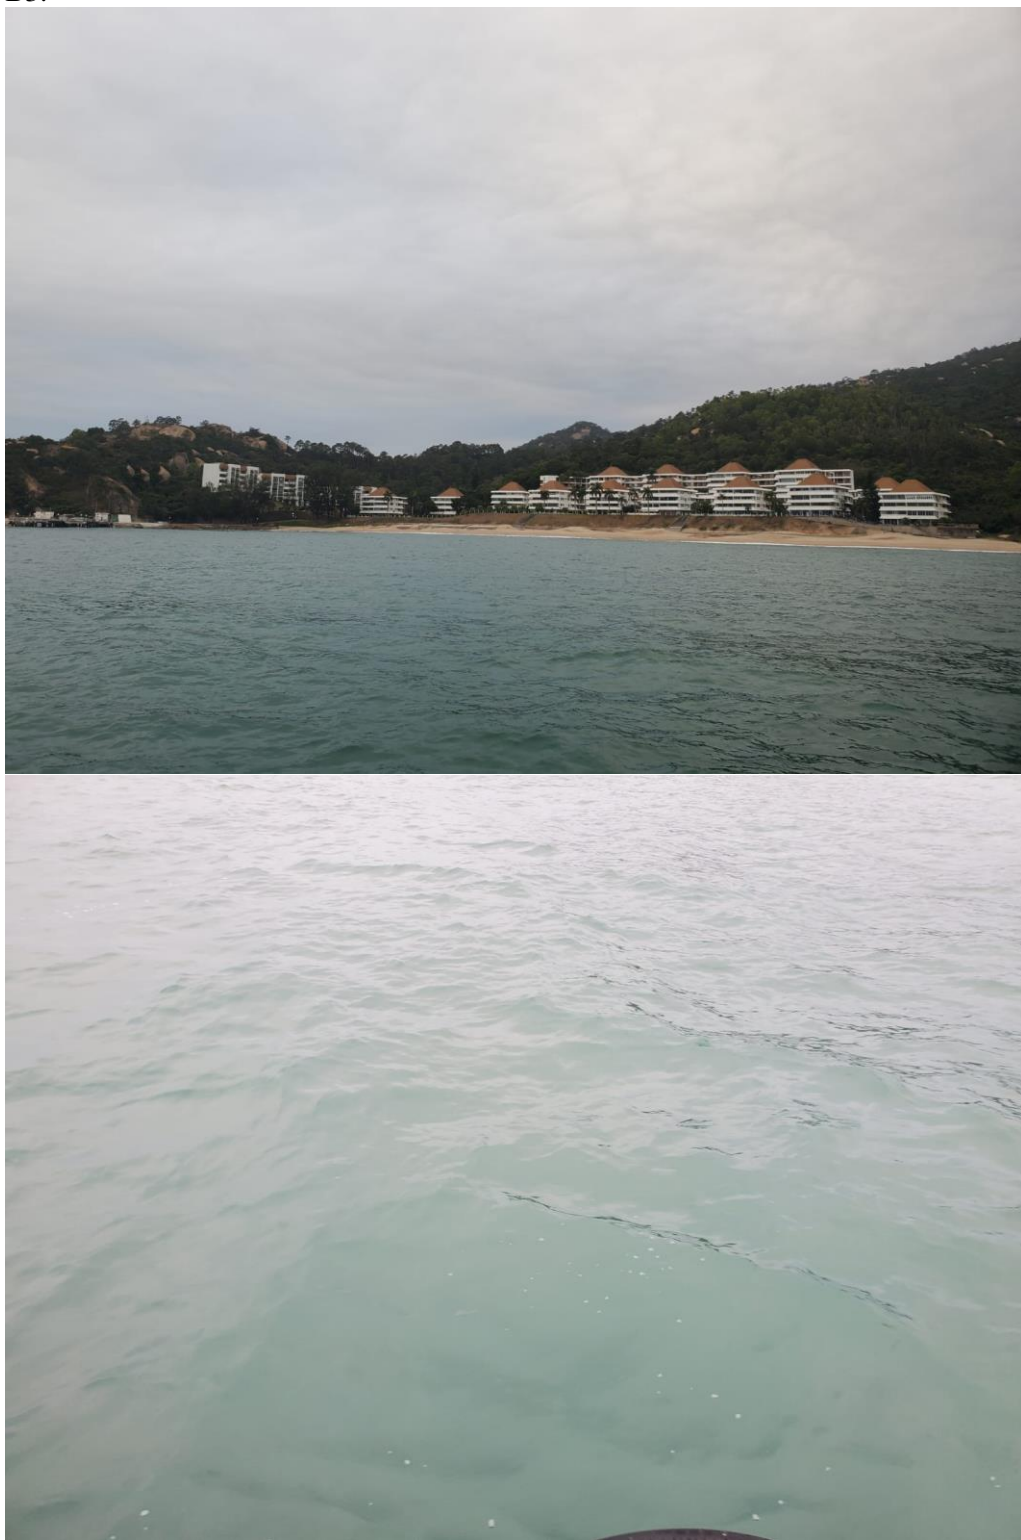
B3:

9.0 mg/L (B3)	3.4 mg/L (C1A) 4.7 mg/L (C2A)	5.3 mg/L (B1) 4.3 mg/L (B2) 5.8 mg/L (B4) 4.5 mg/L (H1) 4.5 mg/L (M1) 6.3 mg/L (F1A) 7.2 mg/L (CR1) 4.2 mg/L (CR2)
Possible reason for Action or Limit Level Non-compliance	<p>Works scheduled on site on 26 Jan 2022 include infilling of caisson, laying of Geotextile at caisson J4, diving works for leveling underlayer rock at Breakwater A CH970 - CH1000, installation of block work at marine access facility, landfilling works for below +6.00mPD, landfilling works for above +6.00mPD, piling pre-drilling works, piling works, piling works for driven pile, piling works for pre-bored socketed H-pile, blockwork seawall and existing caisson extension.</p> <p>Dominant sea current direction was found to be from Northwest to Southeast at waters around Shek Kwu Chau.</p> <p>An exceedance of action level was found at B3. B3 is located at unrelated stream direction (neither upstream nor downstream, far away) to the works location. The exceedance is deemed to be unrelated to the Project.</p>

<p>The installation of caisson No.19 was completed on 18 Mar 2021, the reclamation area was enclosed.</p> <p>According to the field observation by sampling team during sampling event, no silt plume was observed in the Project site and the weather was cloudy during the sampling event.</p> <p>No major observation of improper site practices that contributed to the increase of the suspended solids was recorded during the weekly inspection on 25 Jan 2022.</p> <p>After the investigation, the exceedance on 26 Jan 2022 at B3 is deemed to be unrelated to the Project.</p>
--	--
