Appendix N Exceedance Report

Incident Report on Action Level or Limit Level Non-compliance

Project	Integrated Waste Management Facilities, Phase 1		
Date	03 Jan 2022 (Lab result received on 08 Jan 2022)		
Time	11:25 – 14:55 (Mid-Ebb) 08:00 – 10:59 (Mid-Flood)		
Mid-Ebb			
Monitoring Location	<div>CR2</div>

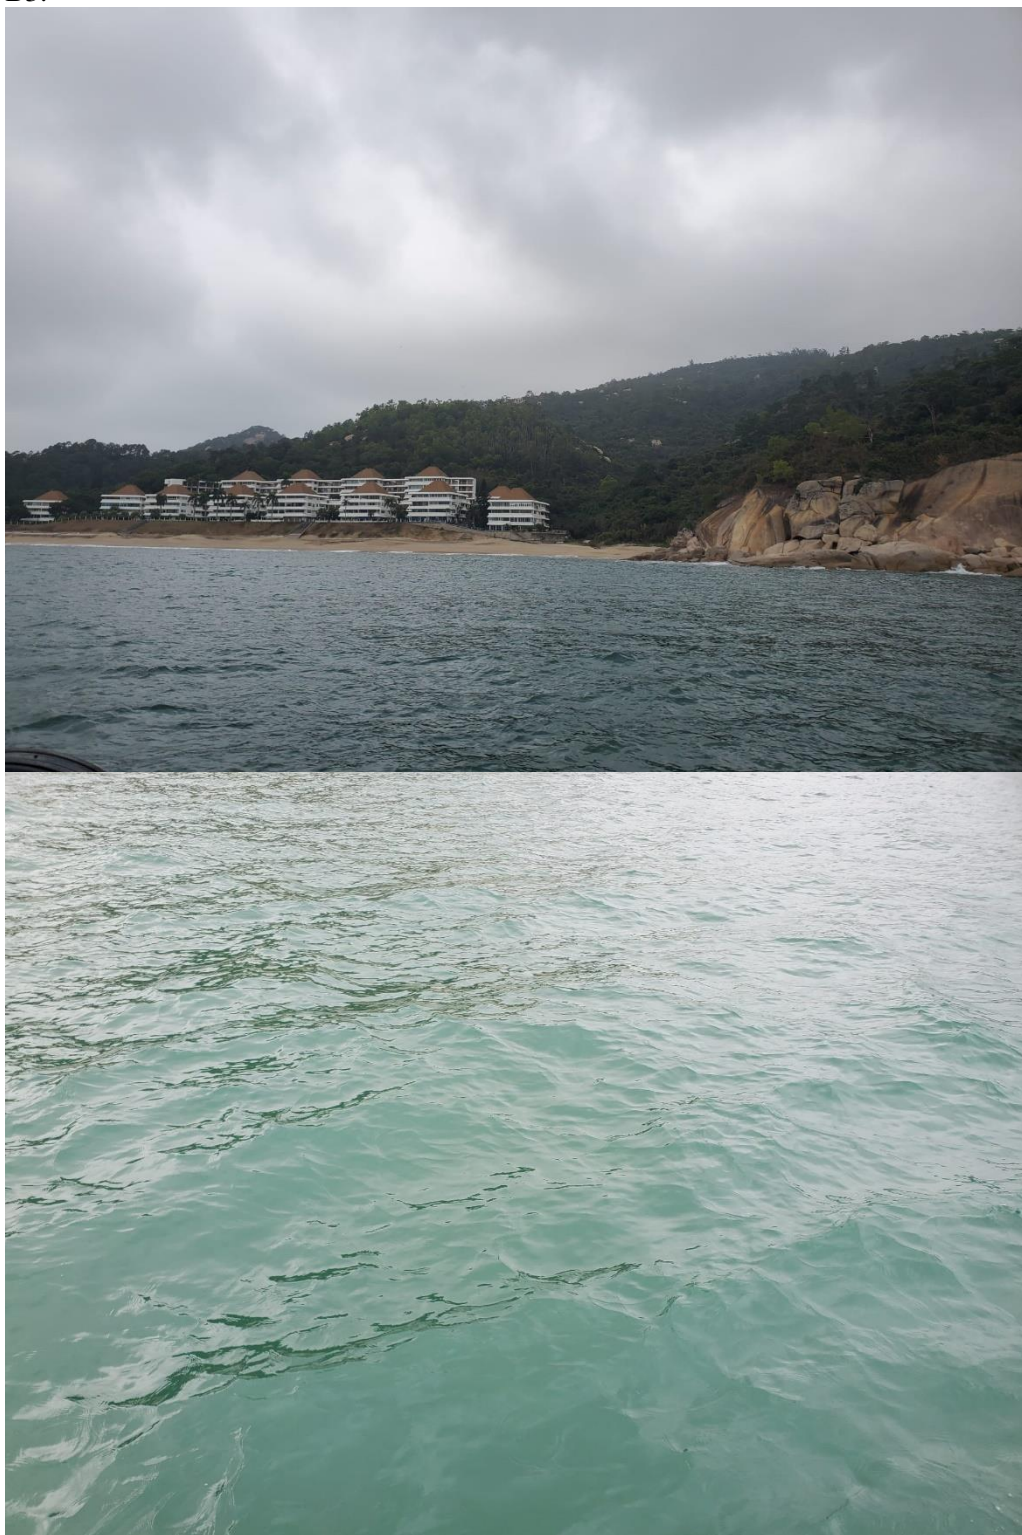
B3:

8.5 mg/L (B3) 8.0 mg/L (B4) 8.0 mg/L (CR2)	5.2 mg/L (C1A) 4.8 mg/L (C2A)	5.5 mg/L (B1) 4.5 mg/L (B2) 6.5 mg/L (H1) 6.2 mg/L (M1) 6.2 mg/L (F1A) 5.5 mg/L (CR1)
Possible reason for Action or Limit Level Non-compliance	<p>Works scheduled on site on 28 Jan 2022 include infilling of caisson, laying of underlayer rock at CH190 – CH230, diving works for leveling underlayer rock at Breakwater A CH950 - CH980, installation of block work at marine access facility, landfilling works for below +6.00mPD, landfilling works for above +6.00mPD, piling pre-drilling works, piling works, piling works for driven pile, piling works for pre-bored socketed H-pile, blockwork seawall and existing caisson extension.</p> <p>Dominant sea current direction was found to be from Northeast to Southwest at waters around Shek Kwu Chau.</p> <p>Exceedances of action level were found at B3, B4 and CR2. B3 and B4 are located at unrelated stream direction (neither upstream nor downstream, far away) to the works location. Exceedances at these monitoring stations are deemed to be unrelated to the Project.</p>

<p>CR2 is located close to the works location within the Project site while no marine work was conducted on 28 Jan 2022</p> <p>The installation of caisson No.19 was completed on 18 Mar 2021, the reclamation area was enclosed.</p> <p>According to the field observation by sampling team during sampling event, no silt plume was observed in the Project site and the weather was cloudy during the sampling event.</p> <p>No major observation of improper site practices that contributed to the increase of the suspended solids was recorded during the weekly inspection on 25 Jan 2022.</p> <p>After the investigation, the exceedances on 28 Jan 2022 at B3, B4 and CR2 are deemed to be unrelated to the Project.</p>
--	--

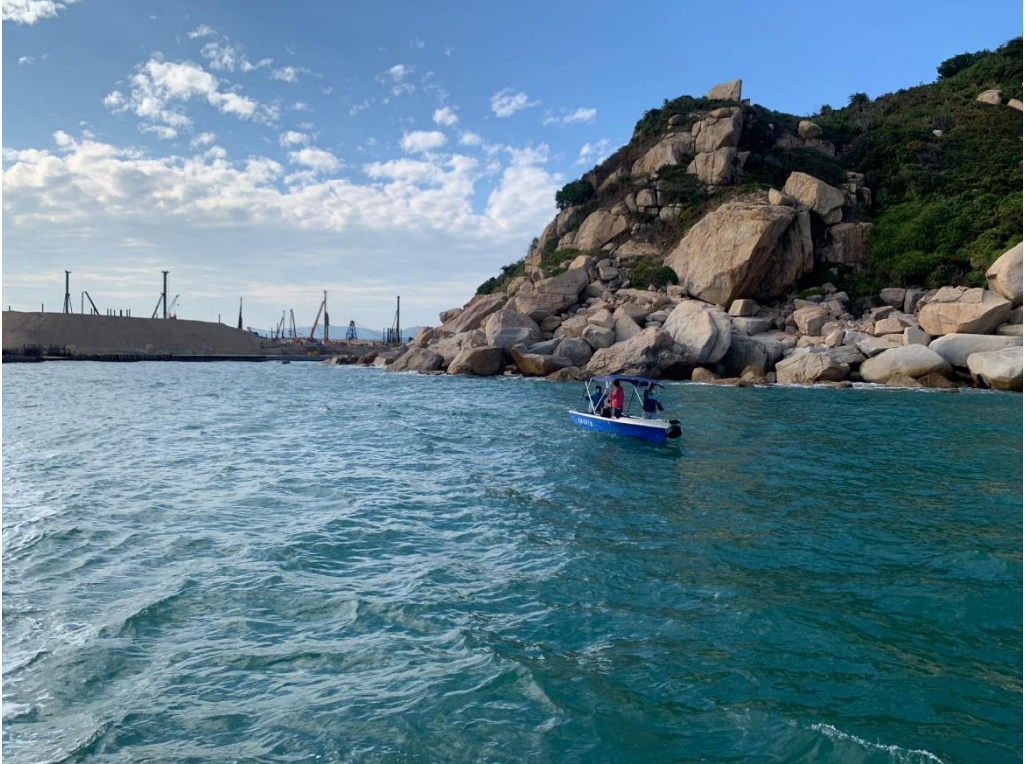
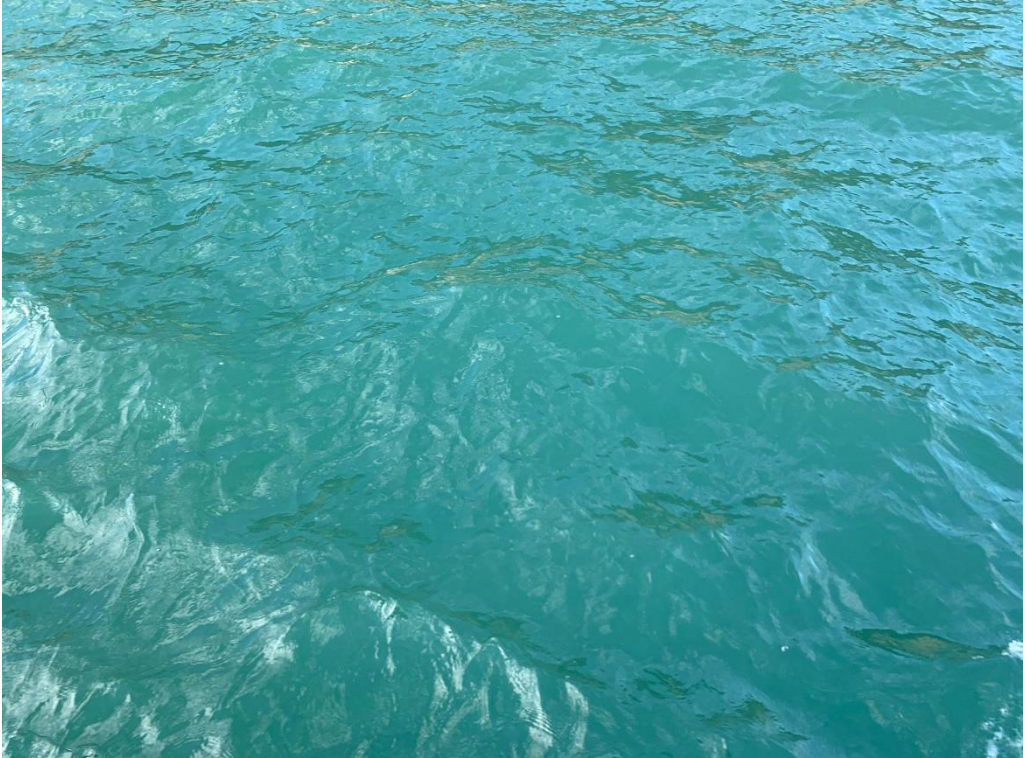
11.8 mg/L (CR1)	6.7 mg/L (C1A) 4.0 mg/L (C2A)	3.1 mg/L (B1) 3.3 mg/L (B2) 3.5 mg/L (B3) 4.8 mg/L (B4) 4.0 mg/L (H1) 4.2 mg/L (M1) 3.8 mg/L (F1A) 6.5 mg/L (CR2)
Possible reason for Action or Limit Level Non-compliance	No site activity was recorded due to public holiday (Sunday).		
	Dominant sea current direction was found to be from Southeast to Northwest at waters around Shek Kwu Chau.		
	Exceedance of limit level was found at CR1.		
	CR1 is located close to the works location within the Project site while no marine work was conducted on 30 Jan 2022		
	The installation of caisson No.19 was completed on 18 Mar 2021, the reclamation area was enclosed.

<p>According to the field observation by sampling team during sampling event, no silt plume was observed in the Project site and the weather was cloudy during the sampling event.</p> <p>No major observation of improper site practices that contributed to the increase of the suspended solids was recorded during the weekly inspection on 25 Jan 2022.</p> <p>After the investigation, the exceedance on 30 Jan 2022 at CR1 is deemed to be unrelated to the Project.</p>
Monitoring photos of stations with exceedance	<p>CR1:</p>
