## Appendix K Coral Translocation Plan

# CORAL TRANSLOCATION PLAN

(Clause 2.12, Further Environmental Permit FEP-01/429/2012/A)

<b>KSZHJV</b>	/	<b>312</b>	/	<b>EPR</b>	/	<b>0001</b>	/	<b>E</b>
Issuer		Project Code		Type of Document		Sequential No.		Revision Index

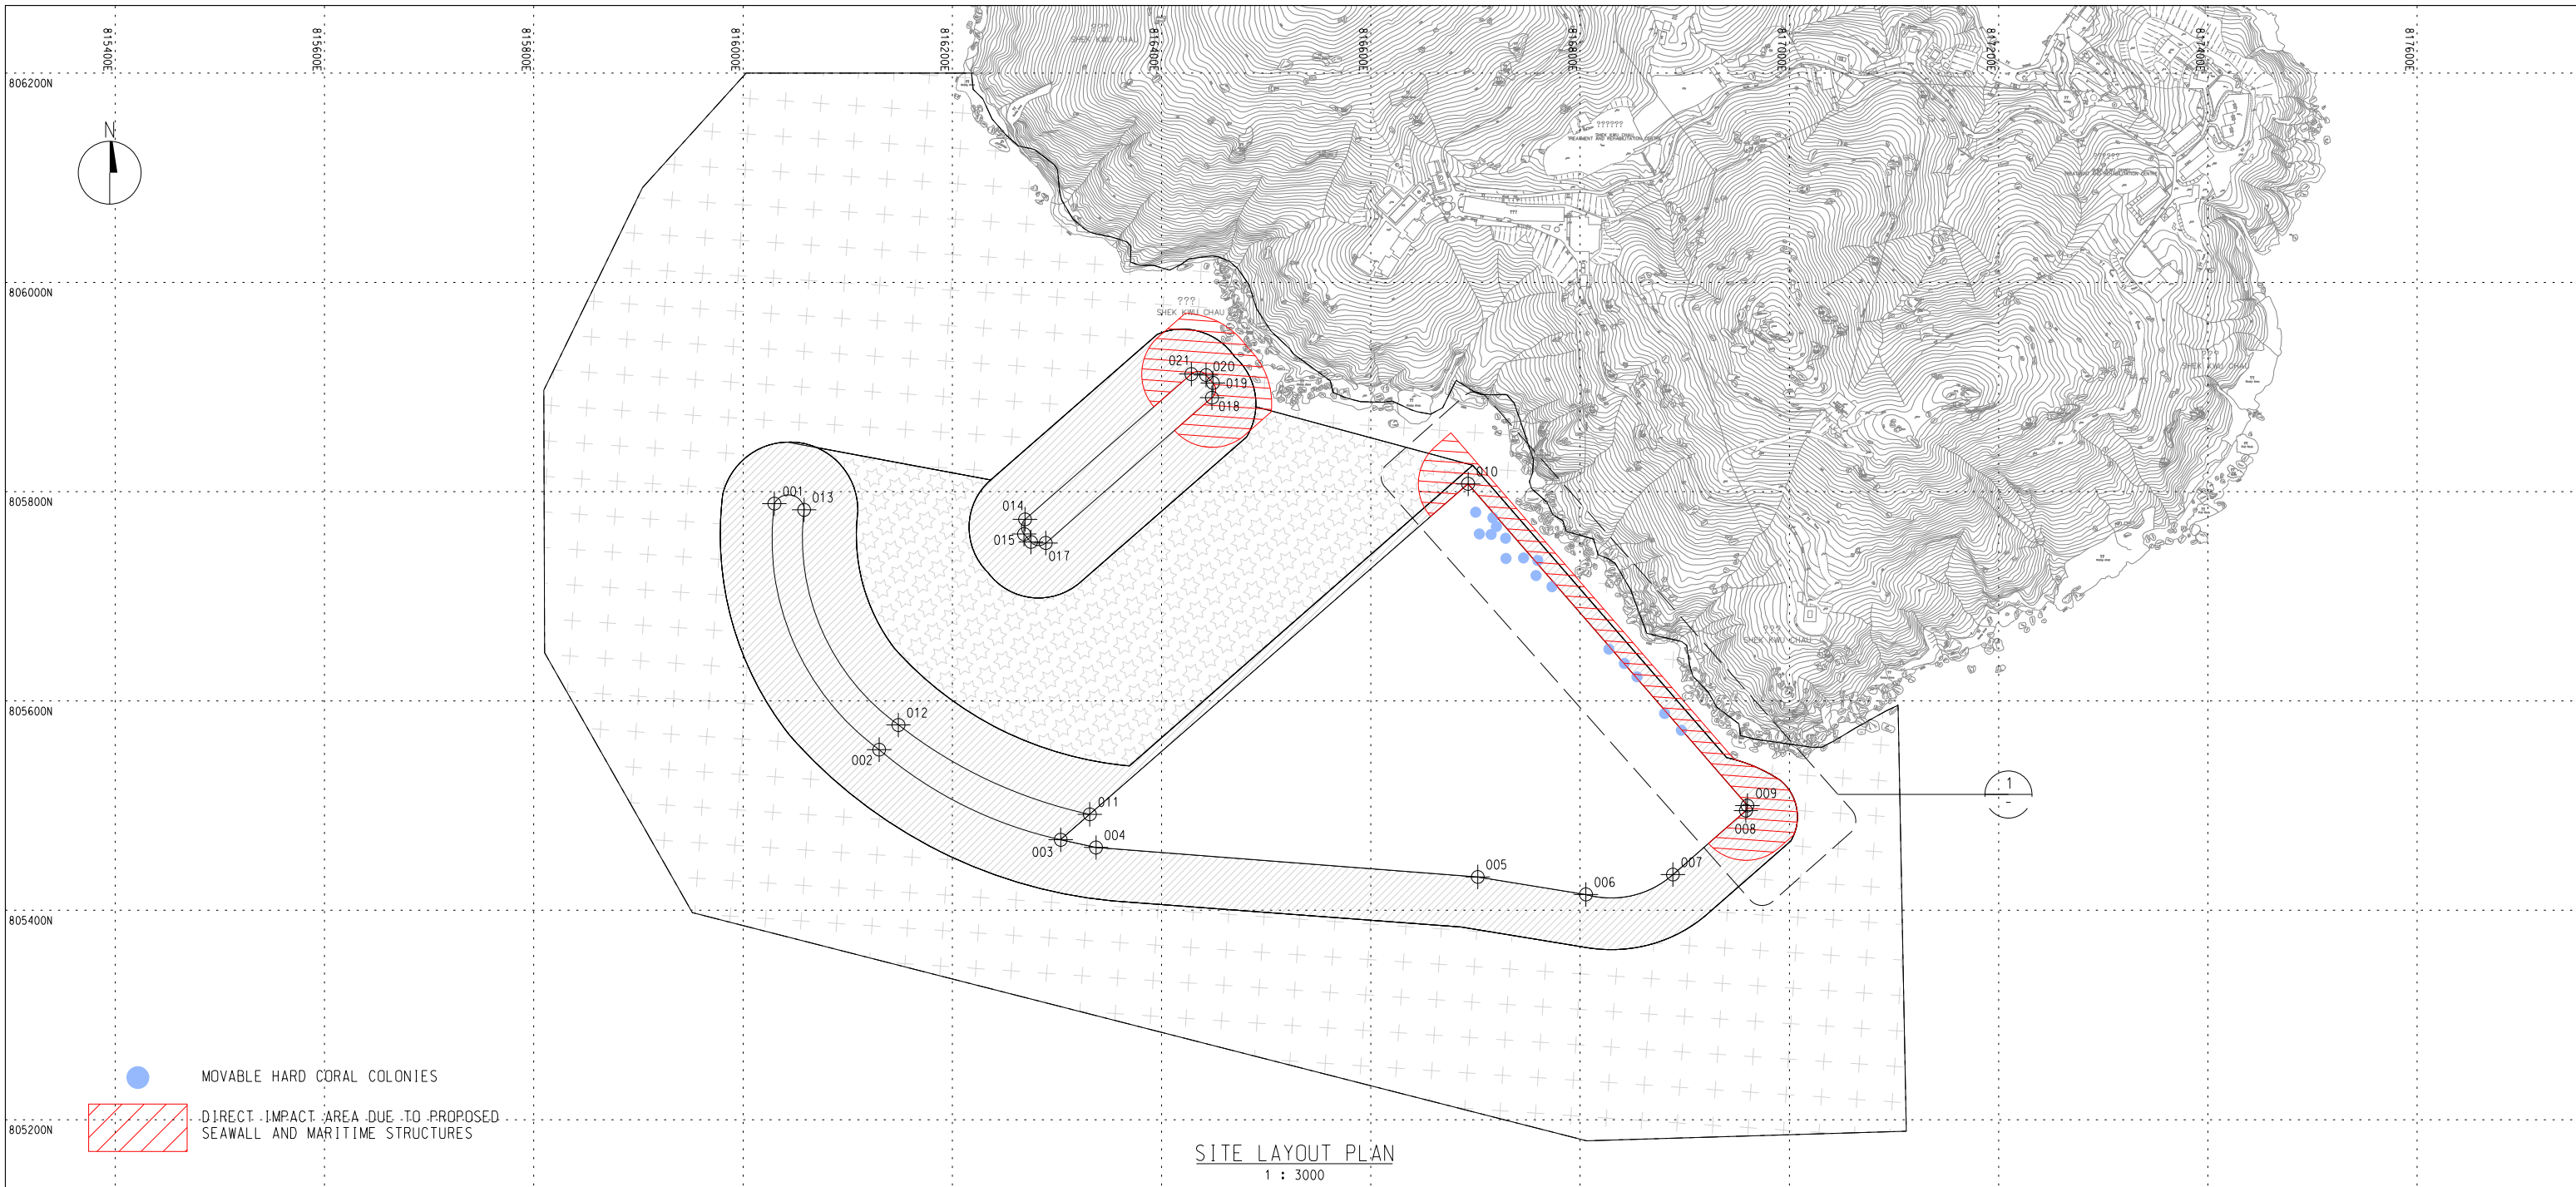
**Figure 2 Locations of Movable Coral Colonies**

SITE LAYOUT PLAN  
1 : 3000

DETAIL  
SCALE 1 : 1000

2.1.1. Since the visibility at SKC was very low (less than 0.5 m most of the time), an active search survey was conducted at the donor site at SKC as part of the detailed coral survey to locate all translocatable coral colonies. The pre-translocation survey areas were shown in **Figure 1**. The active search results of movable and non-movable coral colonies were shown in **Figure 2** and **Figure 3** respectively.

- 3.1.2. Sixty five (65) coral colonies (**Appendix 1**) were mapped during the survey. All corals recorded during the survey colonized on hard substrates, and Forty-nine were attached to non-movable boulders. Locations of movable and non-movable coral colonies found during the active search surveys are shown in **Figure 2** and **Figure 3** respectively.
- 3.1.3. The mapped corals comprised 6 species, besides the uncommon *Coscinaraea* sp., all common to dominant in Hong Kong (see **Table 3.1** below). All corals were recorded at the water depth range of 2.5 m to 4.5 m. Photos of the site and representative corals are shown in **Photo Plate 1**.

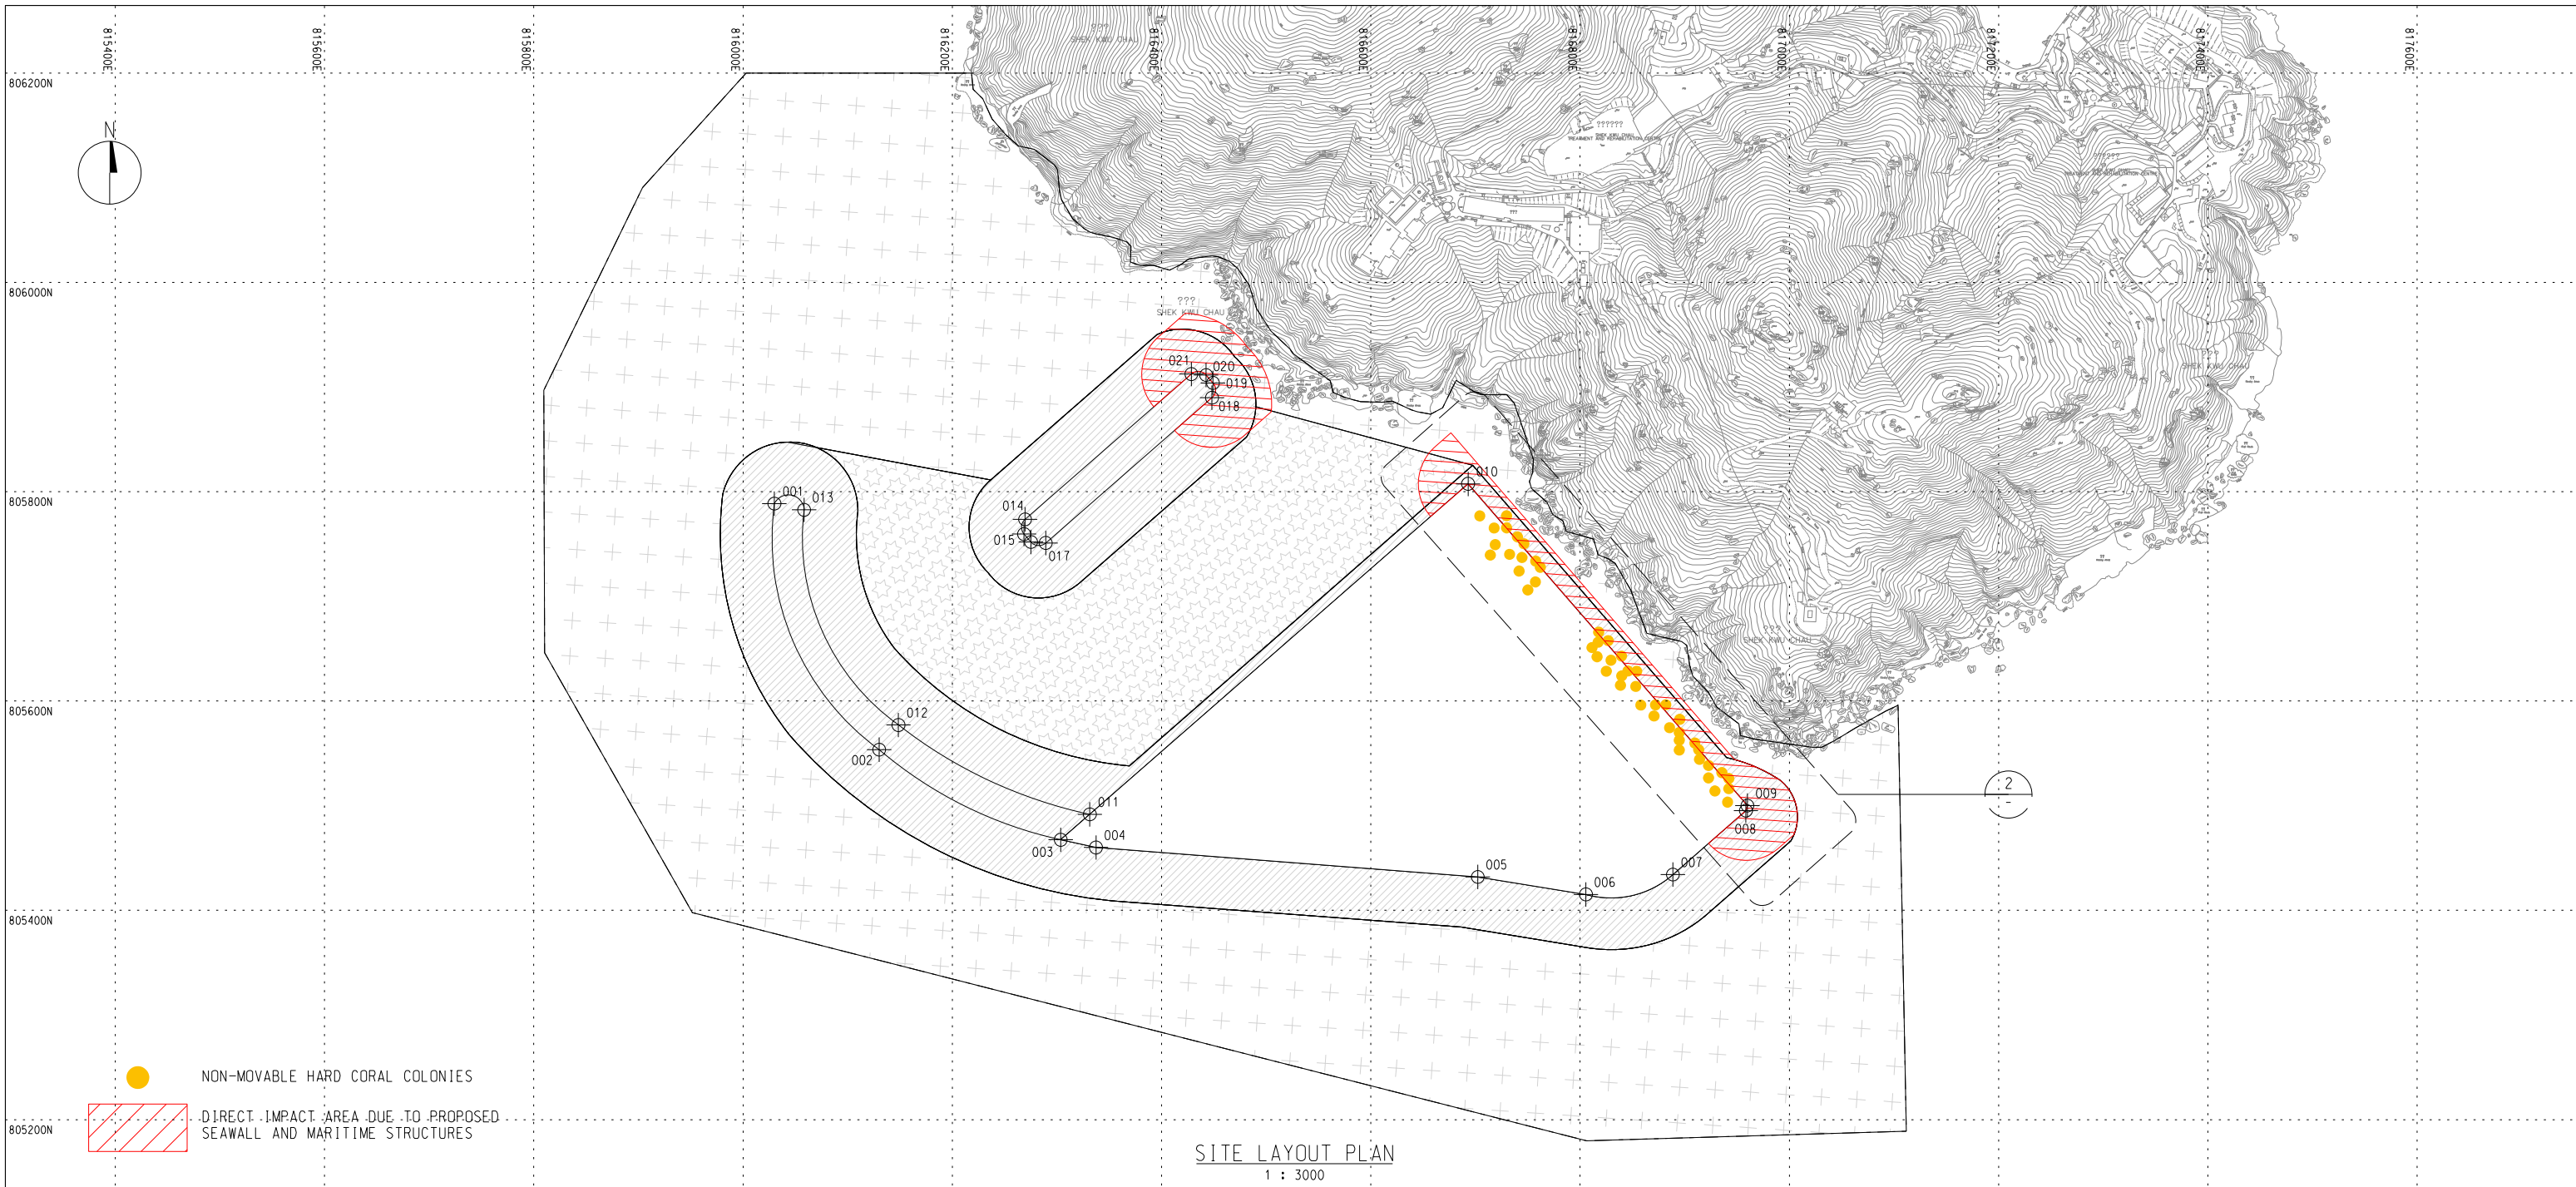
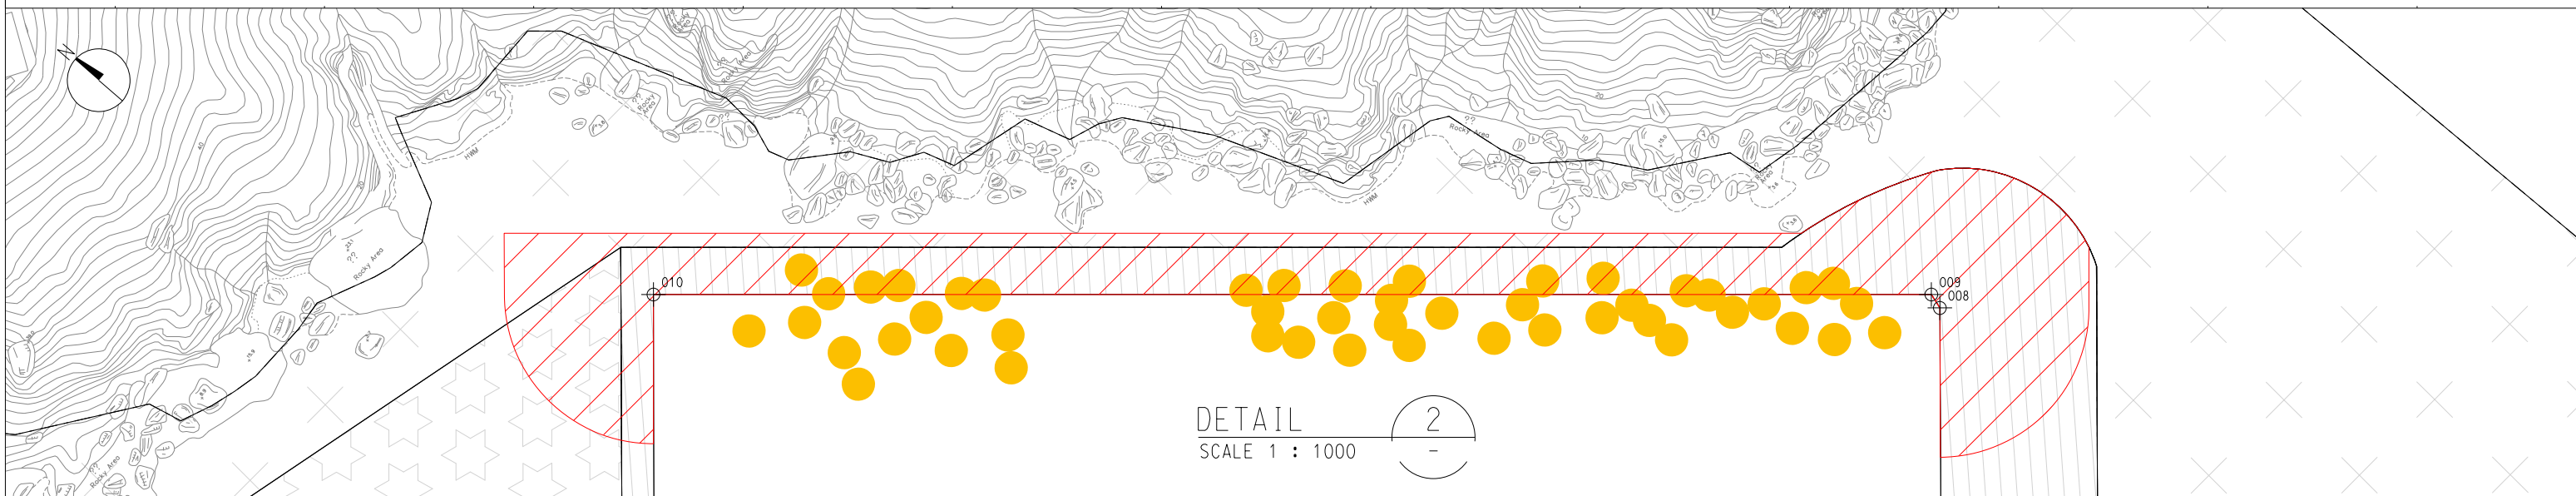
**Figure 3 Locations of Non-Movable Coral Colonies**

● NON-MOVABLE HARD CORAL COLONIES

▨ DIRECT IMPACT AREA DUE TO PROPOSED SEAWALL AND MARITIME STRUCTURES

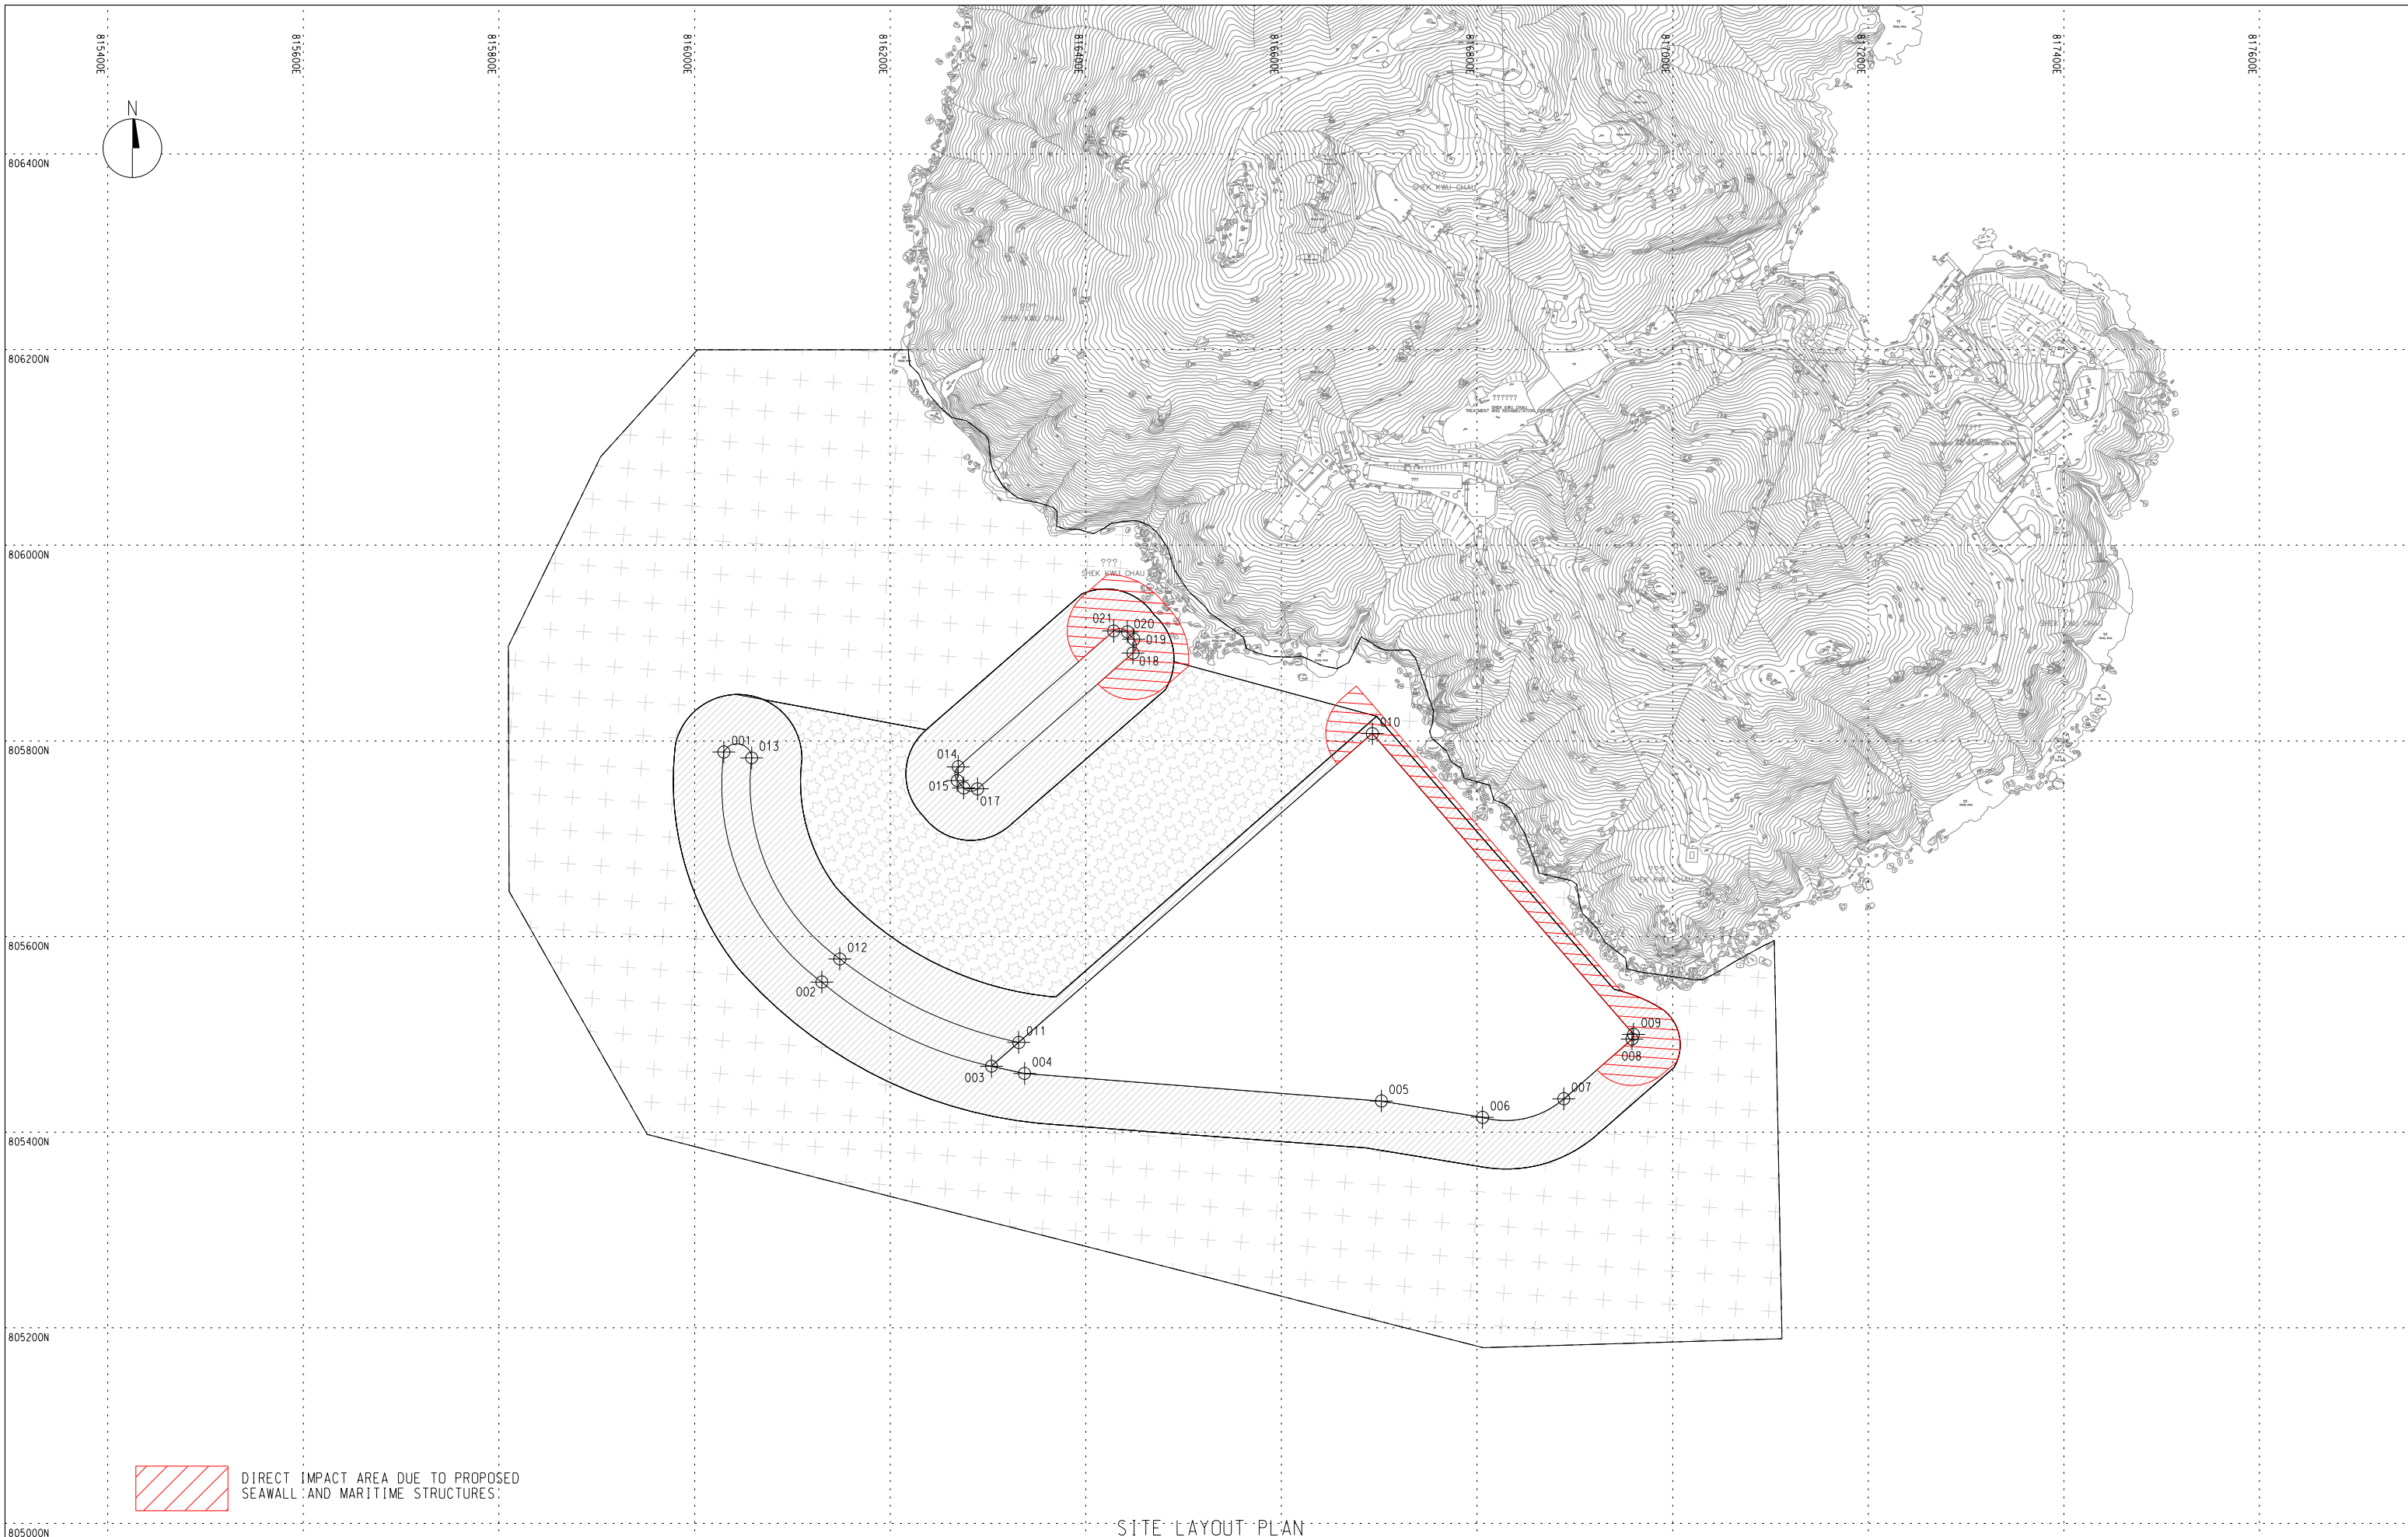
**Figure 5 Direct Impact Area**

DIRECT IMPACT AREA DUE TO PROPOSED SEAWALL AND MARITIME STRUCTURES

- 4.1.2. The extent of direct impact areas (i.e. areas to be affected by the proposed seawall and maritime structure) is shown in **Figure 5**. Translocatable corals identified in these areas will be translocated to recipient site during the coral translocation work.

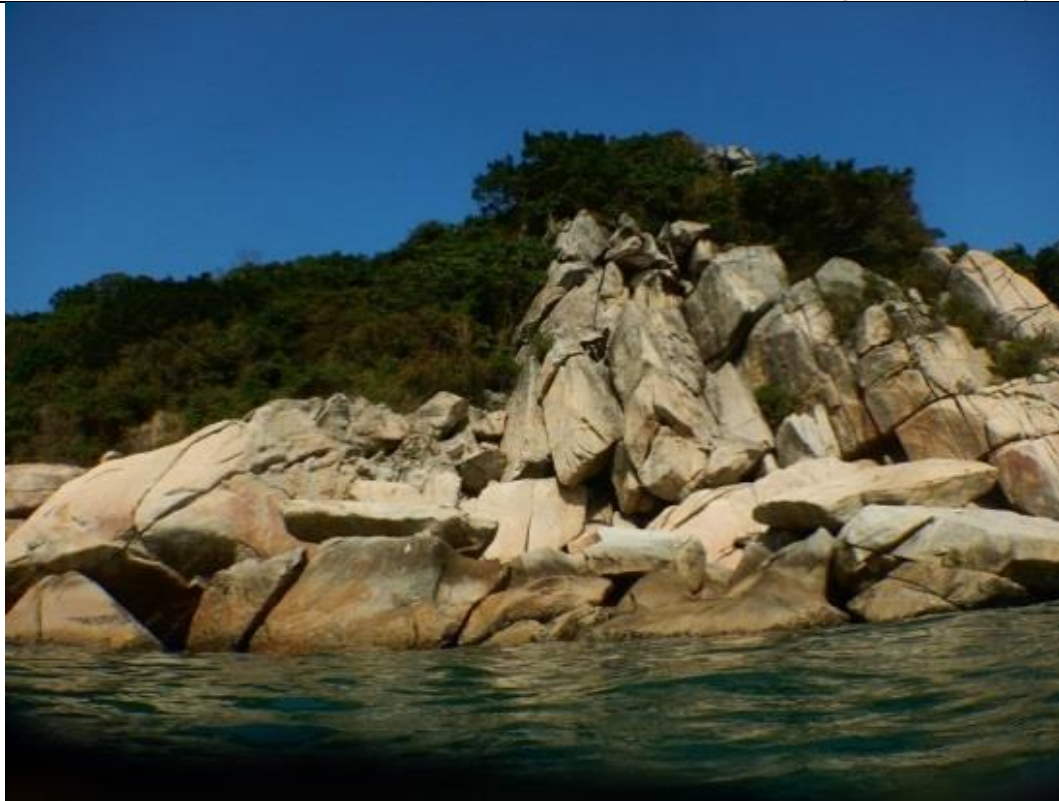
**Photo 1. Bedrock at Shek Kwu Chau**

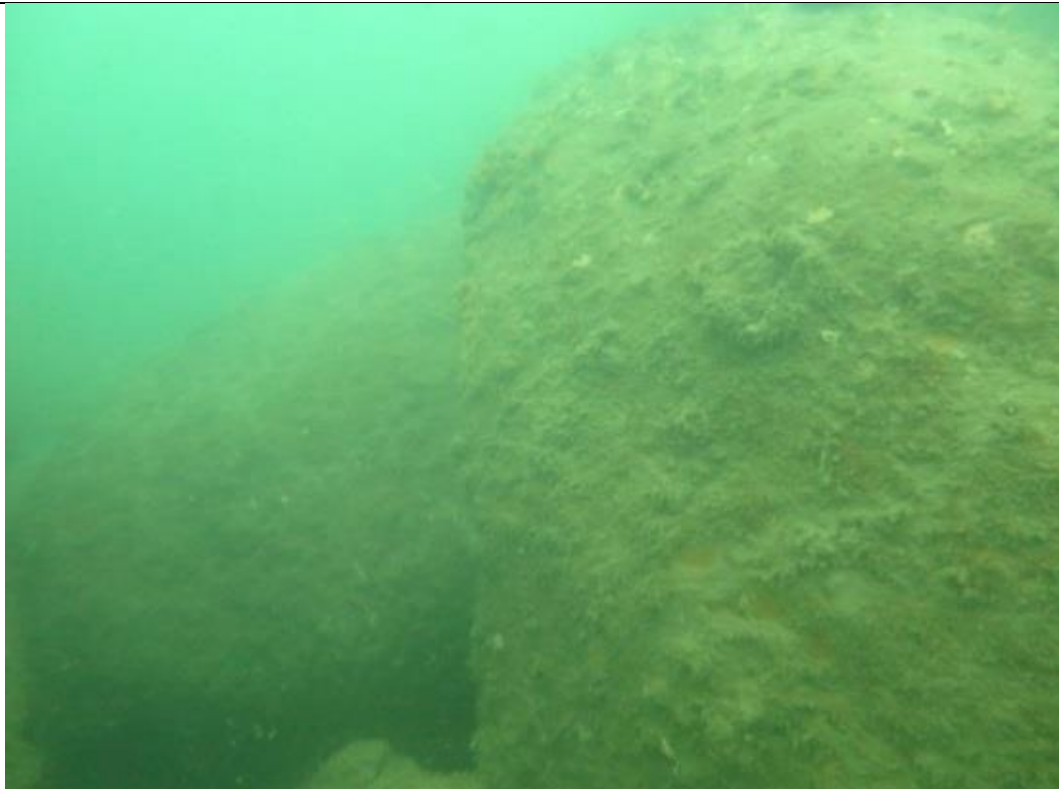
**Photo 2. Boulders at Shek Kwu Chau**

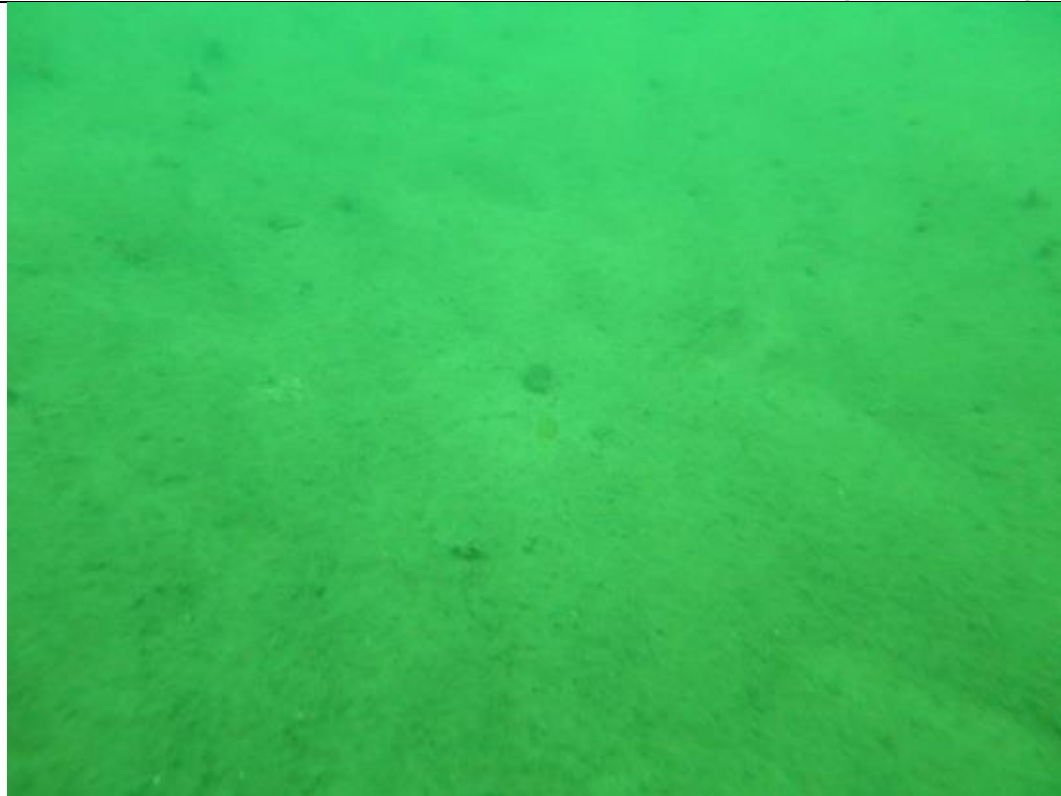
**Photo 3. Sandy Bottom at Shek Kwu Chau**

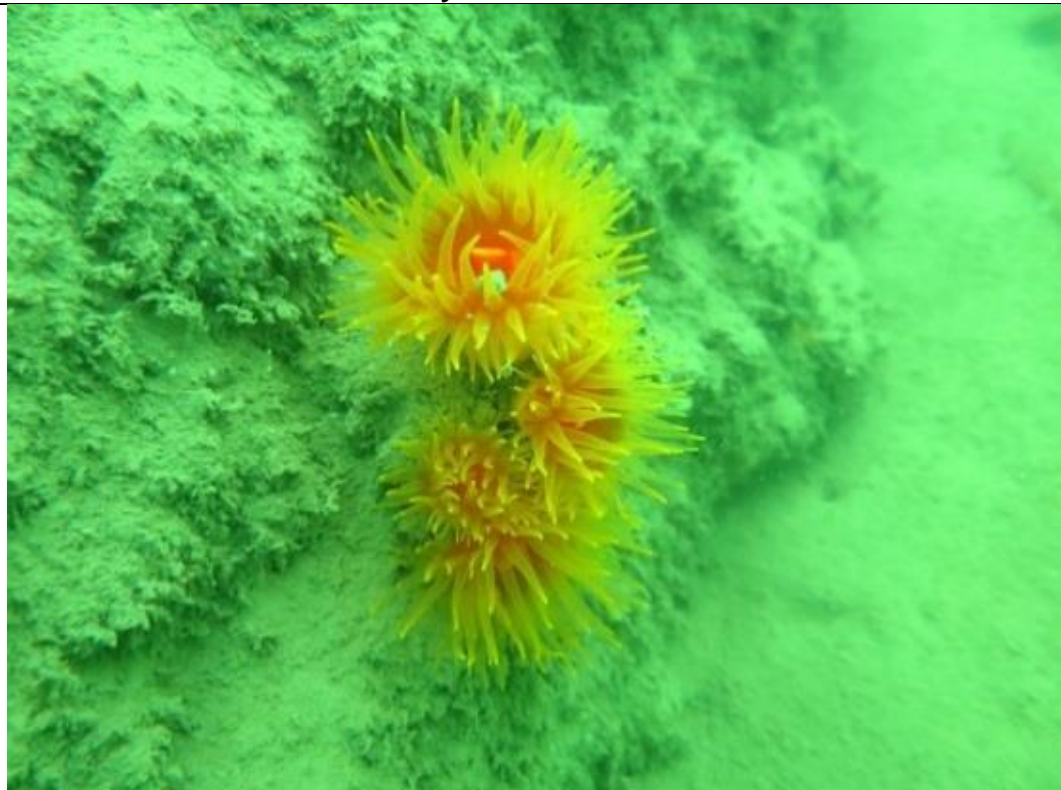
**Photo 4. *Tubastrea* sp. at Shek Kwu Chau**

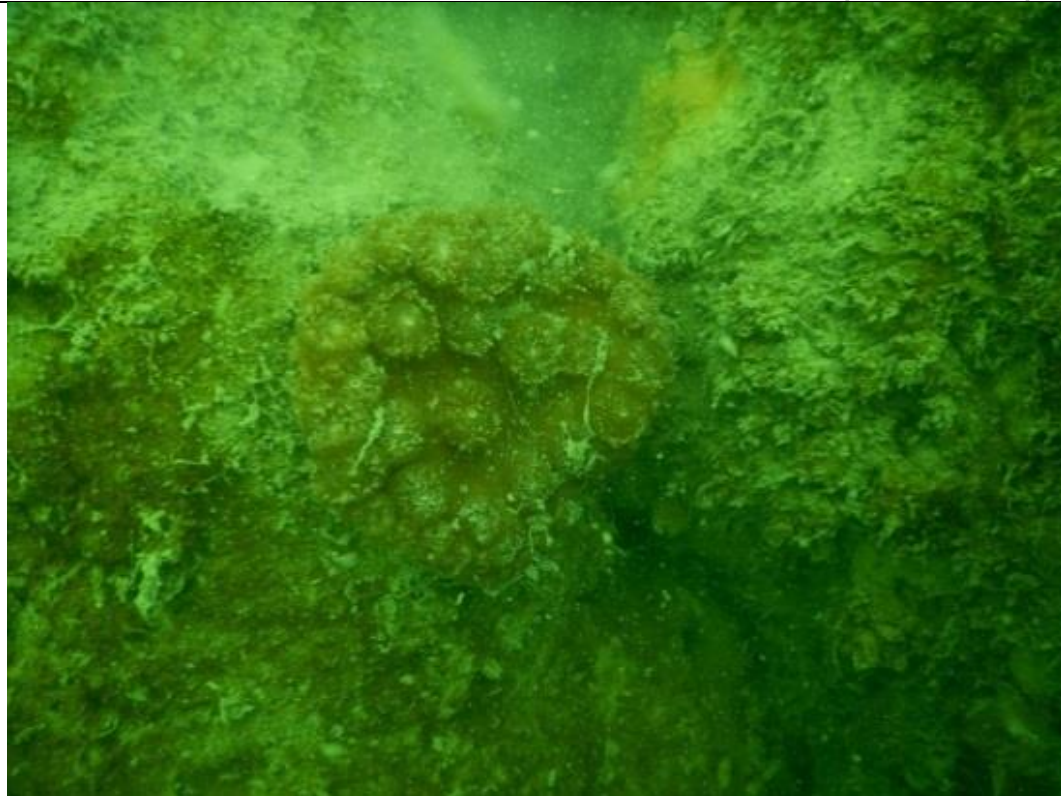
**Photo 5. *Turbinaria peltata* at Shek Kwu Chau**

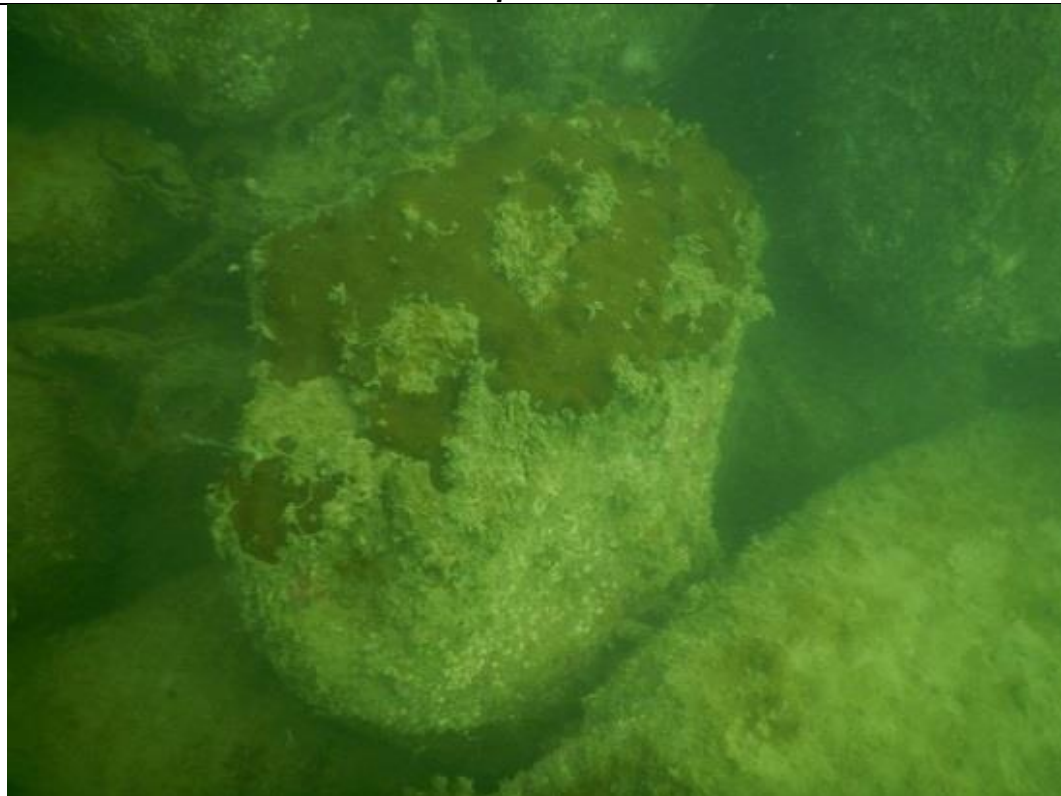
**Photo 6. Movable *Psammocora superficialis* at Shek Kwu Chau**

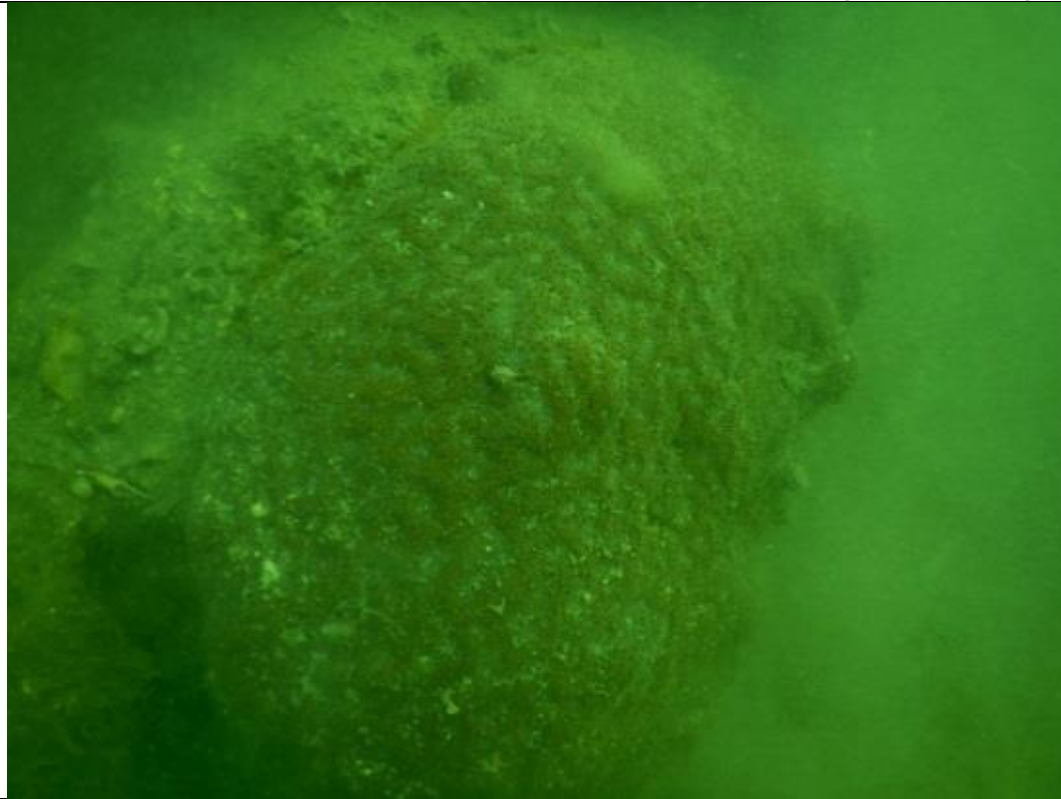
**Photo 7. Movable *Coscinaraea n* sp. at Shek Kwu Chau**

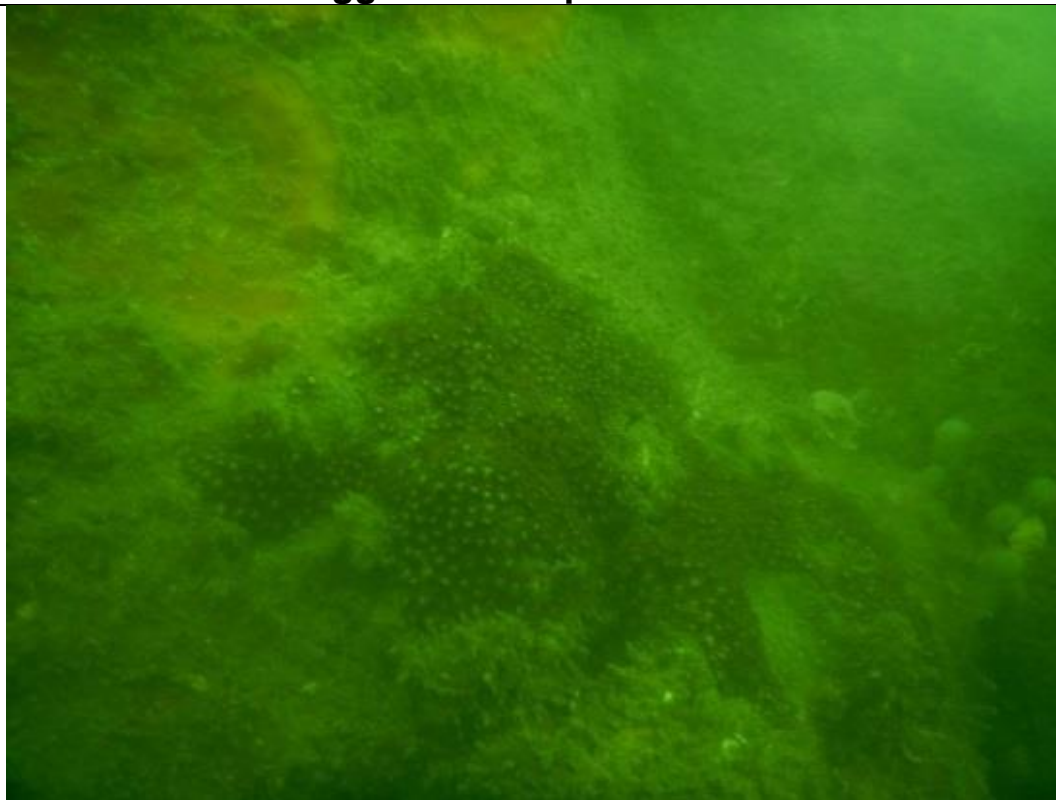
**Photo 8. *Goniopora stutchburyi* at Suggested Recipient Site R3**

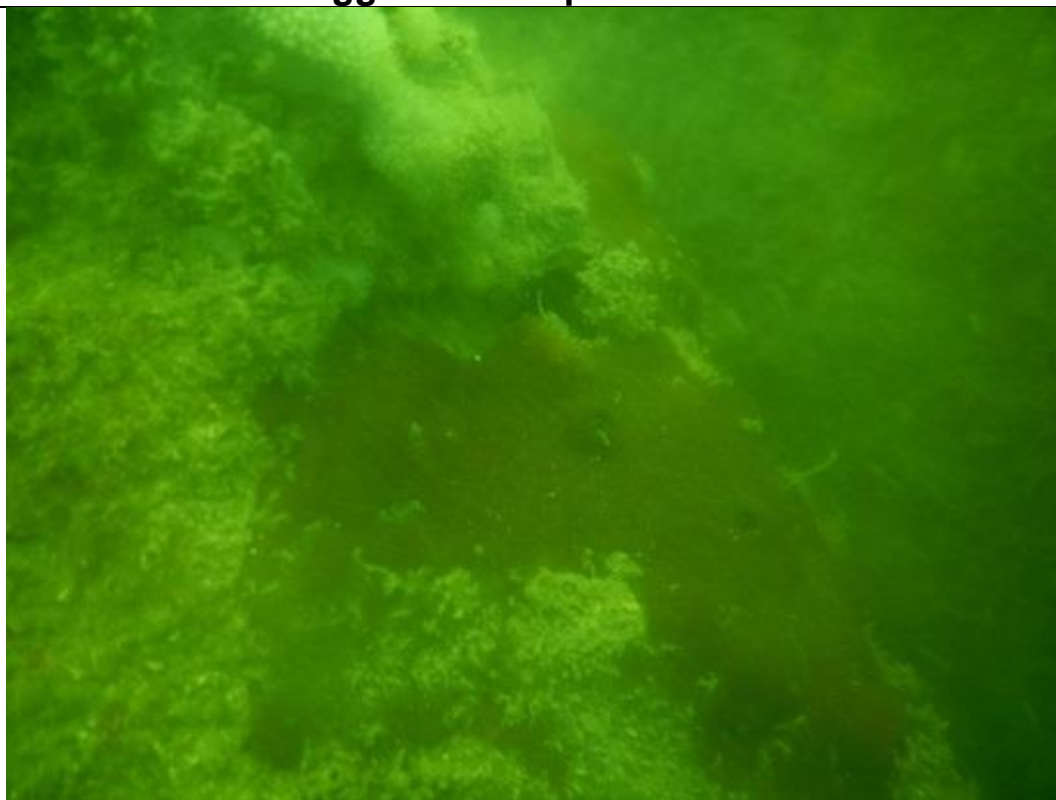
**Photo 10. *Coscinarea* sp. at Suggested Recipient Site R3**

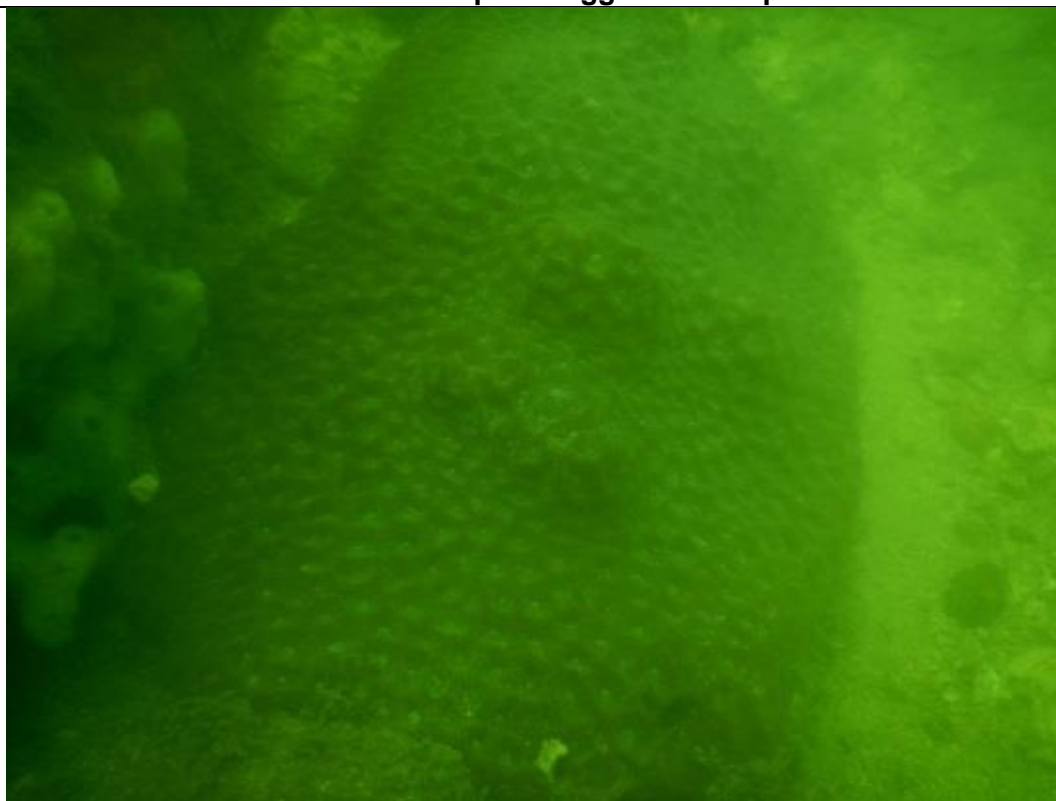
**Photo 11. *Favites chinensis* at Suggested Recipient Site R3**

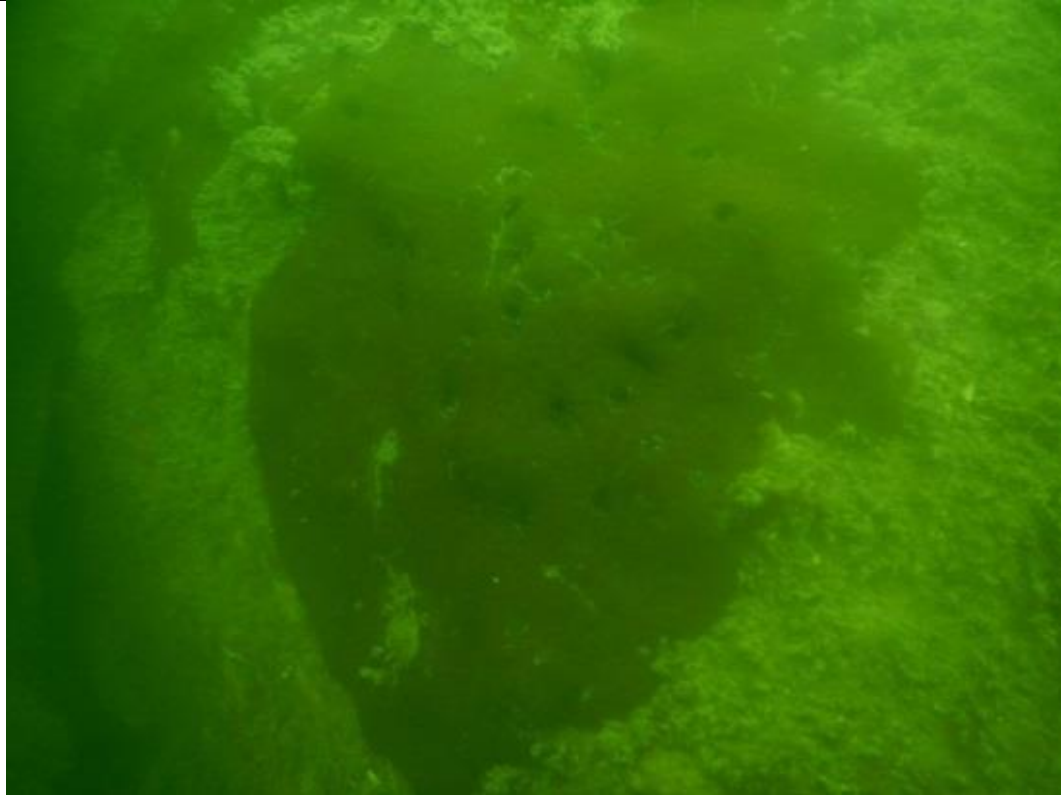
**Photo 12. *Psammocora superficialis* at Suggested Recipient Site R3**

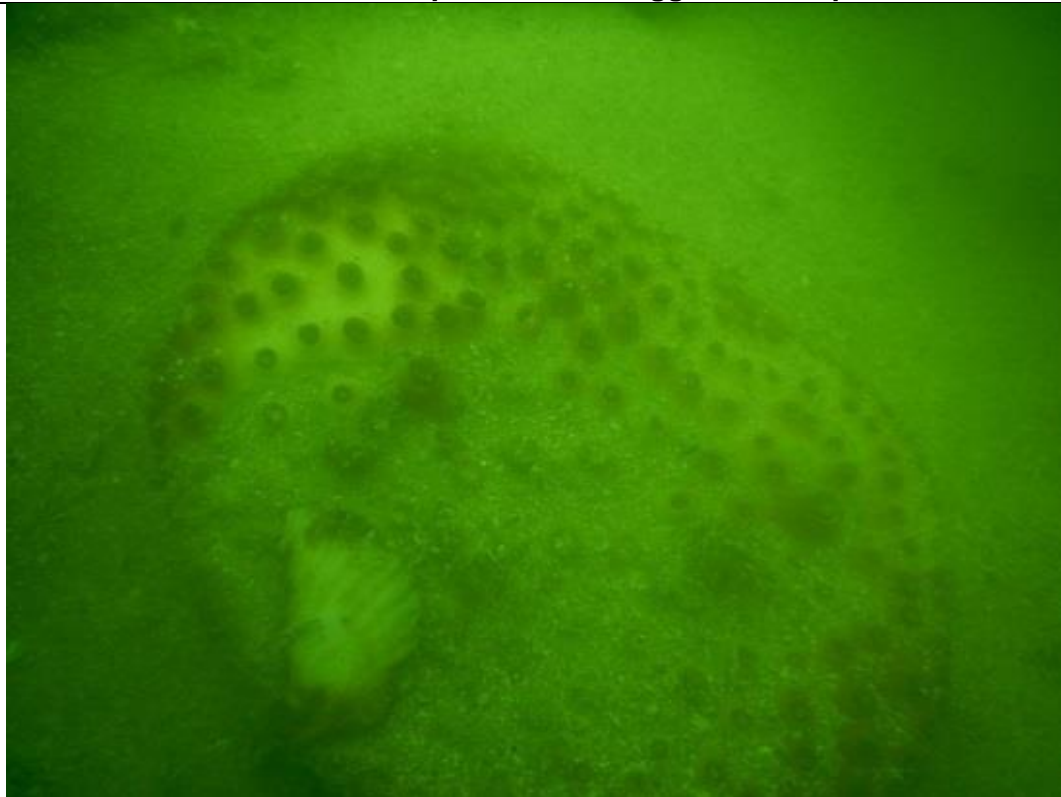
**Photo 13. *Turbinaria peltata* at Suggested Recipient Site R3**
