**Contract No. EP/SP/66/12**  
**Integrated Waste Management Facilities, Phase 1**  
**Monthly EM&A Report No.16**

## Monthly EM&A Report No.16

### (Period from 1 October to 31 October 2019)

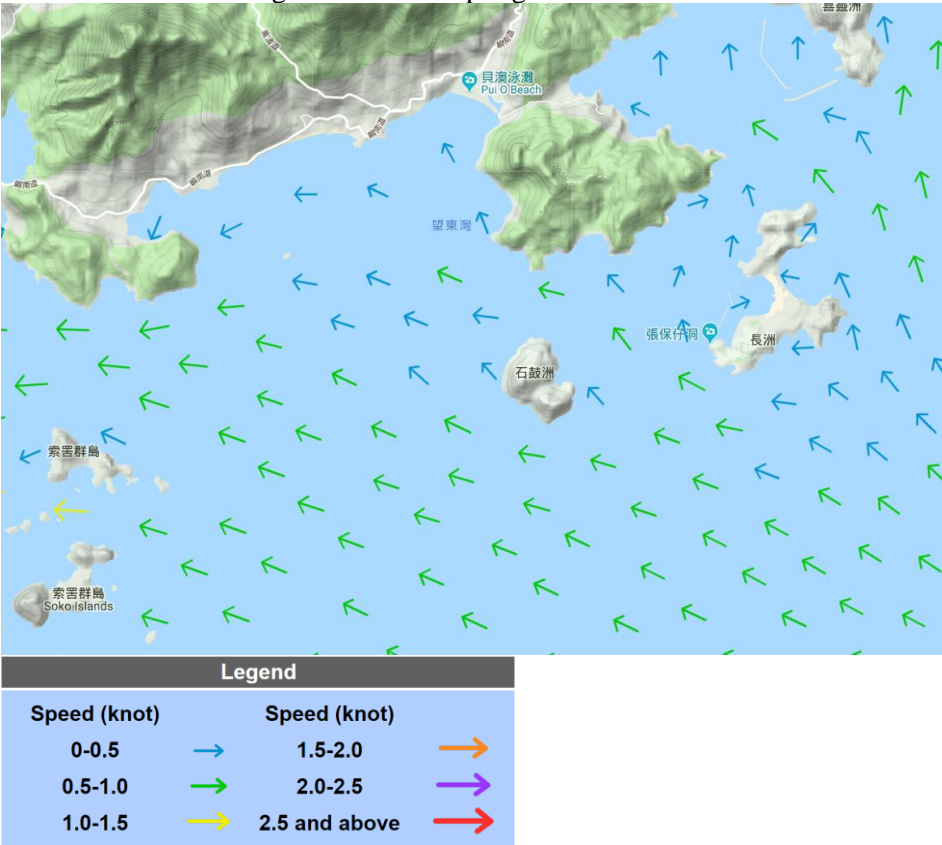
<p>Actions taken / to be taken</p>	<p>Examination of environmental performance of the Project will be continued during the weekly inspection, and the Contractor is reminded to implement all applicable mitigation measures as per the Updated EM&amp;A Manual.</p>
<p>Remarks</p>	<p>Current direction during mid-flood sampling on 25/09:</p>

<p>(Sourced from <a href="http://current.hydro.gov.hk/en/map.html">http://current.hydro.gov.hk/en/map.html</a>)</p>

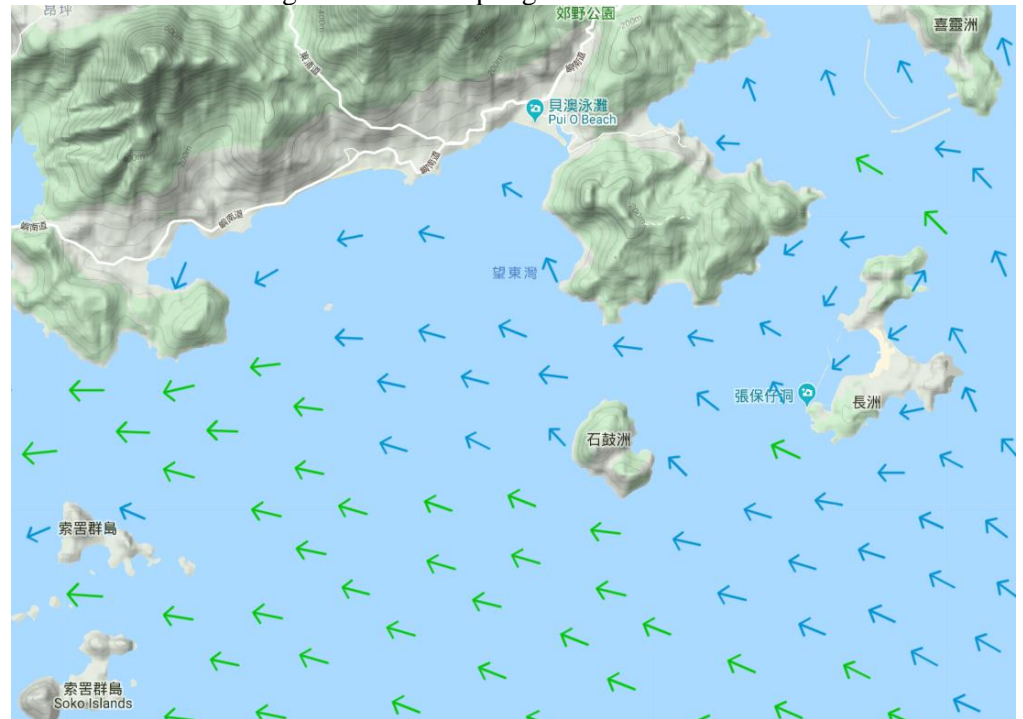
Current direction during mid-flood sampling on 12/10:

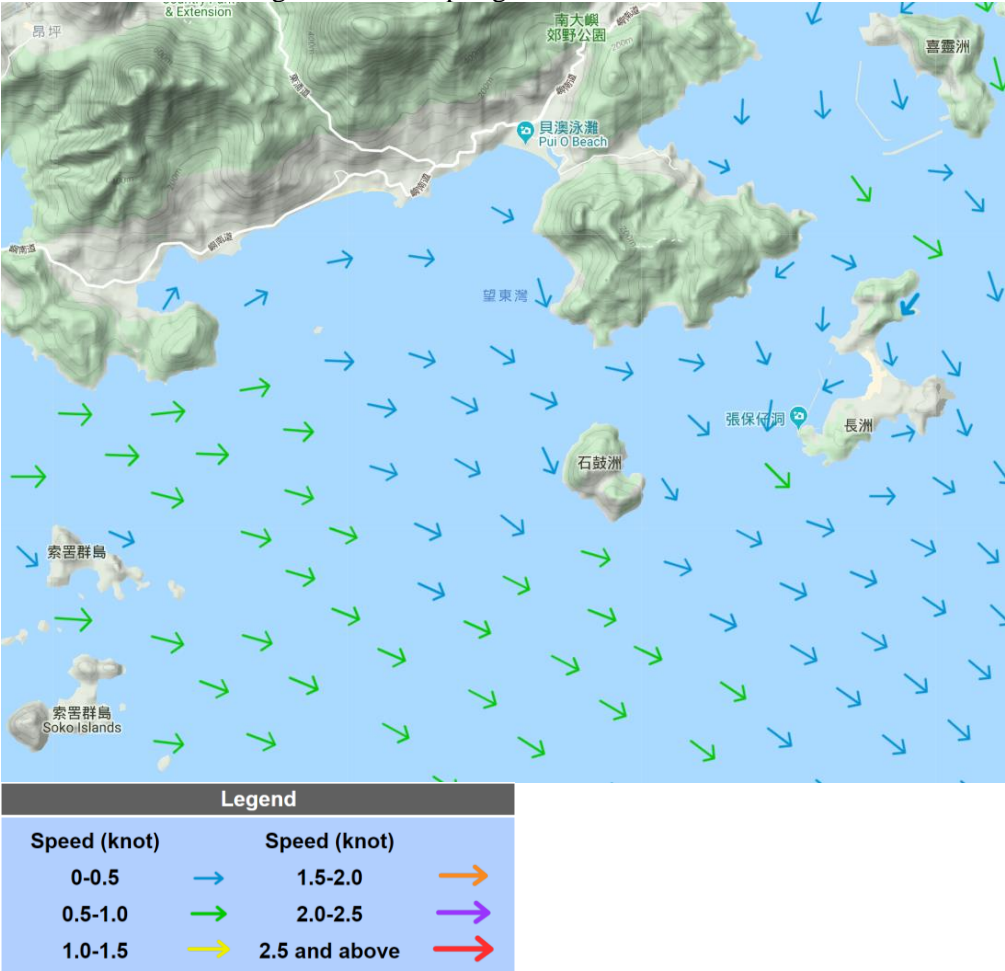
<p>Actions taken / to be taken</p>	<p>Examination of environmental performance of the Project will be continued during the weekly inspection, and the Contractor is reminded to implement all applicable mitigation measures as per the Updated EM&amp;A Manual.</p>
<p>Remarks</p>	<p>Current direction during mid-ebb sampling on 14/10:</p>

<p>(Sourced from <a href="http://current.hydro.gov.hk/en/map.html">http://current.hydro.gov.hk/en/map.html</a>)</p>
<p>Prepared by</p>	<p>Polar Chan</p>
<p>Date</p>	<p>18 Oct 2019</p>

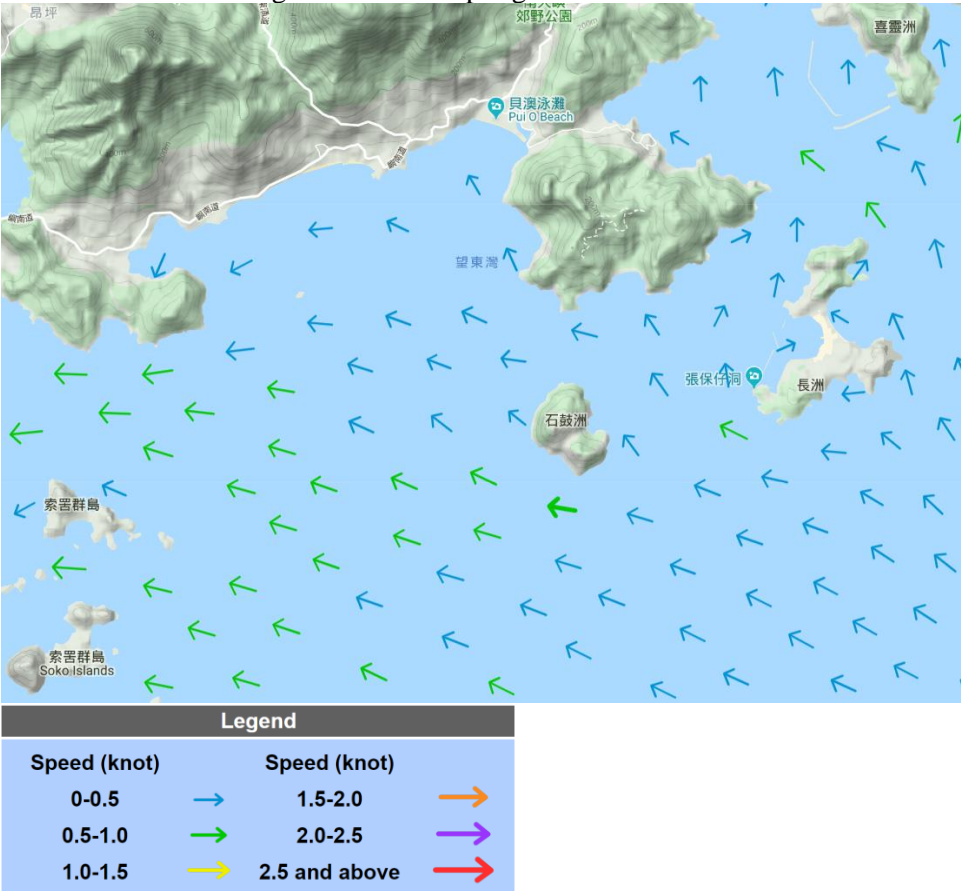
<p>Actions taken / to be taken</p>	<p>Examination of environmental performance of the Project will be continued during the weekly inspection, and the Contractor is reminded to implement all applicable mitigation measures as per the Updated EM&amp;A Manual.</p>
<p>Remarks</p>	<p>Current direction during mid-flood sampling on 22/10:</p>

<p>(Sourced from <a href="http://current.hydro.gov.hk/en/map.html">http://current.hydro.gov.hk/en/map.html</a>)</p>
<p>Prepared by</p>	<p>Polar Chan</p>
<p>Date</p>	<p>25 Oct 2019</p>

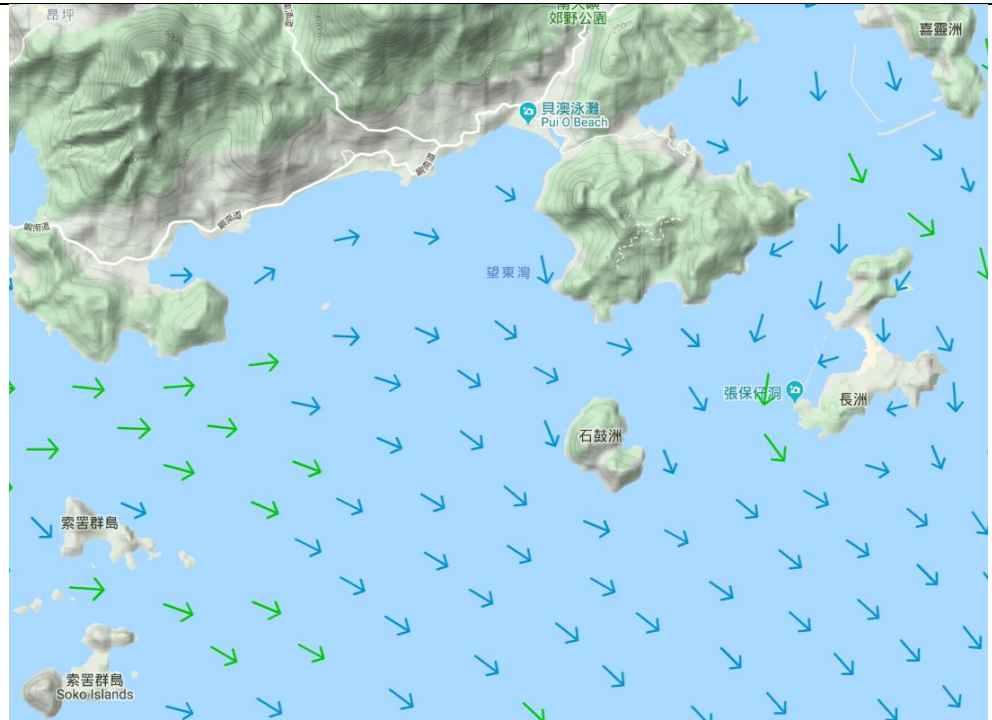
Current direction during mid-ebb sampling on 28/10:

(Sourced from <https://cd.epic.epd.gov.hk/EPICRIVER/marine/history/> and <http://current.hydro.gov.hk/en/map.html>)
