Contract No. EP/SP/66/12
Integrated Waste Management Facilities, Phase 1
Monthly EM&A Report No.2

Monthly EM&A Report No.2 (Period from 1 August to 31 August 2018)

(Clause 3.3, Further Environmental Permit FEP-01/429/2012/A)

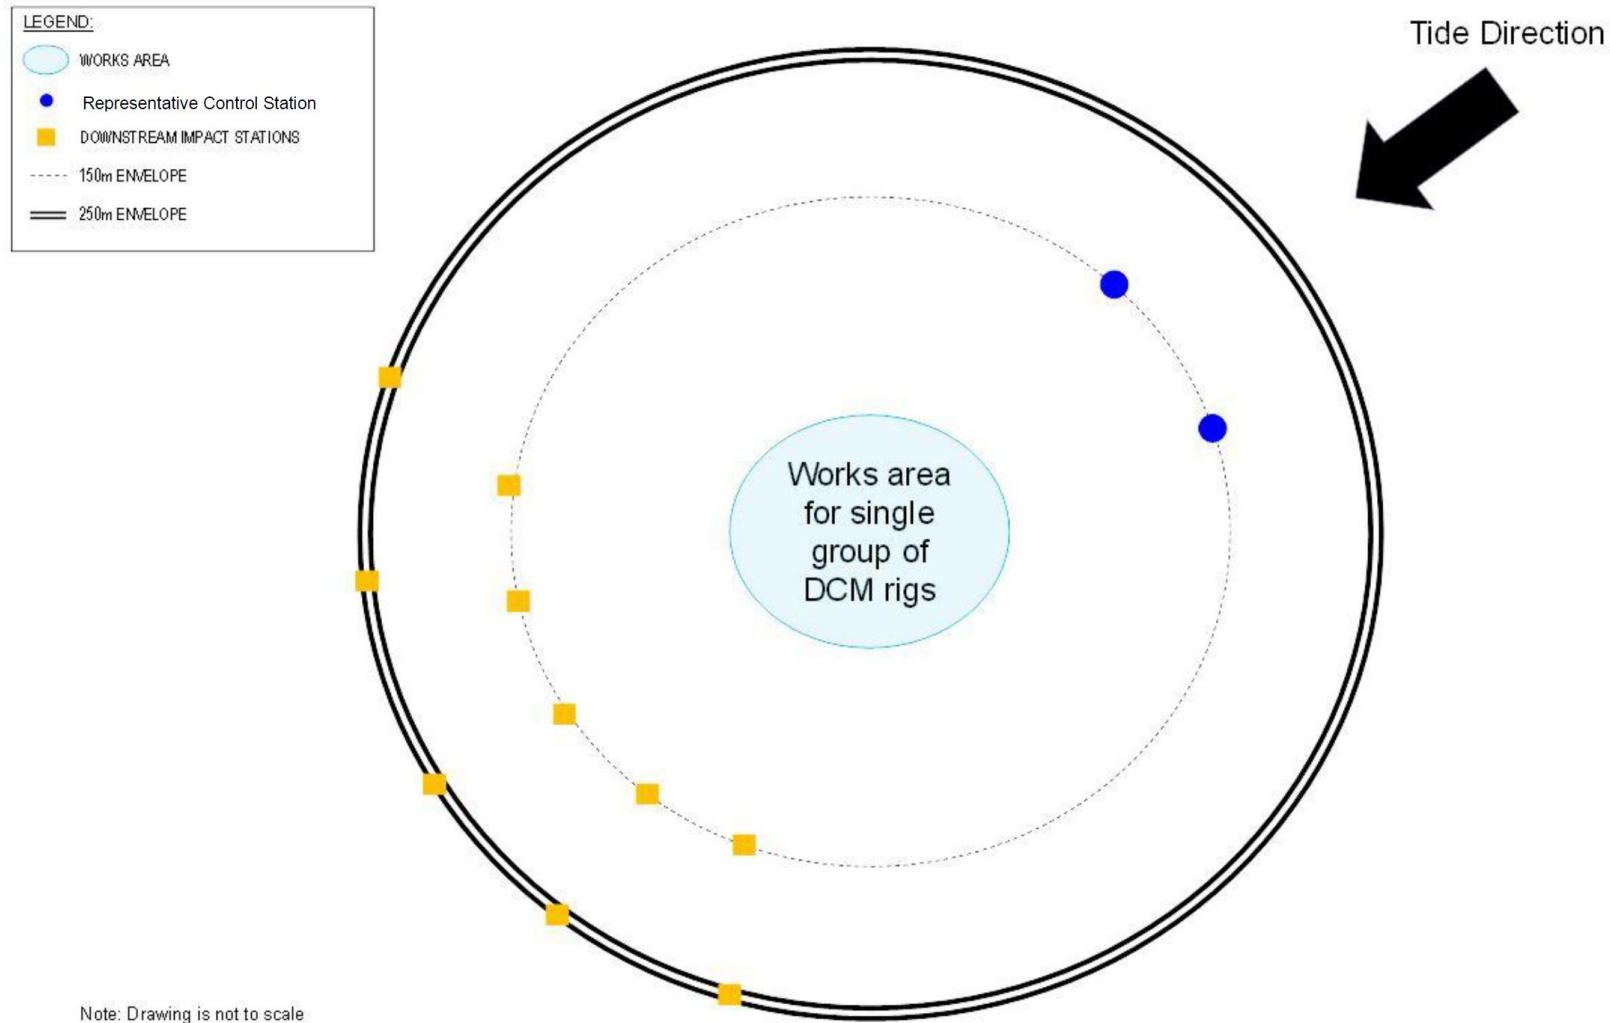
Figure 2.2 Water monitoring locations during intensive DCM monitoring

- Two monitoring stations upstream and at 150 m envelope of DCM group works area (Representative Control stations).
- Five monitoring stations downstream and at 150 m envelope of DCM group works area (Impact 1 stations).
- Five monitoring stations downstream and at 250 m envelope of DCM group works area (Impact 2 stations).
- Monitoring stations should be at least 50 m apart;
- Downstream monitoring stations should be perpendicular to the tidal direction.

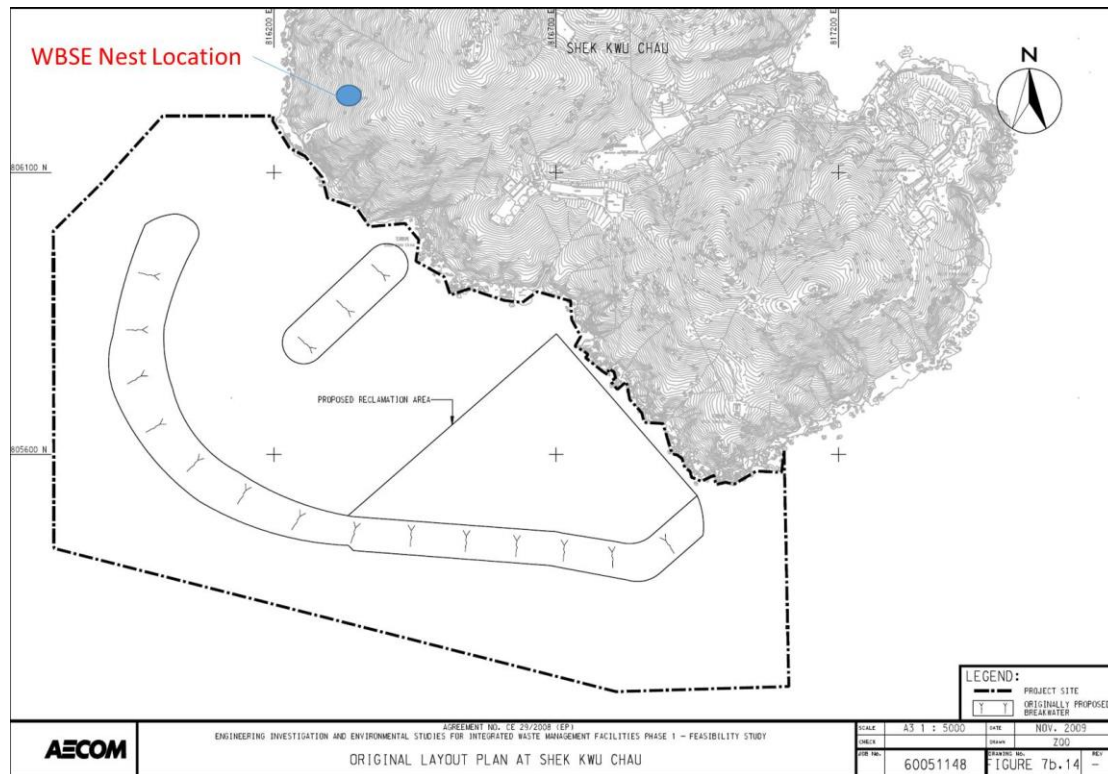
Figure 7.1 Location of WBSE Nest on SKC

7.5.2 One adult was recorded during the monitoring and was appeared on the tree top for about 15 minutes on SKC Island. The WBSE nest was located at the western part of SKC Island (**Figure 7.1**) which is quite away for the Shek Kwu Chau Treatment and Rehabilitation Centre. Any disturbances from anthropogenic activities on the island were not recorded during the monitoring survey. However, there was one fishing boat moving close to the shore were recorded. Since the nest is about 160m away from the shore and it is not accessible, fishing boat activities didn't show any direct disturbance to the WBSE nest.
