Appendix N Exceedance Report

Incident Report on Action Level or Limit Level Non-compliance

Project	Integrated Waste Management Facilities, Phase 1		
Date	14 Feb 2023 (Lab result received on 21 February 2023)		
Time	17:09 – 19:00 (Mid-Ebb)		
Mid-Ebb			
Monitoring Location	B3, H1, M1

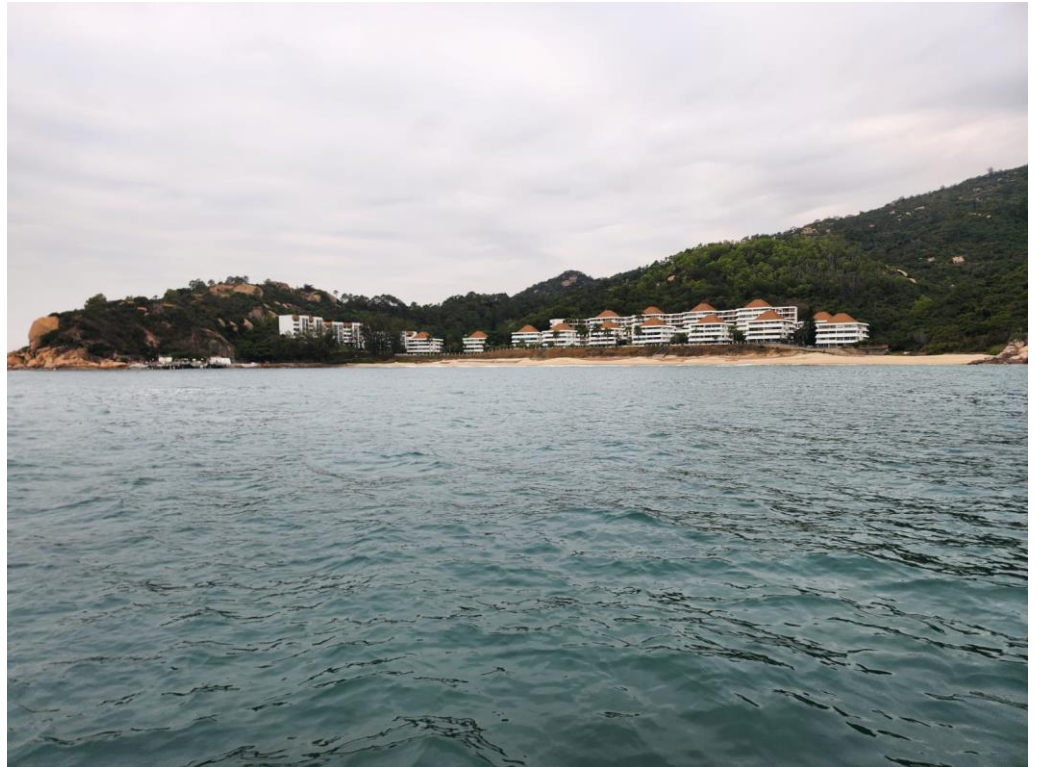
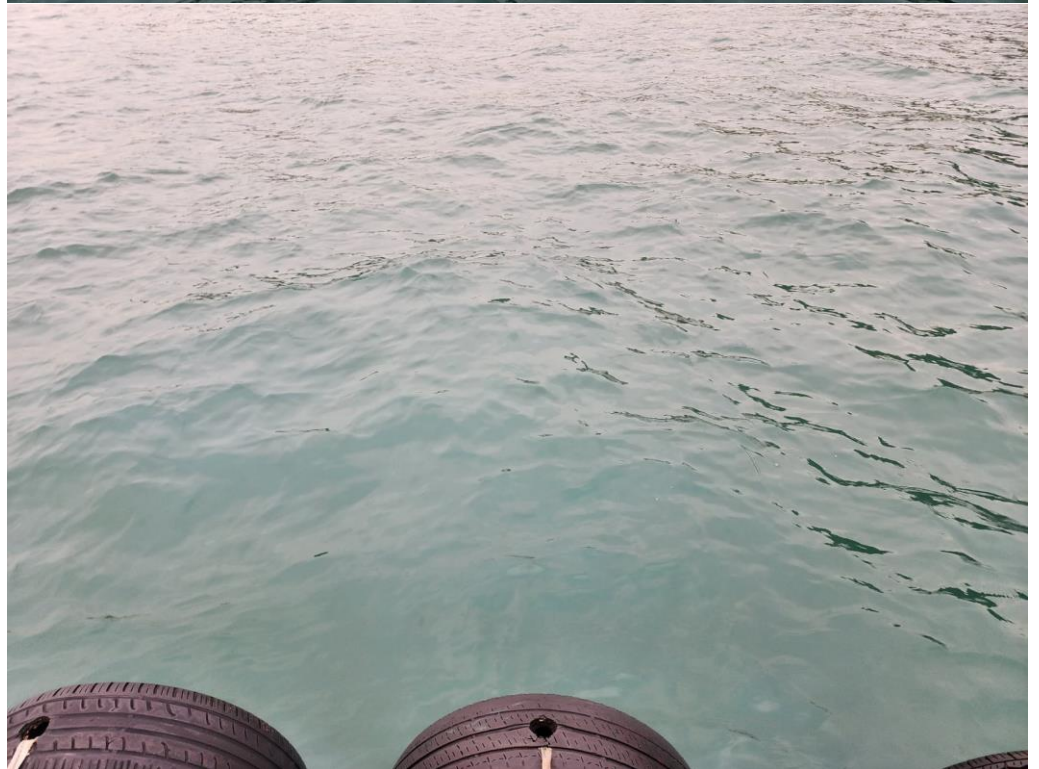
B3:

9.3 mg/L (B3) 9.7 mg/L (H1) 8.1 mg/L (M1)	5.2 mg/L (C1A) 4.0 mg/L (C2A)	6.5 mg/L (B1) 7.0 mg/L (B2) 7.8 mg/L (B4) 5.7 mg/L (F1A) 4.9 mg/L (CR1) 4.8 mg/L (CR2)
Possible reason for Action or Limit Level Non-compliance	<p>Works scheduled on site on 14 Feb 2023 include inspection works at Breakwater A seaside CH700 - CH720, piling works, piling works for driven pile, piling works for pre-bored socketed H-pile, pile cap construction, blockwork seawall and existing caisson extension, and Process Building construction works.</p> <p>Dominant sea current direction was found to be from Northwest to Southeast at waters around Shek Kwu Chau.</p> <p>Exceedances of action level were found at B3, H1 and M1. B3, H1 and M1 are located at unrelated stream direction (neither upstream nor downstream, far away) to the works location. Exceedances at B3, H1 and M1 are deemed to be unrelated to the Project.</p> <p>The installation of caisson No.19 was completed on 18 Mar 2021, the reclamation area was enclosed.</p>

<p>According to the field observation by sampling team during sampling event, no silt plume was observed in the Project site and the weather was overcast during the sampling event.</p> <p>No major observation of improper site practices that contributed to the increase of the suspended solids was recorded during the weekly site inspection on 14 February 2023.</p> <p>After the investigation, the exceedances on 14 February 2023 during ebb tide at B3, H1 and M1 are deemed to be unrelated to the Project.</p>
--	--

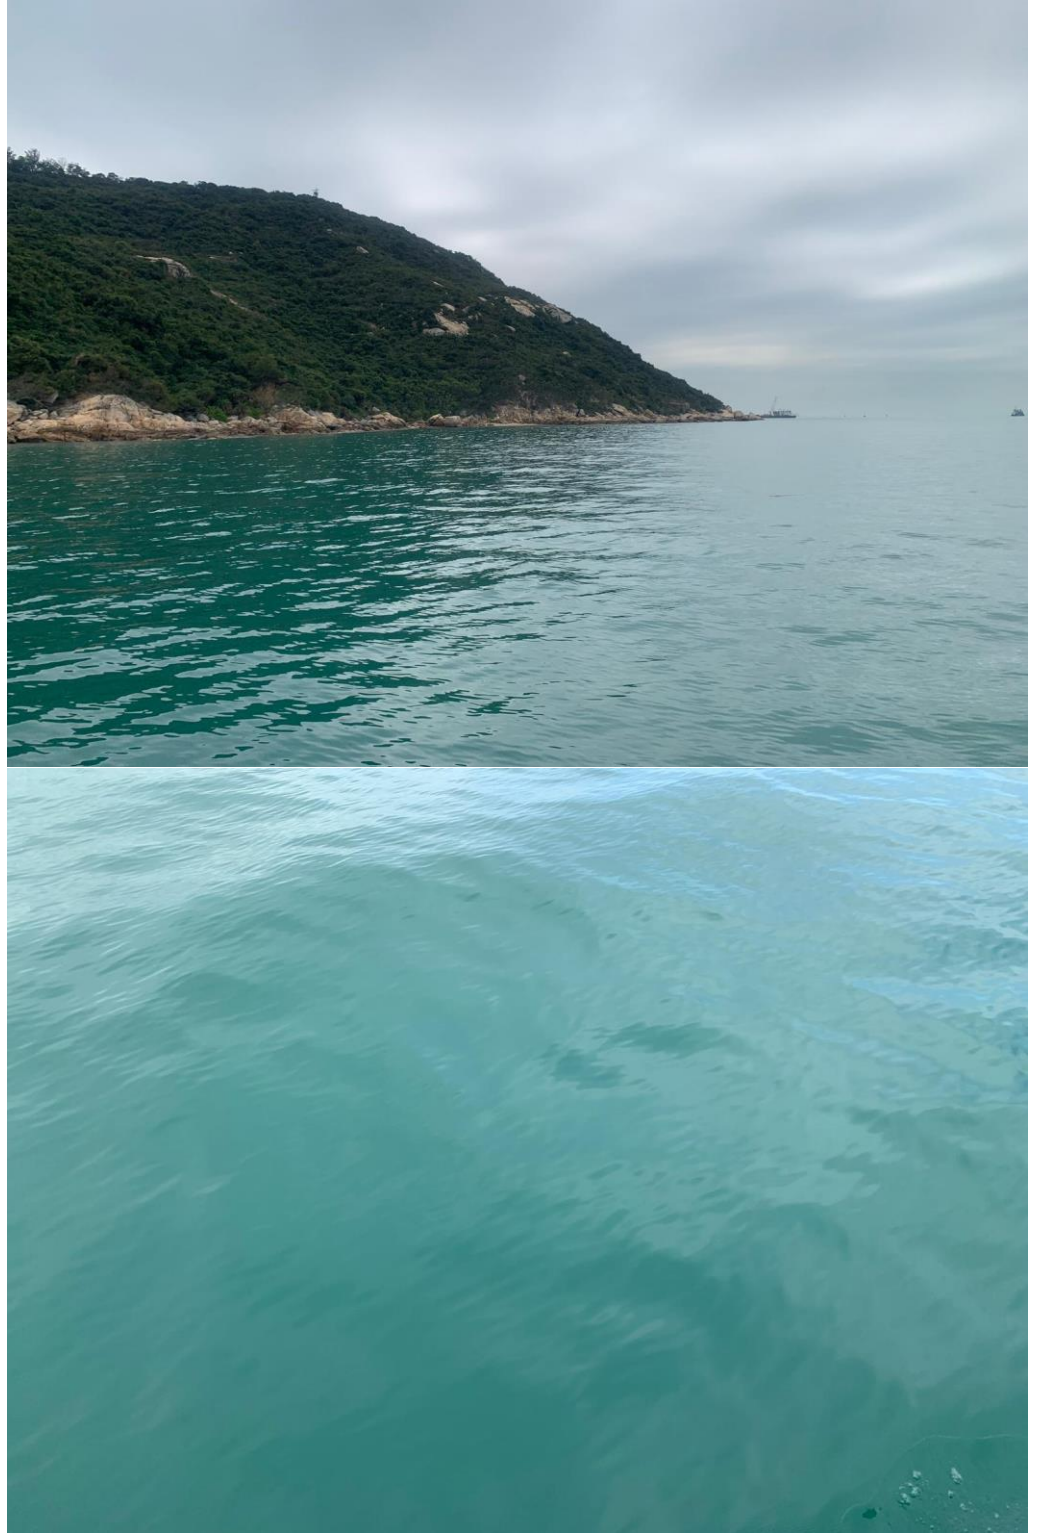
H1:

8.0 mg/L (H1)	5.5 mg/L (C1A) 7.3 mg/L (C2A)	4.4 mg/L (B1) 4.1 mg/L (B2) 6.0 mg/L (B3) 7.3 mg/L (B4) 6.5 mg/L (M1) 5.5 mg/L (F1A) 6.3 mg/L (CR1) 5.3 mg/L (CR2)
Possible reason for Action or Limit Level Non-compliance	<p>Works scheduled on site on 18 Feb 2023 include inspection works at Breakwater A seaside CH710 - CH720, piling works, piling works for driven pile, piling works for pre-bored socketed H-pile, pile cap construction, blockwork seawall and existing caisson extension, and Process Building construction works.</p> <p>Dominant sea current direction was found to be from Southeast to Northwest at waters around Shek Kwu Chau.</p> <p>An exceedance of action level was found at H1. H1 is located at unrelated stream direction (neither upstream nor downstream, far away) to the works location. An exceedance at H1 is deemed to be unrelated to the Project.</p>

<p>According to the field observation by sampling team during sampling event, no silt plume was observed in the Project site and the weather was overcast during the sampling event.</p> <p>No major observation of improper site practices that contributed to the increase of the suspended solids was recorded during the weekly site inspection on 23 February 2023.</p> <p>After the investigation, an exceedance on 18 February 2023 during ebb tide at H1 is deemed to be unrelated to the Project.</p>
--	--

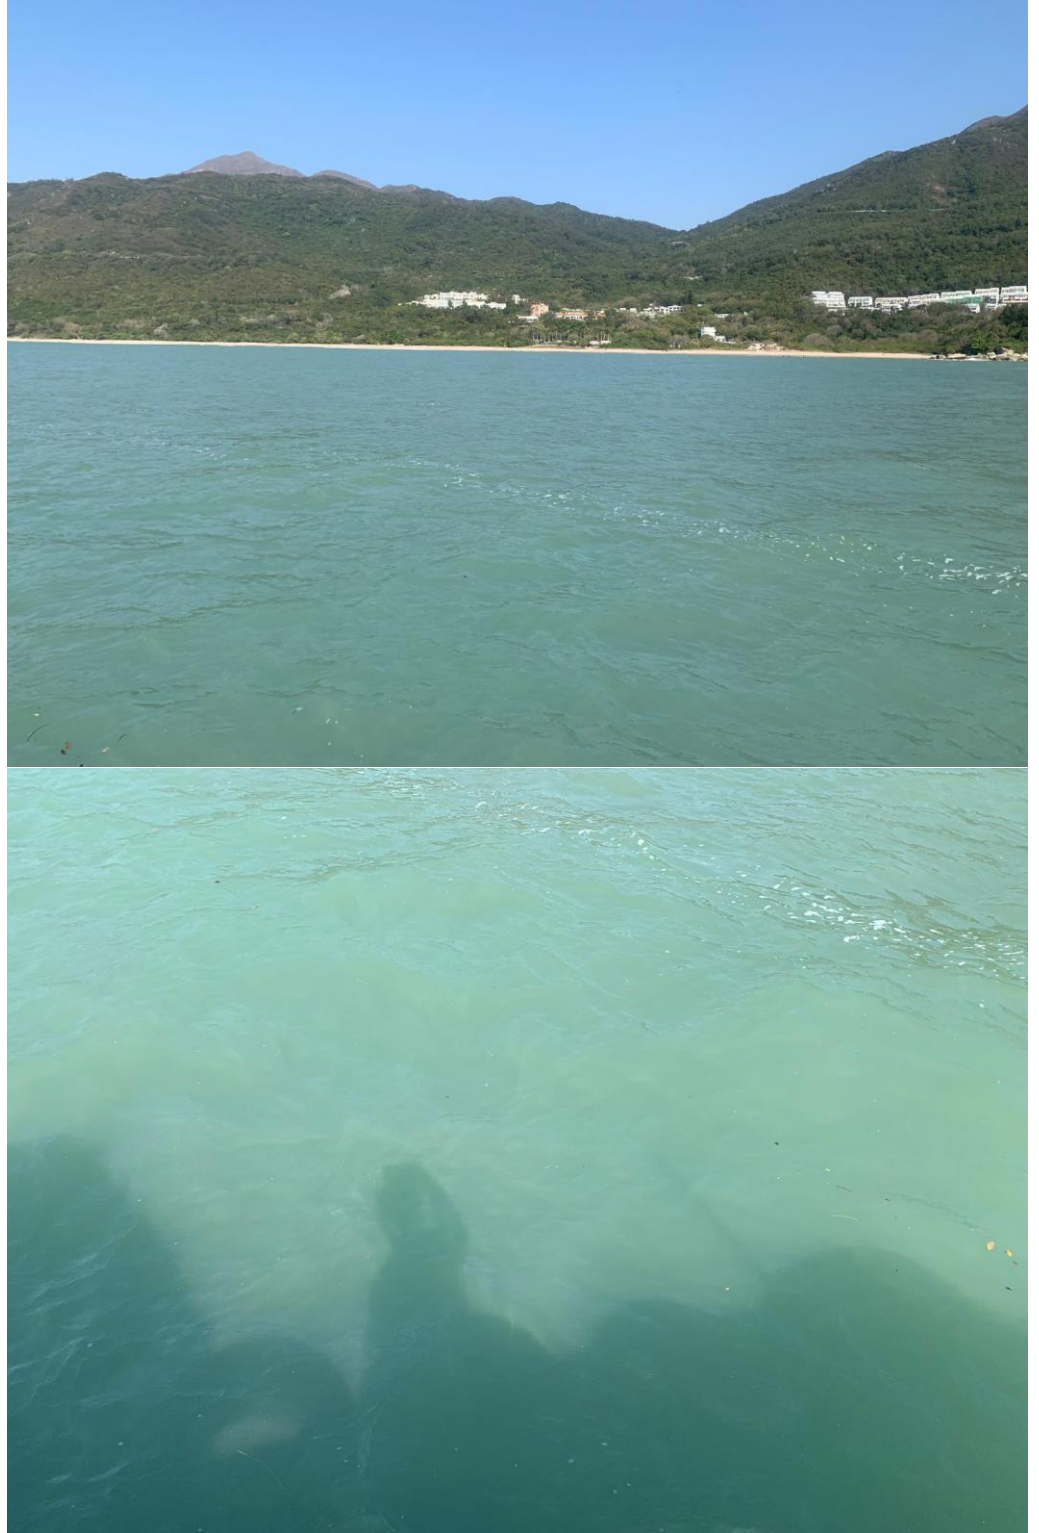
B1:

11.8 mg/L (B1) 14.5 mg/L (B2) 10.5 mg/L (B3) 12.5 mg/L (B4) 11.0 mg/L (H1)	10.7 mg/L (C1A) 7.8 mg/L (C2A)	9.3 mg/L (M1) 8.3 mg/L (F1A) 8.2 mg/L (CR1) 7.0 mg/L (CR2)
Possible reason for Action or Limit Level Non-compliance	<p>Works scheduled on site on 18 Feb 2023 include inspection works at Seawall A CH370 - CH440, piling works, piling works for driven pile, piling works for pre-bored socketed H-pile, pile cap construction, blockwork seawall and existing caisson extension, and Process Building construction works.</p> <p>Dominant sea current direction was found to be from Southeast to Northwest at waters around Shek Kwu Chau.</p> <p>Exceedances of limit level were found at B1, B2, B3, B4 and H1. B1, B2, B3, B4 and H1 are located at unrelated stream direction (neither upstream nor downstream, far away) to the works location. Exceedances at B1, B2, B3, B4 and H1 are deemed to be unrelated to the Project.</p> <p>The installation of caisson No.19 was completed on 18 Mar 2021, the reclamation area was enclosed.</p>

<p>According to the field observation by sampling team during sampling event, no silt plume was observed in the Project site and the weather was fine during the sampling event.</p> <p>No major observation of improper site practices that contributed to the increase of the suspended solids was recorded during the weekly site inspection on 23 February 2023.</p> <p>After the investigation, the exceedances on 22 February 2023 during flood tide at B1, B2, B3, B4 and H1 are deemed to be unrelated to the Project.</p>
--	--
