Contract No. EP/SP/66/12 Integrated Waste Management Facilities, Phase 1 Monthly EM&A Report No.64

Monthly EM&A Report No.64 (Period from 1 October to 31 October 2023)

(Clause 3.3, Further Environmental Permit FEP-01/429/2012/A)

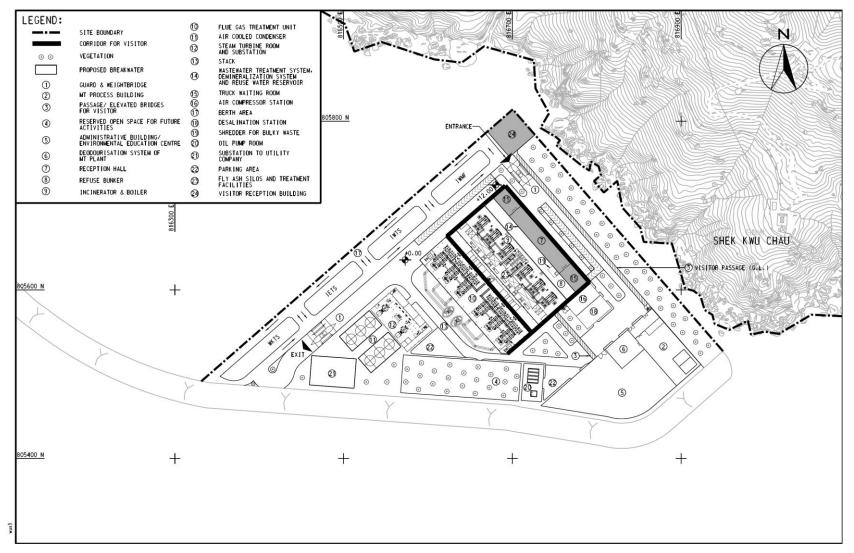
Figure 1.2 General Layout of the IWMF at the Artificial Island near SKC

1.1.5 The location of the IWMF near Shek Kwu Chau (SKC) and general layout of IWMF are shown in **Figure 1.1** and **Figure 1.2** respectively.

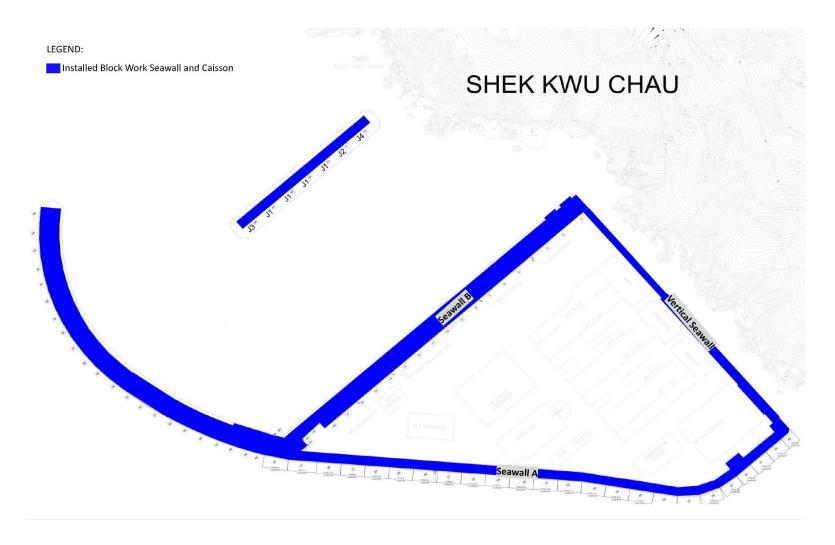
Figure 1.4 Location of Major Construction Activities Undertaken during the Reporting Month

Location of works	Construction activities undertaken	Remarks on progress
Reclamation area	Installation of Instrumentation	On-going
	Site Investigation works for foundation	On-going
	Foundation works (including Driven H Pile and Socketed H Pile)	On-going
	Pile cap construction	On-going
	Structural steel work	On-going
	Superstructure construction	On-going
Seawall portion	Caisson extension works, from +3mPD to +6mPD, at Seawall A and B	On-going
	Construction of wave wall along the vertical seawall above +3mPD	On-going

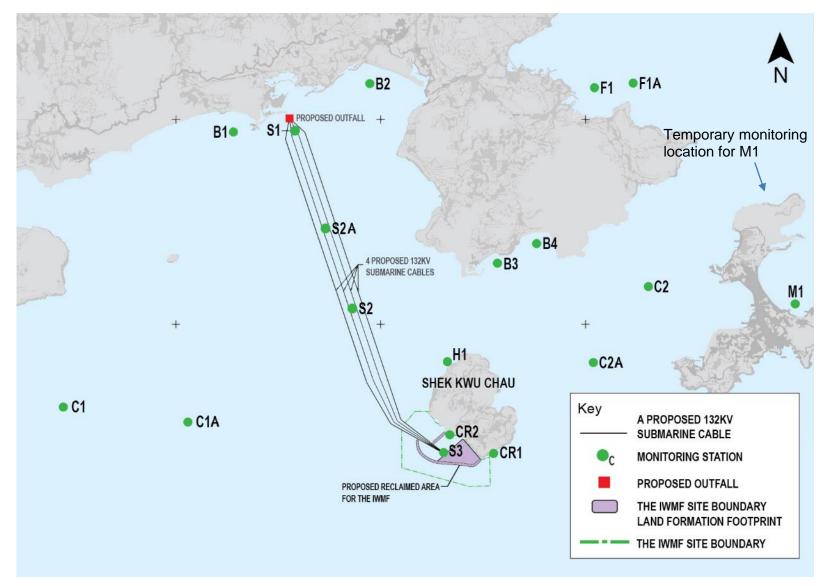
Figure 2.1 Water monitoring locations at Artificial Island near SKC

- 2.3 Water Quality Monitoring Locations
- 2.3.1 Impact water quality monitoring was conducted at eleven monitoring locations (B1-B4, H1, C1, C2, F1, CR1, CR2 & M1) during general water quality monitoring in the reporting period as shown in **Figure 2.1**. As per the relocation proposal verified by IEC and approved by EPD, the monitoring location C1, C2, S2, F1 are relocated at C1A, C2A, S2A, F1A as equivalent points respectively to clear up the concerns from stakeholders.

- 2.3.2 B1 to B4 are located at 4 beaches respectively at the southern shore of Lantau Island. Monitoring station H1 is located at the horseshoe crab habitat at northern SKC, while CR1 and CR2 are located at the coral communities at southwestern shore of SKC. Monitoring station F1 is located at the Cheung Sha Wan Fish Culture Zone while monitoring station M1 is located at Tung Wan at Cheung Chau. Monitoring station F1A is relocated for F1 at the Cheung Sha Wan Fish Culture Zone. S1, S2 and S3 are located at the northern landing site, midway and southern landing site of the proposed submarine cable, respectively. S2A is the relocated monitoring station of S2 which represents the midway landing site of the proposed submarine cable. S1, S2/S2A and S3 are required for monitoring due to the laying of submarine cable. Control stations C1 and C2 at far field locations are for comparison. Control stations C1A and C2A are relocated for C1 and C2 respectively as equivalent far field locations for comparison.

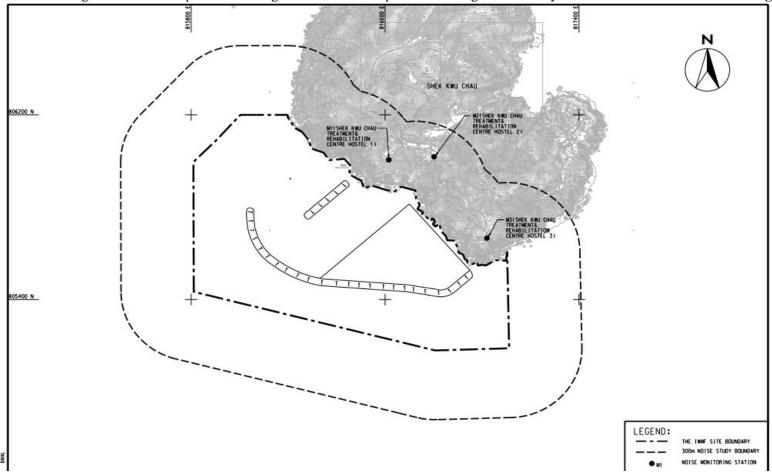
Figure 3.1 Noise monitoring locations at SKC

3.3.1 Three noise monitoring locations for impact monitoring and additional impact monitoring at the nearby sensitive receivers are shown in **Figure 3.1.**

- 3.3.2 M1, M2 and M3 are Shek Kwu Chau Treatment and Rehabilitation Centre Hostel 1, 2 and 3 respectively of The Society for the Aid and Rehabilitation of Drug Abusers (SARDA) located at southern part of Shek Kwu Chau.

- 3.3.3 Measurements at M1 & M3 were conducted at a point 1m from the exterior of the sensitive receivers building façade and at a position 1.2m above the ground. Measurement setup at M3 has been varying with minor adjustment to minimize the disturbance to the users of Treatment Centre. Measurement at M2 was conducted at a point 1m from building façade of the ceiling of 1st floor level for avoidance of mutual disturbance with users of Treatment Centre. The minor adjustment of monitoring locations, which were in favour to mutual convenience with the users of Treatment Centre, were found with no effect on monitoring result based on on-site observation and experience from the Baseline monitoring of the Project. The noise monitoring stations are summarized in **Table 3.2** below.

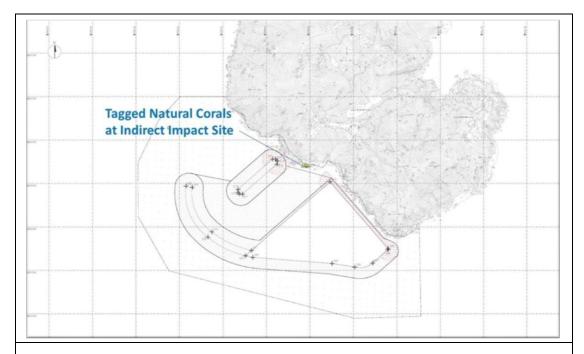
Figure 5.1 Tagged Natural Corals at Indirect Impact Site Near SKC for re-tagging after typhoon Mangkhut

5.3.1 Location of the ten tagged coral colonies at each of the proposed indirect impact site (re-tagging after typhoon Mangkhut), control site (baseline) and recipient site R3 (translocation) are shown in **Figure 5.1**, **Figure 5.2** and **Figure 5.3** respectively:

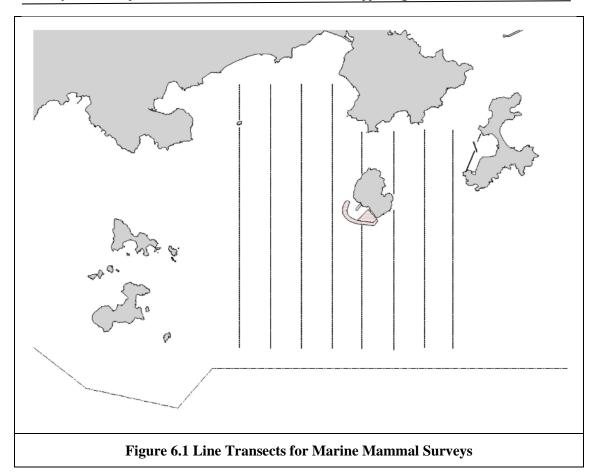
- 6.2.1.2 Eight transect lines are set at Southeast Lantau survey area, including Shek Kwu Chau, waters between Shek Kwu Chau and the Soko Islands, inshore waters of Lantau Island (e.g. Pui O Wan) as well as southwest corner of Cheung Chau as shown in **Figure 6.1** below:

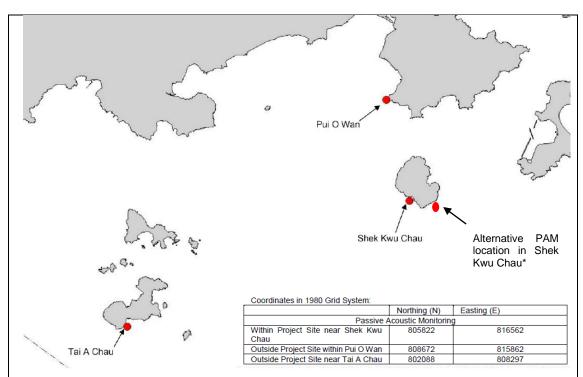
Figure 6.2 Locations of Passive Acoustic Monitoring

The PAM aims to study the usage of an area by Finless Porpoise by using an array of automated static porpoise detectors (e.g. C-POD) which would be deployed at different locations to detect the unique ultra-high frequency sounds produced by Finless Porpoise. During the construction period, the PAM survey will be conducted including placement of two passive porpoise detectors outside the Project Area as control site (i.e. within Pui O Wan and to the south of Tai A Chau) and one porpoise detector within the Project Area (i.e. near Shek Kwu Chau) as shown in **Figure 6.2** below.

Note*: The alternative PAM device adjacent to the Project site was deployed from 5 Mar to 11 Apr 2019, which contained a full 37 days acoustic monitoring data set. After the confirmation of loss of the original PAM within the Project site, this data set was proposed to replace that of the original one, as consulted with AFCD accordingly.

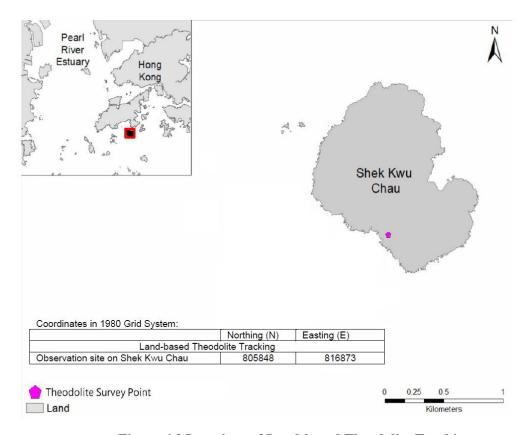
Figure 6.3 Locations of Land-based Theodolite Tracking

- 6.2.4 Land-based Theodolite Tracking
- 6.2.4.1 The Land-based Theodolite Tracking study would use the same station as in the AFCD monitoring study (same as the baseline monitoring location), which is situated at the southwest side of Shek Kwu Chau (GPS position: 22°11.47' N and 113°59.33' E) as shown in below **Figure 6.3**. The station was selected based on its height above sea level (at least 20 metres), close proximity to shore, and relatively unobstructed views of the entire Project Area to the southwest of Shek Kwu Chau. The height of the Shek Kwu Chau Station established by the HKCRP team is 74.6 m high at mean low water, and only a few hundred metres to the IWMF reclamation site, which is ideal for the purpose for the present behavioural and movement monitoring of finless porpoises as well during construction phase considering there as an un-obstructed vantage point at a height above the Project Site.

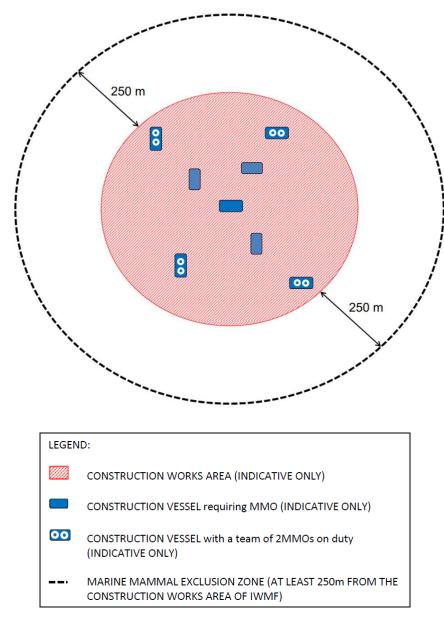
Figure 6.4 Illustration of Typical MMEZ

6.3.1.3 A MMEZ with 250 m distance from the boundary of a work area shall be established during the above situation. A typical MMEZ is indicated in **Figure 6.4** for reference. The MMEZ serves as a monitoring approach to provide appropriate and immediate actions once finless porpoise or Chinese White Dolphin is sighted within the MMEZ. All MMEZ will be monitored by competent Marine Mammal Observers (MMOs) to be provided by the Environmental Team (ET) for the IWMF and trained by the Marine Mammal Monitoring Specialist of the ET who is independent from KSZHJV.

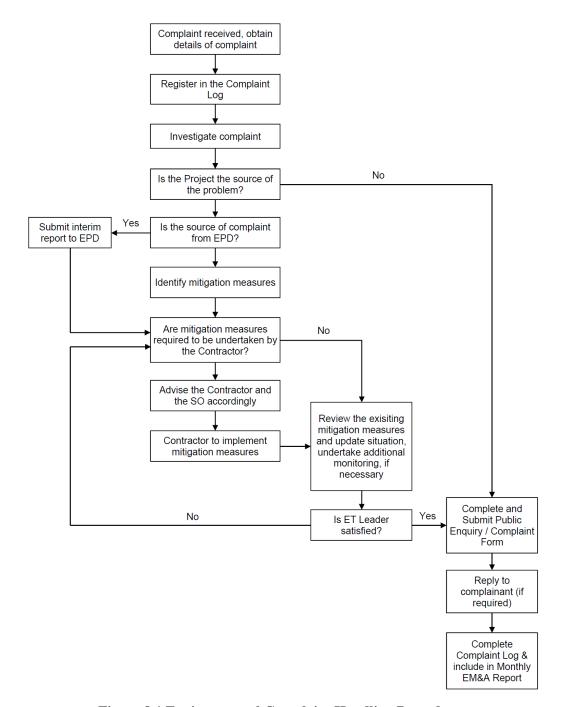
Figure 8.1 Environmental Complaint Handling Procedures

8.1 The Environmental Complaint Handling Procedure is shown in **Figure 8.1**.
