Contract No. EP/SP/66/12  
Integrated Waste Management Facilities, Phase 1  
Monthly EM&A Report No.7

## Monthly EM&A Report No.7 (Period from 1 January to 31 January 2019)

(Clause 3.3, Further Environmental Permit FEP-01/429/2012/A)

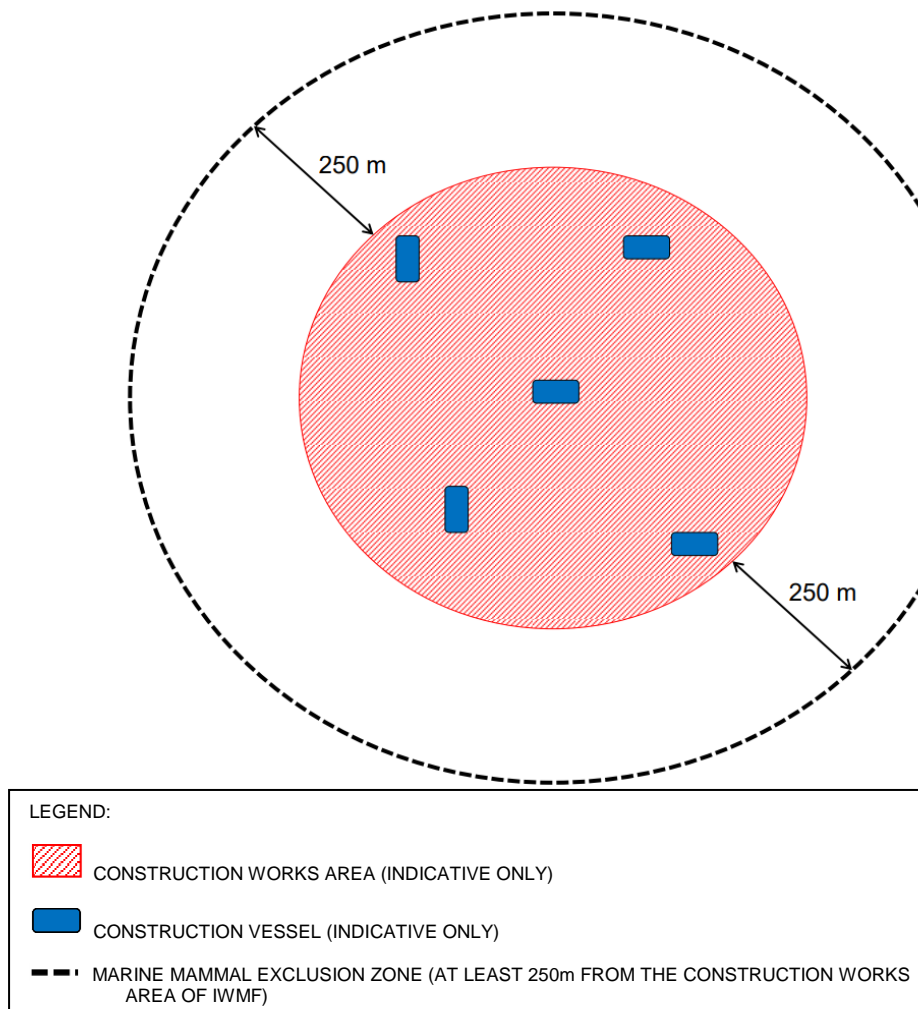
**Figure 6.4 Illustration of Typical MMEZ**

A MMEZ with 250 m distance from the boundary of a work area shall be established during the above situation. A typical MMEZ is indicated in **Figure 6.4** for reference. The MMEZ serves as a monitoring approach to provide appropriate and immediate actions once finless porpoise or Chinese White Dolphin is sighted within the MMEZ. All MMEZ will be monitored by competent Marine Mammal Observers (MMOs) to be provided by the Environmental Team (ET) for the IWMF and trained by the Marine Mammal Monitoring Specialist of the ET who is independent from JV.
