**Contract No. EP/SP/66/12**  
**Integrated Waste Management Facilities, Phase 1**  
**Monthly EM&A Report No.96**

## **Monthly EM&A Report No.96**

### **(Period from 1 June to 30 June 2026)**

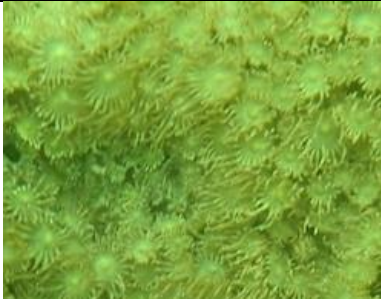
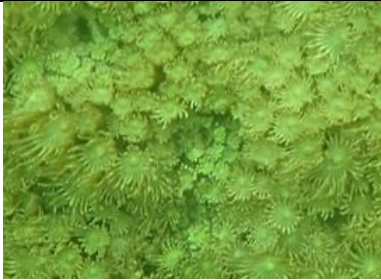
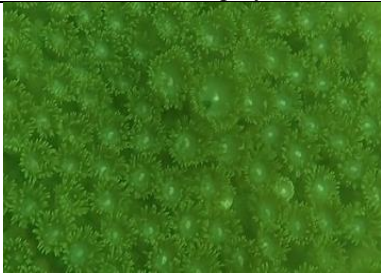
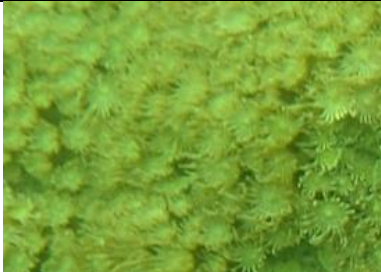
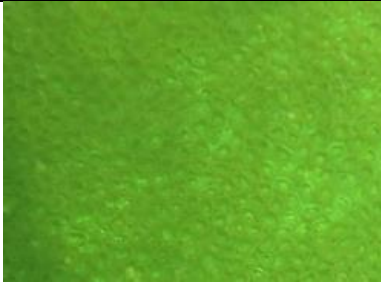
**Photo Plate 5.1      Ten (10) Monitored Corals at Control Site**

5.6.2 Ten (10) hard coral colonies were monitored at each Control site and Indirect Impact Site as suggested in the Construction Phase Monitoring Plan. The general health conditions (size, mortality, bleaching and sediment) were recorded and summarized in **Table 5.8** and **Table 5.9**. Photos of each coral colonies were taken during the monitoring activities shown in **Photo Plate 5.1** and **Photo Plate 5.2**.

- i. The re-tagged corals were marked as ##R.

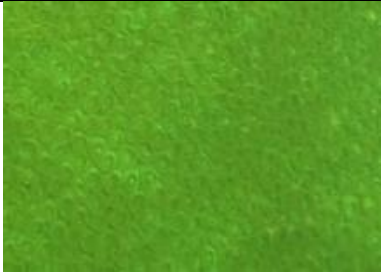
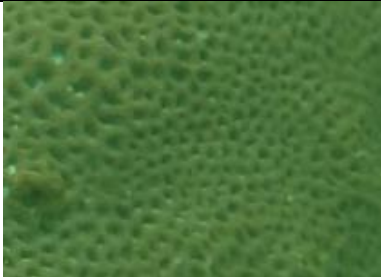
**Photo Plate 5.2      Ten (10) Monitored Corals at Indirect Impact Site**

- i. The re-tagged corals were marked as ##R.

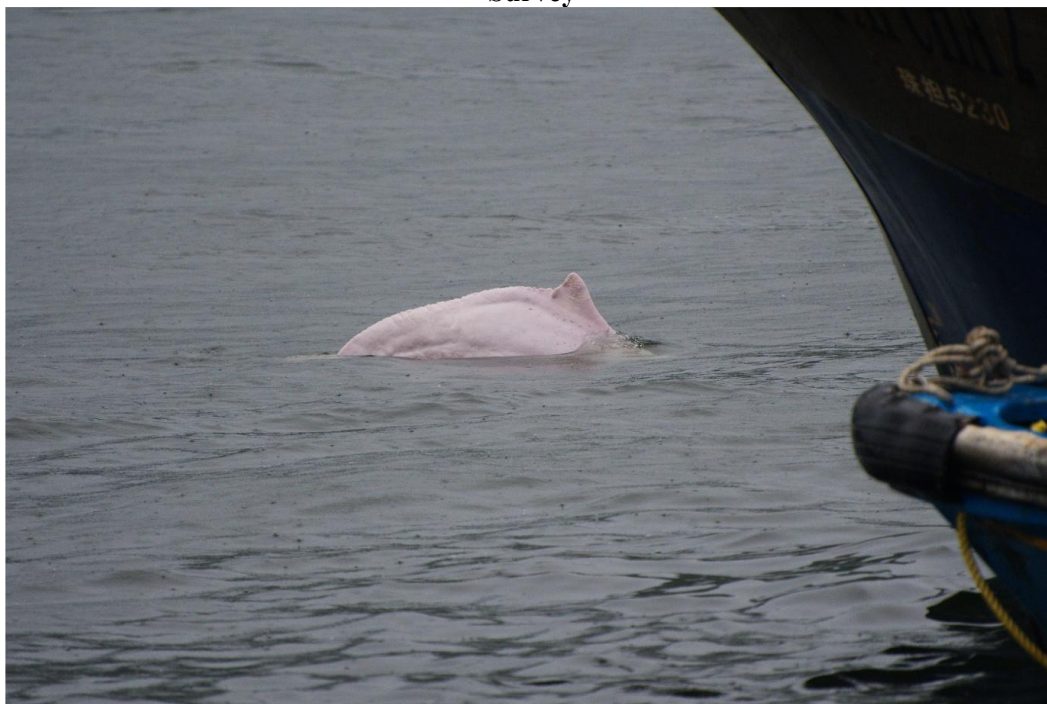
**Figure 6.6 Representative Photos Taken of Sighting Recorded in June 2026**

6.4.1.2 The monthly surveys were conducted on 26 June 2026. As this is the designated non-peak season (June-November), one survey was completed. A total on effort survey length of 41.9 km was completed, 100% of which was conducted at Beaufort Sea State 2 or better (**Table 6.4**). One (1) on-effort Chinese White Dolphin sighting was recorded and confirmed by qualified ecologist (**Table 6.5, Figure 6.5**). Representative photos taken of sighting recorded in June 2026 during vessel-based line-transect survey is presented in **Figure 6.6**.

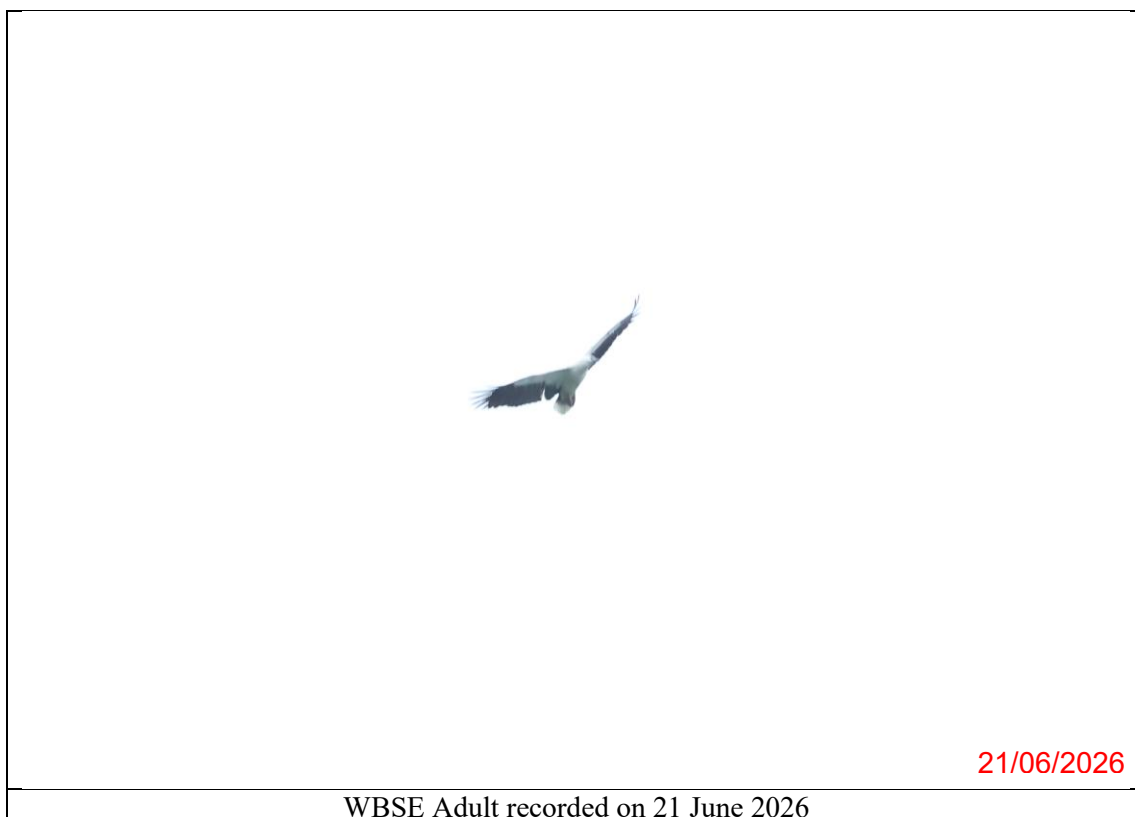
7.5.8 Photo record of WBSE from the survey in this reporting month is shown below:
