Contract No. EP/SP/66/12
Integrated Waste Management Facilities, Phase 1
Monthly EM&A Report No.31

Monthly EM&A Report No.31
(Period from 1 January to 31 January 2021)

(Clause 3.3, Further Environmental Permit FEP-01/429/2012/A)

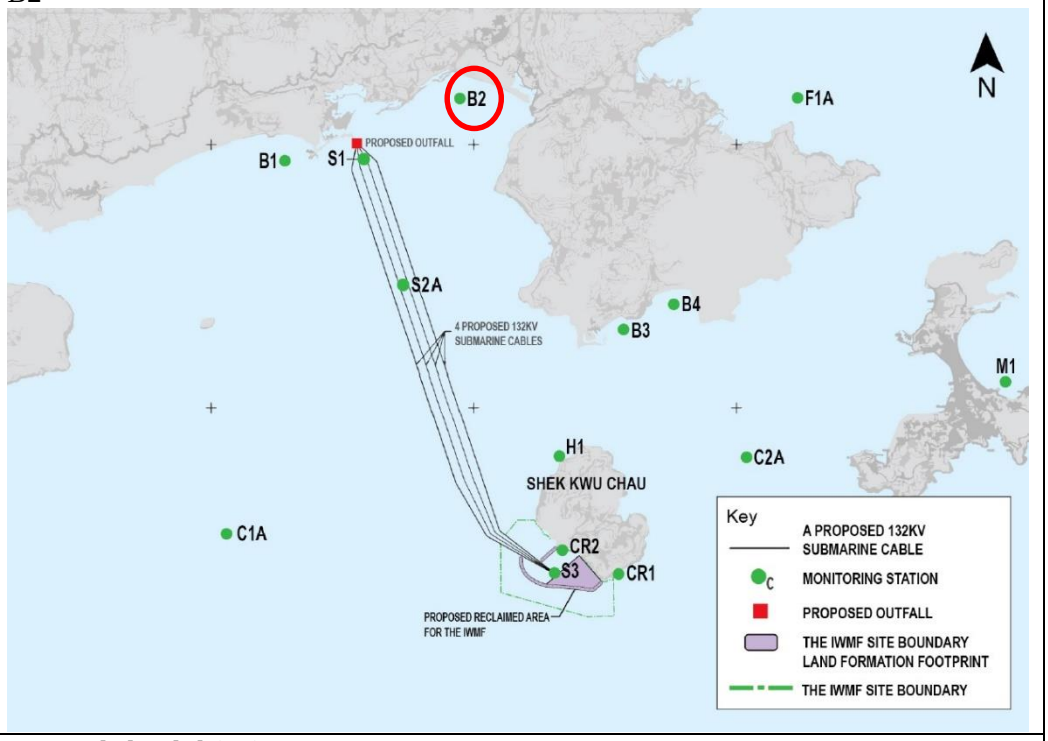
Project	Integrated Waste Management Facilities, Phase 1		
Date	13 Jan 2021 (Lab result received on 18 Jan 2021)		
Time	11:02 – 14:32 (Mid-Ebb)		
Mid-Ebb			
Monitoring Location	B2

Parameter	Suspended Solid (SS)		
Action & Limit Levels	Action Level	Limit Level	
	≥ 8.0 mg/L	≥ 10.0 mg/L	
Measurement Level	Impact Station(s) of Exceedance	Control Stations	Impact Station(s) without Exceedance

From MMO monitoring records on 13 Jan 2021, MMO team was arranged for one derrick barge (金盈 8)) and silt curtain at western marine access area on that day while no deficiency of silt curtain was found before the commencement of and during construction activity. According to the field observation by Marine Mammal Observer team & sampling team during sampling event, no silt plume was observed in the Project site. Site tidiness in the present barges in the Project site were checked during weekly site inspection on 12 Jan 2021. No major observation of improper site practices that could contribute to the increase of the suspended solids recorded.
Remarks	Current direction during mid-ebb sampling on 13 Jan 2021:

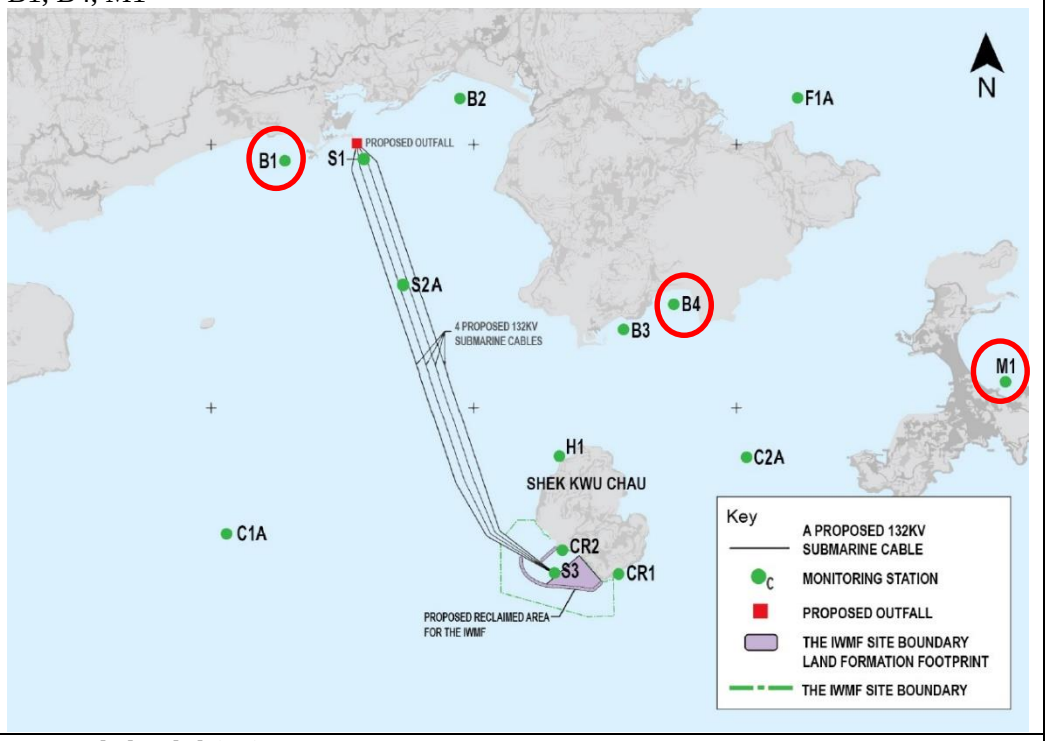
Project	Integrated Waste Management Facilities, Phase 1		
Date	31 Jan 2020 (Lab result received on 3 Feb 2021)		
Time	08:00 – 11:30 (Mid-Flood)		
Mid-Flood			
Monitoring Location	B1, B4, M1

Parameter	Suspended Solid (SS)		
Action & Limit Levels	Action Level	Limit Level	
	≥ 9.0 mg/L (120% of C2A)	≥ 10.0 mg/L	
Measurement Level	Impact Station(s) of Exceedance	Control Stations	Impact Station(s) without Exceedance

no deficiency of silt curtain was found before the commencement of and during construction activity. According to the field observation by Marine Mammal Observer team & sampling team during sampling event, no silt plume was observed in the Project site. Site tidiness in the present barges in the Project site were checked during weekly site inspection on 27 Jan 2021. No major observation of improper site practices that could contribute to the increase of the suspended solids recorded.
Remarks	Current direction during mid-flood sampling on 31 Jan 2021:
