Appendix N Exceedance Report

Incident Report on Action Level or Limit Level Non-compliance

Project	Integrated Waste Management Facilities, Phase 1		
Date	06 Sep 2019 (Lab result received on 11 Sep 2019)		
Time	10:53 – 14:23 (Mid-Flood)		
Mid-Flood			
Monitoring Location	B3 & CR2

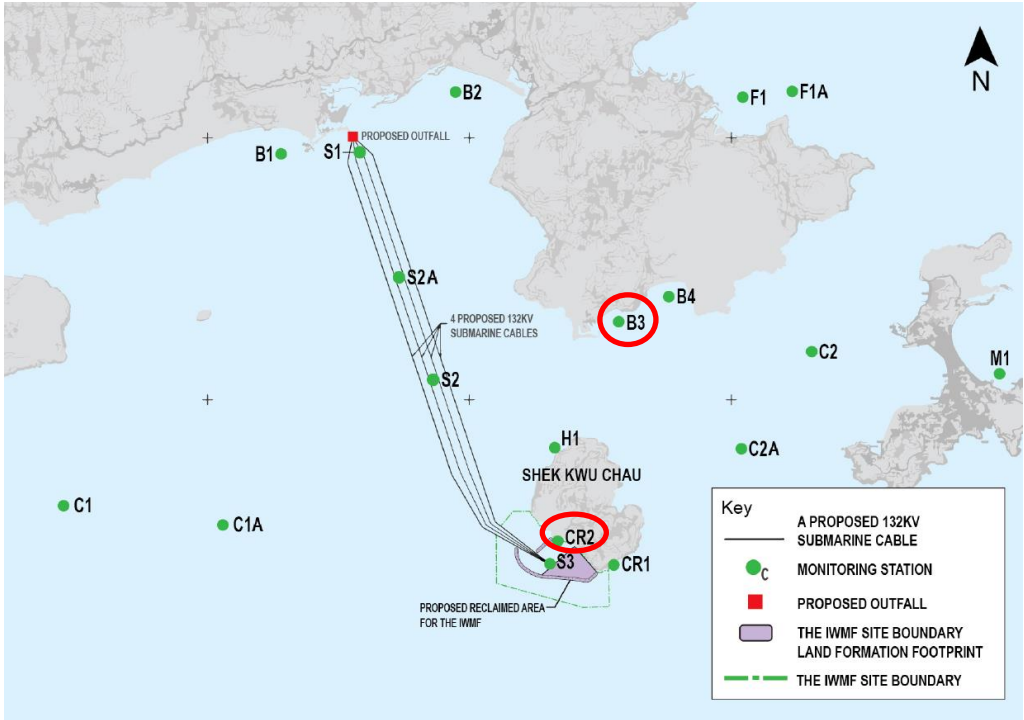
Parameter	Suspended Solid (SS)		
Action & Limit Levels	Action Level		Limit Level
	≥ 12.0 mg/L		≥ 14.0 mg/L
Measurement Level	Impact Station(s) of Exceedance	Control Stations	Impact Station(s) without Exceedance

12.3 mg/L (B3) 13.3 mg/L (CR2)	11.3 mg/L (C1A) 7.3 mg/L (C2A)	8.8 mg/L (B1) 9.3 mg/L (B2) 9.0 mg/L (B4) 8.5 mg/L (F1A) 9.2 mg/L (H1) 9.2 mg/L (M1) 10.3 mg/L (S1) 10.3 mg/L (S2A) 11.2 mg/L (S3) 9.5 mg/L (CR1)
Possible reason for Action or Limit Level Non-compliance	<p>Works scheduled on site on 06/09 include cone penetration test, sand blanket levelling and rock filling works.</p> <p>Dominating sea current direction was found to be from Southeast to Northwest at waters around Shek Kwu Chau.</p> <p>B3 is located at unrelated stream direction (neither upstream nor downstream, far away) to the works location, exceedance of this monitoring station is deemed to be unrelated to the Project.</p> <p>CR2 is located close to the works location within the Project site while silt curtain checking was implemented on Cheung Kee 10 (09:00), GD851 (07:00) & 宏建 2</p>

<p>(12:30) by the Contractor and checking results showed that no deficiency of silt curtain was found on that day. No rock filling work scheduled in Kam Ying 8 was carried out with refer to the site diary on 06/09/2019.</p> <p>From MMO monitoring records on 06/09, MMO teams were arranged for three derrick barges (宏建 2, GD-851 & Cheung Kee No.10) on that day while no deficiency of silt curtain was found before the commencement of and during construction activity. It might suggest that the SS exceedance at B3 & CR2 is deemed to be unrelated to the Project.</p> <p>Weekly site inspection for Portion 7 & 7A (Tung Chung) was conducted on 03/09. For reference, site tidiness in the present barges in the Project site were checked during weekly site inspection on 09/09, where two parts of secondary silt curtain of ESC-62 are found floating outward. Due to the temporal reason, this observation might not contribute to the increase of the suspended solids recorded in 06/09.</p>

<p>Actions taken / to be taken</p>	<p>Two parts of secondary silt curtain of ESC-62 has been maintained in good condition on 11/09. The Contractor was reminded to keep tracking on the status of the deployed silt curtain during construction works.</p> <p>Examination of environmental performance of the Project will be continued during the weekly inspection, and the Contractor is remained to implement all applicable mitigation measures as per the Updated EM&A Manual.</p>
<p>Remarks</p>	<p>Current direction during mid-ebb sampling on 06/09:</p>

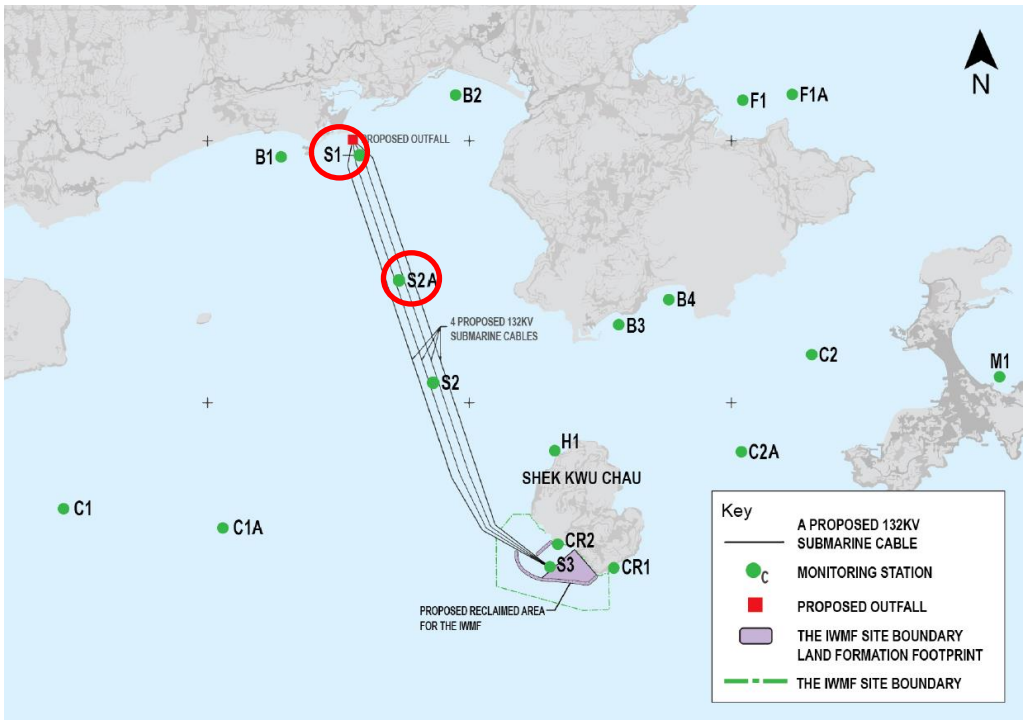
Project	Integrated Waste Management Facilities, Phase 1		
Date	27 Sep 2019 (Lab result received on 02 Oct 2019)		
Time	09:20 – 12:50 (Mid-Ebb) 14:50 – 19:00 (Mid-Flood)		
Mid-Ebb			
Monitoring Location	S1 & S2A

Parameter	Suspended Solid (SS)		
Action & Limit Levels	Action Level		Limit Level
	≥ 13.4 mg/L (120% of C1A)		≥ 14.5 mg/L (130% of C1A)
Measurement Level	Impact Station(s) of Exceedance	Control Stations	Impact Station(s) without Exceedance

15.3 mg/L (S1) 13.8 mg/L (S2A)	11.2 mg/L (C1A) 8.8 mg/L (C2A)	10.5 mg/L (B1) 11.0 mg/L (B2) 10.5 mg/L (B3) 11.8 mg/L (B4) 11.0 mg/L (F1A) 10.5 mg/L (H1) 6.8 mg/L (M1) 7.7 mg/L (S3) 8.7 mg/L (CR1) 8.2 mg/L (CR2)
Possible reason for Action or Limit Level Non-compliance	Dominating sea current direction was found to be from Northwest to Southeast at waters around Shek Kwu Chau. S1 & S2A are located at unrelated stream direction (neither upstream nor downstream, far away) to the works location, exceedances of these monitoring stations are deemed to be unrelated to the Project.		
Mid-Flood			
Monitoring Location	B2, B3 & B4

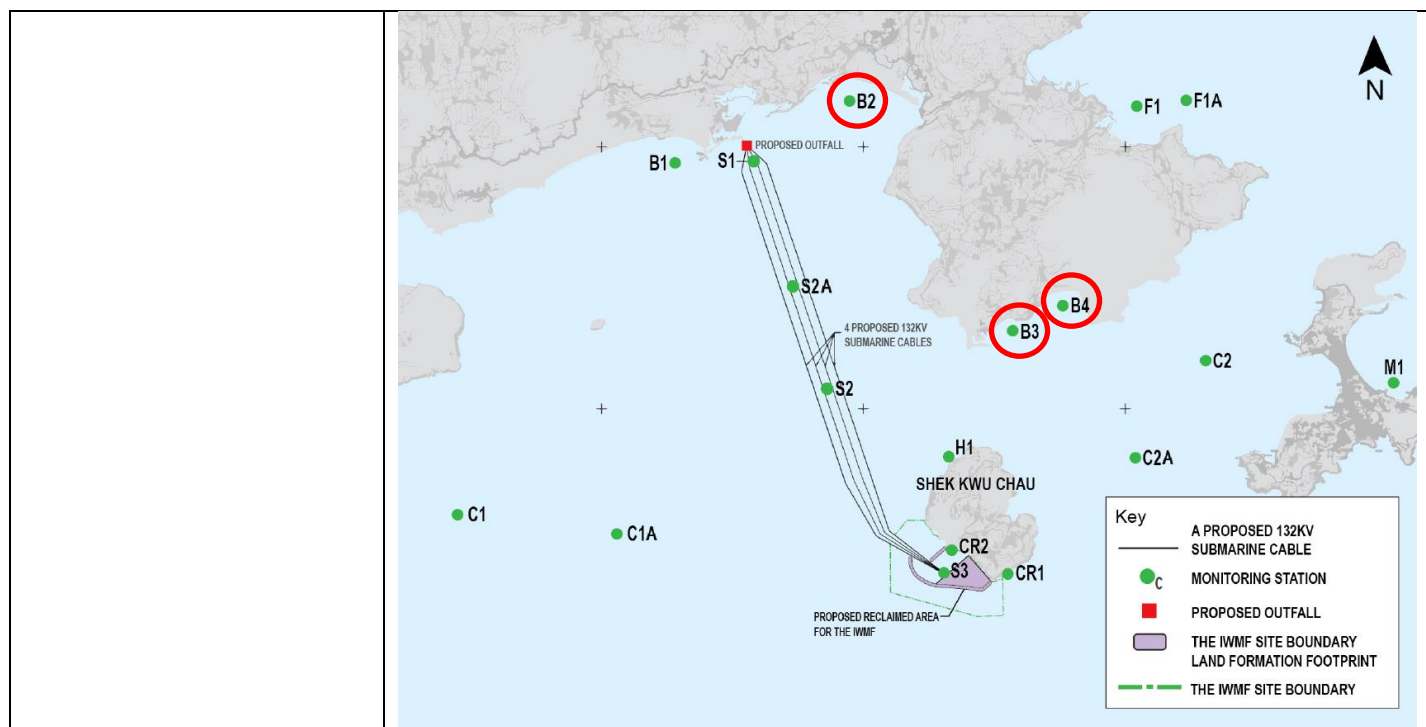
Parameter	Suspended Solid (SS)		
Action & Limit Levels	Action Level		Limit Level
	≥ 13.6 mg/L (120% of C2A)		≥ 14.7 mg/L (130% of C2A)
Measurement Level	Impact Station(s) of Exceedance	Control Stations	Impact Station(s) without Exceedance

14.0 mg/L (B2) 15.5 mg/L (B3) 17.8 mg/L (B4)	10.7 mg/L (C1A) 11.3 mg/L (C2A)	10.0 mg/L (B1) 10.5 mg/L (F1A) 13.2 mg/L (H1) 11.0 mg/L (M1) 10.0 mg/L (S1) 9.8 mg/L (S2A) 10.8 mg/L (S3) 12.2 mg/L (CR1) 11.3 mg/L (CR2)
Possible reason for Action or Limit Level Non-compliance	Dominating sea current direction was found to be from Southeast to Northwest at waters around Shek Kwu Chau.		
	B2, B3 & B4 are located at unrelated stream direction (neither upstream nor downstream, far away) to the works location, exceedances of these monitoring stations are deemed to be unrelated to the Project.		
Actions taken / to be taken	Notified the Contractor to collect more information.		
Remarks	Current direction during mid-ebb sampling on 27/09:
