Appendix N Exceedance Report

Incident Report on Action Level or Limit Level Non-compliance

Project	Integrated Waste Management Facilities, Phase 1		
Date	10 Nov 2020 (Lab result received on 13 Nov 2020)		
Time	08:00 – 11:30 (Mid-Ebb) 12:59 – 16:29 (Mid Flood)		
Mid-Ebb			
Monitoring Location	<div>M1</div> <div>

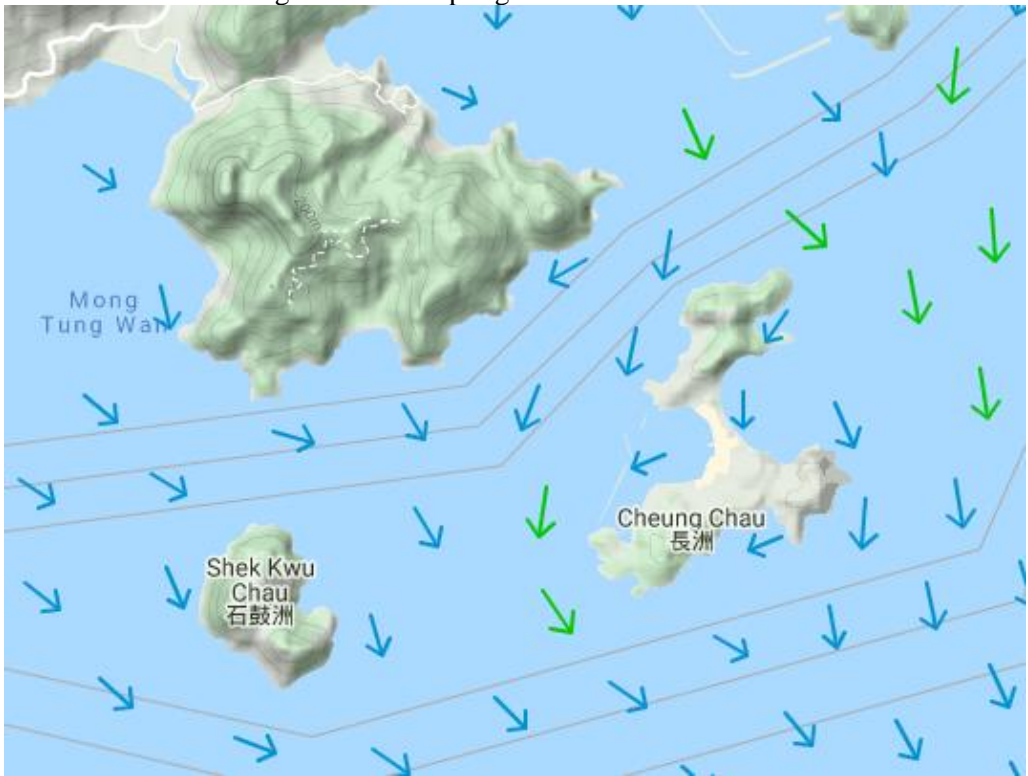
<p>Actions taken / to be taken</p>	<p>Examination of environmental performance of the Project will be continued during the weekly inspection, and the Contractor is reminded to implement all applicable mitigation measures as per the Updated EM&A Manual.</p>
<p>Remarks</p>	<p>Current direction during mid-ebb sampling on 10 Nov 2020:</p>

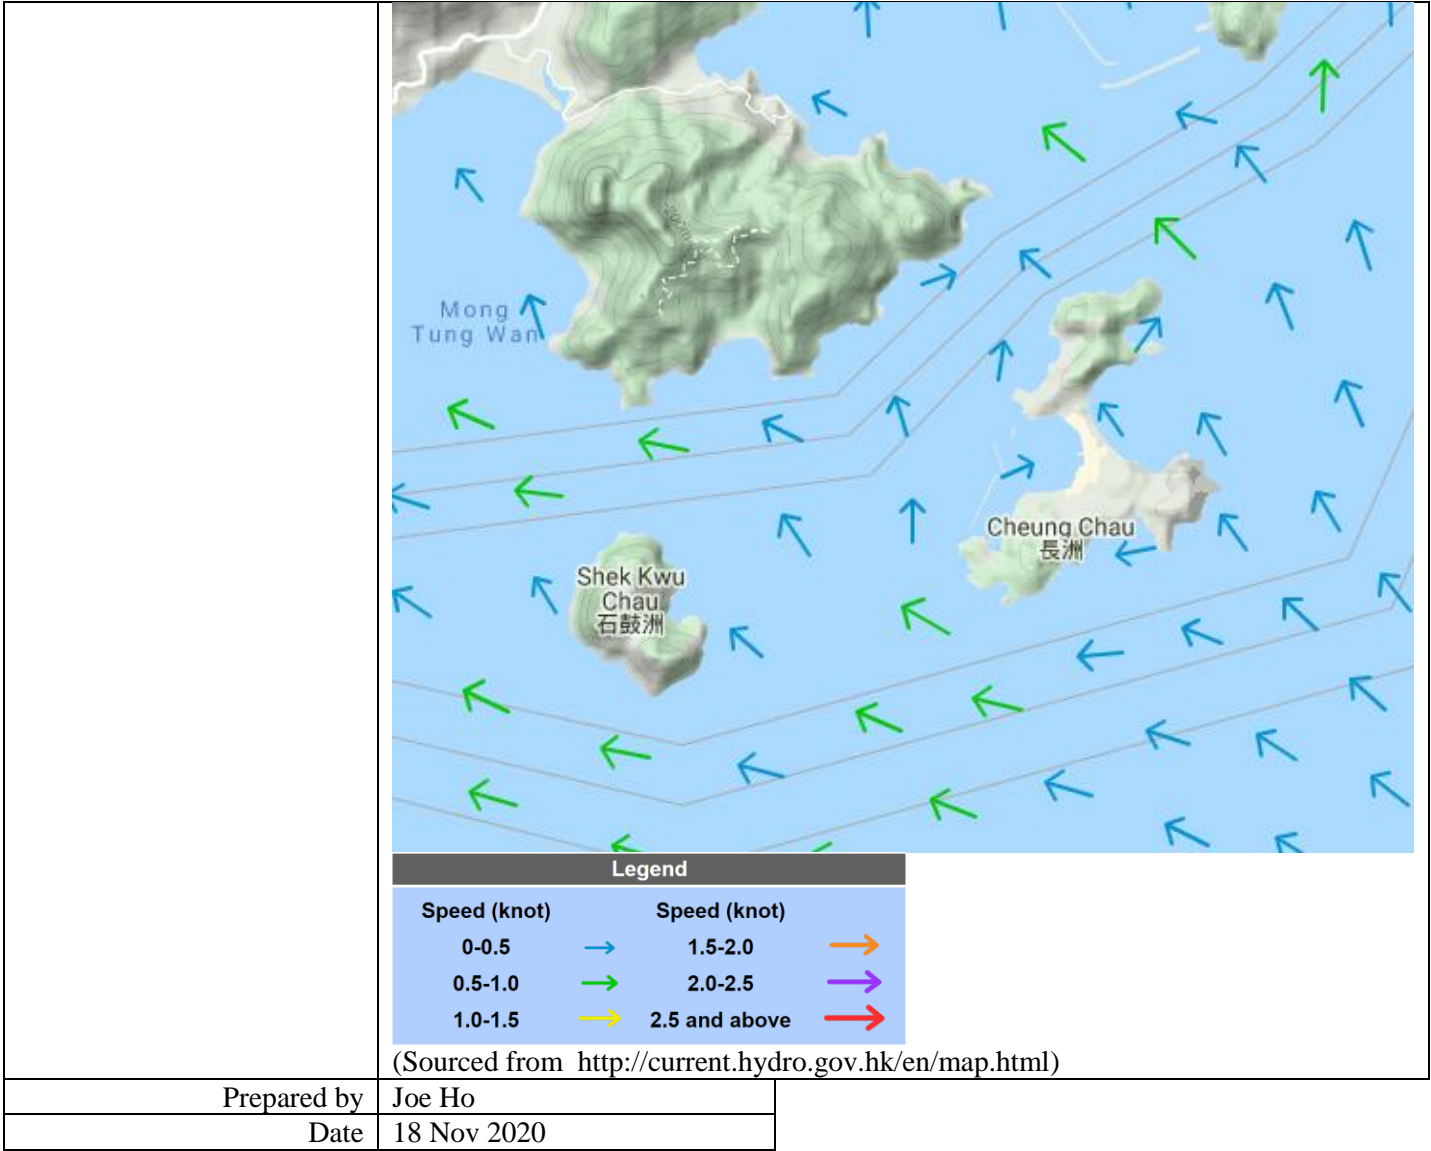
<p>installation.</p> <p>Dominating sea current direction was found to be from Southeast to Northwest at waters around Shek Kwu Chau.</p> <p>B1, B2 and B3 are located at unrelated stream direction (neither upstream nor downstream, far away) to the works location, exceedance of this monitoring station is deemed to be unrelated to the Project.</p> <p>Silt curtain checking by the Contractor was implemented on Marine Access (10 Nov 2020, 09:30am), Eastern Silt Curtain (10 Nov 2020, 09:30am), GD851 (10 Nov 2020, 07:00am) and checking results showed that no deficiency of silt curtain was found on that day.</p> <p>From MMO monitoring records on 10 Nov 2020, MMO team was arranged for one crane barge (GD-851), silt curtain at western marine access area and the eastern silt curtain on that day while no deficiency of silt curtain was found before the commencement of and during construction activity.</p> <p>According to the field observation by Marine Mammal Observer team & sampling team during sampling event, no silt plume was observed in the Project site.</p> <p>Site tidiness in the present barges in the Project site were checked during weekly site inspection on 10 Nov 2020. No major observation of improper site practices that could contribute to the increase of the suspended solids recorded.</p>

<p>Current direction during mid-flood sampling on 10 Nov 2020:</p>

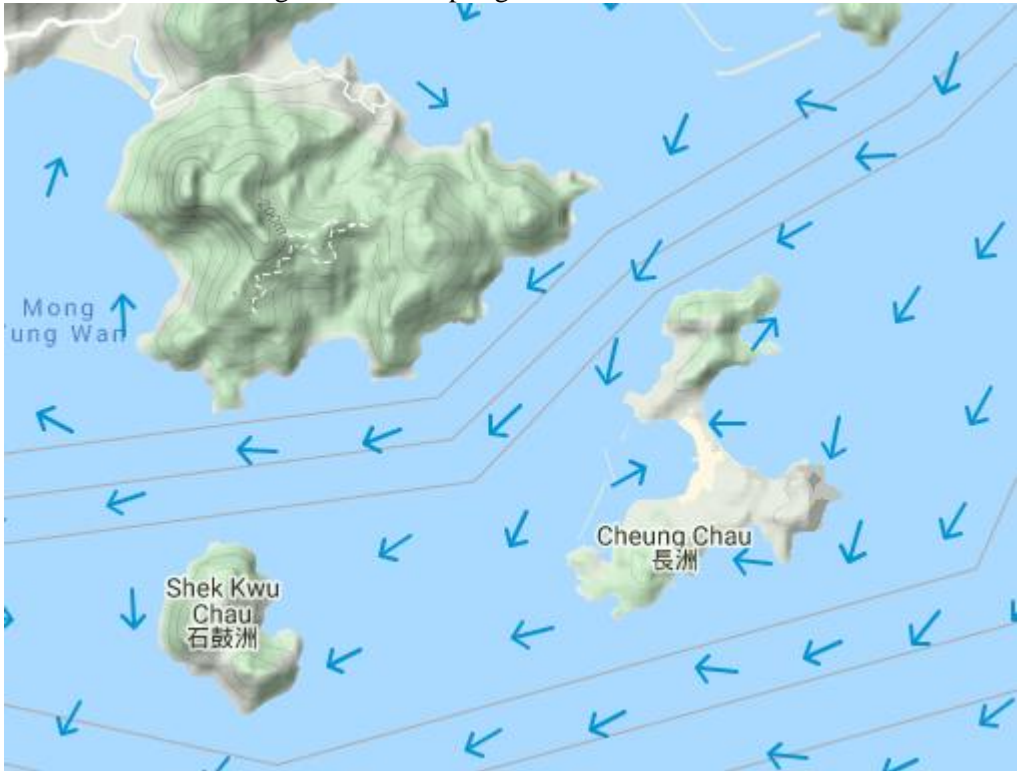
Actions taken / to be taken	Examination of environmental performance of the Project will be continued during the weekly inspection, and the Contractor is reminded to implement all applicable mitigation measures as per the Updated EM&A Manual.
Remarks	<p>Current direction during mid-ebb sampling on 14 Nov 2020:</p>

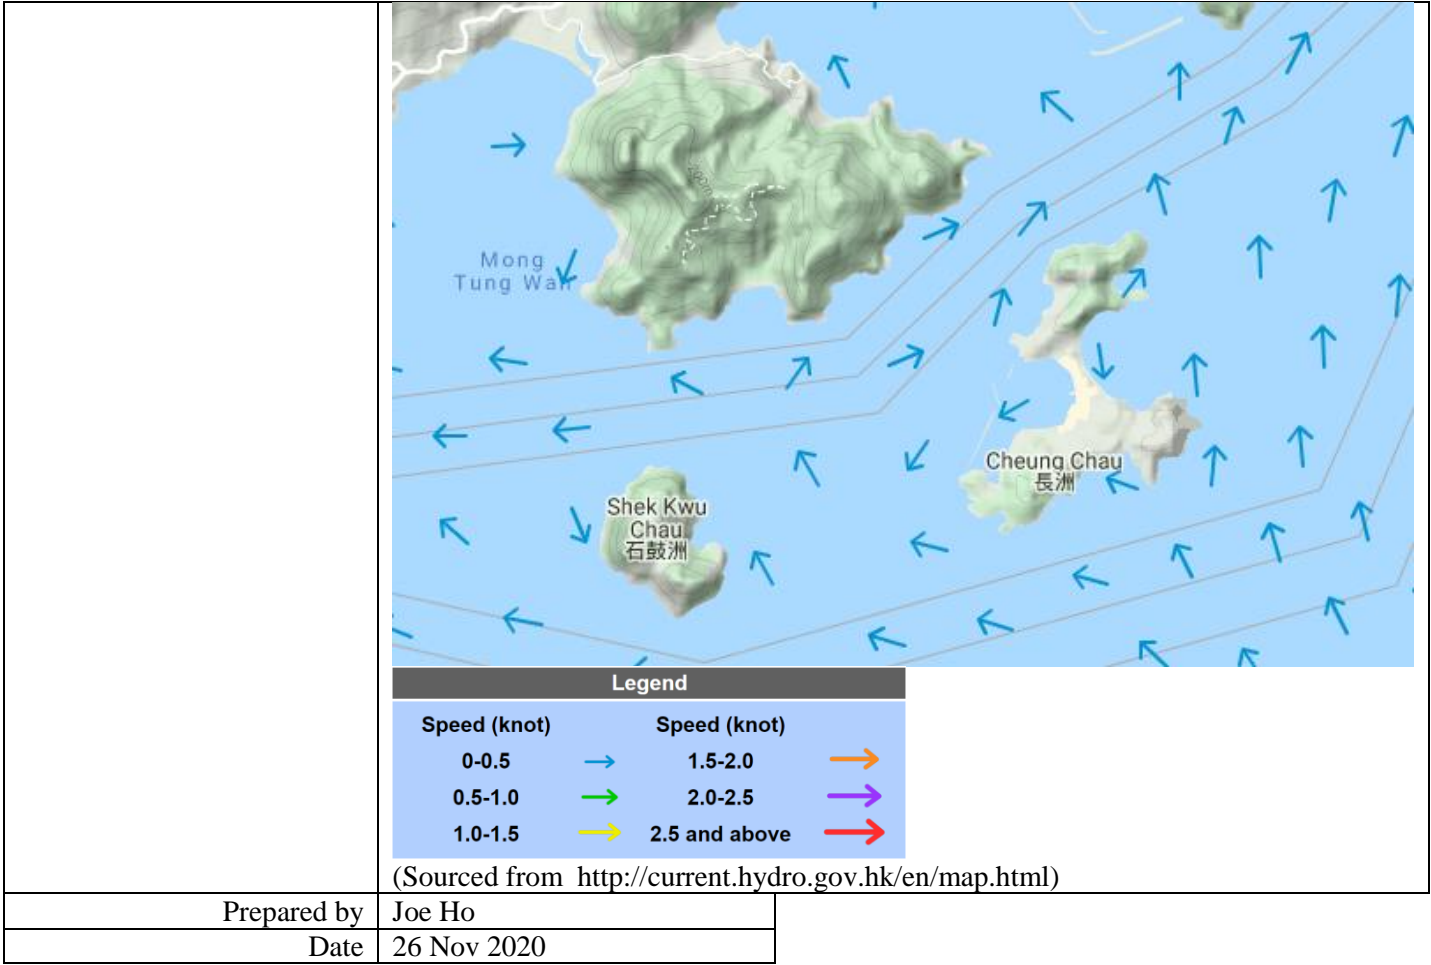
<p>Dominating sea current direction was found to be from Southeast to Northwest at waters around Shek Kwu Chau.</p> <p>S1 is located at unrelated stream direction (neither upstream nor downstream, far away) to the works location, exceedance of this monitoring station is deemed to be unrelated to the Project.</p> <p>S3 is located close to the works location within the Project site while silt curtain checking by the Contractor Silt curtain checking by the Contractor was implemented on Marine Access (14 Nov 2020, 06:00am), Eastern Silt Curtain (14 Nov 2020, 06:00am), GD851 (14 Nov 2020, 07:00am) and checking results showed that no deficiency of silt curtain was found on that day.</p> <p>From MMO monitoring records on 14 Nov 2020, MMO team was arranged for one crane barge (GD-851), silt curtain at western marine access area and the eastern silt curtain on that day while no deficiency of silt curtain was found before the commencement of and during construction activity.</p> <p>According to the field observation by Marine Mammal Observer team & sampling team during sampling event, no silt plume was observed in the Project site.</p> <p>Site tidiness in the present barges in the Project site were checked during weekly site inspection on 10 Nov 2020. No major observation of improper site practices that could contribute to the increase of the suspended solids recorded.</p>

<p>Current direction during mid-flood sampling on 14 Nov 2020:</p>

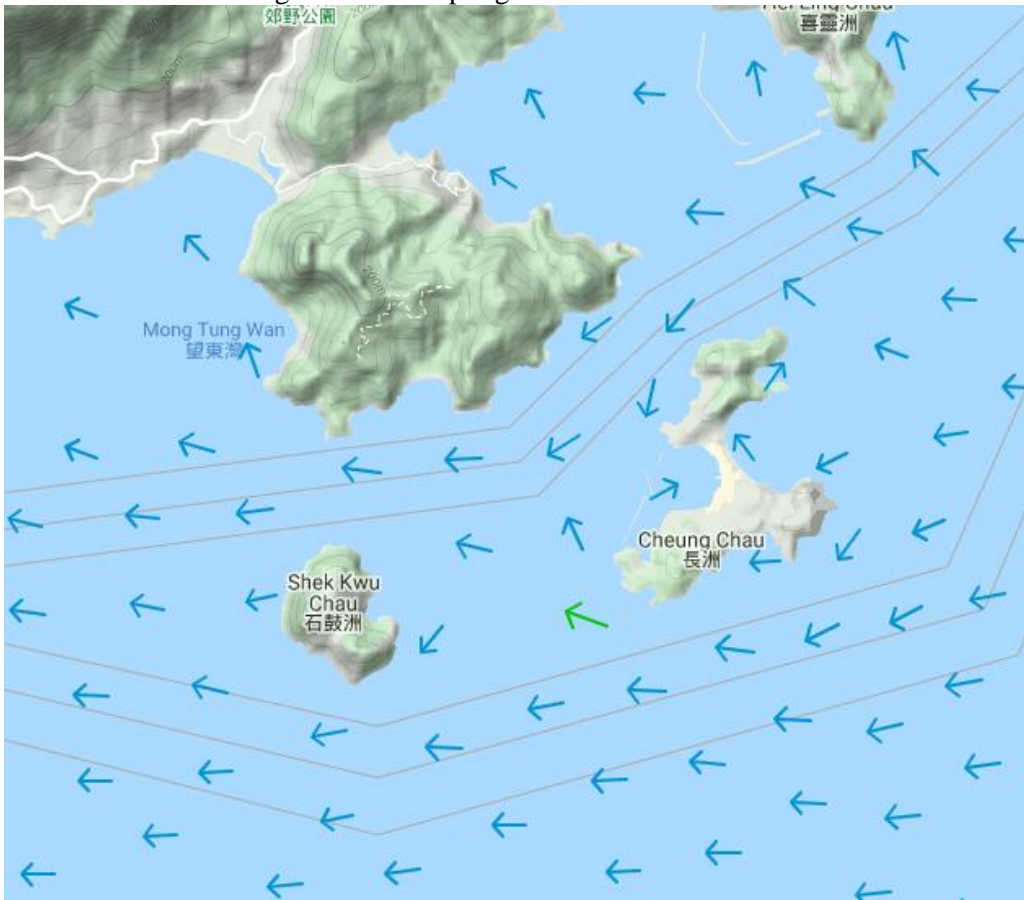
Actions taken / to be taken	<p>Examination of environmental performance of the Project will be continued during the weekly inspection, and the Contractor is reminded to implement all applicable mitigation measures as per the Updated EM&A Manual.</p>
Remarks	<p>Current direction during mid-ebb sampling on 16 Nov 2020:</p>

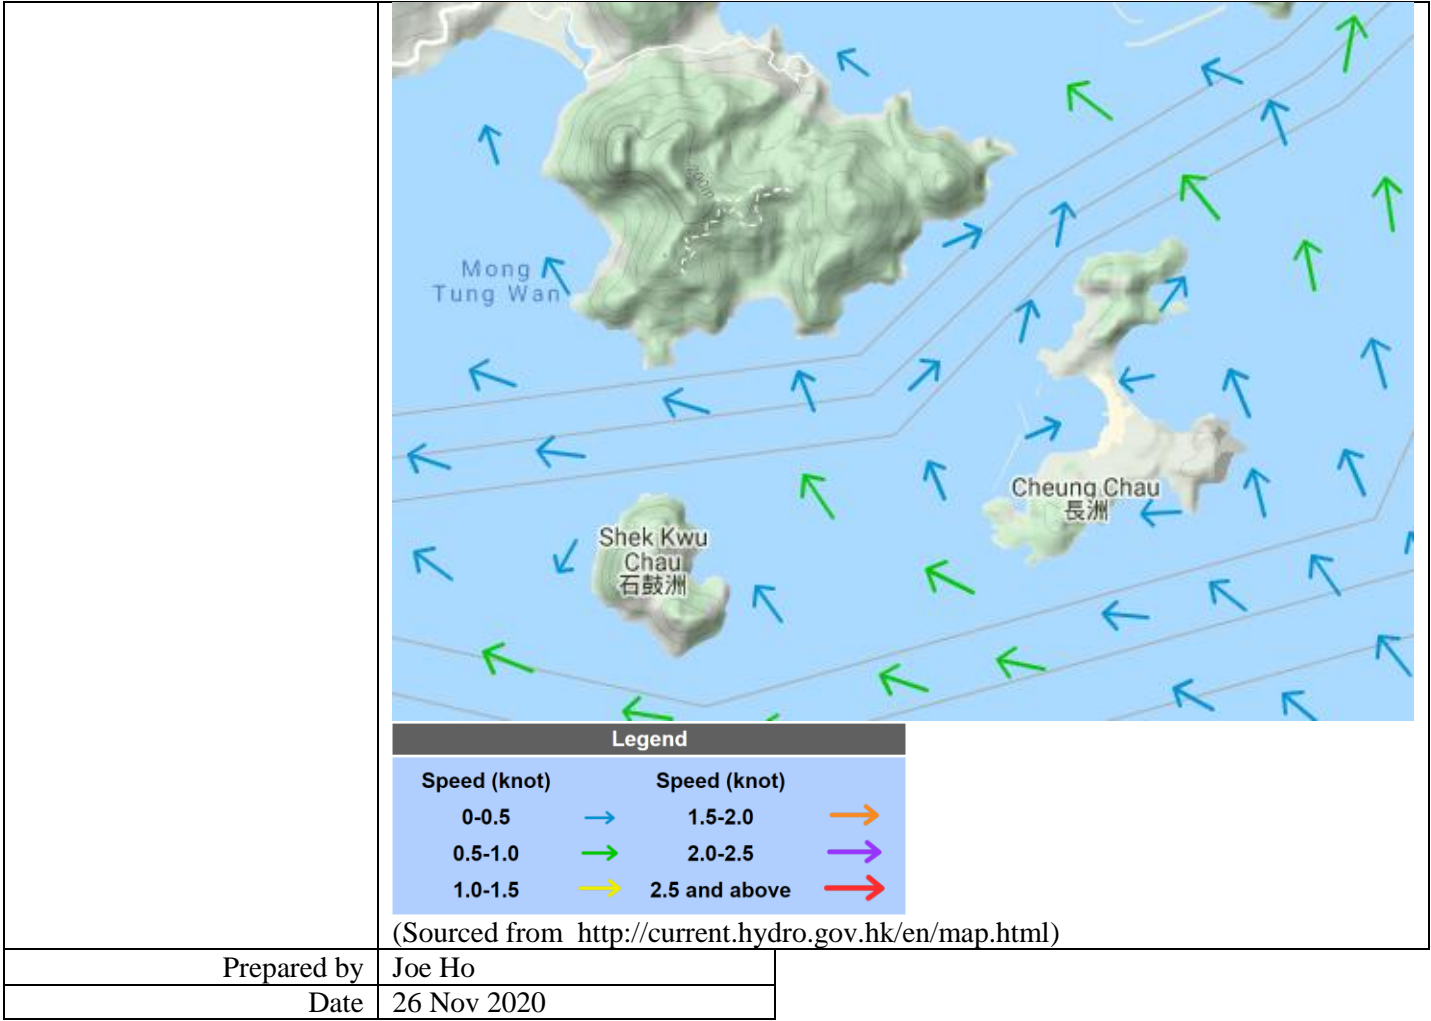
<p>unrelated to the Project.</p> <p>CR2 is located close to the works location within the Project site while silt curtain checking by the Contractor was implemented on Marine Access (16 Nov 2020, 01:00pm), Eastern Silt Curtain (16 Nov 2020, 01:00pm), GD851 (16 Nov 2020, 07:00am) and checking results showed that no deficiency of silt curtain was found on that day.</p> <p>From MMO monitoring records on 16 Nov 2020, MMO team was arranged for one crane barge (GD-851), silt curtain at western marine access area and the eastern silt curtain on that day while no deficiency of silt curtain was found before the commencement of and during construction activity.</p> <p>According to the field observation by Marine Mammal Observer team & sampling team during sampling event, no silt plume was observed in the Project site.</p> <p>Site tidiness in the present barges in the Project site were checked during weekly site inspection on 10 Nov 2020. No major observation of improper site practices that could contribute to the increase of the suspended solids recorded.</p>

<p>Current direction during mid-flood sampling on 16 Nov 2020:</p>

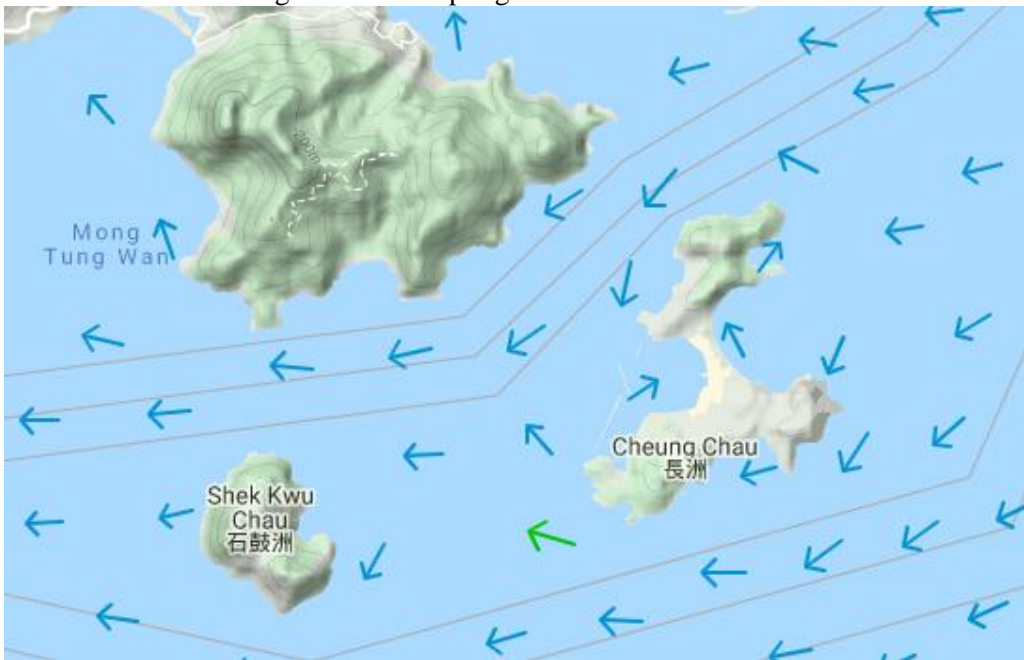
Actions taken / to be taken	Examination of environmental performance of the Project will be continued during the weekly inspection, and the Contractor is reminded to implement all applicable mitigation measures as per the Updated EM&A Manual.
Remarks	<p>Current direction during mid-ebb sampling on 18 Nov 2020:</p>

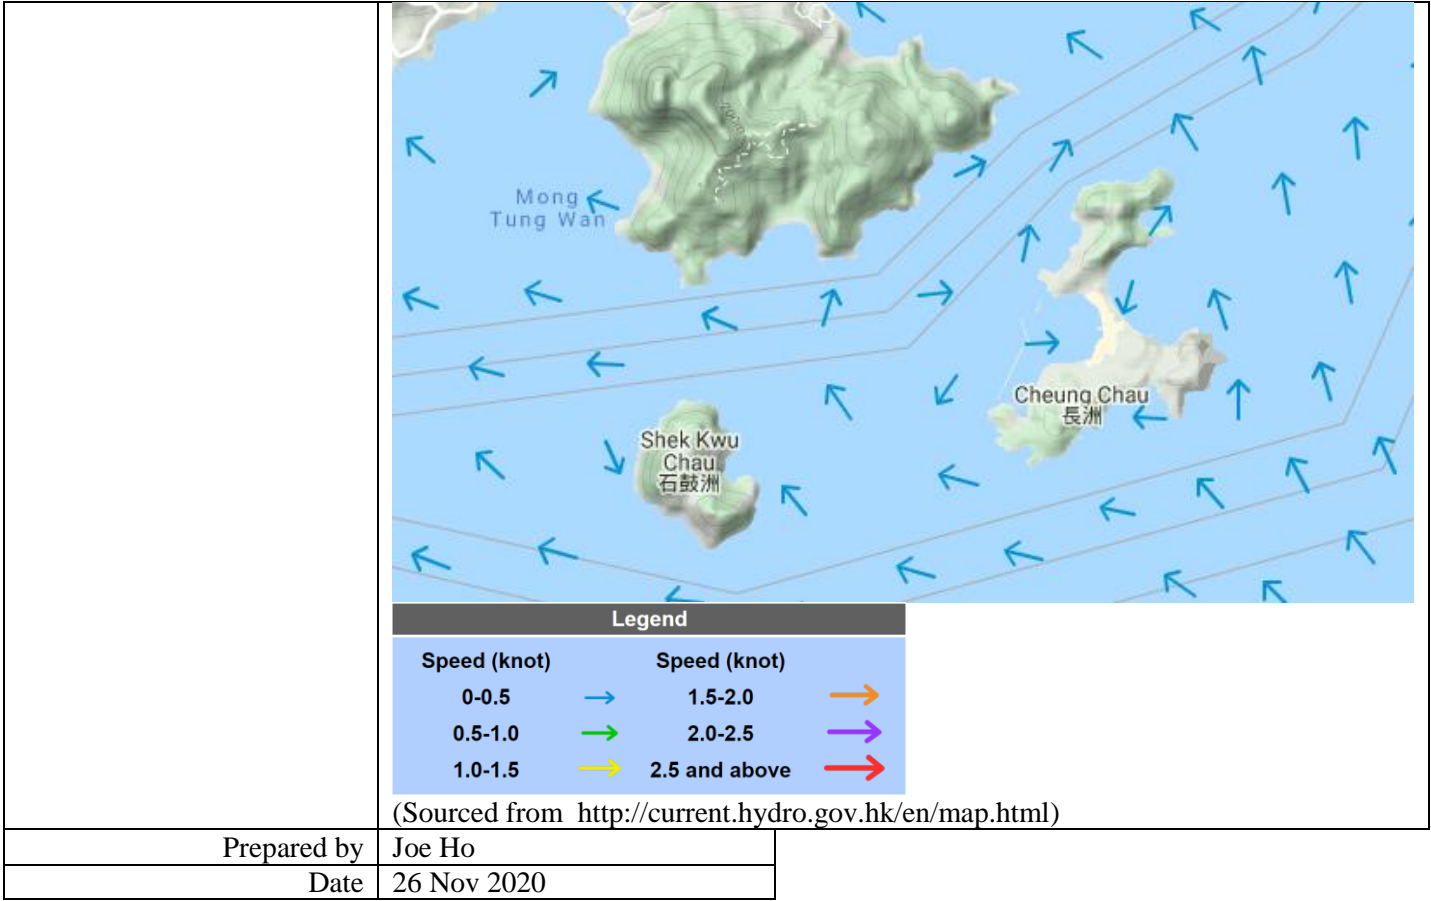
<p>01:00pm), Eastern Silt Curtain (18 Nov 2020, 01:00pm), GD851 (18 Nov 2020, 07:00am) and checking results showed that no deficiency of silt curtain was found on that day.</p> <p>From MMO monitoring records on 18 Nov 2020, MMO team was arranged for one crane barge (GD-851), silt curtain at western marine access area and the eastern silt curtain on that day while no deficiency of silt curtain was found before the commencement of and during construction activity.</p> <p>According to the field observation by Marine Mammal Observer team & sampling team during sampling event, no silt plume was observed in the Project site.</p> <p>Site tidiness in the present barges in the Project site were checked during weekly site inspection on 17 Nov 2020 while some soil was observed on the edge of vertical seawall and this observation had been rectified immediately by Contractor. However, according to the rationale in previous paragraphs, this observation might not contribute to the increase of the suspended solids recorded.</p>

<p>Current direction during mid-flood sampling on 18 Nov 2020:</p>
