## Appendix N Exceedance Report

**Incident Report on Action Level or Limit Level Non-compliance**

Project	Integrated Waste Management Facilities, Phase 1		
Date	1 August 2018 (Lab result received on 7 August 2018)		
Time	13:09 – 16:39 (Mid-Ebb)		
Monitoring Location	B4 and H1

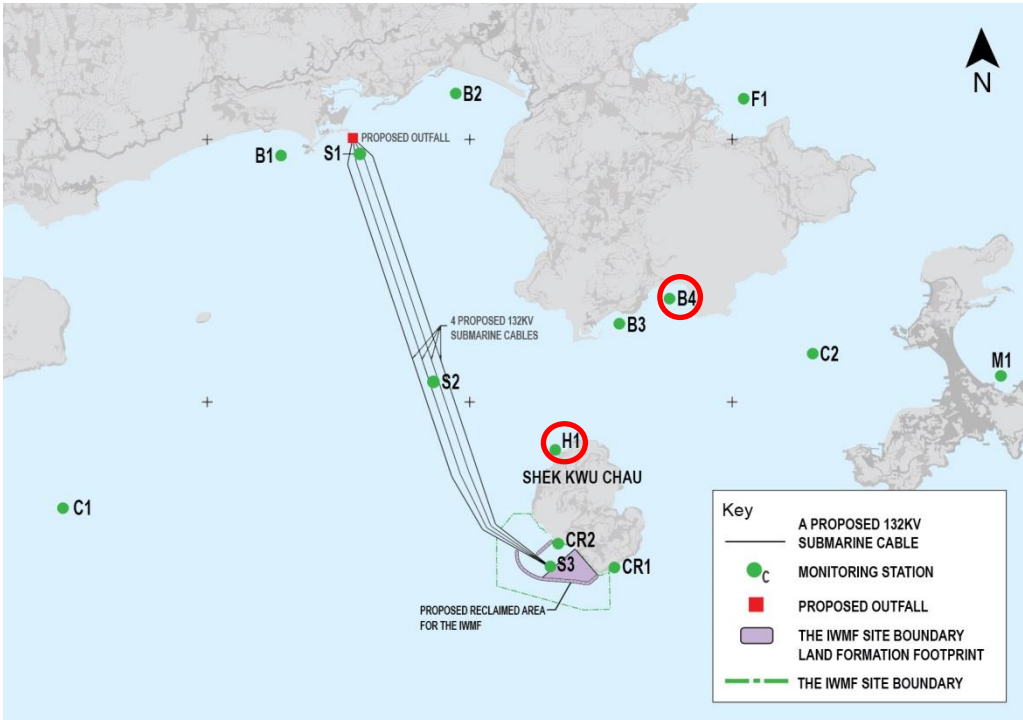
Parameter	Suspended Solid (SS)		
Action & Limit Levels	Action	Limit	
	≥ 8.6 mg/L (120% of C1)	≥ 9.4 mg/L (130% of C1)	
Measurement Level	Impact Station(s) with Exceedance	Control Stations	Impact Station(s) without Exceedance

10.3 mg/L (B4) 9.2 mg/L (H1)	7.2 mg/L (C1) 7.5 mg/L (C2)	8.5 mg/L (B1) 6.8 mg/L (B2) 8.3 mg/L (B3) 7.5 mg/L (CR1) 6.8 mg/L (CR2) 7.5 mg/L (F1) 6.7 mg/L (M1)
Possible reason for Action or Limit Level Non-compliance	<p>Works scheduled on site on 1/8 include ground investigation (GI) works of 3 small borehole drilling, static loading tests and laying works of geotextile, which shall not be a major source of SS concentration increase considering the limited scale and nature of works.</p> <p>Dominating sea current direction was found to be from Northwest to Southeast at waters around Shek Kwu Chau.</p> <p>B4 and H1 are located at unrelated stream direction (neither upstream nor downstream) to the works location, exceedance of this monitoring location is deemed to be unrelated to the Project at the sampling period.</p> <p>Site tidiness in the present barges in the Project site were checked during weekly site inspection on 2/8, where applicable mitigation measures on water quality were found implemented and no improper site practice that might contribute to the increase in SS level was observed during the inspection.</p>

<p>Actions taken / to be taken</p>	<p>Examination of environmental performance of the Project will be continued during the weekly inspection, and the Contractor is reminded to implement all applicable mitigation measures as per the Updated EM&amp;A Manual.</p>	
<p>Remarks</p>	<p>Current direction during mid-ebb sampling on 1/8:</p>

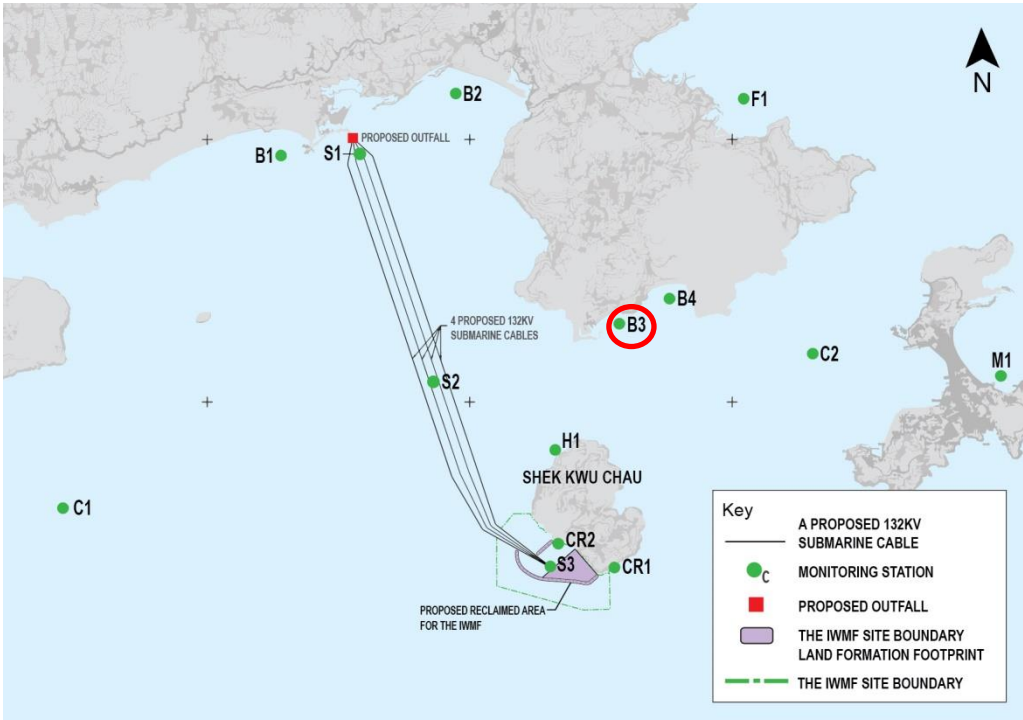
Parameter	Suspended Solid (SS)		
Action & Limit Levels	Action	Limit	
	≥ 8.6 mg/L (120% of C1)	≥ 9.3 mg/L (130% of C1)	
Measurement Level	Impact Station(s) with Exceedance	Control Stations	Impact Station(s) without Exceedance

8.8 mg/L (B3)	7.2 mg/L (C1) 8.5 mg/L (C2)	6.3 mg/L (B1) 8.0 mg/L (B2) 8.5 mg/L (B4) 6.2 mg/L (CR1) 6.3 mg/L (CR2) 6.0 mg/L (F1) 6.8 mg/L (H1) 8.0 mg/L (M1)
Possible reason for Action or Limit Level Non-compliance	<p>Works scheduled on site on 8/8 include ground investigation (GI) works of 3 small borehole drilling and laying works of sand blanket for static loading test. Borehole drilling shall not be a major source of SS concentration increase considering the limited scale and nature of works.</p> <p>Before laying works of sand blanket, contractor employed silt curtain at the surrounding static loading test positions. Records also showed that the contractor had sent a diver to monitor any leakage of sand material from sand blanket to prevent unacceptable SS generation.</p> <p>Dominating sea current direction was found to be from Northwest to Southeast at waters around Shek Kwu Chau.</p> <p>B3 is located at unrelated stream direction (neither upstream nor downstream, far away) to the works location, considering the distance and absence of exceedance in</p>

<p>monitoring stations in between B3 and the Project site, exceedance of this monitoring location is deemed to be unrelated to the Project and a localized event.</p> <p>Site tidiness in the present barges in the Project site were checked during weekly site inspection on 9/8, where applicable mitigation measures on water quality were found implemented and no improper site practice that might contribute to the increase in SS level was observed during the inspection.</p>																				
<p>Actions taken / to be taken</p>	<p>Examination of environmental performance of the Project will be continued during the weekly inspection, and the Contractor is reminded to implement all applicable mitigation measures as per the Updated EM&amp;A Manual.</p>																				
<p>Remarks</p>	<p>Current direction during mid-ebb sampling on 8/8:</p>

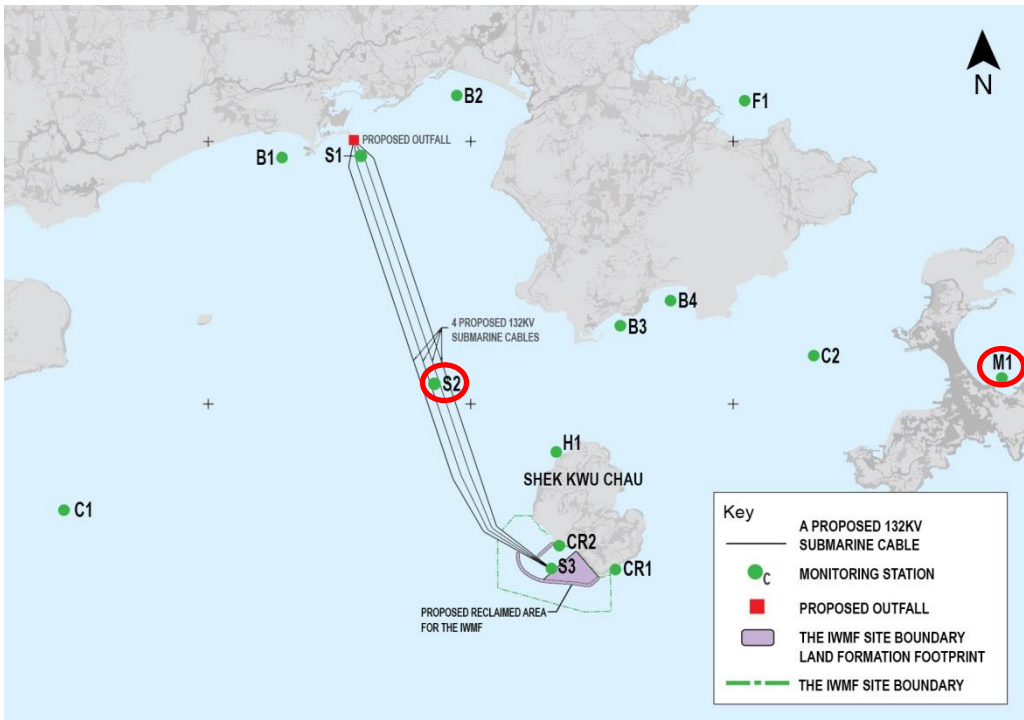
Parameter	Suspended Solid (SS)		
Action & Limit Levels	Action		Limit
	≥ 9.6 mg/L (120% of C2)		≥ 10.4 mg/L (130% of C2)
Measurement Level	Impact Station(s) with Exceedance	Control Stations	Impact Stations without Exceedance

11.3 mg/L (M1) 9.7 mg/L (S2)	9.8 mg/L (C1) 8.0 mg/L (C2)	9.3 mg/L (B1) 8.8 mg/L (B2) 8.5 mg/L (B3) 9.5 mg/L (B4) 8.3 mg/L (CR1) 8.7 mg/L (CR2) 8.0 mg/L (F1) 9.0 mg/L (H1) 9.0 mg/L (S1) 9.0 mg/L (S3)
Possible reason for Action or Limit Level Non-compliance	Works carried out on site on 15/8 include ground investigation (GI) works of 3 small borehole drilling, which shall not be a major source of SS concentration increase considering the limited scale and nature of works.  Dominating sea current direction was found to be from Southeast to Northwest at waters around Shek Kwu Chau.  M1 is located at unrelated stream direction (neither upstream nor downstream, far away) to the works location, exceedance of this monitoring location is deemed to be unrelated to the Project.

<p>CR2, which is the closer downstream monitoring station to S2, also exhibited a much lower SS level. This may also suggest that the present exceedance at S2 was not due to the Project.</p> <p>Site tidiness in the present barges in the Project site were checked during weekly site inspection on 14/8, where applicable mitigation measures on water quality were found implemented and no improper site practice that might contribute to the increase in SS level was observed during the inspection.</p>		
<p>Actions taken / to be taken</p>	<p>Examination of environmental performance of the Project will be continued during the weekly inspection, and the Contractor is reminded to implement all applicable mitigation measures as per the Updated EM&amp;A Manual.</p>		
<p>Mid-ebb</p>			
<p>Monitoring Location</p>	<p>F1, S1, S2 &amp; S3</p>

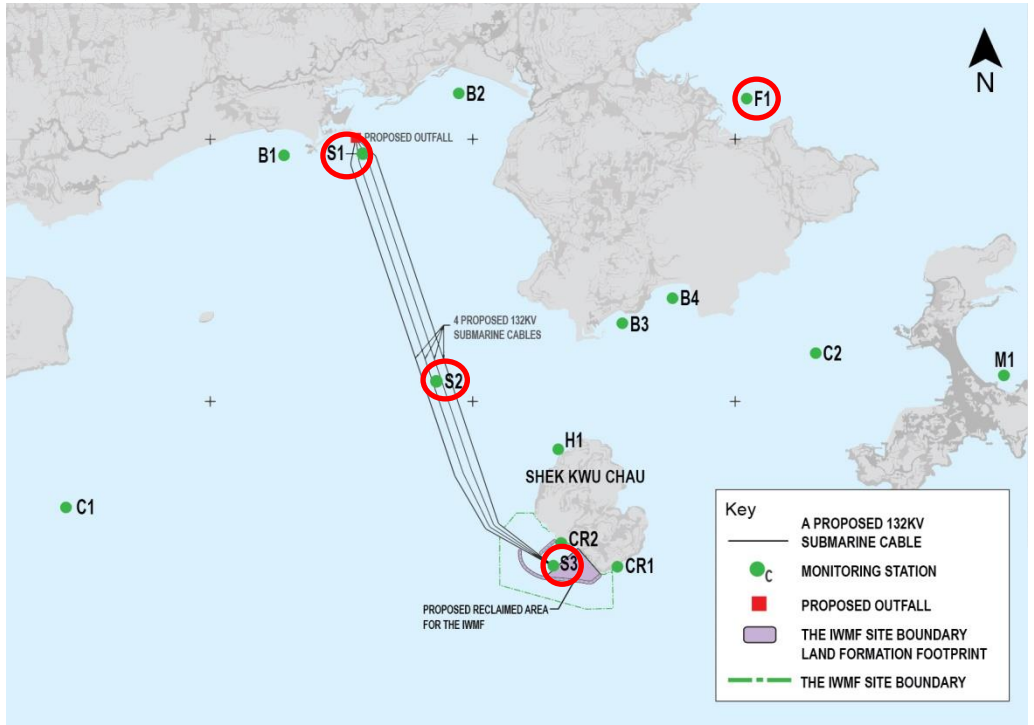
<p>Parameter</p>	<p>Suspended Solid (SS)</p>		
<p>Action &amp; Limit Levels</p>	<p>Action</p>	<p>Limit</p>	
	<p>≥ 10.2 mg/L (120% of C1)</p>	<p>≥ 11.0 mg/L (130% of C1)</p>	
<p>Measurement Level</p>	<p>Impact Station(s) with Exceedance</p>	<p>Control Stations</p>	<p>Impact Stations without Exceedance</p>
	<p>11.5 mg/L (F1)                  11.0 mg/L (S1)                  11.7 mg/L (S2)                  14.5 mg/L (S3)</p>	<p>8.5 mg/L (C1)                  10.6 mg/L (C2)</p>	<p>8.3 mg/L (B1)                  7.3 mg/L (B2)                  8.5 mg/L (B3)                  7.8 mg/L (B4)                  8.3 mg/L (CR1)                  8.2 mg/L (CR2)                  9.0 mg/L (H1)                  6.5 mg/L (M1)</p>
<p>Possible reason for Action or Limit Level Non-compliance</p>	<p>Works carried out on site on 15/8 include ground investigation (GI) works of 3 small borehole drilling, which shall not be a major source of SS concentration increase considering the limited scale and nature of works.</p> <p>Dominating sea current direction was found to be from Northwest to Southeast at waters around Shek Kwu Chau.</p> <p>S1 and F1 are located at unrelated stream direction (neither upstream nor downstream,</p>

<p>far away) and S2 is located at the upstream direction to the works location, exceedance of these monitoring locations are deemed to be unrelated to the Project.</p> <p>CR1 and CR2, which are also close monitoring station to the works location comparable to S3, also exhibited a much lower SS level. This may also suggest that the present exceedance at S3 was not due to the Project.</p> <p>Site tidiness in the present barges in the Project site were checked during weekly site inspection on 14/8, where applicable mitigation measures on water quality were found implemented and no improper site practice that might contribute to the increase in SS level was observed during the inspection.</p>
<p>Actions taken / to be taken</p>	<p>Examination of environmental performance of the Project will be continued during the weekly inspection, and the Contractor is reminded to implement all applicable mitigation measures as per the Updated EM&amp;A Manual.</p>

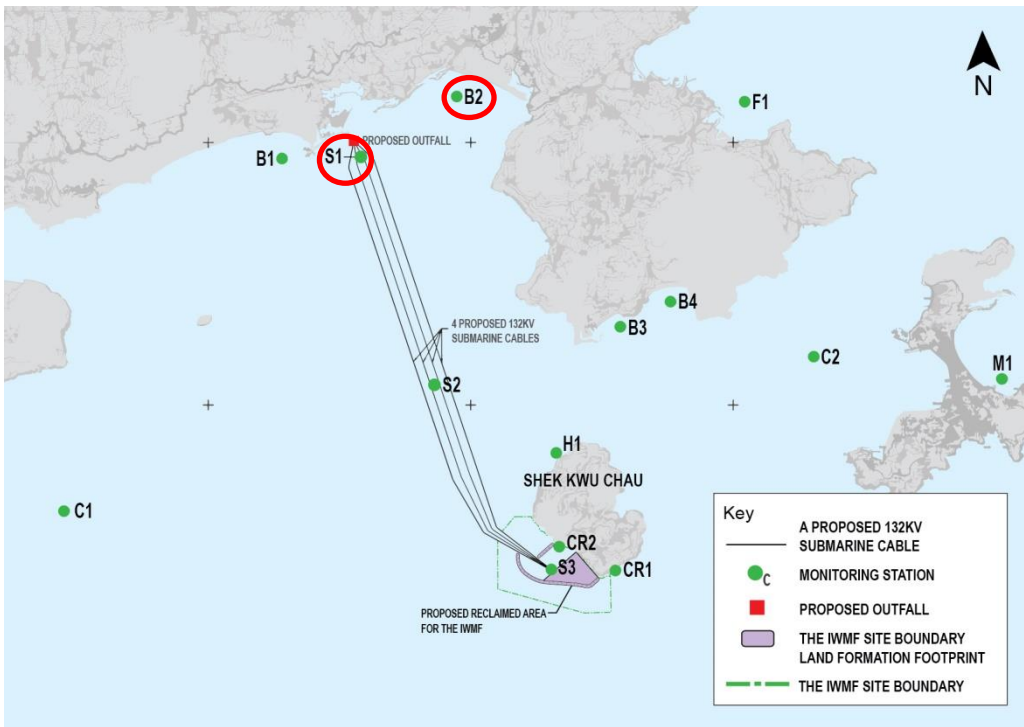
Parameter	Suspended Solid (SS)		
Action & Limit Levels	Action Level		Limit Level
	≥ 9.4 mg/L (120% of C2)		≥ 10.1 mg/L (130% of C2)
Measurement Level	Impact Station(s) with Exceedance	Control Stations	Impact Station(s) without Exceedance

10.5 mg/L (B2) 9.8 mg/L (S1)	7.7 mg/L (C1) 7.8 mg/L (C2)	8.8 mg/L (B1) 7.0 mg/L (B3) 6.5 mg/L (B4) 6.0 mg/L (F1) 8.2 mg/L (H1) 7.3 mg/L (M1) 5.8 mg/L (CR1) 8.2 mg/L (CR2) 7.8 mg/L (S2) 7.7 mg/L (S3)
Possible reason for Action or Limit Level Non-compliance	<p>Works scheduled on site on 24/8 include ground investigation (GI) works of 3 small borehole drilling and 2 sample coring, which shall not be a major source of SS concentration increase considering the limited scale and nature of works.</p> <p>Dominating sea current direction was found to be from Southeast to Northwest at waters around Shek Kwu Chau.</p> <p>B2 and S1 are located at unrelated stream direction (neither upstream nor downstream, far away) to the works location, considering the distance and absence of exceedance in monitoring stations in between B2, S1 and the Project site, exceedance of this monitoring location is deemed to be unrelated to the Project.</p>

<p>Site tidiness in the present barges in the Project site were checked during weekly site inspection on 21/8, where applicable mitigation measures on water quality were found implemented and no improper site practice that might contribute to the increase in SS level was observed during the inspection.</p>		
Actions taken / to be taken	<p>Examination of environmental performance of the Project will be continued during the weekly inspection, and the Contractor is reminded to implement all applicable mitigation measures as per the Updated EM&amp;A Manual.</p>		
Mid-Ebb			
Monitoring Location	<p>B2 &amp; B3</p> <p>The map shows the Shek Kwu Chau area with various monitoring stations (B1, B2, B3, B4, C1, C2, C3, F1, H1, M1, S1, S2, S3, CR1, CR2, CR3) and proposed infrastructure (outfall, cables, reclaimed area). Stations B2 and B3 are circled in red. A key identifies symbols for cables, monitoring stations, outfall, IWMF site boundary, and footprint.</p>

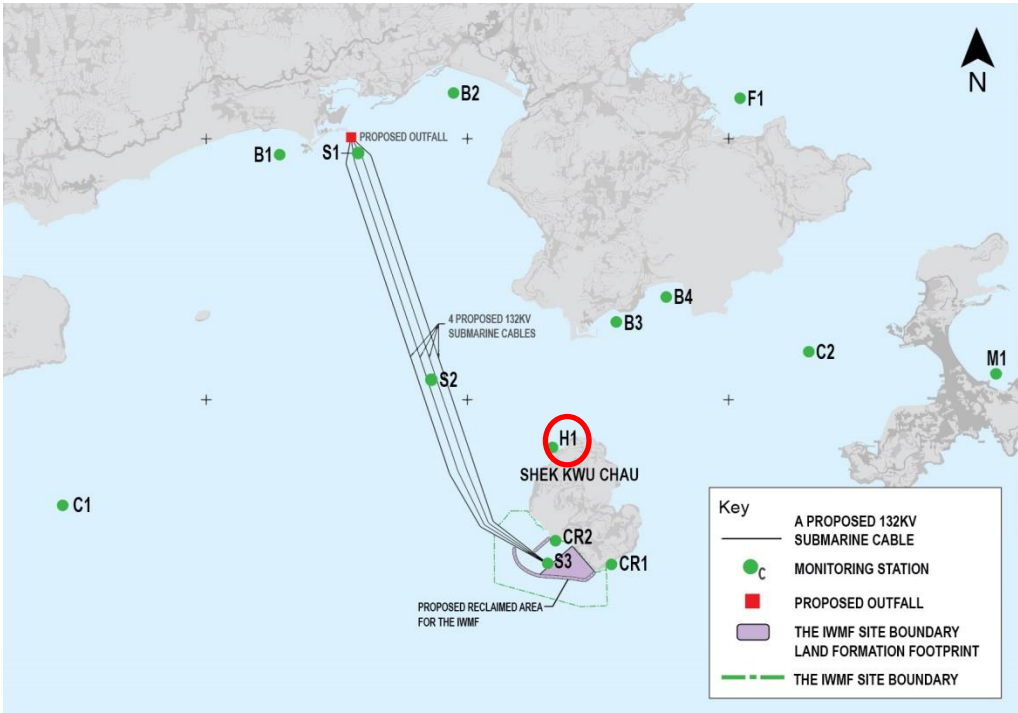
Parameter	Suspended Solid (SS)		
Action & Limit Levels	Action Level	Limit Level	
	≥ 8.6 mg/L (120% of C1)	≥ 10.0 mg/L	
Measurement Level	Impact Station(s) with Exceedance	Control Stations	Impact Station(s) without Exceedance

10.0 mg/L (H1)	7.2 mg/L (C1) 4.8 mg/L (C2)	5.5 mg/L (B1) 4.5 mg/L (B2) 3.5 mg/L (B3) 4.5 mg/L (B4) 4.2 mg/L (F1) 5.8 mg/L (M1) 8.0 mg/L (CR1) 5.7 mg/L (CR2) 4.8 mg/L (S1) 7.3 mg/L (S2) 8.3 mg/L (S3)
Possible reason for Action or Limit Level Non-compliance	<p>Works scheduled on site on 27/8 include ground investigation (GI) works of 3 small borehole drilling and 2 sample coring, which shall not be a major source of SS concentration increase considering the limited scale and nature of works.</p> <p>Dominating sea current direction was found to be from Northwest to Southeast at waters around Shek Kwu Chau.</p> <p>H1 is located at upstream to the works location, considering the absence of exceedance in closer downstream monitoring stations near the Project site, exceedance of this monitoring location is deemed to be unrelated to the Project.</p> <p>Site tidiness in the present barges in the Project site were checked during weekly site</p>

inspection on 28/8, where applicable mitigation measures on water quality were found implemented and no improper site practice that might contribute to the increase in SS level was observed during the inspection.
Actions taken / to be taken	Examination of environmental performance of the Project will be continued during the weekly inspection, and the Contractor is reminded to implement all applicable mitigation measures as per the Updated EM&A Manual.
Remarks	<p>Current direction during mid-ebb sampling on 27/8:</p>
