Appendix N Exceedance Report

Incident Report on Action Level or Limit Level Non-compliance

Project	Integrated Waste Management Facilities, Phase 1		
Date	3 September 2018 (Lab result received on 7 September 2018)		
Time	03:25 - 07:55 (Mid-Ebb)		
Monitoring Location	B2 & H1

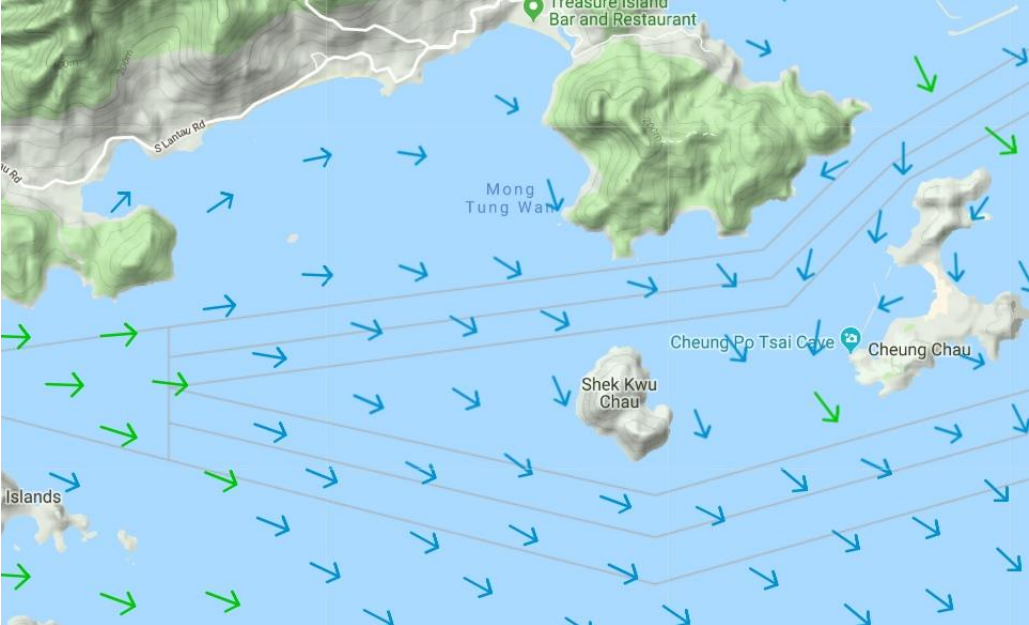
8.5 mg/L (B2) 9.0 mg/L (H1)	6.1 mg/L (C1) 7.3 mg/L (C2)	3.5 mg/L (B1) 4.8 mg/L (B3) 5.0 mg/L (B4) 6.3 mg/L (F1) 4.7 mg/L (M1) 5.7 mg/L (CR1) 7.3 mg/L (CR2) 5.3 mg/L (S1) 5.2 mg/L (S2) 4.3 mg/L (S3)
Possible reason for Action or Limit Level Non-compliance	<p>Works scheduled on site on 3/9 include ground investigation (GI) works of 3 small borehole drilling and 2 sample coring, which shall not be a major source of SS concentration increase considering the limited scale and nature of works.</p> <p>Dominating sea current direction was found to be from Northwest to Southeast at waters around Shek Kwu Chau.</p> <p>B2 is located at unrelated stream direction (neither upstream nor downstream, far away) and H1 is located at upstream direction to the works location, exceedance of this monitoring location is deemed to be unrelated to the Project at the sampling period.</p> <p>Site tidiness in the present barges in the Project site were checked during weekly site</p>

inspection on 4/9, where applicable mitigation measures on water quality were found implemented and no improper site practice that might contribute to the increase in SS level was observed during the inspection.								
Actions taken / to be taken	Examination of environmental performance of the Project will be continued during the weekly inspection, and the Contractor is reminded to implement all applicable mitigation measures as per the Updated EM&A Manual.								
Remarks	<p>Current direction during mid-ebb sampling on 3/9:</p>

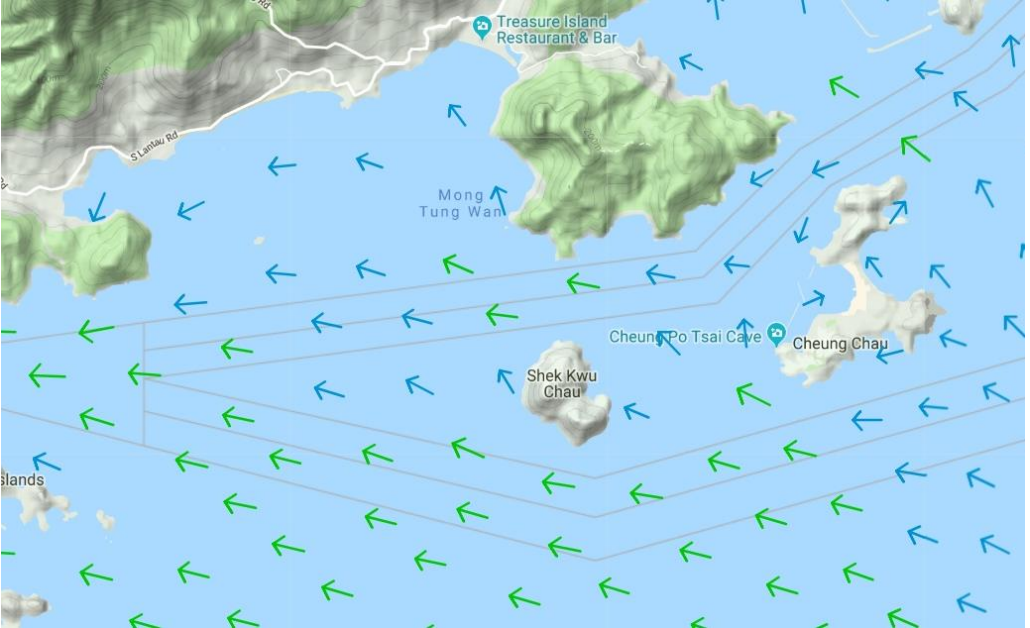
8.2 mg/L (M1)	4.3 mg/L (C1) 2.8 mg/L (C2)	4.8 mg/L (B1) 4.5 mg/L (B2) 4.5 mg/L (B3) 5.3 mg/L (B4) 3.5 mg/L (F1) 4.7 mg/L (H1) 5.7 mg/L (CR1) 5.5 mg/L (CR2)
Possible reason for Action or Limit Level Non-compliance	<p>All works scheduled on site on 14/9 were suspended due to the upcoming typhoon MANGKHUT.</p> <p>Dominating sea current direction was found to be from Southeast to Northwest at waters around Shek Kwu Chau.</p> <p>M1 is located at unrelated stream direction (neither upstream nor downstream, far away) and exceedance of this monitoring location is deemed to be unrelated to the Project at the sampling period.</p> <p>Site tidiness in the present barges in the Project site were checked during weekly site inspection on 11/9, where applicable mitigation measures on water quality were found implemented and no improper site practice that might contribute to the increase in SS level was observed during the inspection.</p>

weekly inspection, and the Contractor is reminded to implement all applicable mitigation measures as per the Updated EM&A Manual.																					
Remarks	<p>Current direction during mid-flood sampling on 14/9:</p>

Actions taken / to be taken	Examination of environmental performance of the Project will be continued during the

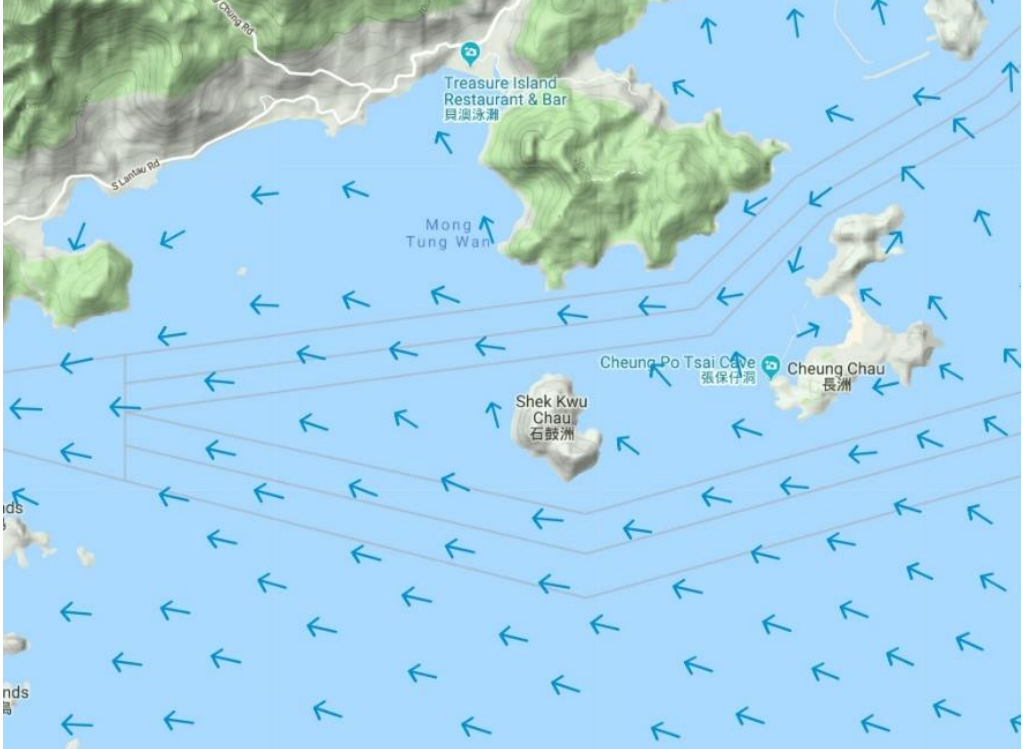
14.0 mg/L (CR1)	10.5 mg/L (C1) 11.5 mg/L (C2)	11.0 mg/L (B1) 9.8 mg/L (B2) 8.0 mg/L (B3) 12.0 mg/L (B4) 9.7 mg/L (F1) 10.8 mg/L (H1) 9.7 mg/L (M1) 7.5 mg/L (CR2)
Possible reason for Action or Limit Level Non-compliance	<p>All works scheduled on site on 18/9 were suspended due to the yet to recover progress from typhoon MANGKHUT.</p> <p>Dominating sea current direction was found to be from Southeast to Northwest at waters around Shek Kwu Chau.</p> <p>CR2 and S3, the closer downstream monitoring stations to CR1 (upstream monitoring station), exhibited a much lower SS level. The above and absent of works suggest that the exceedance at CR1 should be unrelated to the Project.</p> <p>Site tidiness in the present barges in the Project site were checked during weekly site inspection on 11/9, where applicable mitigation measures on water quality were found implemented and no improper site practice that might contribute to the increase in SS level was observed during the inspection.</p>

Remarks Current direction during mid-flood sampling on 18/9:

Actions taken / to be taken	Examination of environmental performance of the Project will be continued during the

weekly inspection, and the Contractor is reminded to implement all applicable mitigation measures as per the Updated EM&A Manual.

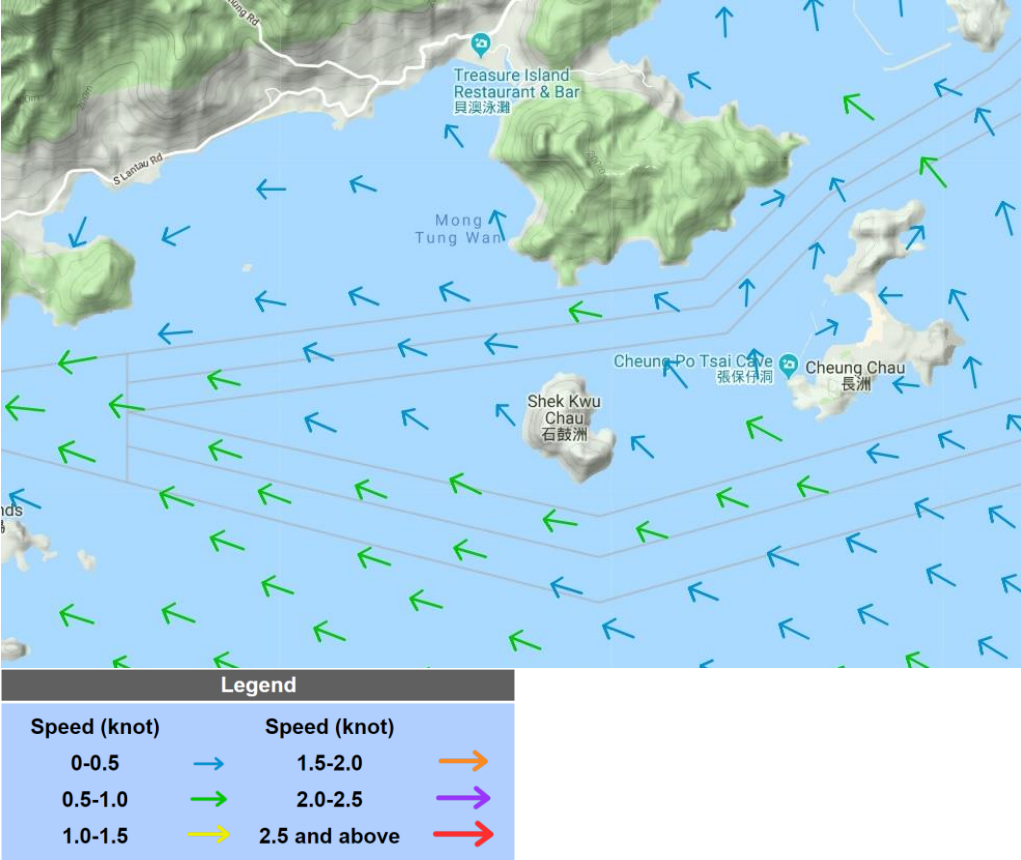
11.5 mg/L (H1)	8.8 mg/L (C1) 9.3 mg/L (C2)	8.8 mg/L (B1) 8.8 mg/L (B2) 9.0 mg/L (B3) 8.8 mg/L (B4) 8.8 mg/L (F1) 8.3 mg/L (M1) 7.8 mg/L (CR1) 10.2 mg/L (CR2)
Possible reason for Action or Limit Level Non-compliance	<p>Works scheduled on site on 24/9 include ground investigation (GI) works of 3 small borehole drilling, which shall not be a major source of SS concentration increase considering the limited scale and nature of works.</p> <p>Dominating sea current direction was found to be from Southeast to Northwest at waters around Shek Kwu Chau.</p> <p>CR2, the closest downstream monitoring stations to H1, exhibited a lower SS level. It may suggest that the exceedance at H1 should be unrelated to the Project.</p> <p>Site tidiness in the present barges in the Project site were checked during weekly site inspection on 26/9, where applicable mitigation measures on water quality were found implemented and no improper site practice that might contribute to the increase in SS level was observed during the inspection.</p>

weekly inspection, and the Contractor is reminded to implement all applicable mitigation measures as per the Updated EM&A Manual.	
Remarks	Current direction during mid-flood sampling on 24/9:

Actions taken / to be taken	Examination of environmental performance of the Project will be continued during the
