## Appendix N Exceedance Report

**Incident Report on Action Level or Limit Level Non-compliance**

Project	Integrated Waste Management Facilities, Phase 1		
Date	01 Oct 2021 (Lab result received on 8 Oct 2021)		
Time	14:40-18:10 (Mid Flood)		
Mid-Flood			
Monitoring Location	<p>B3</p>		
Parameter	Suspended Solid (SS)		
Action & Limit Levels	Action Level		Limit Level
	≥ 14.0 mg/L (120% of C2A)		≥ 15.2 mg/L (130% of C2A)
Measurement Level	Impact Station(s) of Exceedance	Control Stations	Impact Station(s) without Exceedance

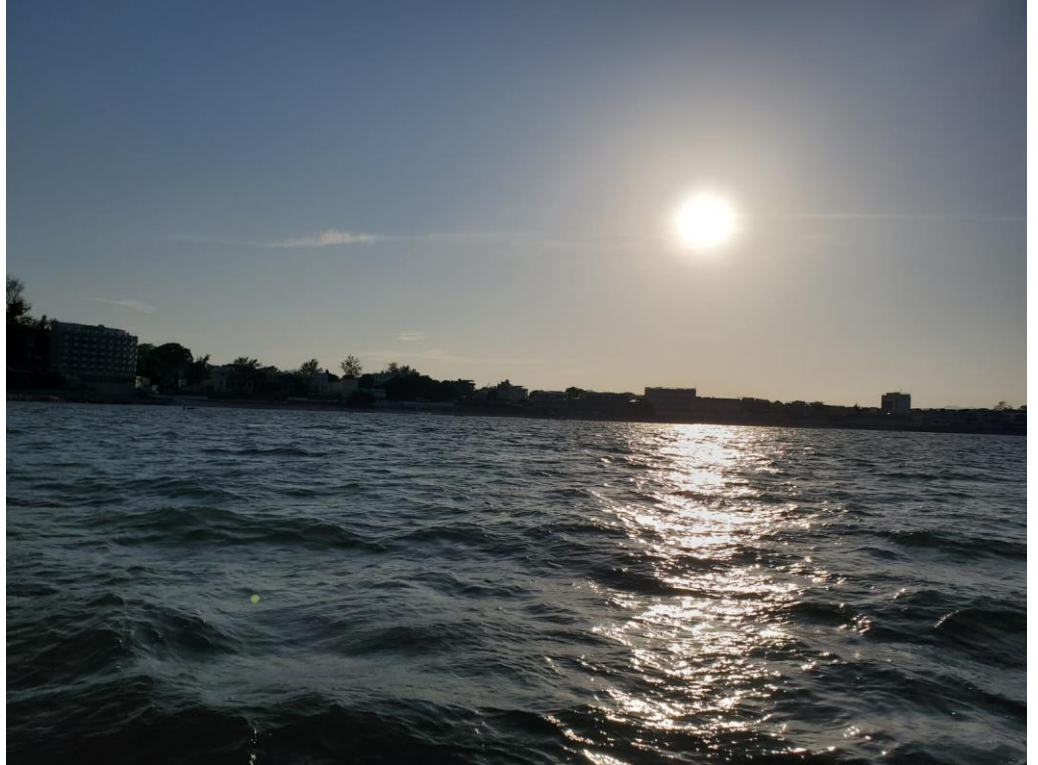
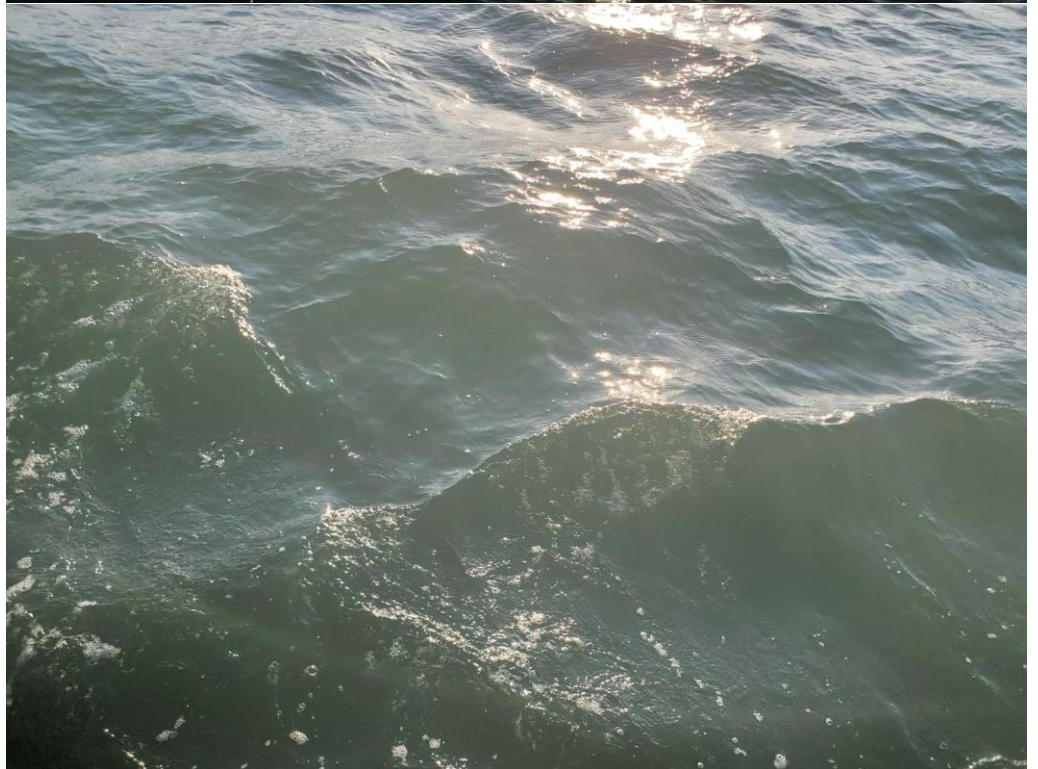
M1:

Impact Station(s) of Exceedance	Control Stations	Impact Station(s) without Exceedance					
8.0 mg/L (H1) 10.5 mg/L (M1) 12.2 mg/L (CR1) 8.8 mg/L (CR2)	5.5 mg/L (C1A) 4.2 mg/L (C2A)	6.3 mg/L (B1) 5.1 mg/L (B2) 7.5 mg/L (B3) 5.3 mg/L (B4) 7.8 mg/L (F1A)					
Possible reason for Action or Limit Level Non-compliance	<p>Works scheduled on site on 04 Oct 2021 include installation of caisson stoppers, landfilling works, installation of instrumentation, piling pre-drilling works, piling works and existing caisson extension.</p> <p>Dominating sea current direction was found to be from Southeast to Northwest at waters around Shek Kwu Chau.</p> <p>Exceedances of SS action level were found at H1 and CR2 on 04 Oct 2021 and exceedances of SS limit level were found at M1 and CR1 on 04 Oct 2021.</p> <p>H1 and M1 are located at unrelated stream direction (neither upstream nor downstream, far away) to the works location, exceedances of these monitoring stations are deemed to be unrelated to the Project.</p> <p>CR1 and CR2 are located close to the works location within the Project site while no marine work was conducted on 04 Oct 2021.</p> <p>The installation of caisson No.19 was completed on 18 Mar 2021, the reclamation area was enclosed.</p> <p>According to the field observation by sampling team during sampling event, no silt</p>

<p>plume was observed in the Project site and the weather was fine during the sampling event.</p> <p>No major observation of improper site practices that could contribute to the increase of the suspended solids was recorded during the weekly inspection on 28 September 2021.</p> <p>After the investigation, the exceedances on 04 Oct 2021 at H1, M1, CR1 and CR2 are deemed to be unrelated to the Project.</p>
Monitoring photos of stations with exceedance	<p>H1:</p>

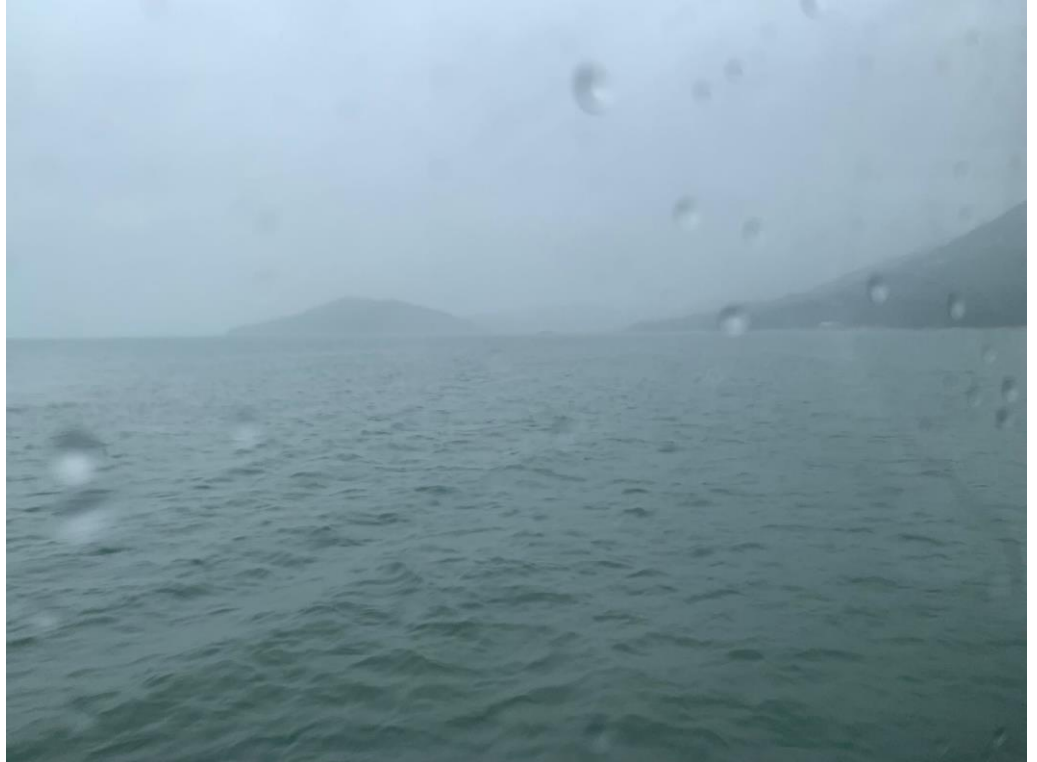
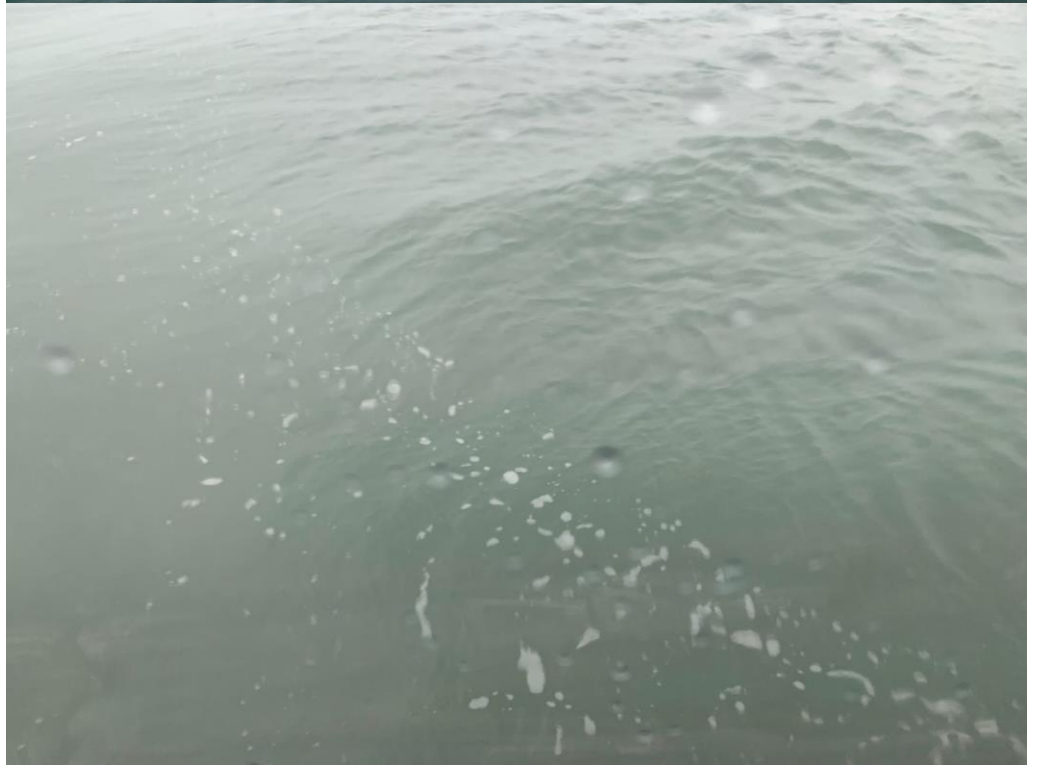
B2:

<p>Parameter</p>	<p>Suspended Solid (SS)</p>		
<p>Action &amp; Limit Levels</p>	<p>Action Level  <math>\geq 8.0</math> mg/L</p>		<p>Limit Level  <math>\geq 10.0</math> mg/L</p>
<p>Measurement Level</p>	<p>Impact Station(s) of Exceedance</p> <p>11.0 mg/L (B1)              13.5 mg/L (B2)              10.5 mg/L (B3)              15.3 mg/L (B4)              9.8 mg/L (F1A)              12.8 mg/L (H1)</p>	<p>Control Stations</p> <p>7.3 mg/L (C1A)              6.5 mg/L (C2A)</p>	<p>Impact Station(s) without Exceedance</p> <p>7.0 mg/L (M1)              6.2 mg/L (CR1)              7.5 mg/L (CR2)</p>
<p>Possible reason for Action or Limit Level Non-compliance</p>	<p>Works scheduled on site on 15 Oct 2021 include installation of blockwork marine access facility, landfilling works, installation of instrumentation, piling pre-drilling works, pilling works, piling works for driven pile, piling works for pre-bored socketed H-pile and existing caisson extension.</p> <p>Dominating sea current direction was found to be from Southeast to Northwest at waters around Shek Kwu Chau.</p> <p>Exceedance of SS action level was found at F1A on 15 Oct 2021 and exceedances of SS limit level were found at B1, B2, B3, B4 and H1 on 15 Oct 2021</p> <p>B1, B2, B3, B4, F1A and H1 are located at unrelated stream direction (neither upstream nor downstream, far away) to the works location, exceedances of these monitoring stations are deemed to be unrelated to the Project.</p> <p>The installation of caisson No.19 was completed on 18 Mar 2021, the reclamation area was enclosed.</p> <p>According to the field observation by sampling team during sampling event, no silt plume was observed in the Project site and the weather was cloudy and rainy during</p>

<p>the sampling event.</p> <p>After the investigation, the exceedances on 15 Oct 2021 at B1, B2, B3, B4, F1A and H1 are deemed to be unrelated to the Project.</p>
<p>Monitoring photos of stations with exceedance</p>	<p>B1:</p>

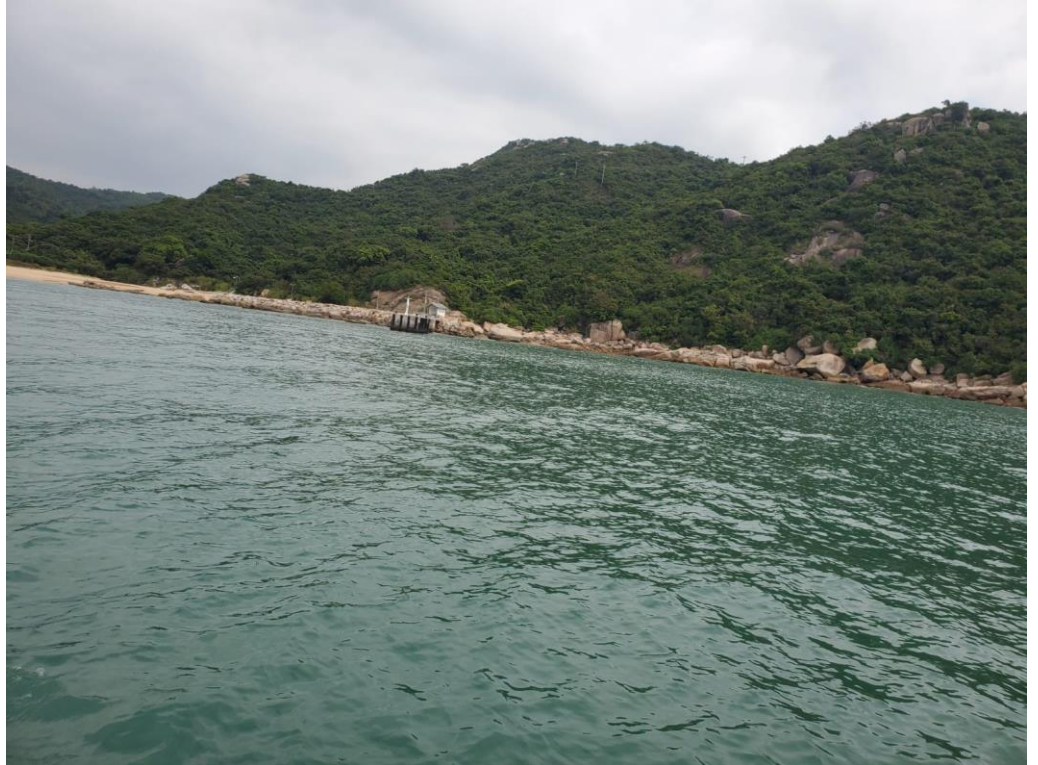
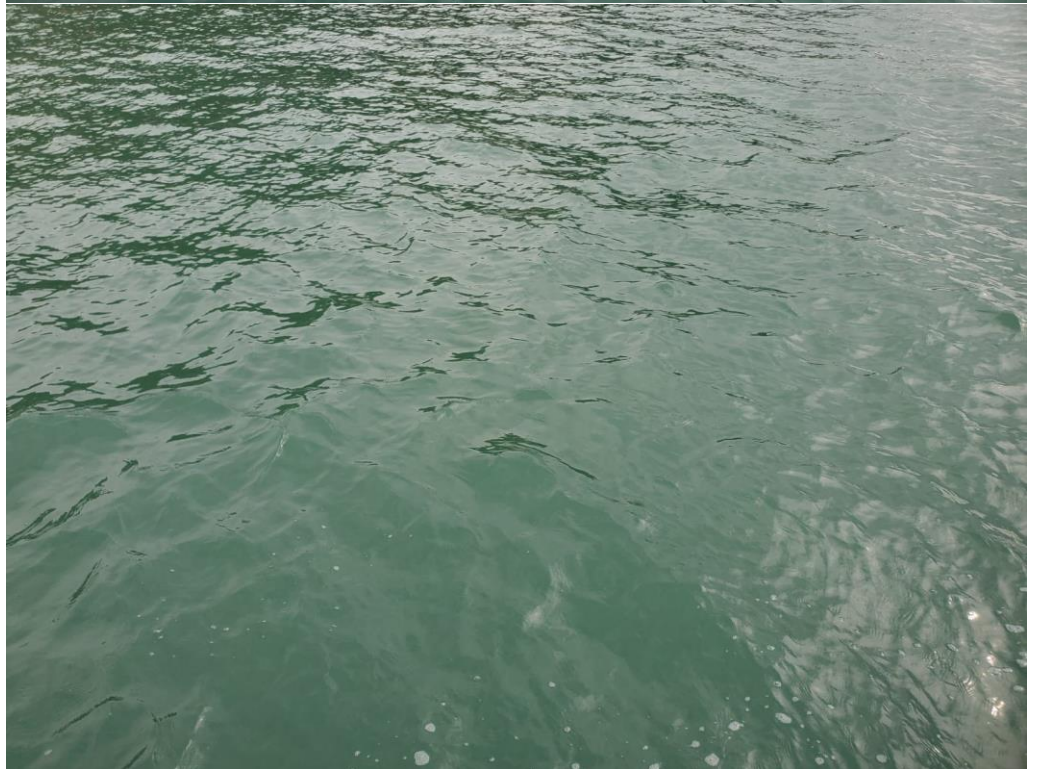
B4:

9.5 mg/L (B1) 8.0 mg/L (B2) 11.3 mg/L (B3) 10.8 mg/L (B4)	6.5 mg/L (C1A) 6.0 mg/L (C2A)	5.3 mg/L (F1A) 7.2 mg/L (H1) 5.5 mg/L (M1) 5.5 mg/L (CR1) 7.0 mg/L (CR2)
Possible reason for Action or Limit Level Non-compliance	<p>Works scheduled on site on 28 Oct 2021 include laying of geotextile, landfilling works, installation of instrumentation, piling pre-drilling works, piling works, piling works for driven pile, piling works for pre-bored socketed H-pile and existing caisson extension.</p> <p>Dominating sea current direction was found to be from Northwest to Southeast at waters around Shek Kwu Chau.</p> <p>Exceedances of action level were found at B1 and B2 and exceedances of limit level were found at B3 and B4.</p> <p>B1, B2, B3 and B4 are located at unrelated stream direction (neither upstream nor downstream, far away) to the works location, exceedances of these monitoring stations are deemed to be unrelated to the Project.</p>

<p>The installation of caisson No.19 was completed on 18 Mar 2021, the reclamation area was enclosed.</p> <p>According to the field observation by sampling team during sampling event, no silt plume was observed in the Project site and the weather was fine during the sampling event.</p> <p>No major observation of improper site practices that could contribute to the increase of the suspended solids was recorded during the weekly inspection on 26 Oct 2021.</p> <p>After the investigation, the exceedances on 28 Oct 2021 at B1, B2, B3 and B4 are deemed to be unrelated to the Project.</p>
<p>Monitoring photos of stations with exceedance</p>	<p>B1:</p>
