Appendix N Exceedance Report

Incident Report on Action Level or Limit Level Non-compliance

Project	Integrated Waste Management Facilities, Phase 1		
Date	1 Nov 2021 (Lab result received on 5 Nov 2021)		
Time	08:00 – 11:08 (Mid-Ebb)		
Monitoring Location	Mid-Ebb B1, B2, M1		
	<p>The map shows the Shek Kwu Chau area with various monitoring stations and proposed infrastructure. Stations B1, B2, and M1 are circled in red. A key identifies symbols for proposed 132KV submarine cables, monitoring stations (green circle with 'c'), proposed outfalls (red square), IWMF site boundary (purple outline), IWMF site boundary land formation footprint (dashed green line), and the IWMF site boundary (solid green line).</p>		
Parameter	Suspended Solid (SS)		
Action & Limit Levels	Action Level		Limit Level
	≥ 8.6 mg/L (120% of C1A)		≥ 10.0 mg/L
Measurement Level	Impact Station(s) of Exceedance	Control Stations	Impact Station(s) without Exceedance

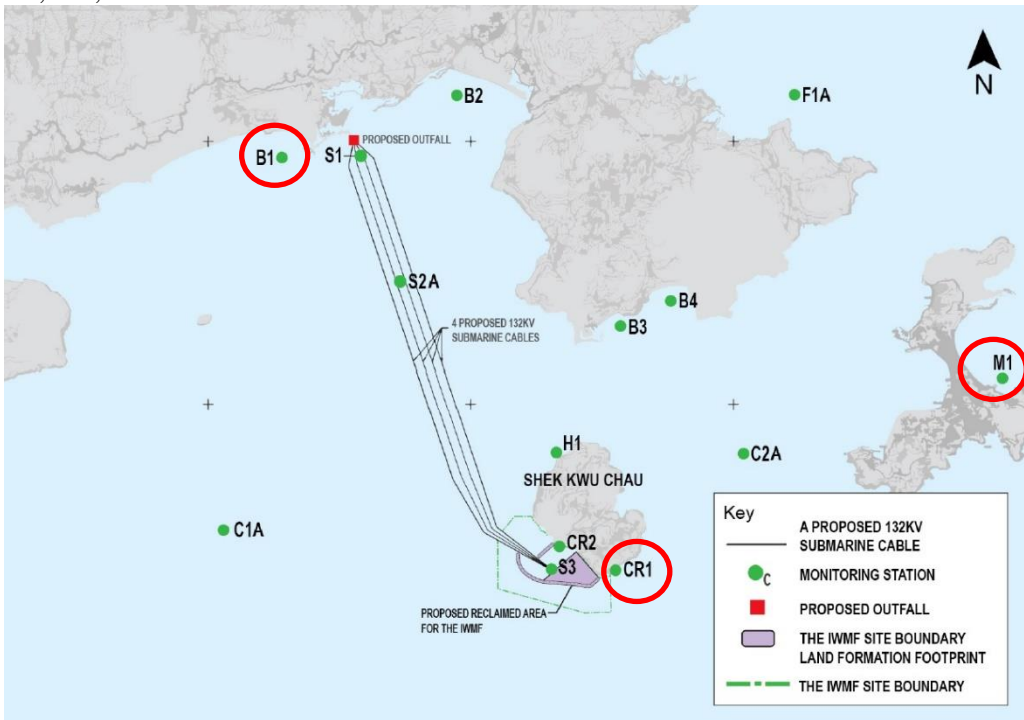
Parameter	Suspended Solid (SS)		
Action & Limit Levels	Action Level		Limit Level
	≥ 11.8 mg/L (120% of C1A)		≥ 12.8 mg/L (130% of C1A)
Measurement Level	Impact Station(s) of Exceedance	Control Stations	Impact Station(s) without Exceedance

12.8 mg/L (B1) 13.2 mg/L (M1) 11.8 mg/L (CR1)	9.8 mg/L (C1A) 11.3 mg/L (C2A)	6.3 mg/L (B2) 5.3 mg/L (B3) 6.0 mg/L (B4) 9.0 mg/L (F1A) 9.3 mg/L (H1) 10.8 mg/L (CR2)
Possible reason for Action or Limit Level Non-compliance	<p>Works scheduled on site on 03 Nov 2021 include infilling of caisson, installation of blockwork for marine access facility, landfilling works for below +6.00mPD, landfilling works for above +6.00mPD, installation of instrumentation, piling pre-drilling works, piling works and existing caisson extension.</p> <p>Dominating sea current direction was found to be from Northwest to Southeast at waters around Shek Kwu Chau.</p> <p>Exceedance of action level was found at CR1 and exceedances of limit level were found at B1 and M1.</p> <p>B1 and M1 are located at unrelated stream direction (neither upstream nor downstream, far away) to the works location, exceedances of these monitoring stations are deemed to be unrelated to the Project.</p>

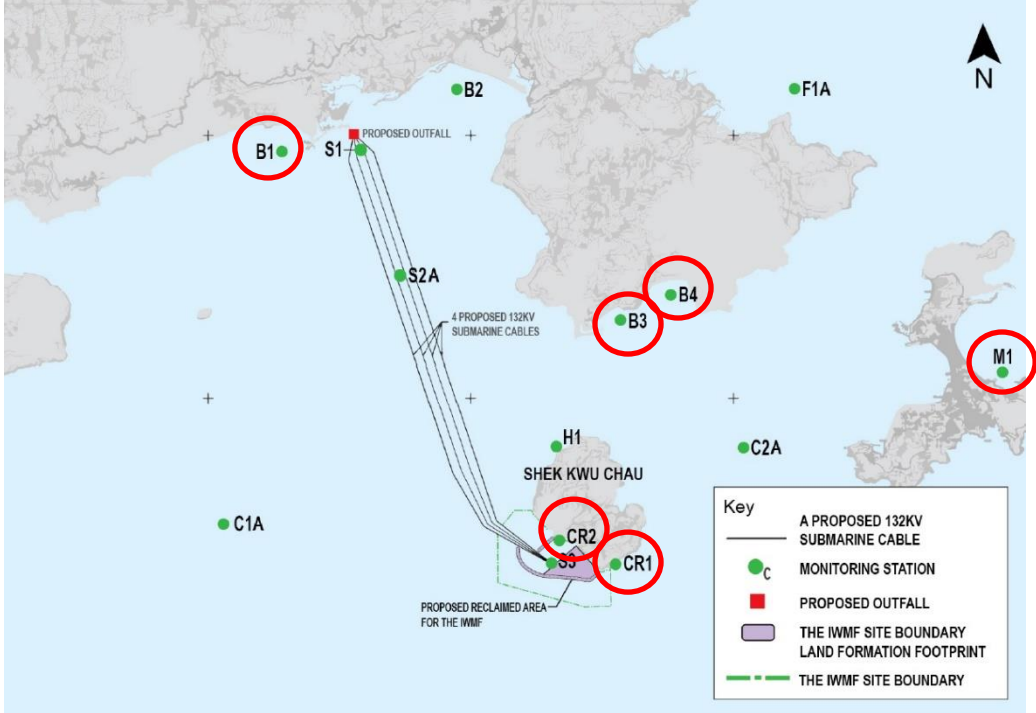
<p>Parameter</p>	<p>Suspended Solid (SS)</p>		
<p>Action & Limit Levels</p>	<p>Action Level $\geq 9.8 \text{ mg/L (120\% of C2A)}$</p>		<p>Limit Level $\geq 10.6 \text{ mg/L (130\% of C2A)}$</p>
<p>Measurement Level</p>	<p>Impact Station(s) of Exceedance</p> <p>10.5 mg/L (B1) 10.3 mg/L (B3) 10.0 mg/L (B4) 11.2 mg/L (M1) 14.2 mg/L (CR1) 12.2 mg/L (CR2)</p>	<p>Control Stations</p> <p>10.8 mg/L (C1A) 8.2 mg/L (C2A)</p>	<p>Impact Station(s) without Exceedance</p> <p>9.8 mg/L (B2) 9.0 mg/L (F1A) 8.8 mg/L (H1)</p>
<p>Possible reason for Action or Limit Level Non-compliance</p>	<p>Works scheduled on site on 03 Nov 2021 include infilling of caisson, installation of blockwork for marine access facility, landfilling works for below +6.00mPD, landfilling works for above +6.00mPD, installation of instrumentation, piling pre-drilling works, piling works and existing caisson extension.</p> <p>Dominating sea current direction was found to be from Southeast to Northwest at waters around Shek Kwu Chau.</p> <p>Exceedances of action level were found at B1, B3 and B4 and exceedances of limit level were found at M1, CR1 and CR2.</p> <p>B1, B3, B4 and M1 are located at unrelated stream direction (neither upstream nor downstream, far away) to the works location, exceedances of these monitoring stations are deemed to be unrelated to the Project.</p> <p>CR1 and CR2 are located close to the works location within the Project site while no marine work was conducted on 03 Nov 2021.</p> <p>The installation of caisson No.19 was completed on 18 Mar 2021, the reclamation area was enclosed.</p>

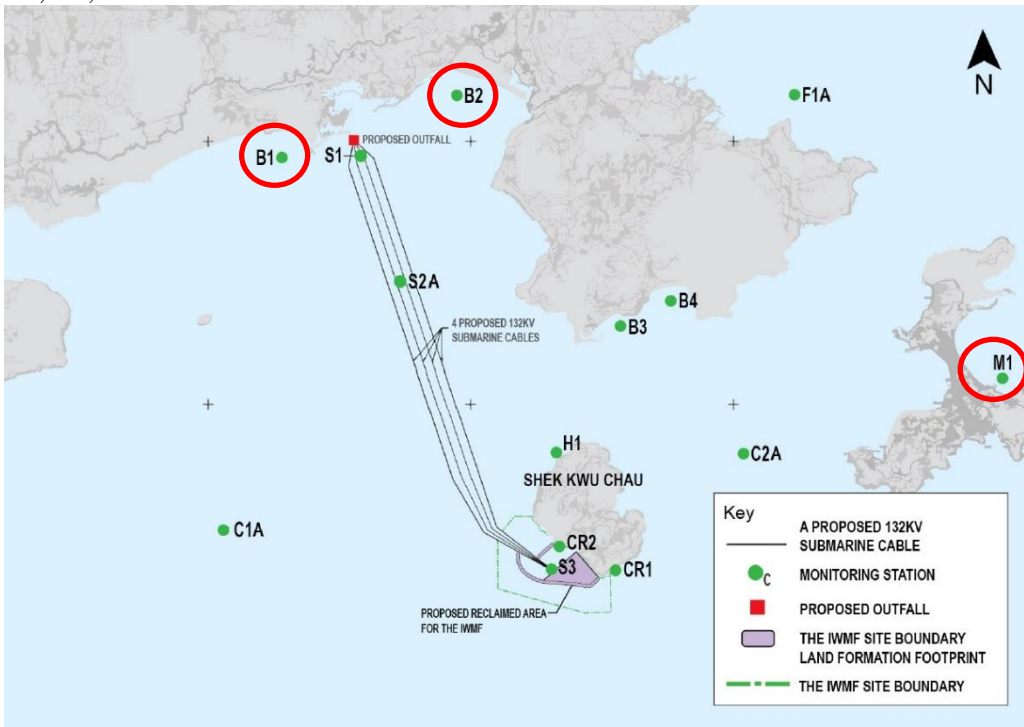
Parameter	Suspended Solid (SS)		
Action & Limit Levels	Action Level		Limit Level
	≥ 10.8 mg/L (120% of C1A)		≥ 11.7 mg/L (130% of C1A)
Measurement Level	Impact Station(s) of Exceedance	Control Stations	Impact Station(s) without Exceedance

13.0 mg/L (B1) 12.0 mg/L (B2) 11.8 mg/L (M1)	9.0 mg/L (C1A) 8.2 mg/L (C2A)	8.0 mg/L (B3) 8.0 mg/L (B4) 7.3 mg/L (F1A) 8.2 mg/L (H1) 8.5 mg/L (CR1) 9.3 mg/L (CR2)
Possible reason for Action or Limit Level Non-compliance	<p>Works scheduled on site on 05 Nov 2021 include infilling of caisson, installation of blockwork for marine access facility, landfilling works for below +6.00mPD, landfilling works for above +6.00mPD, installation of instrumentation, piling pre-drilling works, piling works, piling works for pre-bored socketed H-pile and existing caisson extension.</p> <p>Dominating sea current direction was found to be from Northwest to Southeast at waters around Shek Kwu Chau.</p> <p>Exceedances of limit level were found at B1, B2 and M1.</p> <p>B1, B2 and M1 are located at unrelated stream direction (neither upstream nor downstream, far away) to the works location, exceedances of these monitoring stations are deemed to be unrelated to the Project.</p>

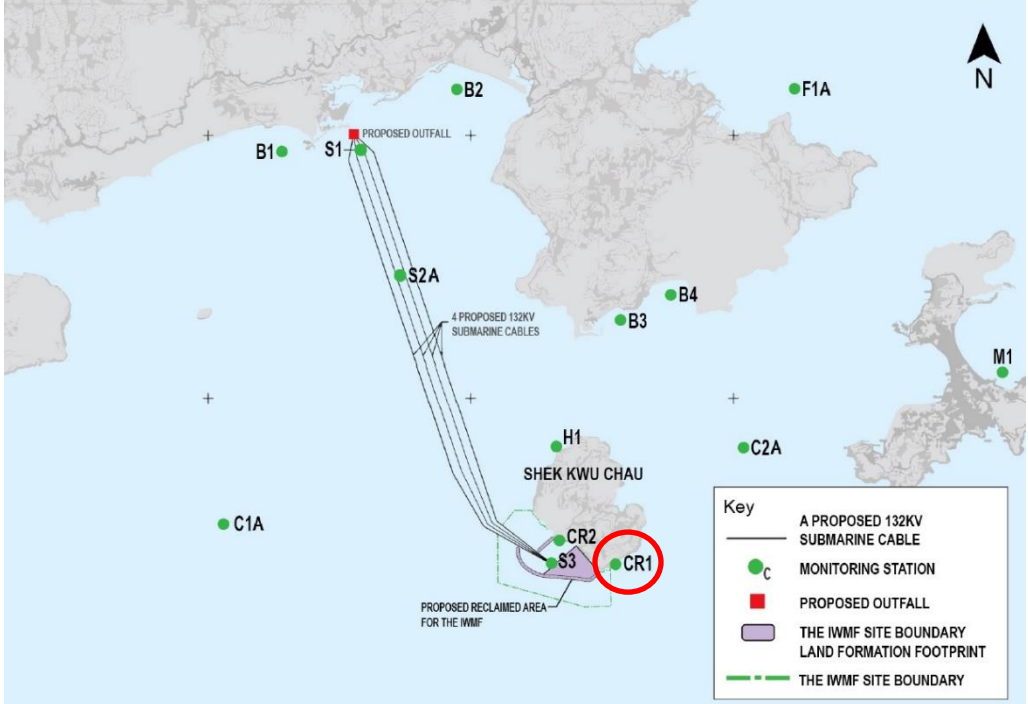
<p>Parameter</p>	<p>Suspended Solid (SS)</p>		
<p>Action & Limit Levels</p>	<p>Action Level ≥ 12.0 mg/L (120% of C2A)</p>		<p>Limit Level ≥ 13.0 mg/L (130% of C2A)</p>
<p>Measurement Level</p>	<p>Impact Station(s) of Exceedance 13.0 mg/L (CR1)</p>	<p>Control Stations 10.7 mg/L (C1A) 10.0 mg/L (C2A)</p>	<p>Impact Station(s) without Exceedance 10.3 mg/L (B1) 10.8 mg/L (B2) 10.8 mg/L (B3) 11.0 mg/L (B4) 10.8 mg/L (F1A) 11.0 mg/L (H1) 7.7 mg/L (M1) 6.3 mg/L (CR2)</p>
<p>Possible reason for Action or Limit Level Non-compliance</p>	<p>Works scheduled on site on 05 Nov 2021 include infilling of caisson, installation of blockwork marine access facility, landfilling works for below +6.00mPD, landfilling works for above +6.00mPD, installation of instrumentation, piling pre-drilling works, piling works, piling works for pre-bored socketed H-pile and existing caisson extension.</p> <p>Dominating sea current direction was found to be from Southeast to Northwest at waters around Shek Kwu Chau.</p> <p>Exceedance of limit level was found at CR1.</p> <p>CR1 is located close to the works location within the Project site while no marine work was conducted on 05 Nov 2021.</p> <p>The installation of caisson No.19 was completed on 18 Mar 2021, the reclamation area was enclosed.</p>

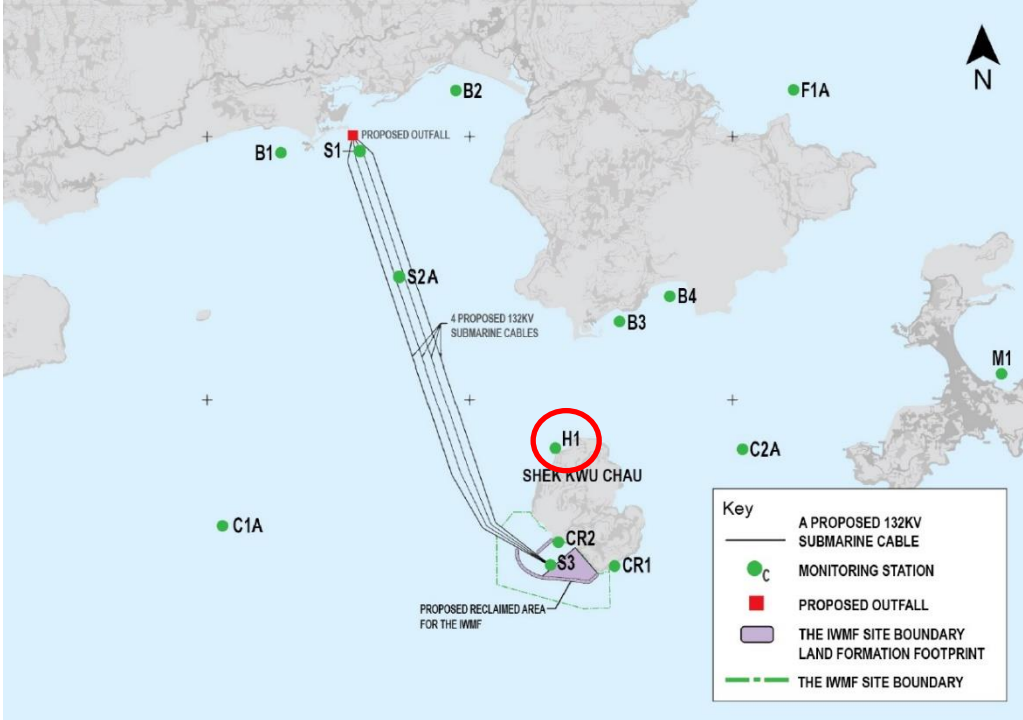
Parameter	Suspended Solid (SS)		
Action & Limit Levels	Action Level		Limit Level
	≥ 11.4 mg/L (120% of C1A)		≥ 12.4 mg/L (130% of C1A)
Measurement Level	Impact Station(s) of Exceedance	Control Stations	Impact Station(s) of Exceedance

12.3 mg/L (H1)	9.5 mg/L (C1A) 10.5 mg/L (C2A)	10.0 mg/L (B1) 6.8 mg/L (B2) 9.0 mg/L (B3) 8.3 mg/L (B4) 7.2 mg/L (F1A) 10.3 mg/L (M1) 9.7 mg/L (CR1) 10.0 mg/L (CR2)
Possible reason for Action or Limit Level Non-compliance	<p>Works scheduled on site on 12 Nov 2021 include installation of blockwork marine for access facility, landfilling works for below +6.00mPD, landfilling works for above +6.00mPD, installation of instrumentation, piling pre-drilling works, piling works, piling works for pre-bored socketed H-pile, existing caisson extension and armour scour protection.</p> <p>Dominating sea current direction was found to be from Northwest to Southeast at waters around Shek Kwu Chau.</p> <p>Exceedance of action level was found at H1.</p> <p>H1 is located at unrelated stream direction (neither upstream nor downstream, far away) to the works location, exceedance of this monitoring stations is deemed to be</p>

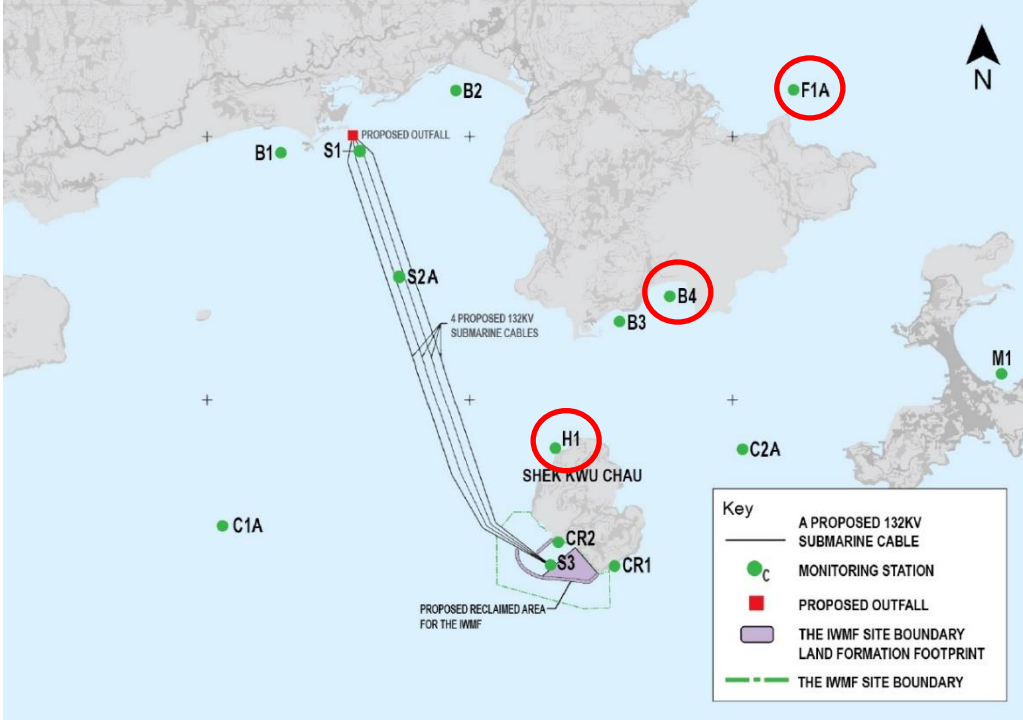
Parameter	Suspended Solid (SS)		
Action & Limit Levels	Action Level		Limit Level
	≥ 8.0 mg/L		≥ 10.0 mg/L
Measurement Level	Impact Station(s) of Exceedance	Control Stations	Impact Station(s) of Exceedance

8.0 mg/L (B4) 8.0 mg/L (F1A) 8.5 mg/L (H1)	7.3 mg/L (C1A) 6.3 mg/L (C2A)	6.8 mg/L (B1) 6.8 mg/L (B2) 7.3 mg/L (B3) 7.0 mg/L (M1) 6.3 mg/L (CR1) 5.8 mg/L (CR2)
Possible reason for Action or Limit Level Non-compliance	<p>Works scheduled on site on 22 Nov 2021 include installation of blockwork marine for access facility, landfilling works for below +6.00mPD, landfilling works for above +6.00mPD, installation of instrumentation, piling pre-drilling works, piling works, piling works for pre-bored socketed H-pile, existing caisson extension and armour scour protection.</p> <p>Dominating sea current direction was found to be from Southeast to Northwest at waters around Shek Kwu Chau.</p> <p>Exceedances of action level were found at B4, F1A and H1.</p> <p>B4 and F1A are located at unrelated stream direction (neither upstream nor downstream, far away) to the works location, exceedances of these monitoring stations are deemed to be unrelated to the Project.</p>

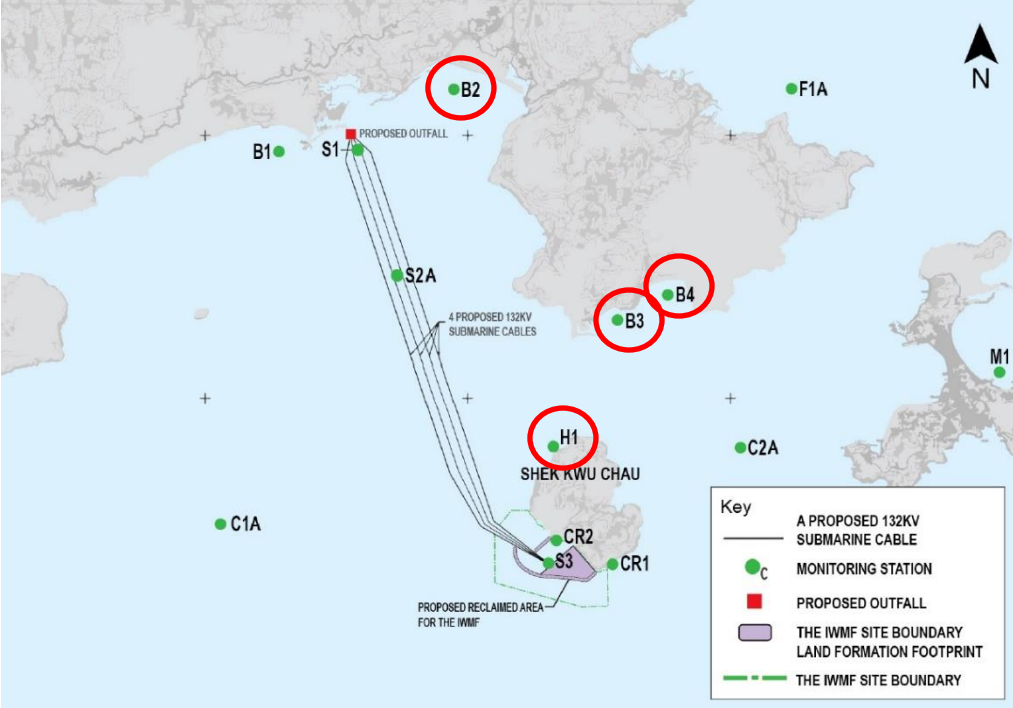
<p>Parameter</p>	<p>Suspended Solid (SS)</p>		
<p>Action & Limit Levels</p>	<p>Action Level $\geq 11.0 \text{ mg/L (120\% of C2A)}$</p>		<p>Limit Level $\geq 11.9 \text{ mg/L (130\% of C2A)}$</p>
<p>Measurement Level</p>	<p>Impact Station(s) of Exceedance</p> <p>16.5 mg/L (B2) 11.5 mg/L (B3) 12.5 mg/L (B4) 12.0 mg/L (H1)</p>	<p>Control Stations</p> <p>16.5 mg/L (C1A) 9.2 mg/L (C2A)</p>	<p>Impact Station(s) without Exceedance</p> <p>10.0 mg/L (B1) 8.3 mg/L (F1A) 9.5 mg/L (M1) 10.3 mg/L (CR1) 9.5 mg/L (CR2)</p>
<p>Possible reason for Action or Limit Level Non-compliance</p>	<p>Works scheduled on site on 29 Nov 2021 include installation of blockwork for marine access facility, landfilling works for below +6.00mPD, landfilling works for above +6.00mPD, installation of instrumentation, piling pre-drilling works, piling works, piling works for driven pile, piling works for pre-bored socketed H-pile and existing caisson extension and armour scour protection.</p> <p>Dominating sea current direction was found to be from Southeast to Northwest at waters around Shek Kwu Chau.</p> <p>Exceedance of action level was found at B3 and exceedances of limit level were found at B2, B4 and H1.</p> <p>B2, B3, B4, H1 are located at unrelated stream direction (neither upstream nor downstream, far away) to the works location, exceedances of these monitoring stations are deemed to be unrelated to the Project.</p> <p>The installation of caisson No.19 was completed on 18 Mar 2021, the reclamation area was enclosed.</p>
