## Appendix N Exceedance Report

**Incident Report on Action Level or Limit Level Non-compliance**

Project	Integrated Waste Management Facilities, Phase 1		
Date	08 August 2022 (Lab result received on 16 August 2022)		
Time	14:45 – 18:15 (Mid-Flood)		
Monitoring Location	Mid-Flood B2, B3, B4		
Parameter	Suspended Solid (SS)		
Action & Limit Levels	Action Level		Limit Level
	≥ 12.0 mg/L		≥ 14.0 mg/L
Measurement Level	Impact Station(s) of Exceedance	Control Stations	Impact Station(s) without Exceedance

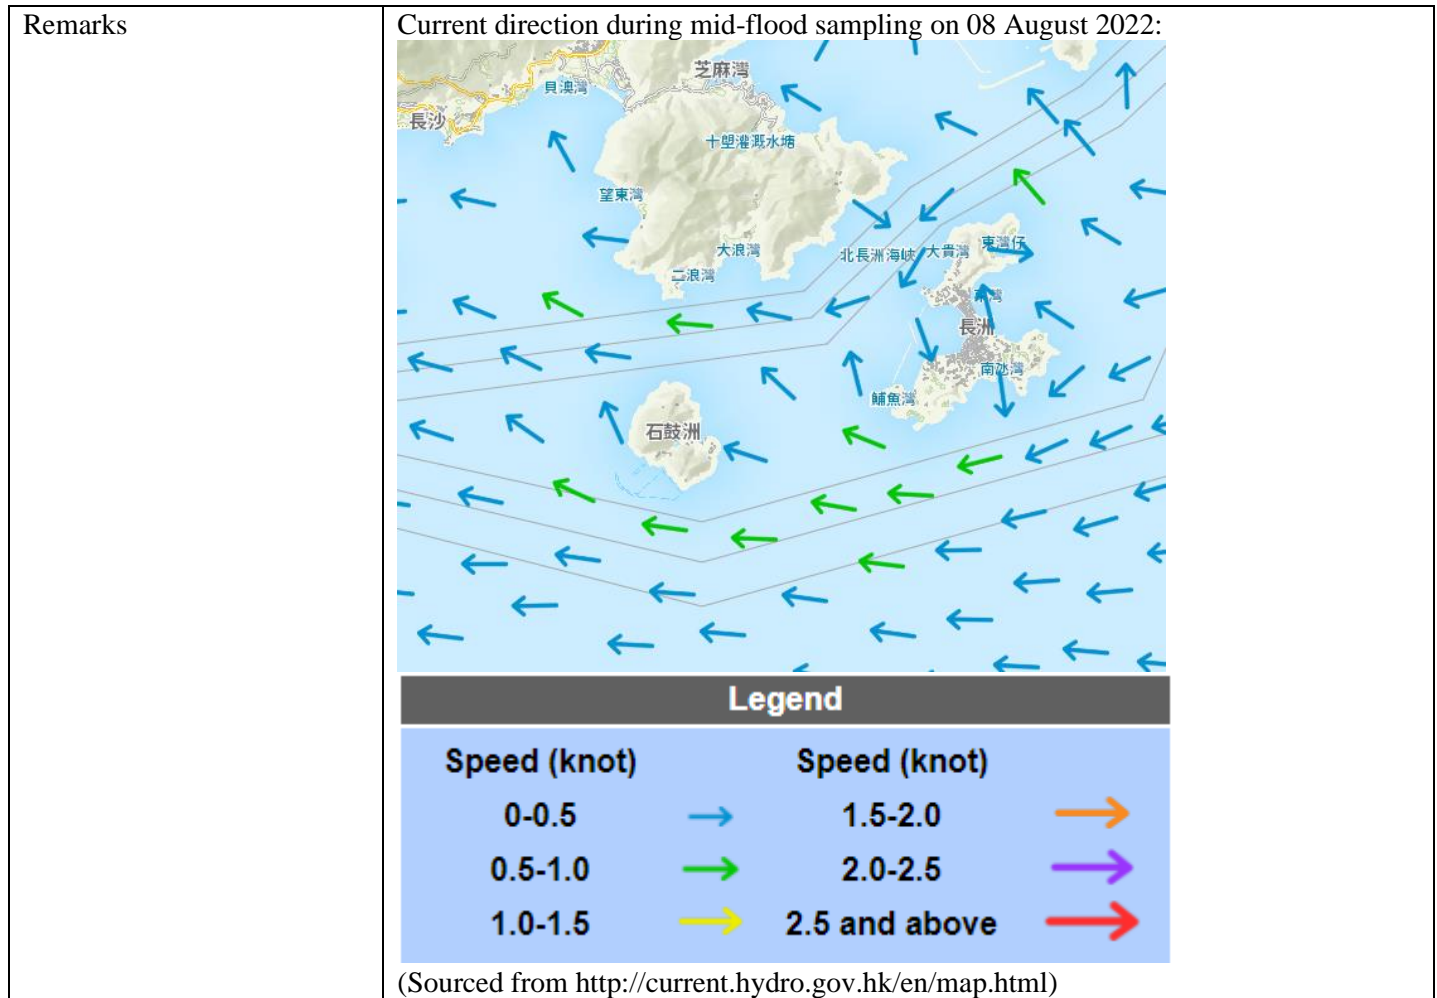
B4:

12.8 mg/L (B2) 15.8 mg/L (B3) 14.8 mg/L (B4)	3.8 mg/L (C1A) 2.9 mg/L (C2A)	10.5 mg/L (B1) 3.3 mg/L (F1A) 8.3 mg/L (H1) 9.0 mg/L (M1) 6.0 mg/L (CR1) 5.5 mg/L (CR2)
Possible reason for Action or Limit Level Non-compliance	<p>Works scheduled on site on 08 Aug 2022 include infilling of caisson, performing weighing test on 1.85T armour rock, laying 1.85T armour rock at Caisson 58 - 60, landfilling works for below +6.00mPD, landfilling works for above +6.00mPD, installation of instrumentation, piling pre-drilling works, piling works, piling works for driven pile, piling works for pre-bored socketed H-pile, piling works for bored pile, pile cap construction, blockwork seawall and existing caisson extension.</p> <p>Dominant sea current direction was found to be from Southeast to Northwest at waters around Shek Kwu Chau.</p> <p>An exceedance of action level was found at B2, exceedances of limit level were found at B3 and B4.</p>

<p>B2, B3 and B4 are located at unrelated stream direction (neither upstream nor downstream, far away) to the works location. Exceedances are deemed to be unrelated to the Project.</p> <p>The installation of caisson No.19 was completed on 18 Mar 2021, the reclamation area was enclosed.</p> <p>According to the field observation by sampling team during sampling event, no silt plume was observed in the Project site and the weather was cloudy during the sampling event.</p> <p>No major observation of improper site practices that contributed to the increase of the suspended solids was recorded during the weekly inspection on 09 August 2022.</p> <p>After the investigation, the exceedances on 08 August 2022 at B2, B3 and B4 are deemed to be unrelated to the Project.</p>
--	--
