Appendix N Exceedance Report

Incident Report on Action Level or Limit Level Non-compliance

Project	Integrated Waste Management Facilities, Phase 1		
Date	04 Jan 2023 (Lab result received on 13 January 2023)		
Time	09:49 – 11:56 (Mid-Ebb) 14:07 – 17:37 (Mid-Flood)		
Mid-Ebb			
Monitoring Location	B1, B2, B3, B4, H1, M1, CR1, CR2		
Parameter	Suspended Solid (SS)		
Action & Limit Levels	Action Level		Limit Level
	≥ 11.6 mg/L (120% of C1A)		≥ 12.6 mg/L (130% of C1A)
Measurement Level	Impact Station(s) of Exceedance	Control Stations	Impact Station(s) without Exceedance

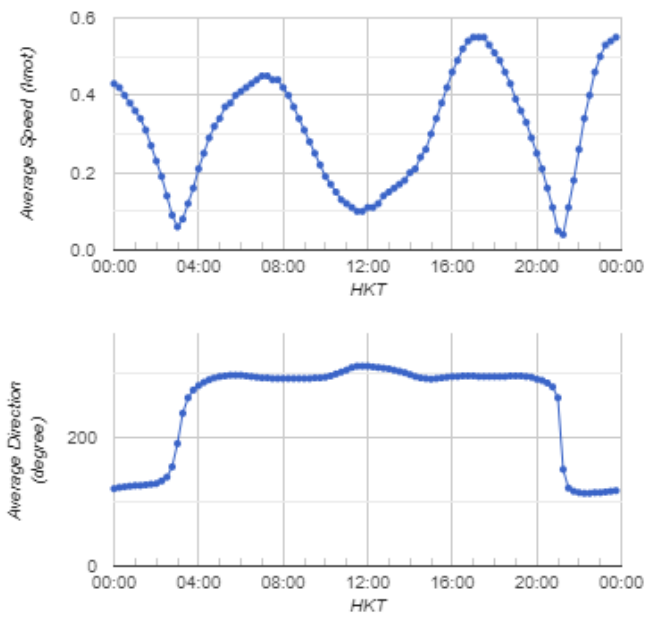
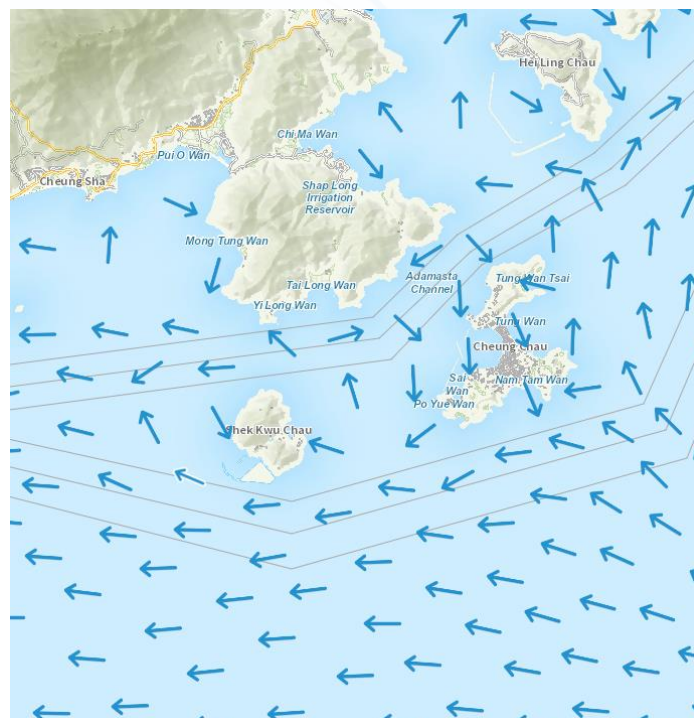
Current direction during mid-ebb sampling on 04 Jan 2023:

HKT	2023-01-04 10:00		UPDATE
Date & Time	2023-01-04 10:00		
Prediction Mode	Average	Change Mode	
Position (WGS84)	22 - 11.28 N / 113 - 58.49 E		
Speed:	0.19 knot(s)		
Direction:	293 °(TN)

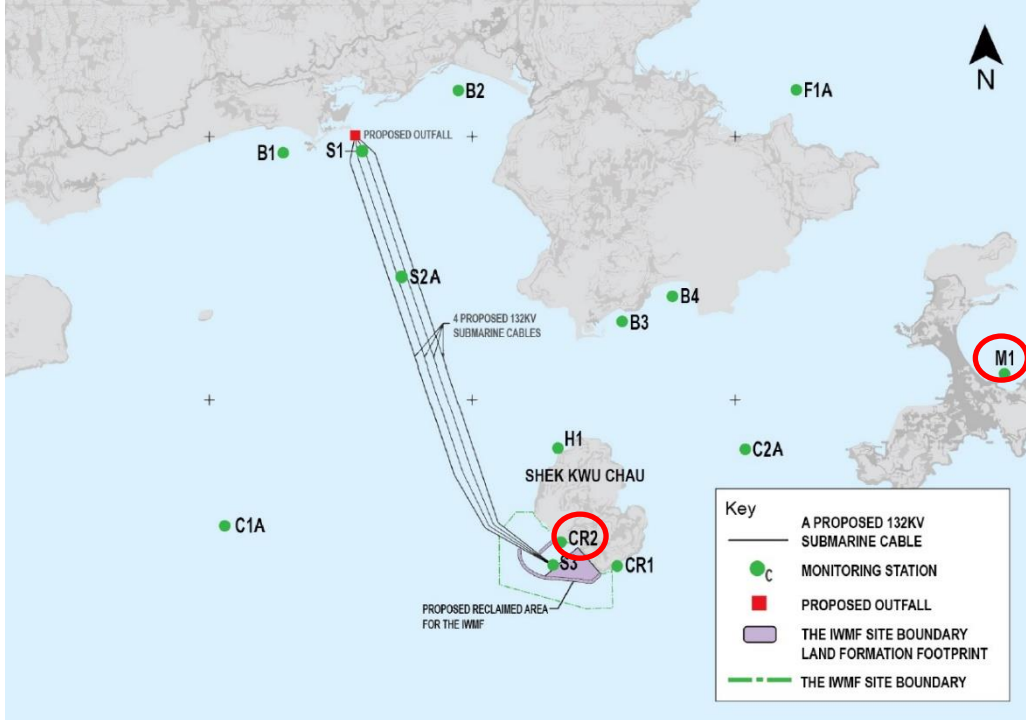
Parameter	Suspended Solid (SS)		
Action & Limit Levels	Action Level		Limit Level
	≥ 8.0 mg/L		≥ 10.0 mg/L
Measurement Level	Impact Station(s) of Exceedance	Control Stations	Impact Station(s) without Exceedance

10.5 mg/L (M1) 9.0 mg/L (CR2)	4.5 mg/L (C1A) 5.8 mg/L (C2A)	6.0 mg/L (B1) 6.8 mg/L (B2) 6.5 mg/L (B3) 7.3 mg/L (B4) 5.8 mg/L (H1) 4.8 mg/L (F1A) 6.2 mg/L (CR1)
Possible reason for Action or Limit Level Non-compliance	<p>Works scheduled on site on 09 Jan 2023 include laying of 900kg underlayer rock at Breakwater A landside CH935 - CH945, installation of Chinese pod at Caissons 47 - 49, inspection works of stoppers at Seawall A CH20 - CH170, remove the surcharge materials from Zone 5 to flat top barge Hong Hong 3132, piling works, piling works for driven pile, piling works for pre-bored socketed H-pile, pile cap construction, blockwork seawall and existing caisson extension, and Process Building construction works.</p> <p>Dominant sea current direction was found to be from Southeast to Northwest at waters around Shek Kwu Chau.</p> <p>An exceedance of action level was found at CR2, and an exceedance of limit level was found at M1. M1 is located at unrelated stream direction (neither upstream nor downstream) to the works location.</p>

<p>The installation of caisson No.19 was completed on 18 Mar 2021, the reclamation area was enclosed.</p> <p>According to the field observation by sampling team during sampling event, no silt plume was observed in the Project site and the weather was overcast during the sampling event.</p> <p>No major observation of improper site practices that contributed to the increase of the suspended solids was recorded during the weekly site inspection on 10 January 2023.</p> <p>After the investigation, the exceedances on 09 January 2023 during ebb tide at M1 and CR2 are deemed to be unrelated to the Project.</p>
--	---

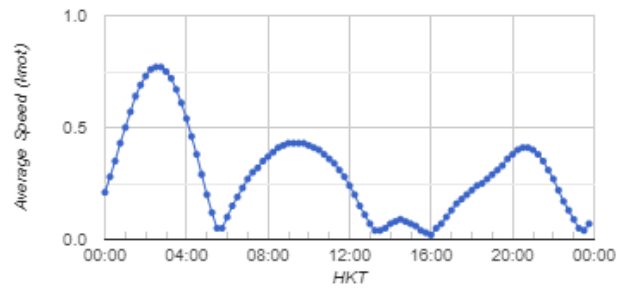
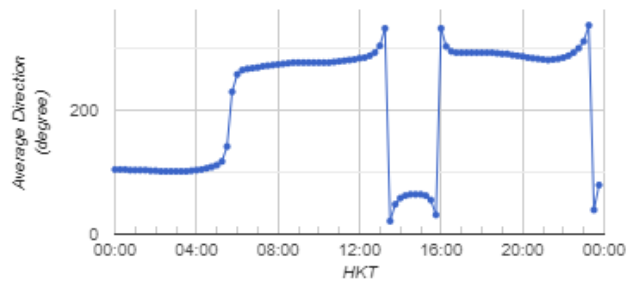
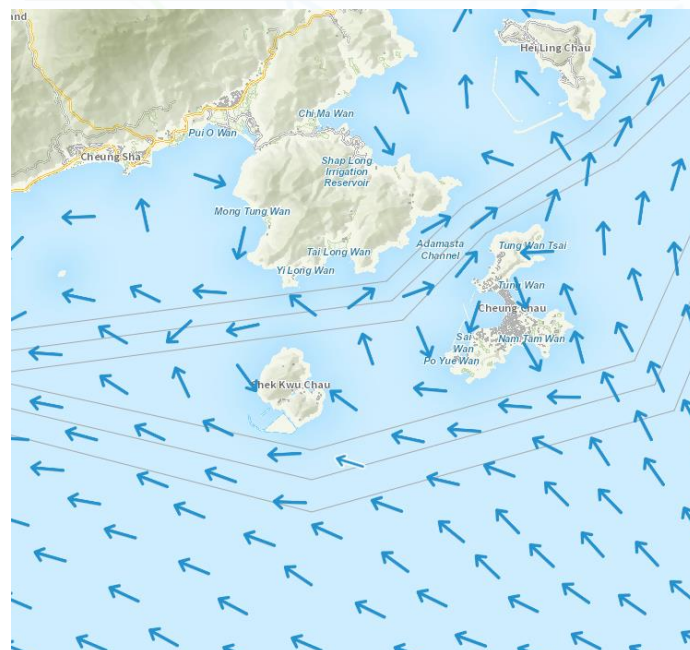
Current direction during mid-ebb sampling on 09 Jan 2023:

HKT	2023-01-09 12:30		UPDATE
Date & Time	2023-01-09 12:30		
Prediction Mode	Average	Change Mode	
Position (WGS84)	22 - 10.933 N / 113 - 59.972 E		
Speed:	0.15 knot(s)		
Direction:	287 °(TN)

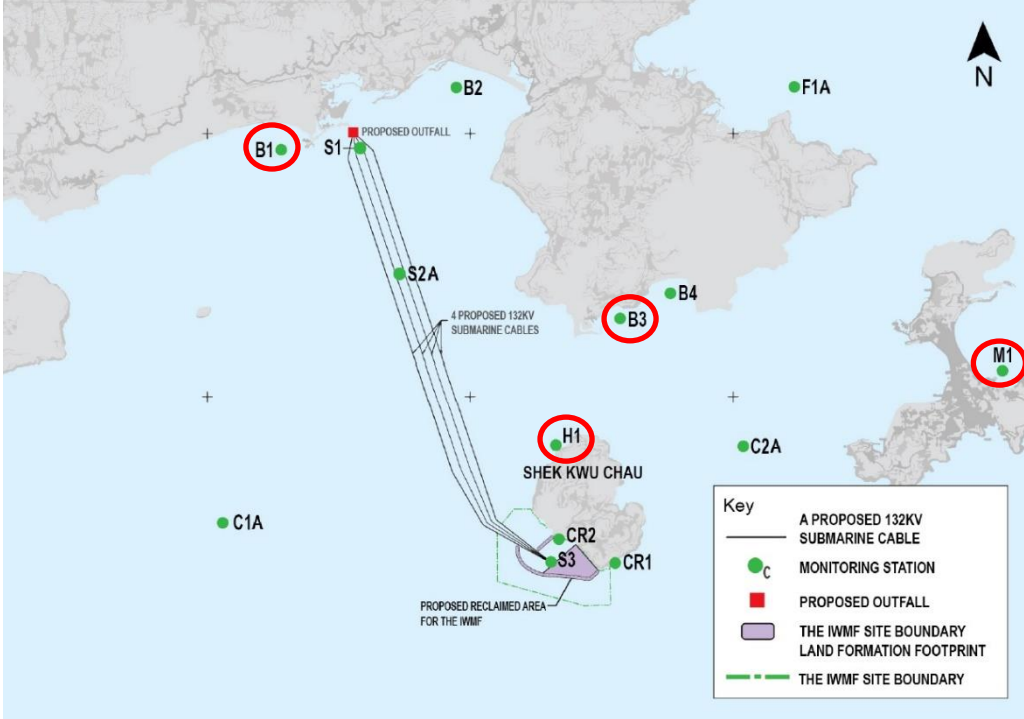
Parameter	Suspended Solid (SS)		
Action & Limit Levels	Action Level		Limit Level
	≥ 8.0 mg/L		≥ 10.0 mg/L
Measurement Level	Impact Station(s) of Exceedance	Control Stations	Impact Station(s) without Exceedance

8.3 mg/L (B1) 8.8 mg/L (B3) 9.0 mg/L (H1) 9.0 mg/L (M1)	3.8 mg/L (C1A) 5.3 mg/L (C2A)	5.3 mg/L (B2) 6.3 mg/L (B4) 4.1 mg/L (F1A) 7.8 mg/L (CR1) 7.3 mg/L (CR2)
Possible reason for Action or Limit Level Non-compliance	<p>Works scheduled on site on 28 Jan 2023 include laying of 900kg underlayer rock at Breakwater A seaside CH540 - CH670, inspection works at Breakwater B landside CH200, piling works, piling works for driven pile, piling works for pre-bored socketed H-pile, pile cap construction, blockwork seawall and existing caisson extension, and Process Building construction works.</p> <p>Dominant sea current direction was found to be from Northwest to Southeast at waters around Shek Kwu Chau.</p> <p>An exceedance of action level was found at B1, B3, H1 and M1. B1, B3, H1 and M1 are located at unrelated stream direction (neither upstream nor downstream, far away) to the works location. Exceedances at B1, B3, H1 and M1 are deemed to be unrelated to the Project.</p> <p>The installation of caisson No.19 was completed on 18 Mar 2021, the reclamation area was enclosed.</p>

<p>According to the field observation by sampling team during sampling event, no silt plume was observed in the Project site and the weather was fine during the sampling event.</p> <p>No major observation of improper site practices that contributed to the increase of the suspended solids was recorded during the weekly site inspection on 31 January 2023.</p> <p>After the investigation, the exceedances on 28 January 2023 during ebb tide at B1, B3, H1 and M1 are deemed to be unrelated to the Project.</p>
--	--

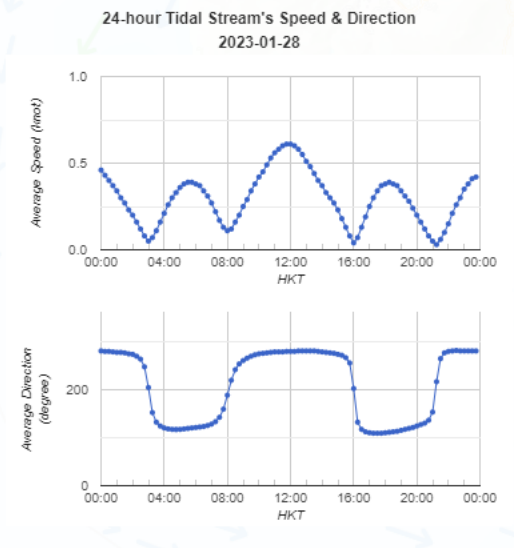
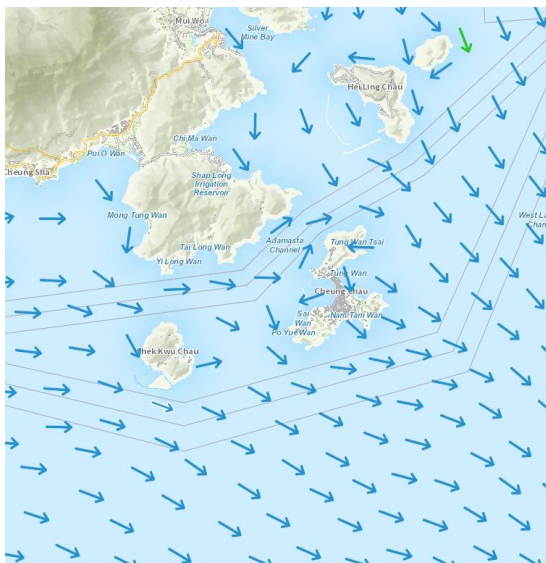
Current direction during mid-ebb sampling on 28 Jan 2023:

HKT	2023-01-28 17:00		UPDATE
Date & Time	2023-01-28 17:00		
Prediction Mode	Average	Change Mode	
Position (WGS84)	22 - 11.017 N / 113 - 59.24 E		
Speed:	0.25 knot(s)		
Direction:	110 °(TN)
