Appendix L Complaint Log

Statistical Summary of Environmental Complaints

COMPLAINT DETAILS

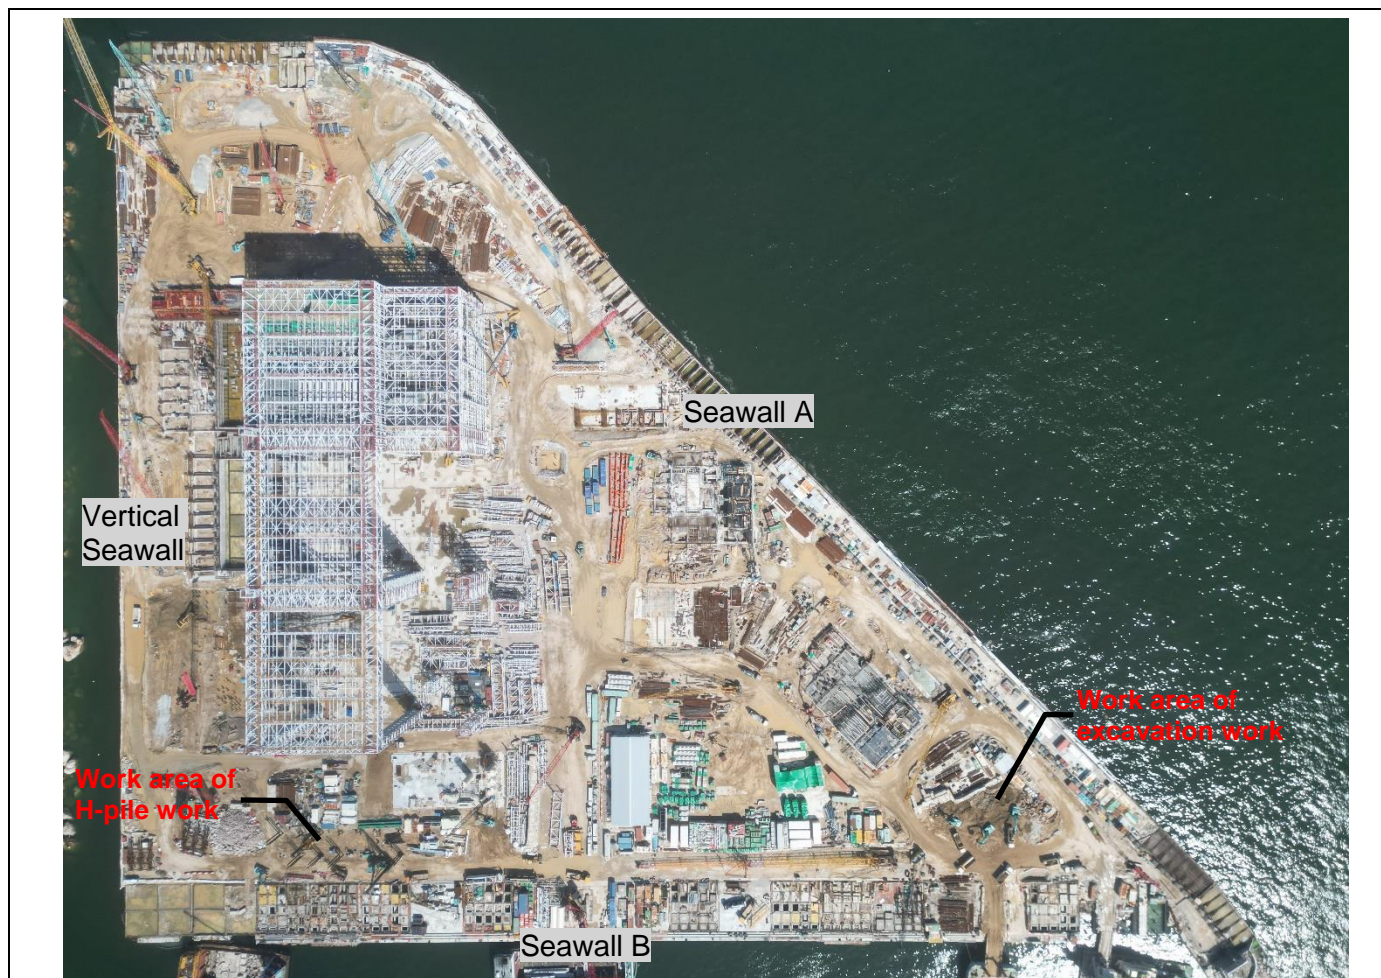
Figure 1: Location of Work Area

With reference to the work schedule provided by the Contractor, construction works conducted in recent time mainly involves excavation works near bunker 3 of Process Building, socketed H-pile works near Administration Building and elevated driveway and substructure works and superstructure works in other work areas. Among the various construction works, excavation works near bunker 3 of Process Building and socketed H-pile works near Administration Building and elevated driveway were the two construction works that possibly generate construction dust because of their work nature. The work areas of the excavation and H-pile work are indicated in **Figure 1**.

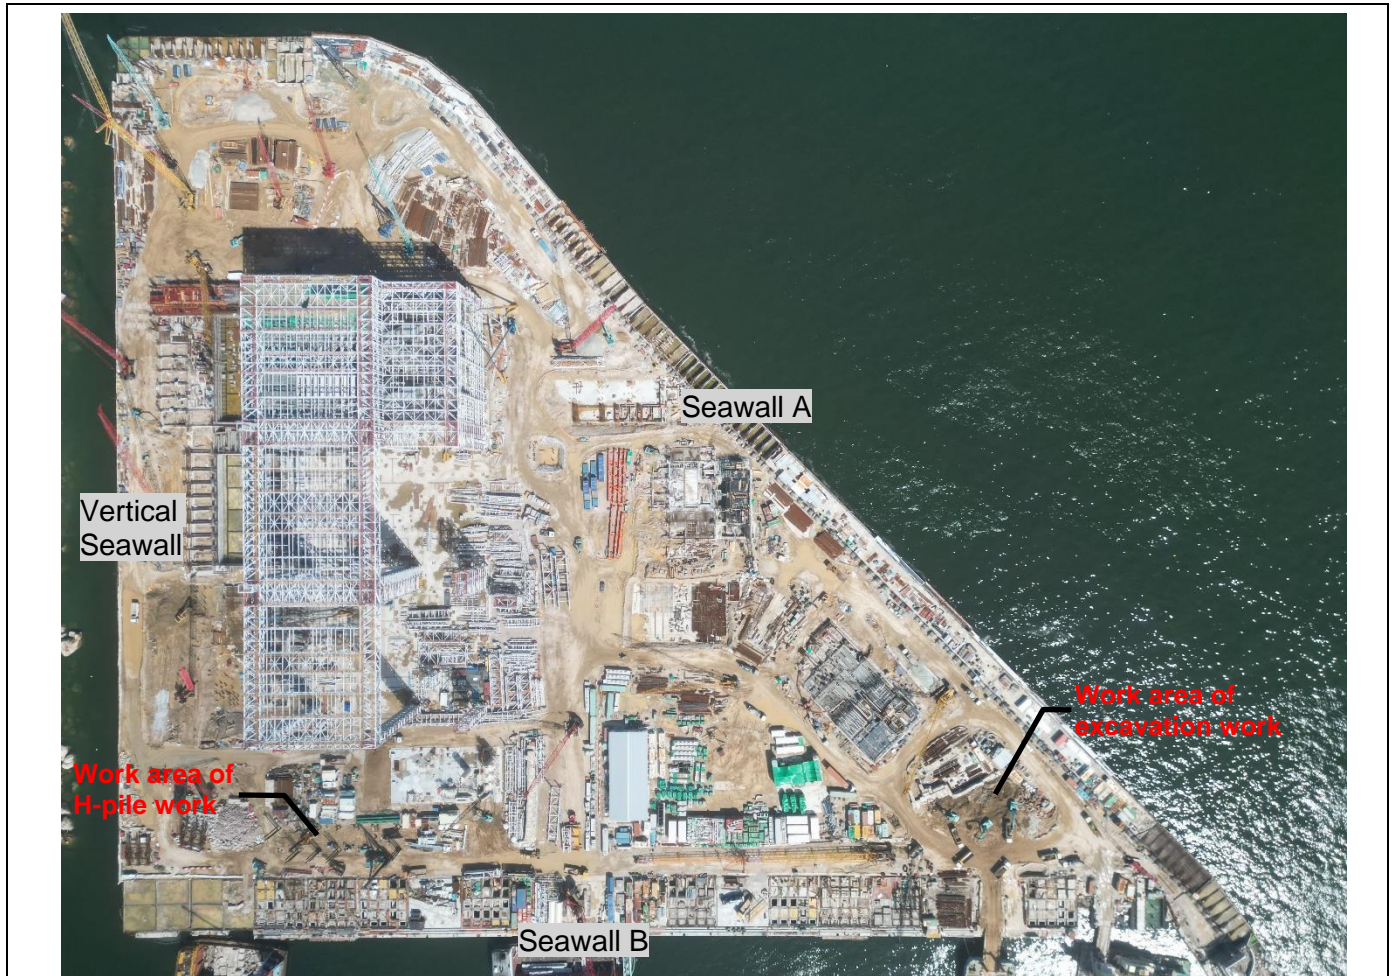
Figure 1: Location of Work Area

With reference to the work schedule provided by the Contractor, construction works conducted in recent time mainly involves excavation works near bunker 3 of Process Building, socketed H-pile works near Administration Building and elevated driveway and substructure works and superstructure works in other work areas. Among the various construction works, excavation works near bunker 3 of Process Building and socketed H-pile works near Administration Building and elevated driveway were the two construction works that possibly generate construction dust because of their work nature. The work areas of the excavation and H-pile work are indicated in **Figure 1**.
