Appendix N Exceedance Report

Incident Report on Action Level or Limit Level Non-compliance

Project	Integrated Waste Management Facilities, Phase 1		
Date	11 November 2024 (Lab result received on 18 November 2024)		
Time	13:40 - 17:10 (Mid-Flood)		
Monitoring Location	Mid-Flood F1A, CR1		
Parameter	Suspended Solid (SS)		
Action & Limit Levels	Action Level		Limit Level
	≥ 8.0 mg/L		≥ 10 mg/L
Measurement Level	Impact Station(s) of Exceedance	Control Stations	Impact Station(s) without Exceedance
	8.4 mg/L (F1A) 8.4 mg/L (CR1)	7.1 mg/L (C1A) 6.6 mg/L (C2A)	7.9 mg/L (B1) 7.3 mg/L (B2) 6.9 mg/L (B3) 8.0 mg/L (B4) 7.3 mg/L (H1) 7.7 mg/L (M1) 7.7 mg/L (CR2)

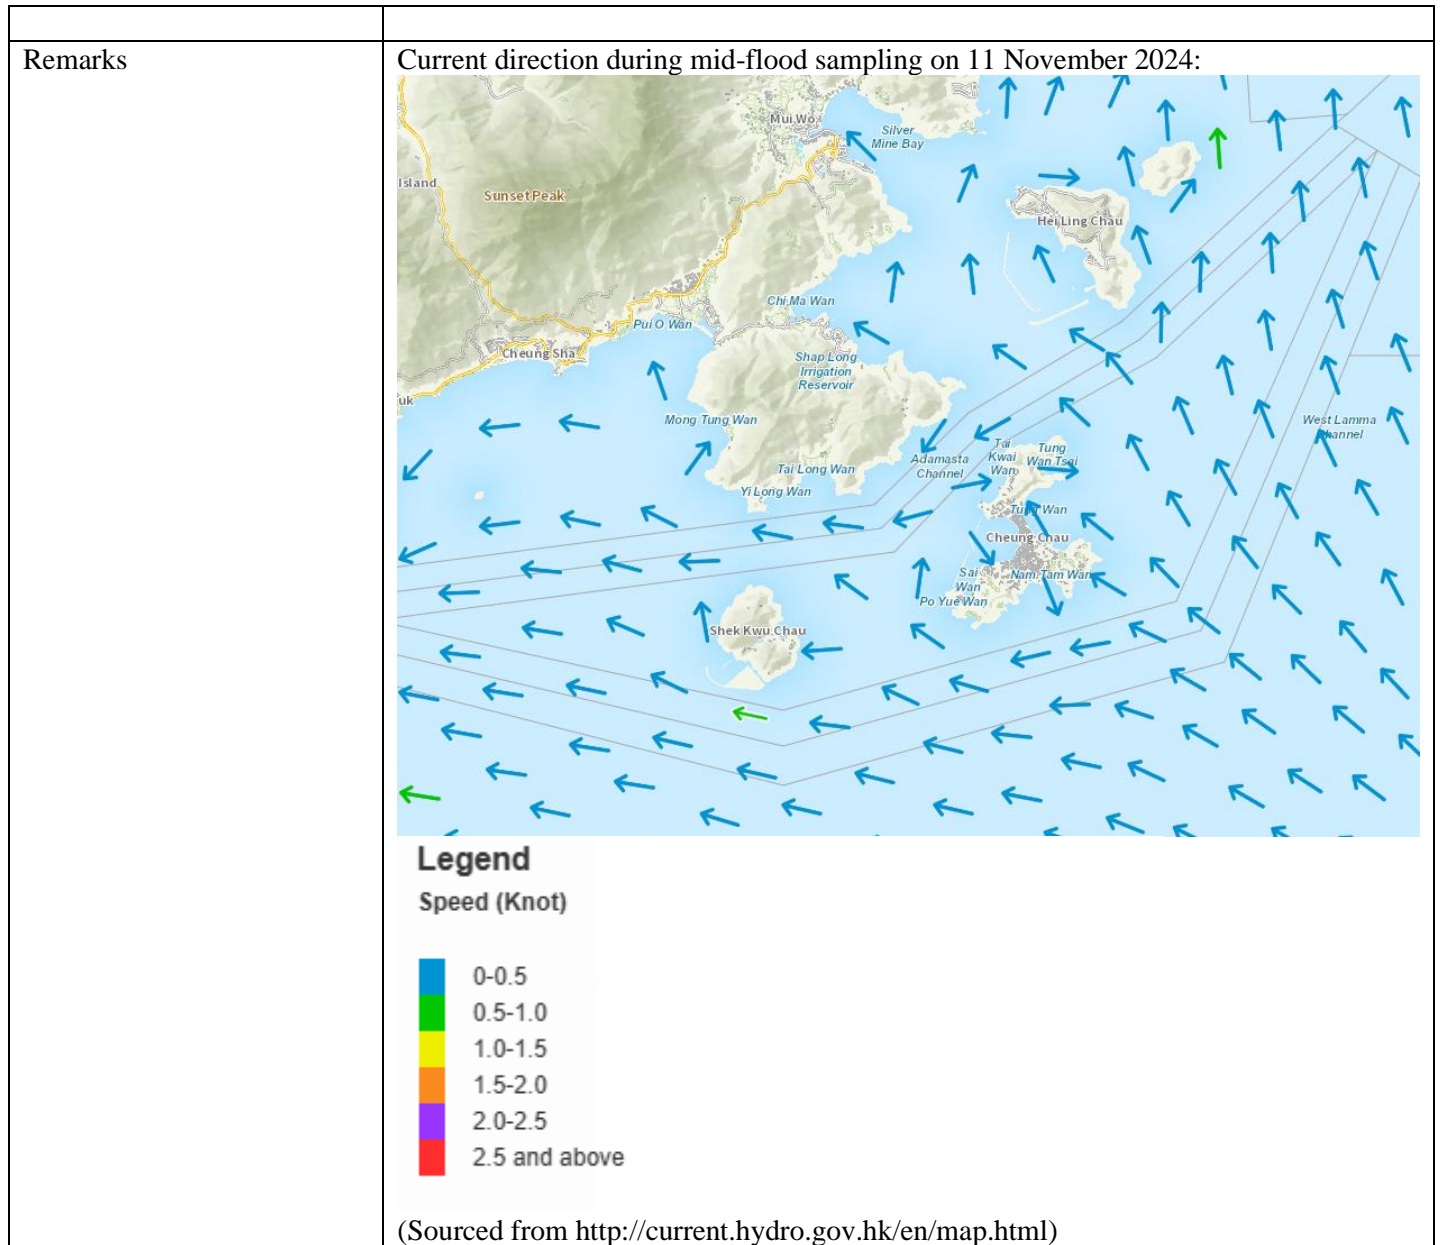
CR1:

Exceedances of action level were found at F1A and CR1, F1A and CR1 are located at unrelated stream direction (neither upstream nor downstream) to the works location during mid-flood tide, based on the dominant tidal flow.. Exceedances at the monitoring stations are deemed to be unrelated to the Project. In view of only slight exceedances were found at F1A and CR1, the exceedances at F1A and CR1 possibly caused by the disturbance of ocean current to seabed.

According to the field observation by sampling team during sampling event, no silt plume was observed in the Project site.
