Appendix N Exceedance Report

Incident Report on Action Level or Limit Level Non-compliance

Project	Integrated Waste Management Facilities, Phase 1		
Date	02 Aug 2019 (Lab result received on 6 Aug 2019)		
Time	17:09 – 19:00 (Mid-Flood)		
Mid-Flood			
Monitoring Location	CR1 & CR2

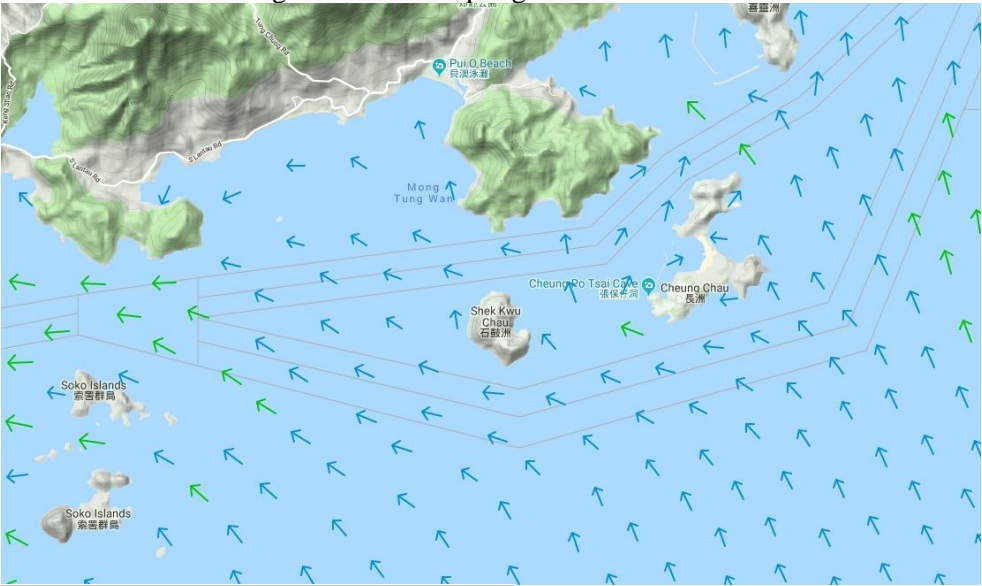
<p>unrelated to the Project.</p> <p>From MMO monitoring records on 02/08, no MMO teams was arranged since no construction work required MMO's observation on that day.</p> <p>Site tidiness on the barges was checked during the weekly site inspection on 30 Jul 2019. Sand accumulation was found at the edge of Cheung Kee No.10, however, Cheung Kee No.10 was tugged back to Hei Ling Chau due to hitting of Typhoon WIPHA on 31 Jul 2019. Therefore, this observation might not contribute to the increase of SS level.</p>								
<p>Actions taken / to be taken</p>	<p>Examination of environmental performance of the Project will be continued during the weekly inspection, and the Contractor is reminded to implement all applicable mitigation measures as per the Updated EM&A Manual.</p>								
<p>Remarks</p>	<p>Current direction during mid-flood sampling on 02/08:</p>

<table><tr> <th>Speed (knot)</th> <th>Speed (knot)</th> </tr><tr> <td>0-0.5</td> <td>1.5-2.0</td> </tr><tr> <td>0.5-1.0</td> <td>2.0-2.5</td> </tr><tr> <td>1.0-1.5</td> <td>2.5 and above</td> </tr></table>

<p>(Sourced from http://current.hydro.gov.hk/en/map.html)</p>	Speed (knot)	Speed (knot)	0-0.5	1.5-2.0	0.5-1.0	2.0-2.5	1.0-1.5	2.5 and above
Speed (knot)	Speed (knot)								
0-0.5	1.5-2.0								
0.5-1.0	2.0-2.5								
1.0-1.5	2.5 and above								
<p>Prepared by</p>	<p>Polar Chan</p>								
<p>Date</p>	<p>7 Aug 2019</p>

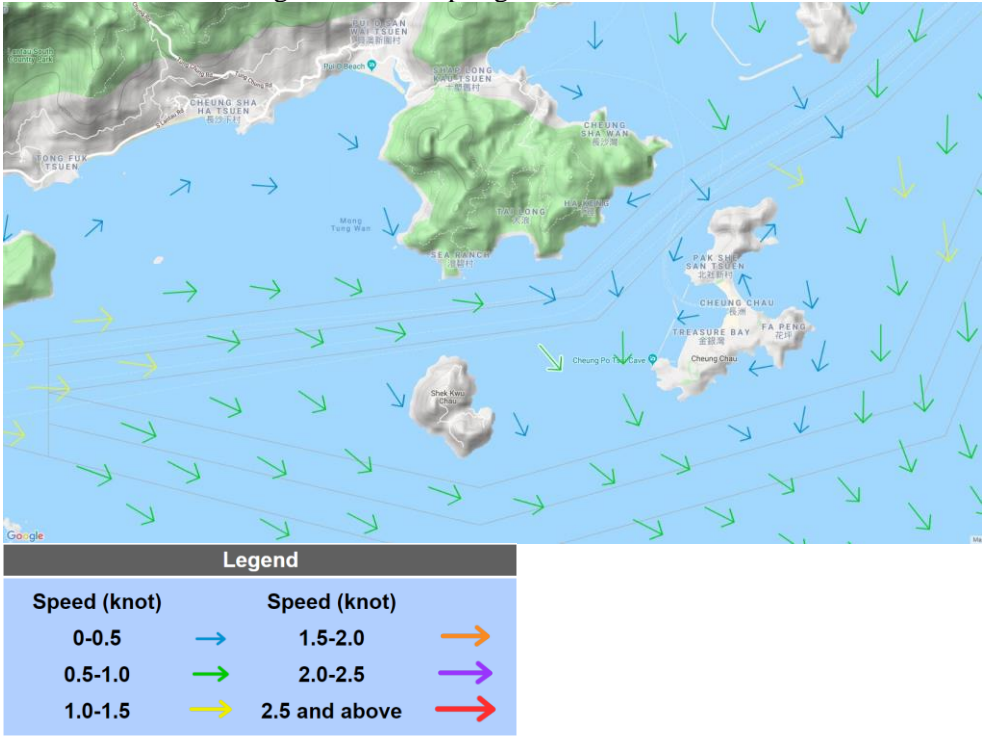
<p>Actions taken / to be taken</p>	<p>The Contractor was reminded to keep tracking on the status of the deployed silt curtain during construction works.</p> <p>Examination of environmental performance of the Project will be continued during the weekly inspection, and the Contractor is reminded to implement all applicable mitigation measures as per the Updated EM&A Manual.</p>
<p>Remarks</p>	<p>Current direction during mid-ebb sampling on 19/08:</p>

<p>(Sourced from http://current.hydro.gov.hk/en/map.html)</p>
<p>Prepared by</p>	<p>Nelson Tsui</p>
<p>Date</p>	<p>22 Aug 2019</p>

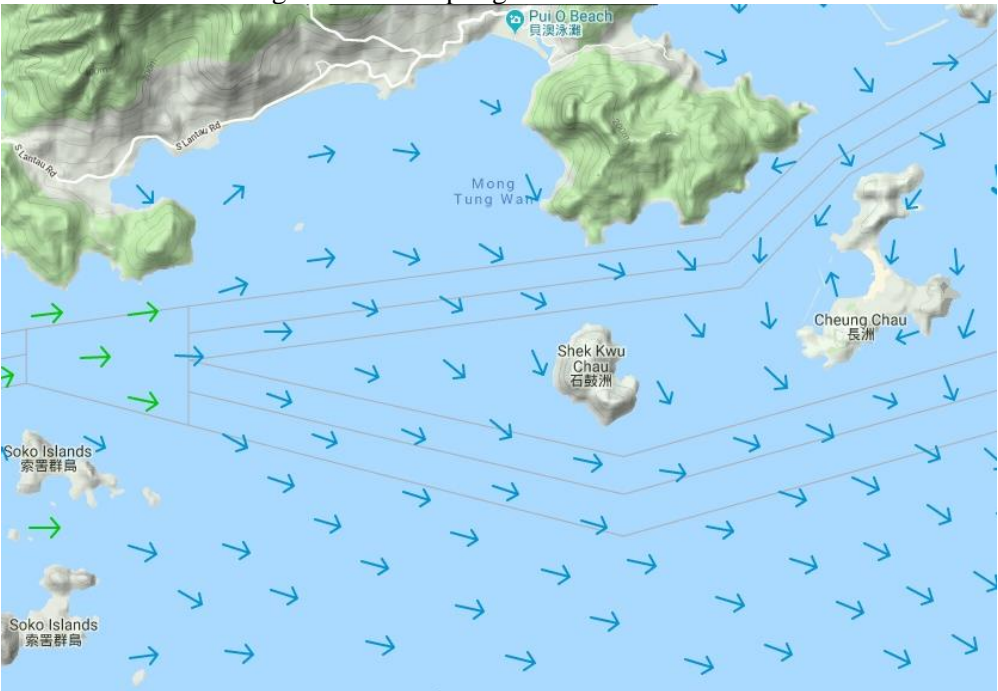
<p>Actions taken / to be taken</p>	<p>Sediment at the edge of DL5 has been cleared to avoid falling into the sea on 29/08. The Contractor was reminded to clean up the sediment at the edge of barges to avoid the falling of sediment into the sea.</p> <p>Examination of environmental performance of the Project will be continued during the weekly inspection, and the Contractor is reminded to implement all applicable mitigation measures as per the Updated EM&A Manual.</p>
<p>Remarks</p>	<p>Current direction during mid-ebb sampling on 28/08:</p>

<p>(Sourced from http://current.hydro.gov.hk/en/map.html)</p>
<p>Prepared by</p>	<p>Polar Chan</p>
<p>Date</p>	<p>4 Sep 2019</p>
