## Appendix N Exceedance Report

**Incident Report on Action Level or Limit Level Non-compliance**

Project	Integrated Waste Management Facilities, Phase 1		
Date	02 Oct 2019 (Lab result received on 08 Oct 2019)		
Time	08:00 – 12:01 (Mid-Flood)		
Mid-Flood			
Monitoring Location	B3, B4, H1, CR1 & S3		
Parameter	Suspended Solid (SS)		
Action & Limit Levels	Action Level		Limit Level
	≥ 8.0 mg/L		≥ 10.0 mg/L
Measurement Level	Impact Station(s) of Exceedance	Control Stations	Impact Station(s) without Exceedance

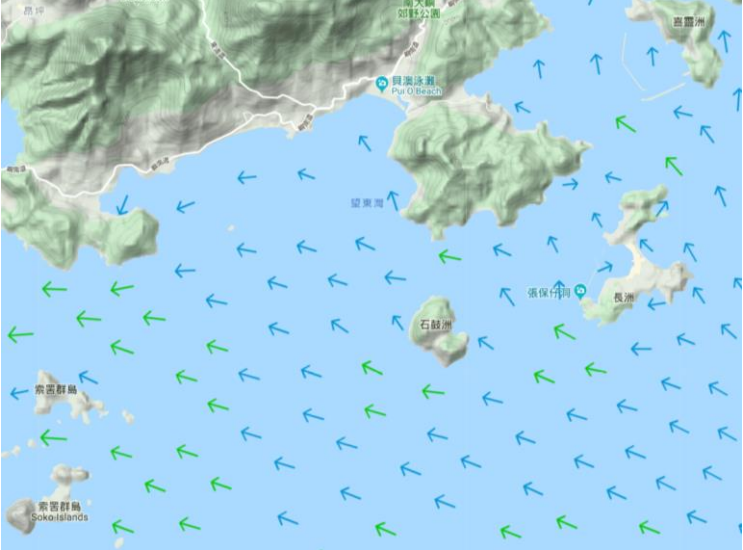
<p>Actions taken / to be taken</p>	<p>Sediment accumulated on the edge of the silt curtain has been cleaned on 5 October 2019. The Contractor was reminded to clean it regularly to prevent falling into the sea.</p> <p>Examination of environmental performance of the Project will be continued during the weekly inspection, and the Contractor is reminded to implement all applicable mitigation measures as per the Updated EM&amp;A Manual.</p>
<p>Remarks</p>	<p>Current direction during mid-flood sampling on 02/10:</p>

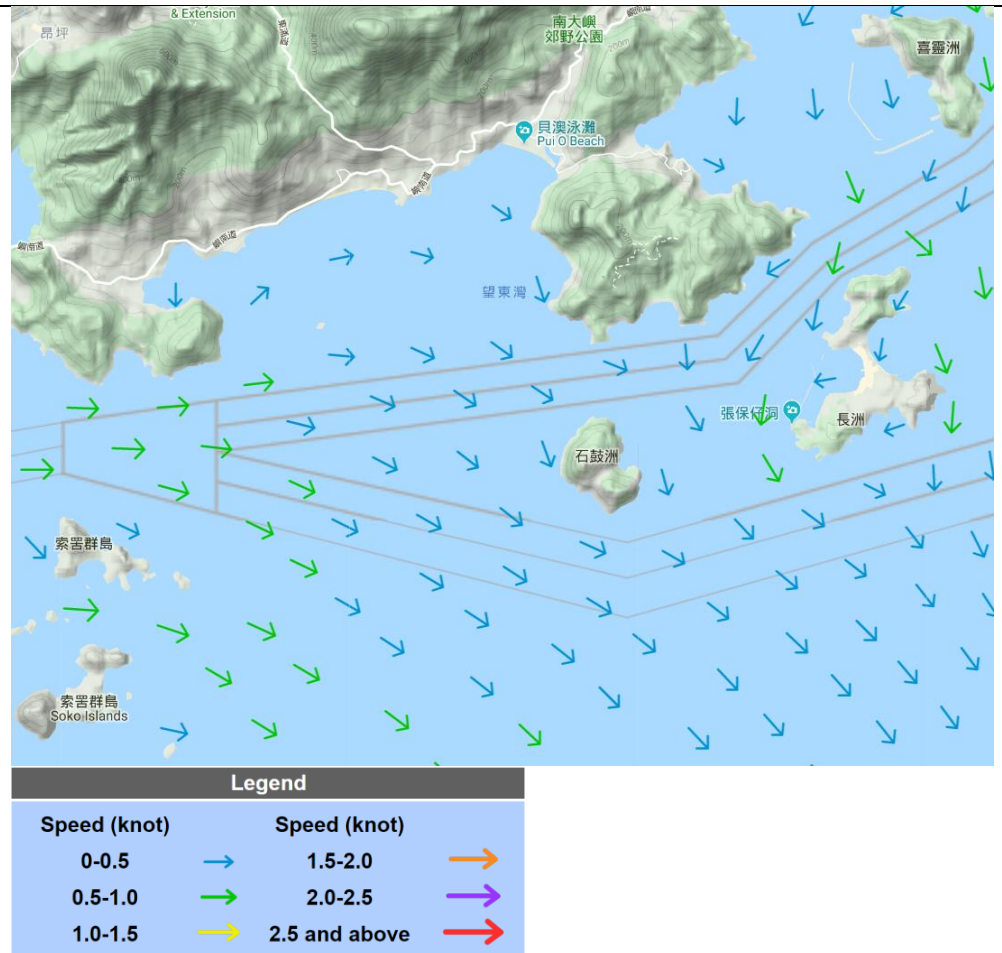
Current direction during mid-ebb sampling on 01/11:

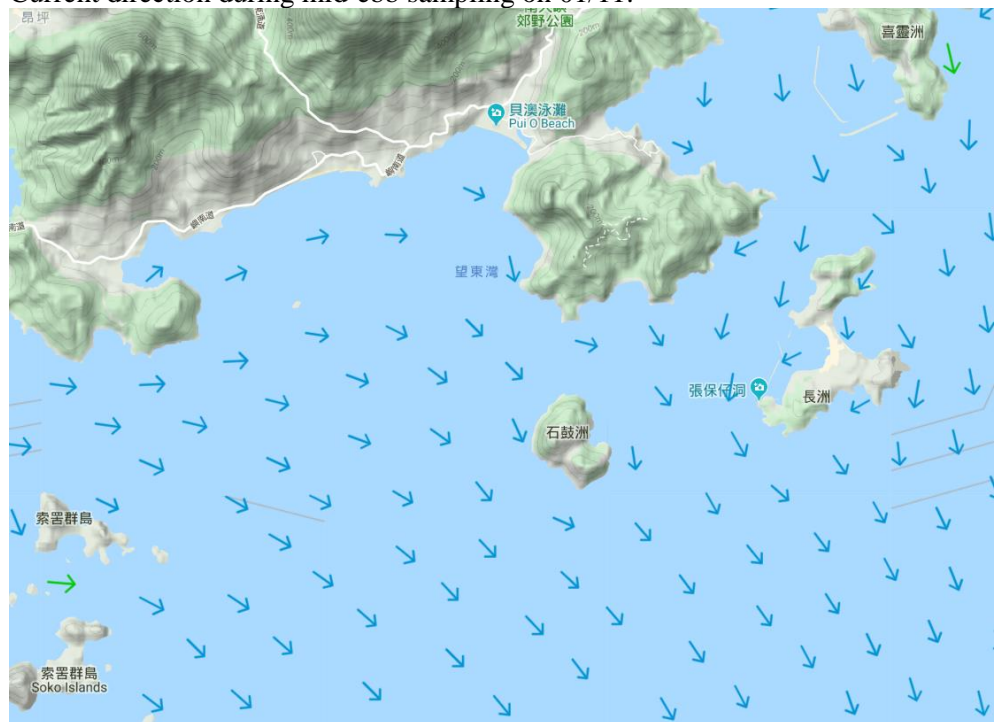
Current direction during mid-ebb sampling on 01/11:

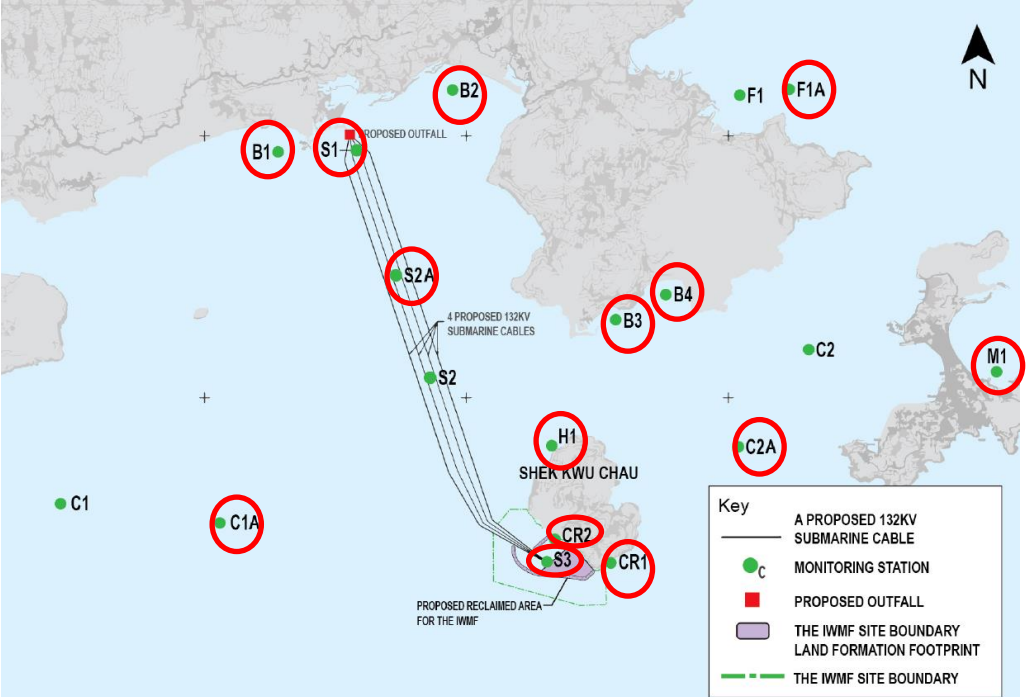
<p>The map shows the project site near Sher Kwu Chau. A proposed outfall is located near station S1. Four proposed 132KV submarine cables run from the site towards the west. Monitoring stations are marked with green dots and red circles. The IWMF site boundary is shown as a purple shaded area, and the land formation footprint is a dashed green line. A key in the bottom right corner defines the symbols: a solid line for the proposed 132KV submarine cable, a green dot for a monitoring station, a red square for a proposed outfall, a purple shaded area for the IWMF site boundary land formation footprint, and a dashed green line for the IWMF site boundary.</p>

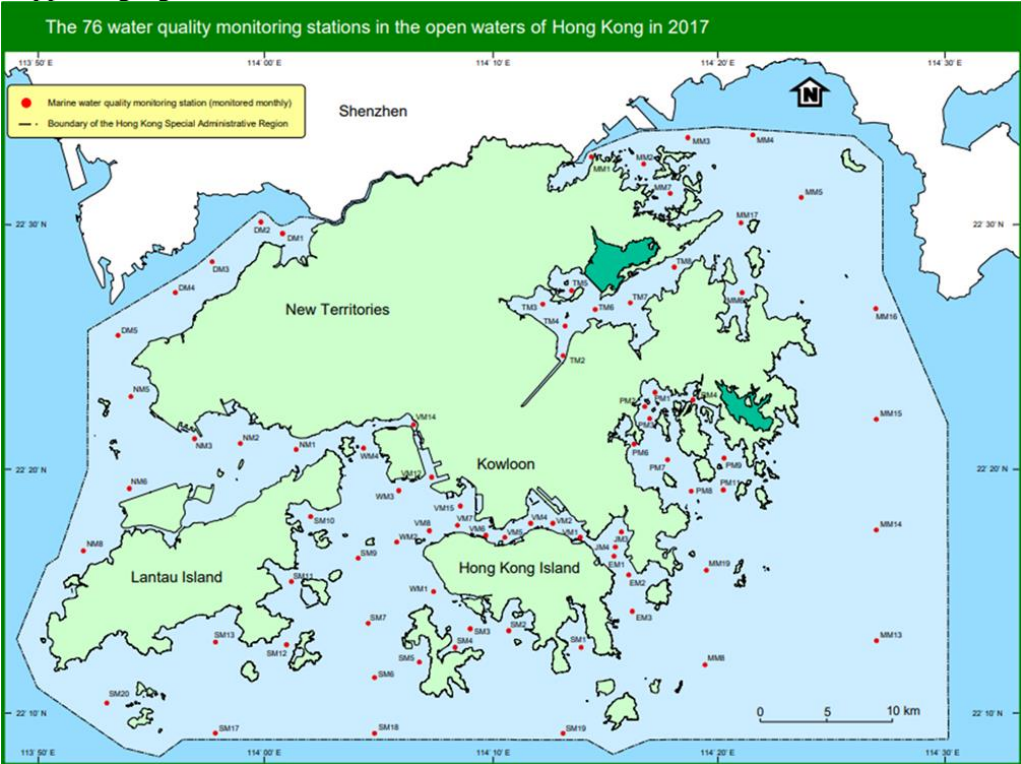
<p>The 76 water quality monitoring stations in the open waters of Hong Kong in 2017</p> <p><b>Southern(SM12) Surface Water</b>          Period: 2016-01-01 to 2017-12-31</p>

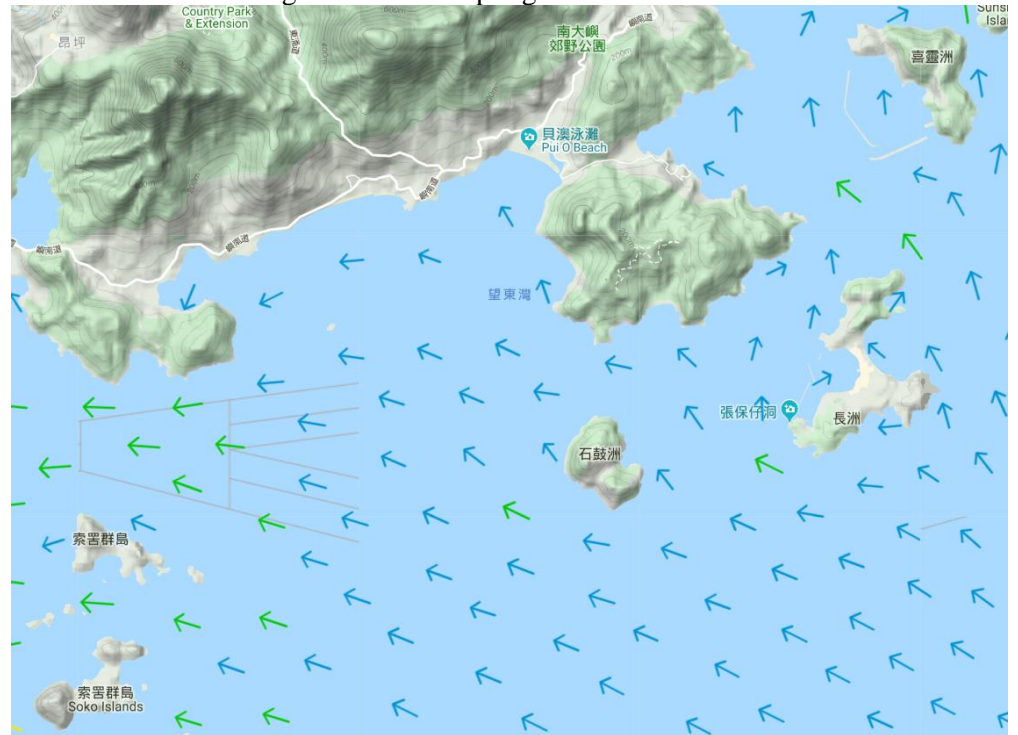
Current direction during mid-flood sampling on 05/11:

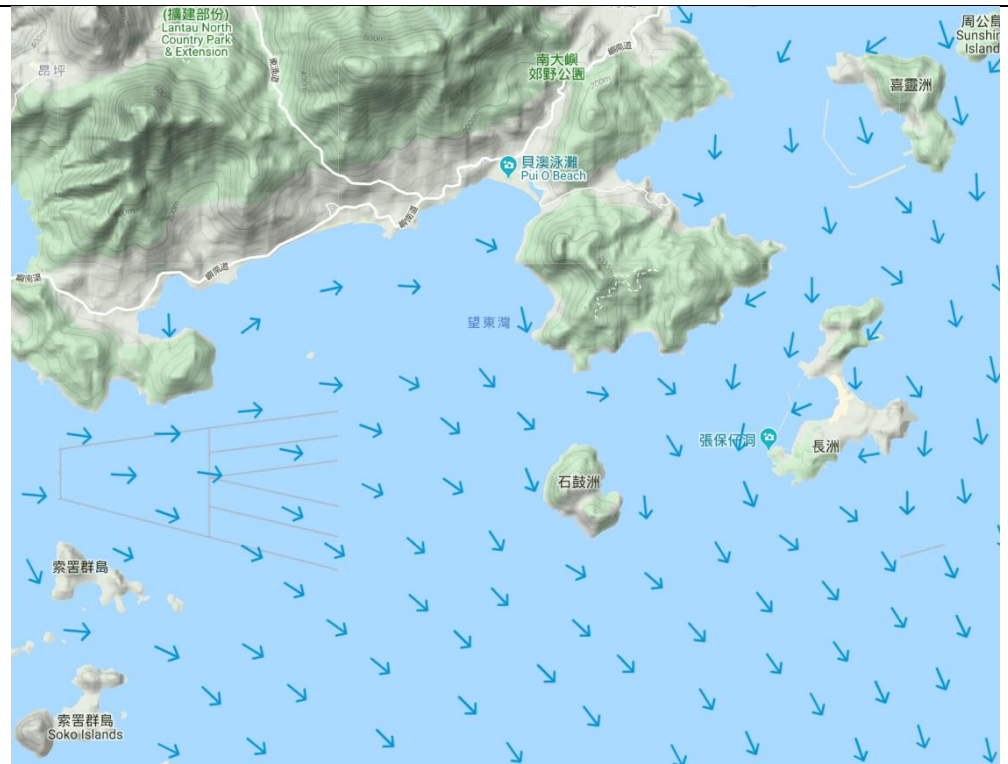
Current direction during mid-ebb sampling on 05/11:

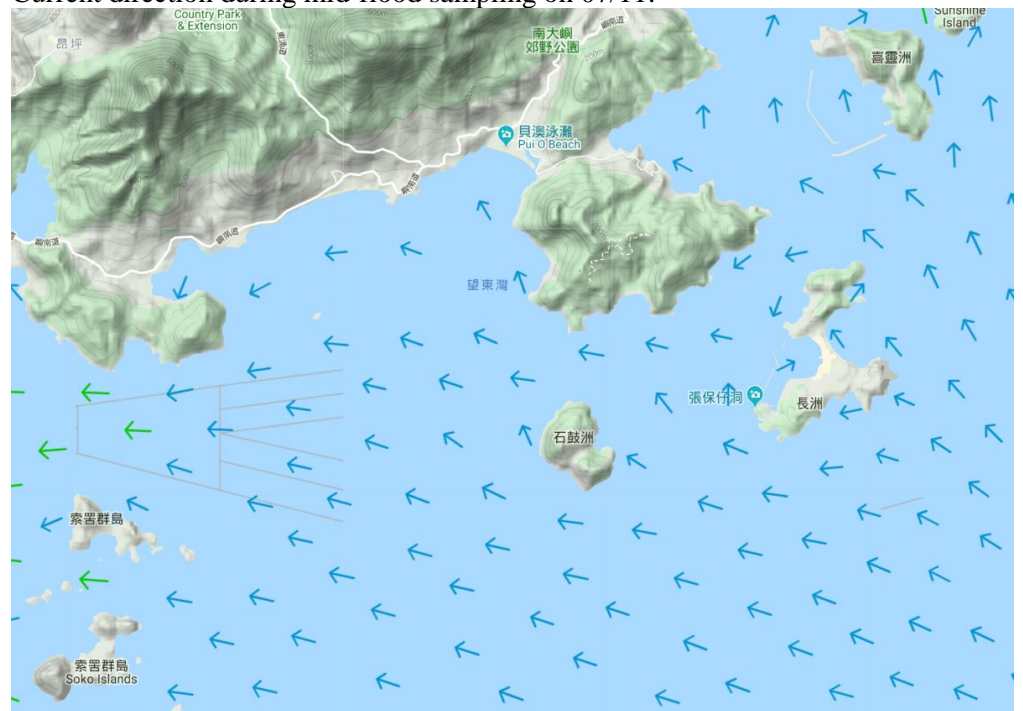
Current direction during mid-flood sampling on 07/11:

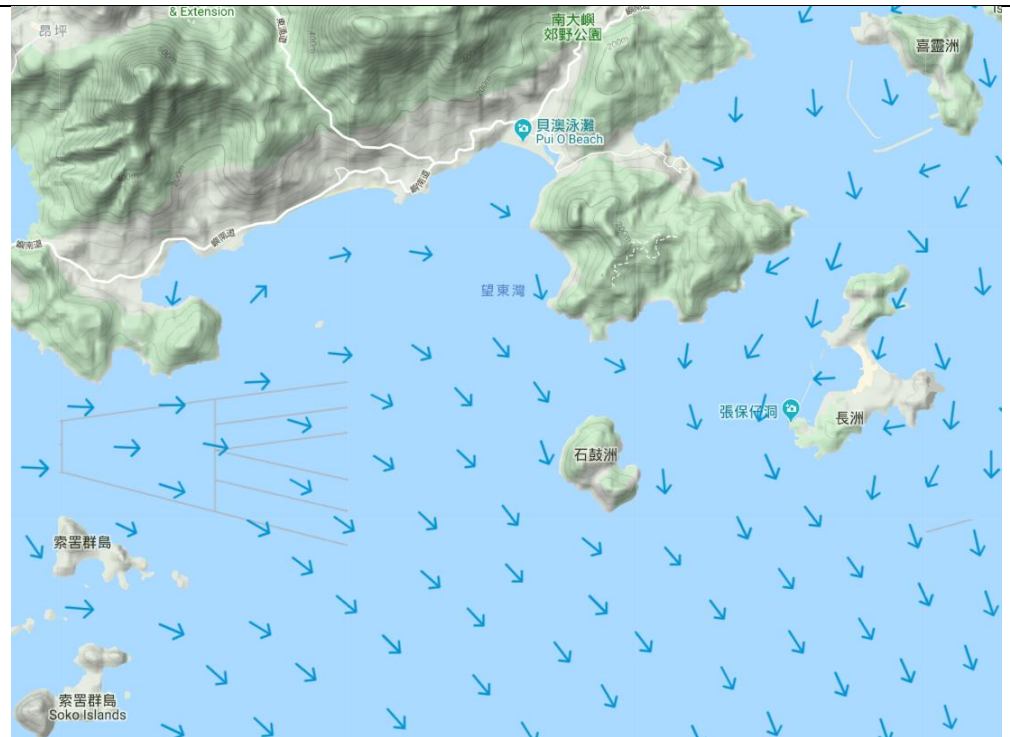
Current direction during mid-ebb sampling on 07/11:

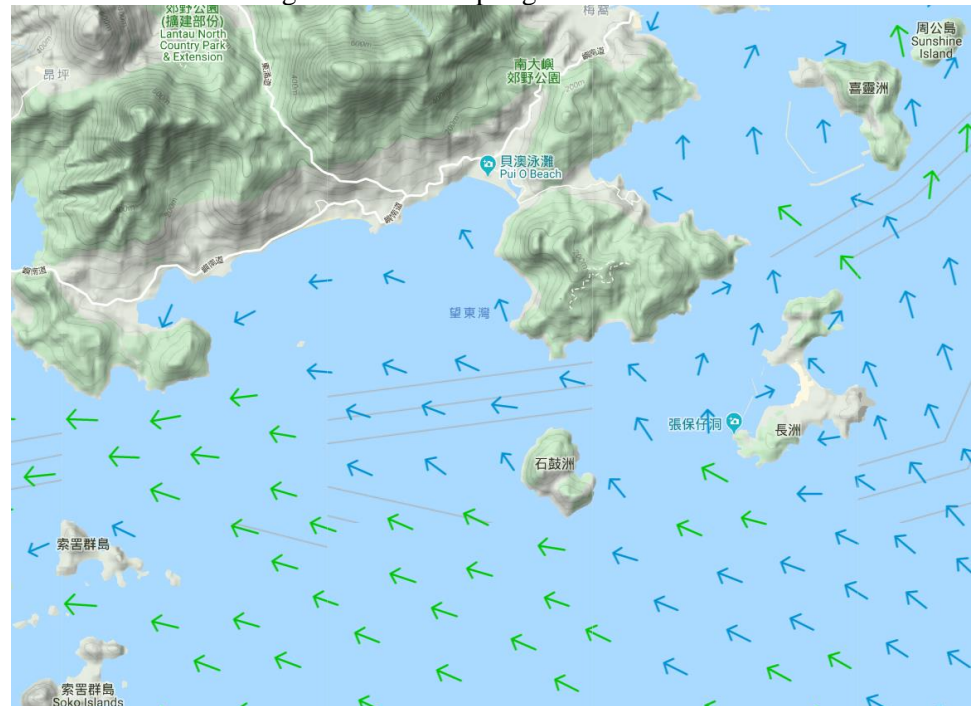
Current direction during mid-flood sampling on 09/11:

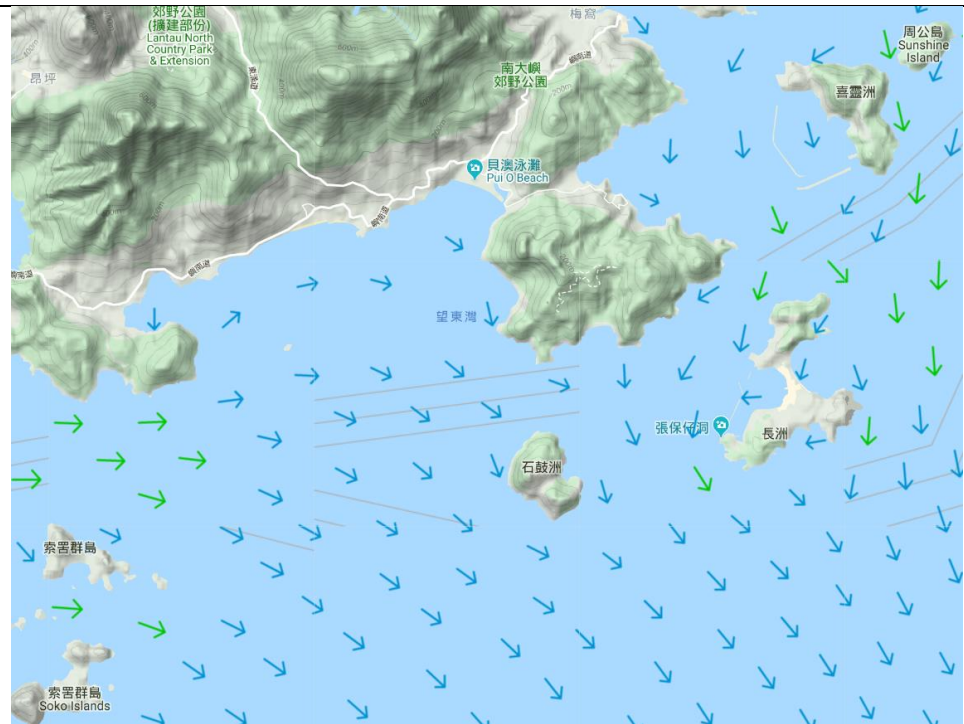
Current direction during mid-ebb sampling on 09/11:

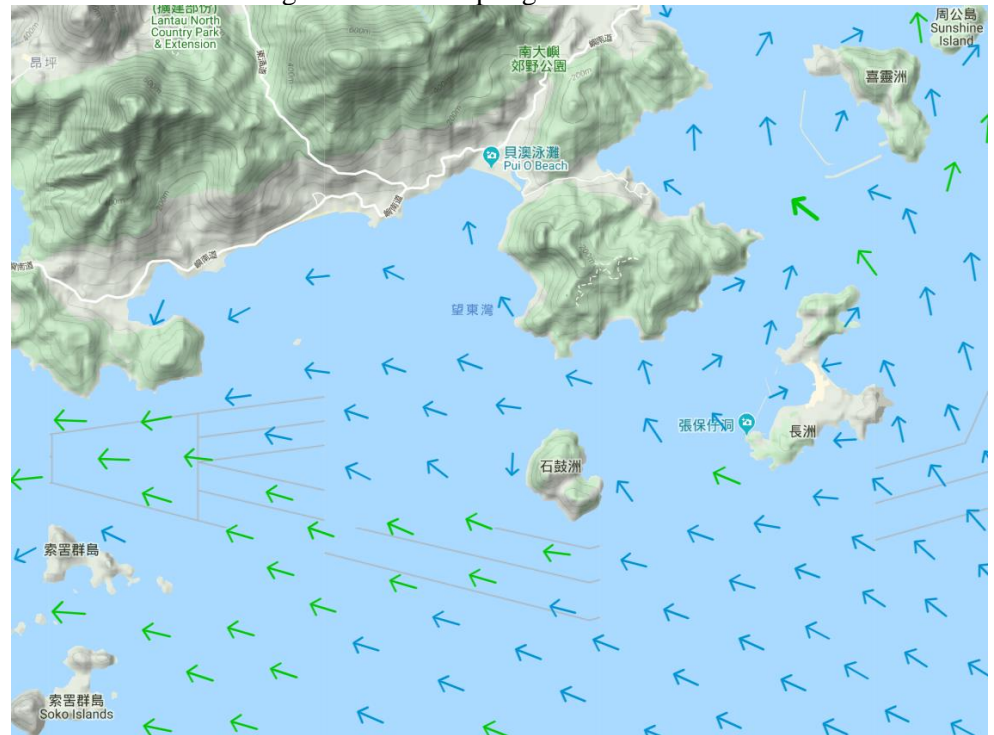
Current direction during mid-flood sampling on 11/11:

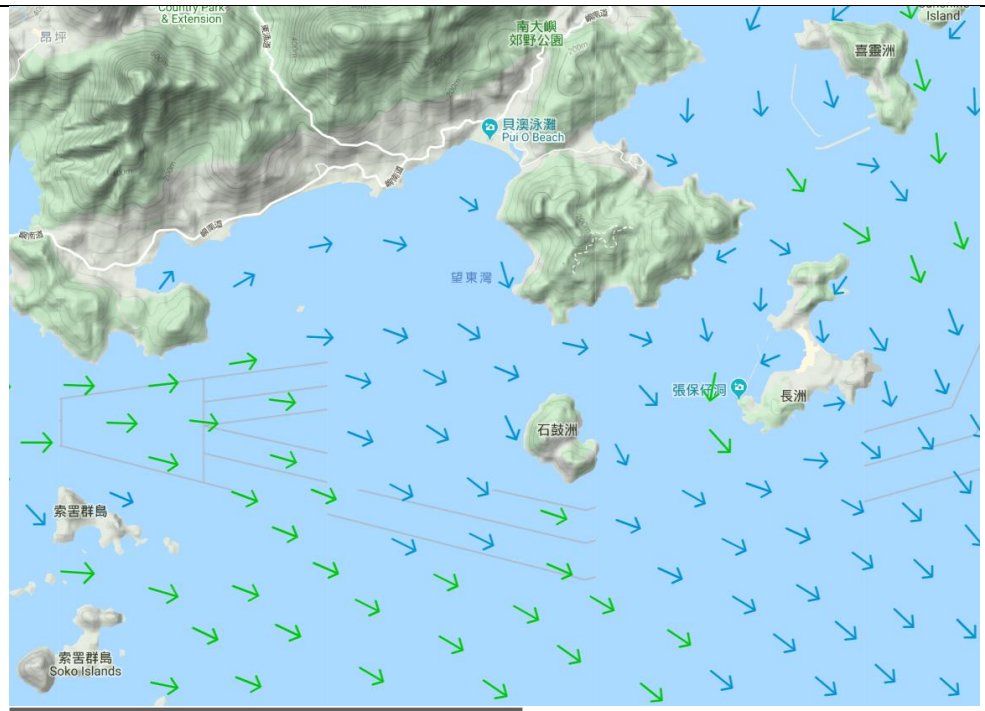
Current direction during mid-ebb sampling on 11/11:

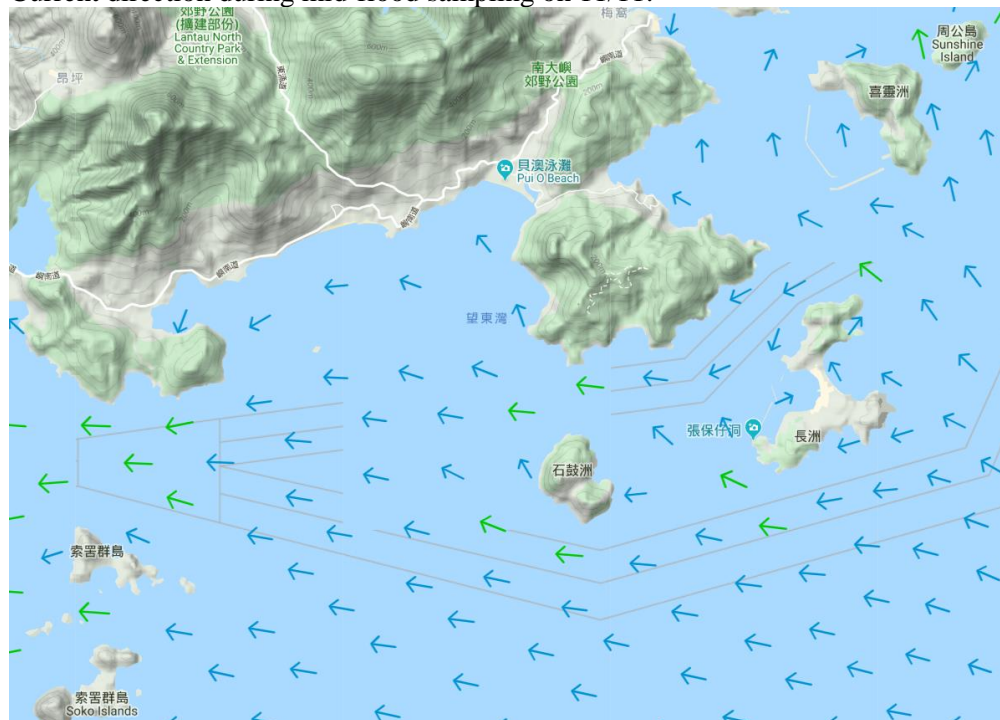
Current direction during mid-flood sampling on 11/11:

Legend			
Speed (knot)		Speed (knot)	
0-0.5	→	1.5-2.0	→
0.5-1.0	→	2.0-2.5	→
1.0-1.5	→	2.5 and above	→

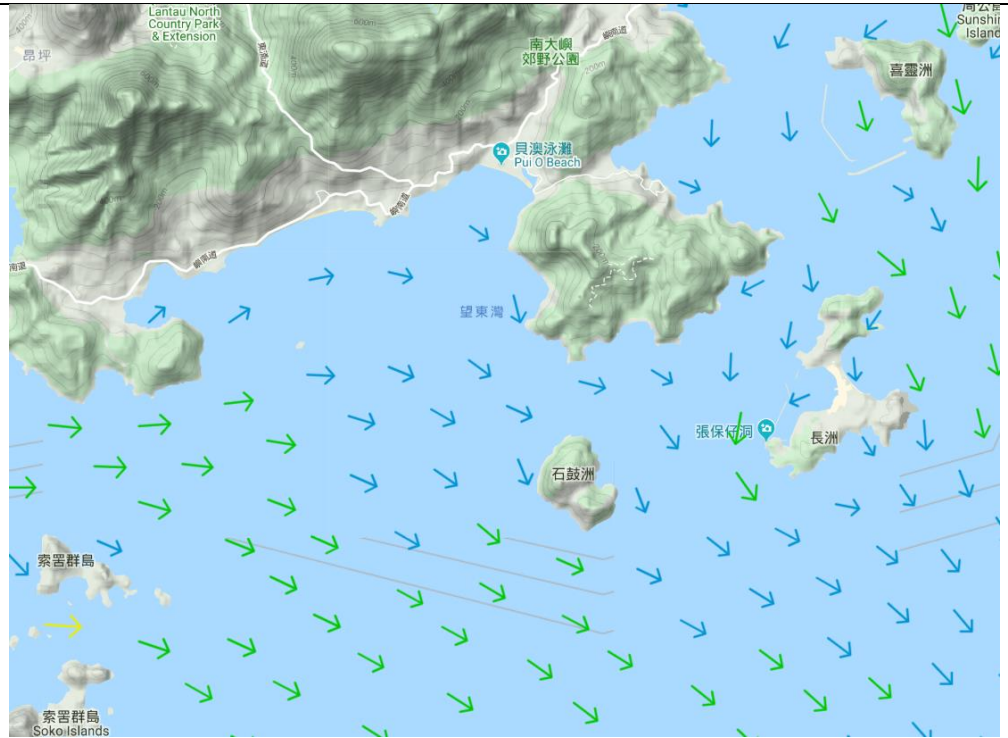
Actions taken / to be taken	Examination of environmental performance of the Project will be continued during the weekly inspection, and the Contractor is reminded to implement all applicable mitigation measures as per the Updated EM&A Manual.		
Remarks	Current direction during mid-ebb sampling on 22/11:

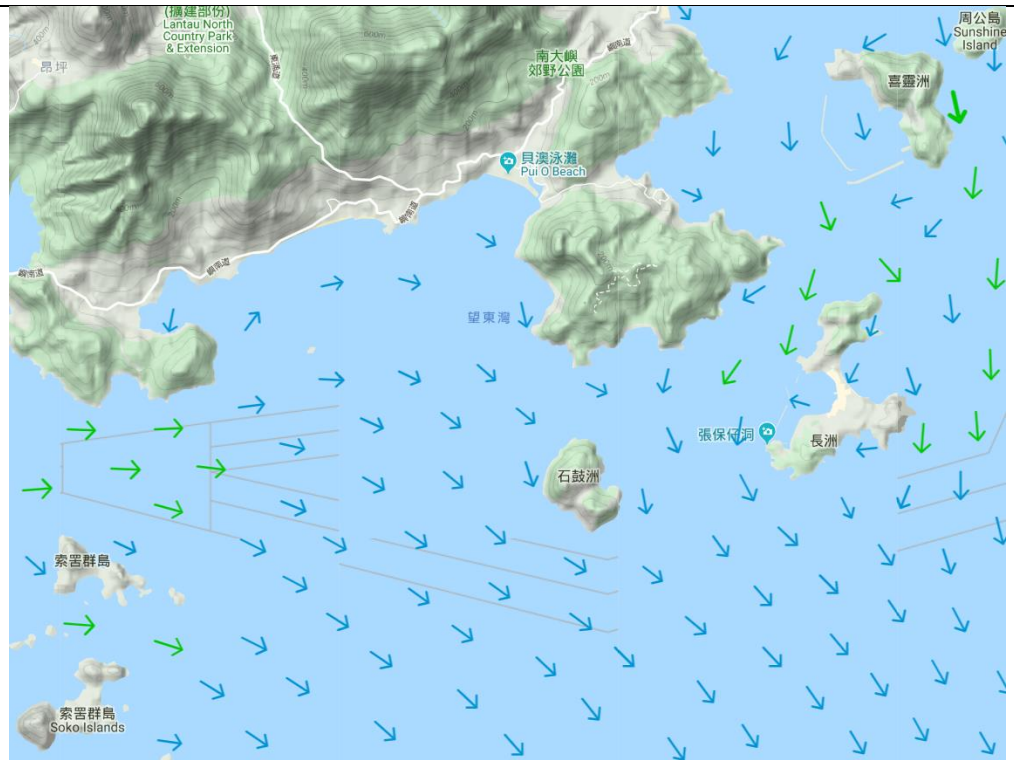
Current direction during mid-ebb sampling on 25/11:

Legend			
Speed (knot)		Speed (knot)	
0-0.5	→	1.5-2.0	→
0.5-1.0	→	2.0-2.5	→
1.0-1.5	→	2.5 and above	→

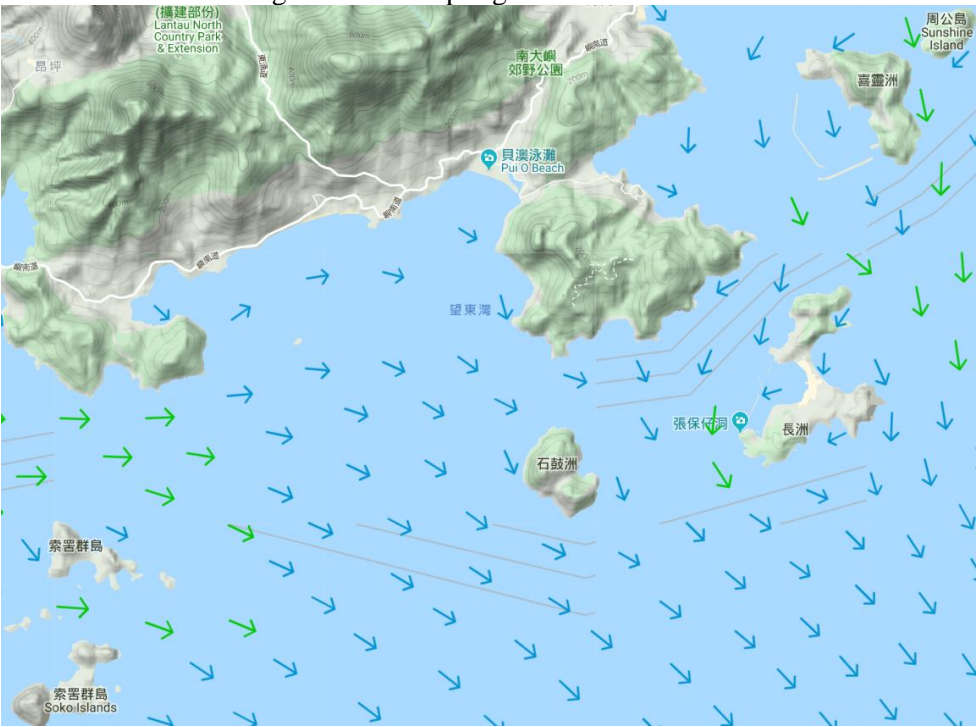
<p>Actions taken / to be taken</p>	<p>Examination of environmental performance of the Project will be continued during the weekly inspection, and the Contractor is reminded to implement all applicable mitigation measures as per the Updated EM&amp;A Manual.</p>
<p>Remarks</p>	<p>Current direction during mid-ebb sampling on 29/11:</p>
