Appendix N Exceedance Report

Incident Report on Action Level or Limit Level Non-compliance

Project	Integrated Waste Management Facilities, Phase 1		
Date	10 Feb 2020 (Lab result received on 13 Feb 2020)		
Time	11:37 – 15:07 (Mid-Ebb)		
Monitoring Location	Mid-Ebb B1, F1A & S1		
Parameter	Suspended Solid (SS)		
Action & Limit Levels	Action Level		Limit Level
	≥ 10.6 mg/L (120% of C1A)		≥ 11.5 mg/L (130% of C1A)
Measurement Level	Impact Station(s) of Exceedance	Control Stations	Impact Station(s) without Exceedance

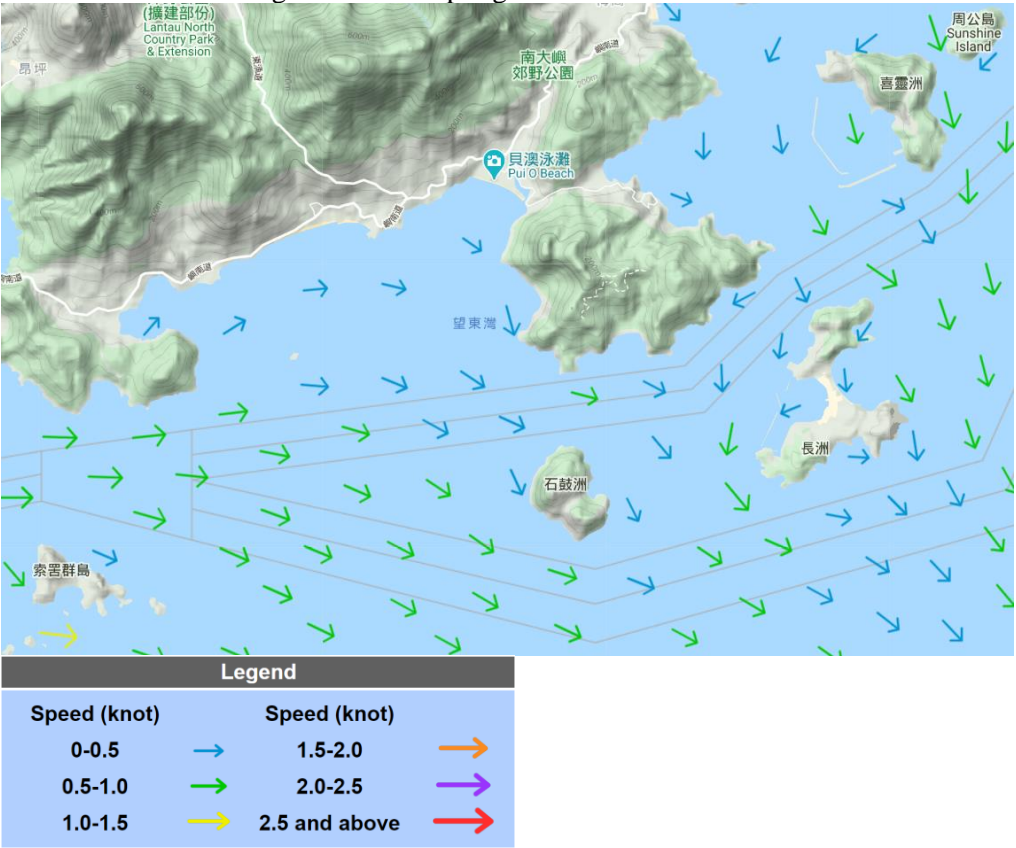
<p>Actions taken / to be taken</p>	<p>Examination of environmental performance of the Project will be continued during the weekly inspection, and the Contractor is reminded to implement all applicable mitigation measures as per the Updated EM&A Manual.</p>
<p>Remarks</p>	<p>Current direction during mid-ebb sampling on 10 Feb 2020:</p>

<p>(Sourced from http://current.hydro.gov.hk/en/map.html)</p>
<p>Prepared by</p>	<p>Polar Chan</p>
<p>Date</p>	<p>14 Feb 2020</p>

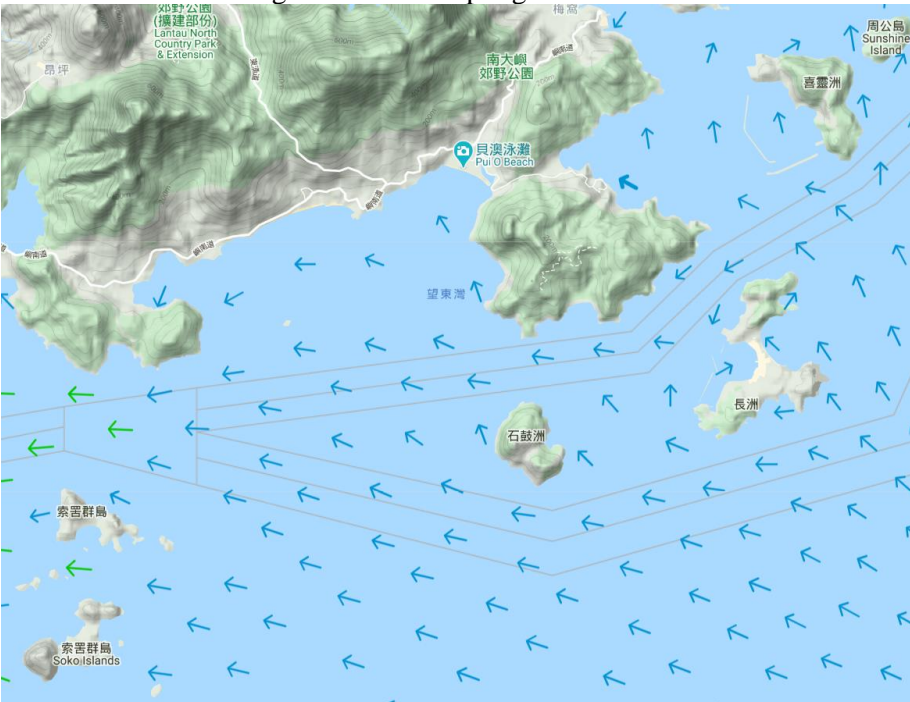
<p>Actions taken / to be taken</p>	<p>The frame of the silt curtain has been cleaned and installed to other barge on 13 Feb 2020 while standing by. The Contractor was reminded that the loose soil should be cleared to prevent falling into the water body.</p> <p>Examination of environmental performance of the Project will be continued during the weekly inspection, and the Contractor is reminded to implement all applicable mitigation measures as per the Updated EM&A Manual.</p>
<p>Remarks</p>	<p>Current direction during mid-flood sampling on 12 Feb 2020:</p>

<p>(Sourced from http://current.hydro.gov.hk/en/map.html)</p>	Legend				Speed (knot)		Speed (knot)		0-0.5	→	1.5-2.0	→	0.5-1.0	→	2.0-2.5	→	1.0-1.5	→	2.5 and above	→	
Legend																						
Speed (knot)		Speed (knot)																				
0-0.5	→	1.5-2.0	→																			
0.5-1.0	→	2.0-2.5	→																			
1.0-1.5	→	2.5 and above	→																			
Prepared by	Polar Chan																					
Date	18 Feb 2020

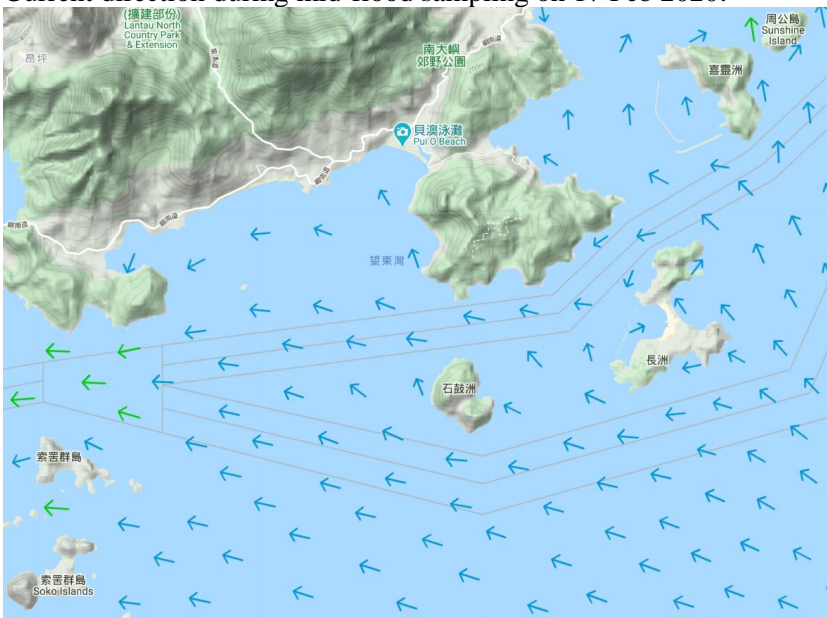
<p>Actions taken / to be taken</p>	<p>The frame of the silt curtain on GD-851 had been cleaned and installed to other barge on 13 Feb 2020 while standing by. The Contractor was reminded that the loose soil should be cleared to prevent falling into the water body.</p> <p>Examination of environmental performance of the Project will be continued during the weekly inspection, and the Contractor is reminded to implement all applicable mitigation measures as per the Updated EM&A Manual.</p>
<p>Remarks</p>	<p>Current direction during mid-flood sampling on 17 Feb 2020:</p>

<p>(Sourced from http://current.hydro.gov.hk/en/map.html)</p>
<p>Prepared by</p>	<p>Polar Chan</p>
<p>Date</p>	<p>20 Feb 2020</p>
