Appendix N Exceedance Report

Incident Report on Action Level or Limit Level Non-compliance

Project	Integrated Waste Management Facilities, Phase 1		
Date	11 Mar 2021 (Lab result received on 15 Mar 2021)		
Time	15:07 – 18:37 (Mid Flood)		
Mid-Flood			
Monitoring Location	B1, B3

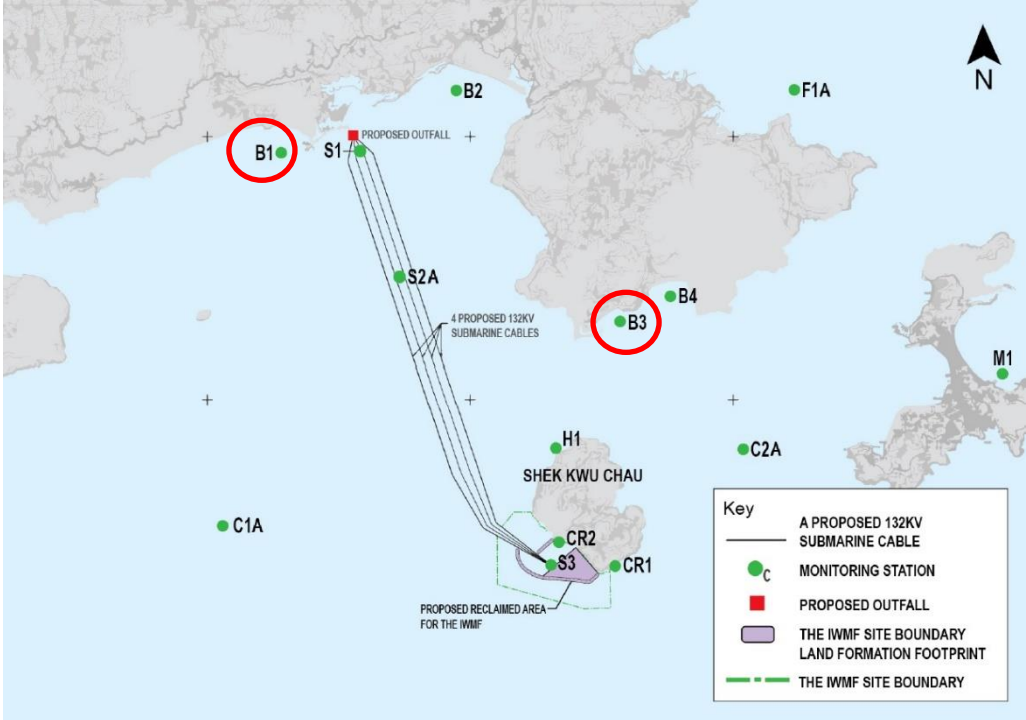
Parameter	Suspended Solid (SS)		
Action & Limit Levels	Action Level		Limit Level
	≥ 8.0 mg/L		≥ 10.0 mg/L
Measurement Level	Impact Station(s) of Exceedance	Control Stations	Impact Station(s) of Exceedance

8.0 mg/L (B1) 8.3 mg/L (B3)	5.7 mg/L (C1A) 6.2 mg/L (C2A)	7.3 mg/L (B2) 7.0 mg/L (B4) 7.0 mg/L (F1A) 7.3 mg/L (H1) 6.5 mg/L (M1) 7.0 mg/L (CR1) 6.0 mg/L (CR2)
Possible reason for Action or Limit Level Non-compliance	<p>Works scheduled on site on 11 Mar 2021 include reclamation works, laying of rockfill and caisson installation.</p> <p>Dominating sea current direction was found to be from Southeast to Northwest at waters around Shek Kwu Chau.</p> <p>B1 and B3 are located at unrelated stream direction (neither upstream nor downstream, far away) to the works location, exceedance of this monitoring station is deemed to be unrelated to the Project.</p> <p>Silt curtain checking by the Contractor was implemented on Marine Access (11 Mar 2021, 08:30am) and checking results showed that no deficiency of silt curtain was found on that day.</p> <p>From MMO monitoring records on 11 Mar 2021, MMO team was arranged for one</p>

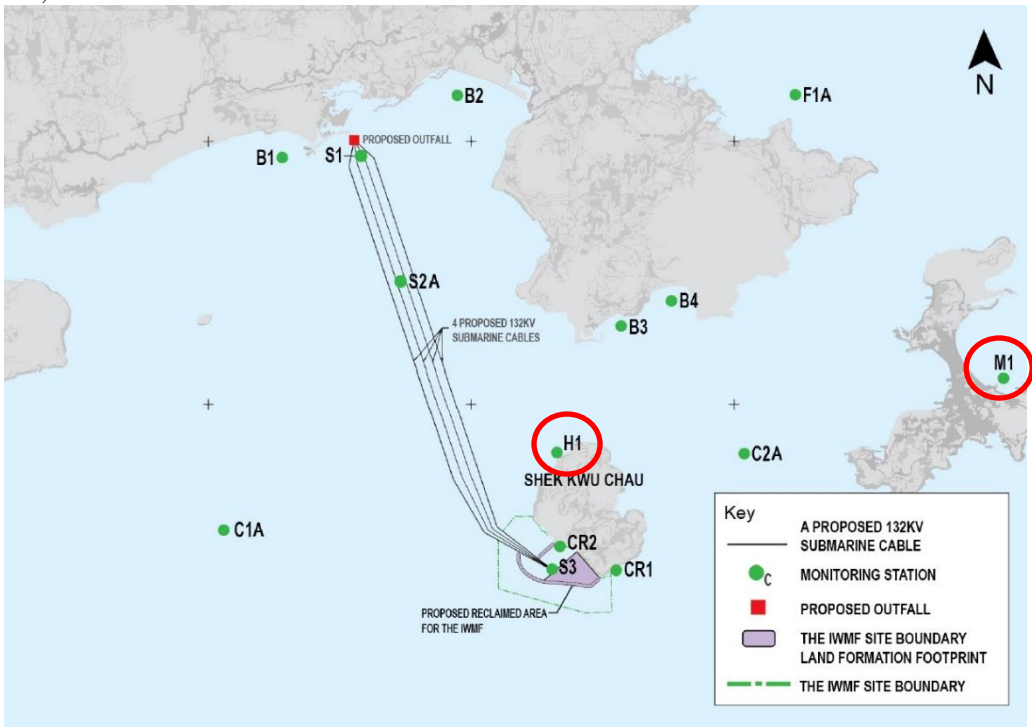
Project	Integrated Waste Management Facilities, Phase 1		
Date	13 Mar 2021 (Lab result received on 16 Mar 2021)		
Time	10:45 – 14:15 (Mid-Ebb) 15:30 – 19:00 (Mid Flood)		
Mid-Ebb			
Monitoring Location	H1, M1

Parameter	Suspended Solid (SS)		
Action & Limit Levels	Action Level		Limit Level
	≥ 8.0 mg/L		≥ 10.0 mg/L
Measurement Level	Impact Station(s) of Exceedance	Control Stations	Impact Station(s) without Exceedance

9.7 mg/L (H1) 8.0 mg/L (M1)	5.8 mg/L (C1A) 5.3 mg/L (C2A)	5.5 mg/L (B1) 6.0 mg/L (B2) 5.3 mg/L (B3) 5.3 mg/L (B4) 5.8 mg/L (F1A) 6.0 mg/L (CR1) 5.2 mg/L (CR2)
Possible reason for Action or Limit Level Non-compliance	<p>Works scheduled on site on 13 Mar 2021 include reclamation works, laying of rockfill and caisson installation.</p> <p>Dominating sea current direction was found to be from Northwest to Southeast at waters around Shek Kwu Chau.</p> <p>H1 and M1 are located at unrelated stream direction (neither upstream nor downstream, far away) to the works location, exceedance of this monitoring station is deemed to be unrelated to the Project.</p> <p>Silt curtain checking by the Contractor was implemented on Marine Access (13 Mar 2021, 08:30am) and checking results showed that no deficiency of silt curtain was found on that day.</p>

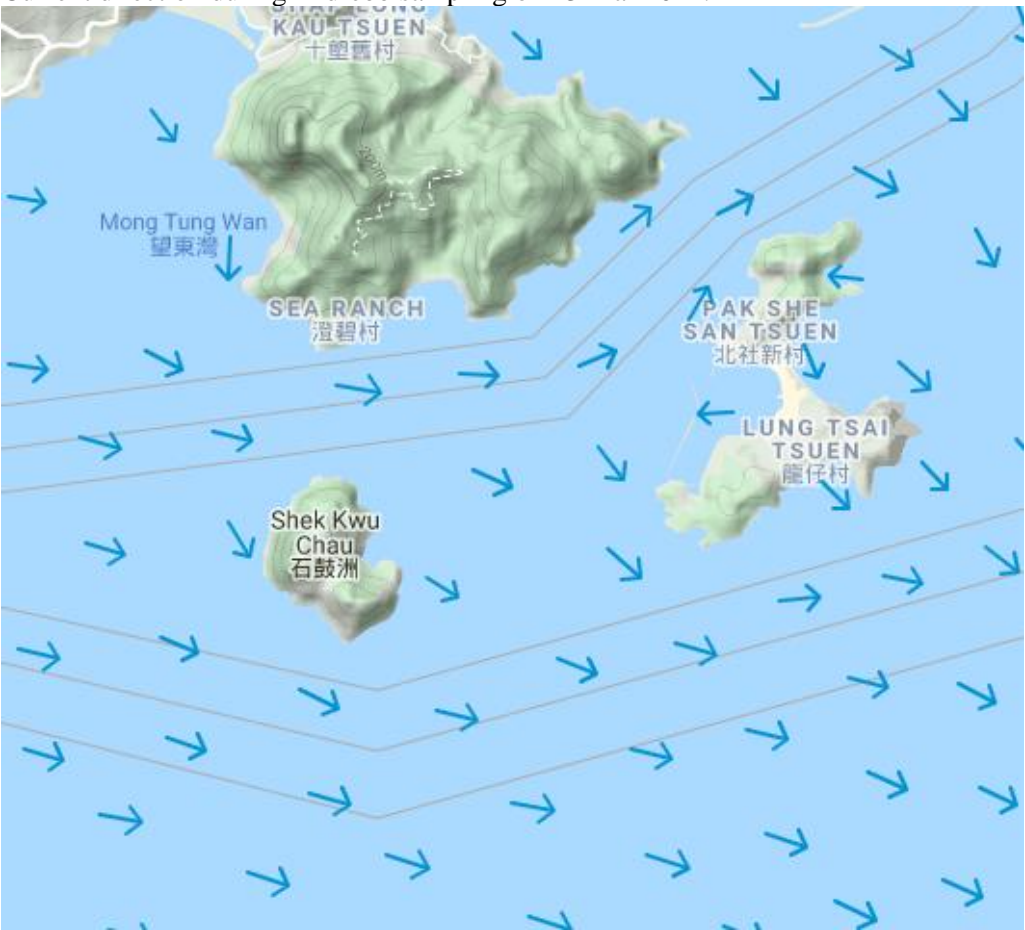
Dominating sea current direction was found to be from Southeast to Northwest at waters around Shek Kwu Chau.

<p>Remarks</p>	<p>Current direction during mid-ebb sampling on 13 Mar 2021:</p>

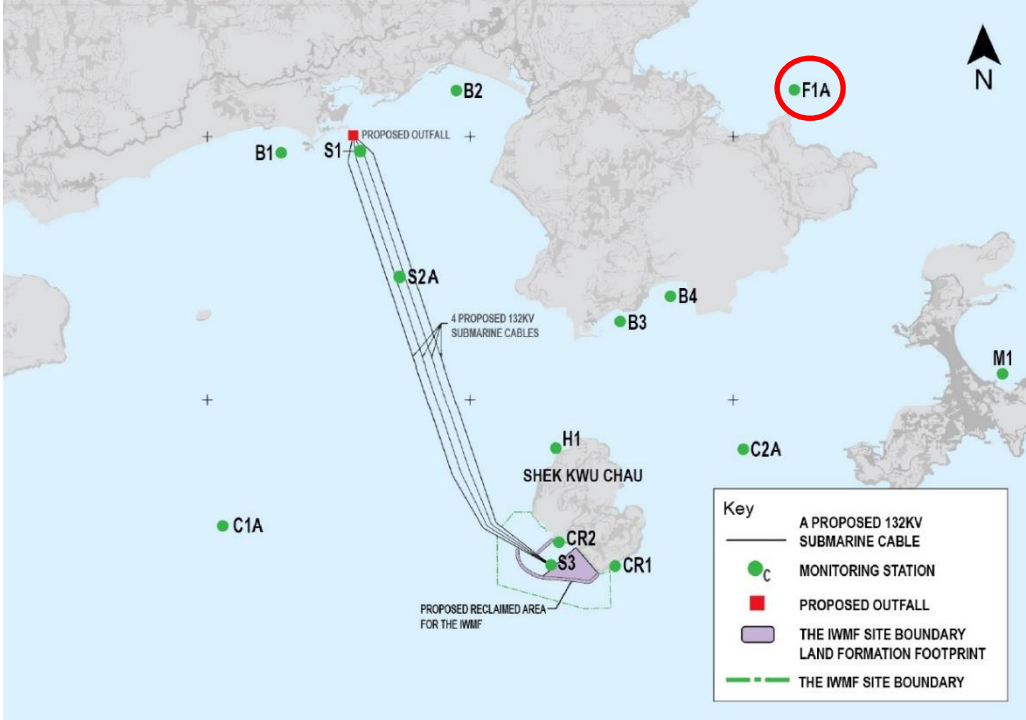
Project	Integrated Waste Management Facilities, Phase 1		
Date	24 Mar 2021 (Lab result received on 29 Mar 2021)		
Time	08:00-11:30 (Mid Flood)		
Mid-Flood			
Monitoring Location	F1A

Parameter	Suspended Solid (SS)		
Action & Limit Levels	Action Level		Limit Level
	≥ 8.0 mg/L		≥ 10.0 mg/L
Measurement Level	Impact Station(s) of Exceedance	Control Stations	Impact Station(s) of Exceedance

8.5 mg/L (F1A)	5.7 mg/L (C1A) 6.5 mg/L (C2A)	6.5 mg/L (B1) 5.5 mg/L (B2) 5.3 mg/L (B3) 7.0 mg/L (B4) 6.7 mg/L (H1) 4.2 mg/L (M1) 4.3 mg/L (CR1) 6.0 mg/L (CR2)
Possible reason for Action or Limit Level Non-compliance	<p>Works scheduled on site on 24 Mar 2021 include reclamation works, laying of rockfill and caisson installation.</p> <p>Dominating sea current direction was found to be from Southeast to Northwest at waters around Shek Kwu Chau.</p> <p>F1A is located at unrelated stream direction (neither upstream nor downstream, far away) to the works location, exceedance of this monitoring station is deemed to be unrelated to the Project.</p> <p>The installation of caisson No.19 was completed on 18 Mar 2021, the reclamation area was enclosed. Floating type silt curtain at marine access was abandoned, thus no silt curtain checking was conducted by contractor.</p>
